# **LIDAR Inspection Report of Box Culvert ch.938+911**

**Bridge Chainage:** 938+911

- **Bridge No:** -
- **Chainage:** 938+911
- **Structure type:** Box Culvert

- **CKRP:** Chittorgarh to kota
- **State:** Rajasthan NH 27
- **Zone:** RJ-20

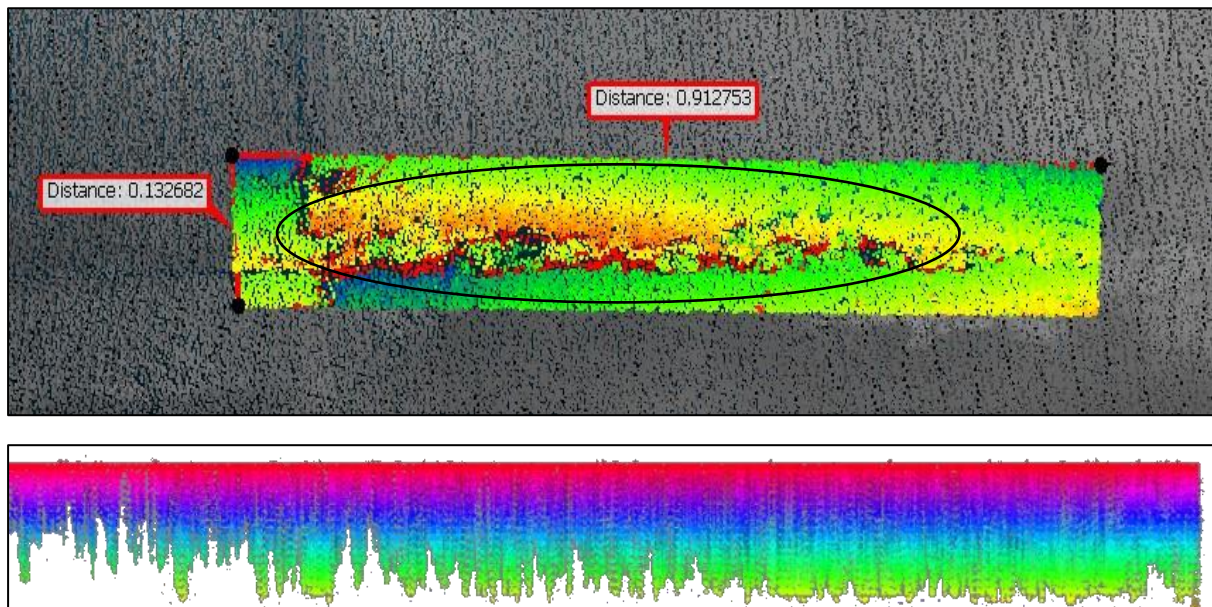
| Element Name | Observation | Location of Distress | Photo No. | Units | Distress Details | | | Area of Repair (Sq.m/R MT/m3) |
|---|---|---|---|---|---|---|---|---|
| Abutment 1 | Scalling | - | 1 | Sq m | 0.91 | 0.13 | - | 0.118 |

**1. Scaling observed on Abutment 1 LHS side, measuring 0.91 m in length and 0.13 m in width, covering an area of 0.118 m<sup>2</sup>.**
