# **LIDAR Inspection Report of Slab Culvert ch.939+917**

**Bridge Chainage:** 939 + 917 (CKRP)

- **CKRP:** Chittorgarh to kota
- **State:** Rajasthan NH 27
- **Zone:** RJ-06

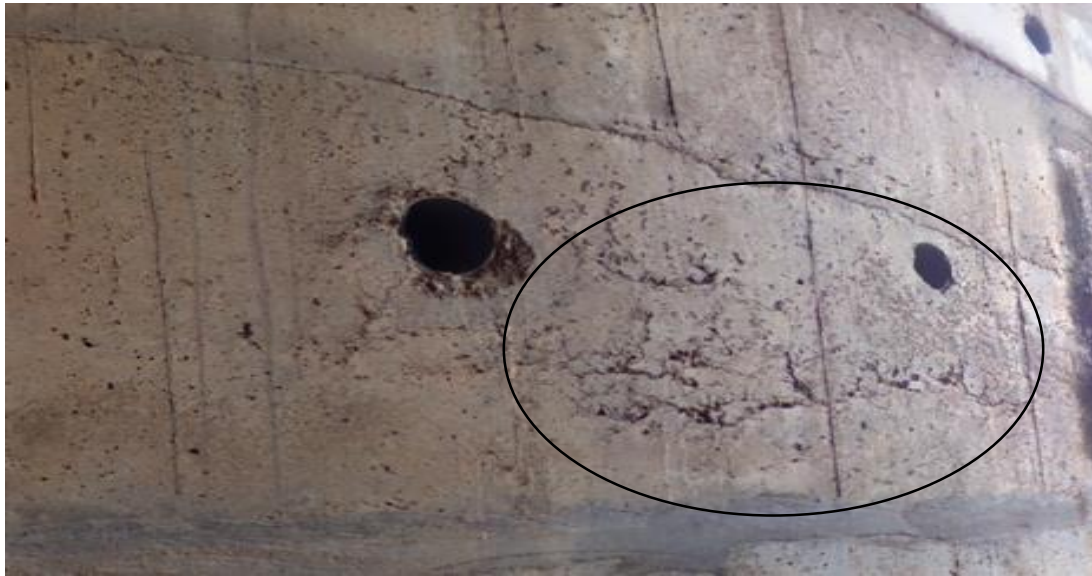
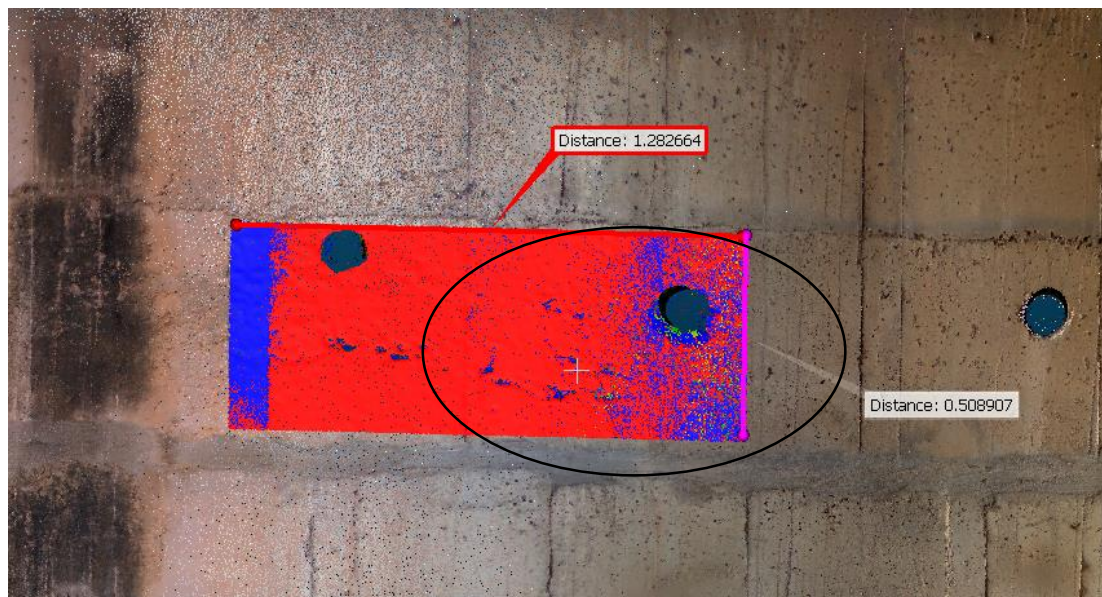
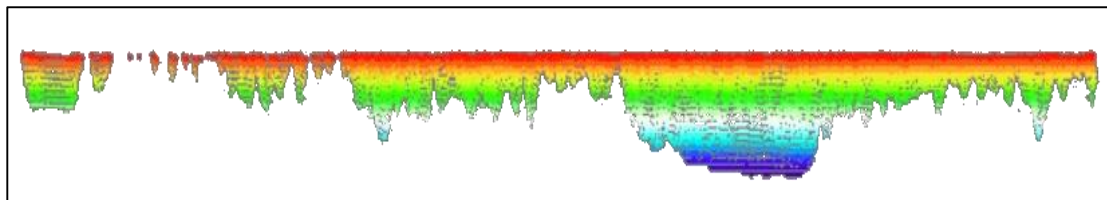
| Element Name | Observation | Location of Distress | Photo No. | Units | Distress Details | | | Area of Repair<br>(Sq.m/R MT/m3) |
|---|---|---|---|---|---|---|---|---|
| Abutment 2 | Scaling | | 1 | M | 1.28 | 0.50 | | 0.64 |

**1. Scaling observed on LHS Abutment 2 , measuring 1.28 m in length and 0.50 m in width, covering an area of 0.64 m<sup>2</sup>.**

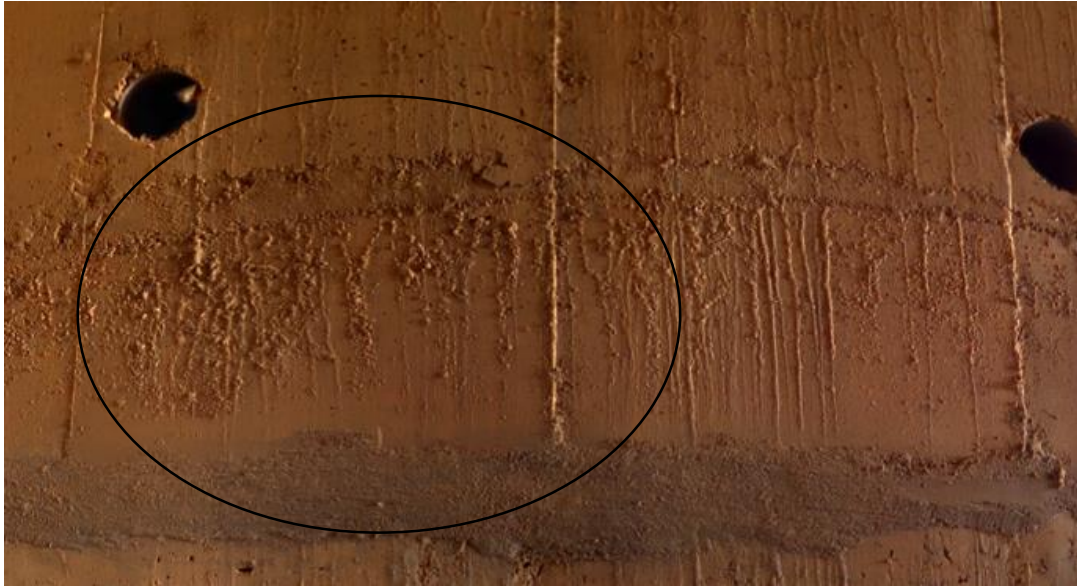
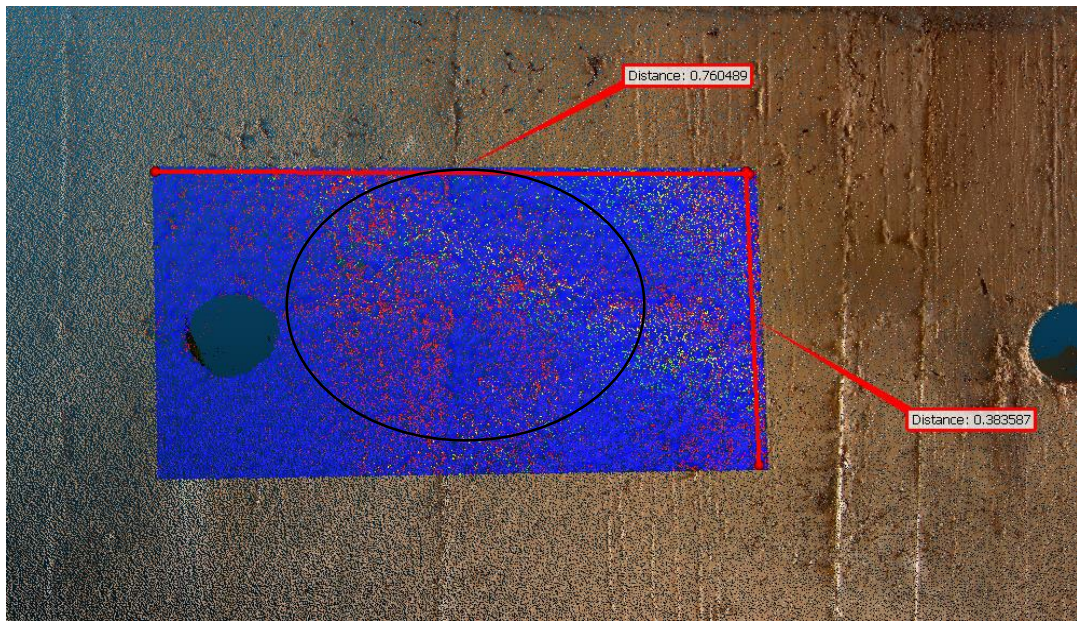
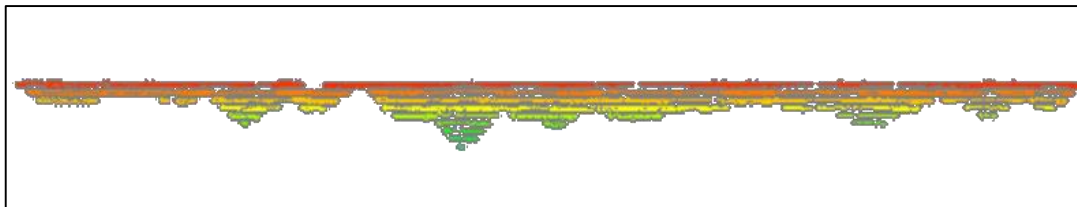
| Element Name | Observation | Location of Distress | Photo No. | Units | Distress Details | | | Area of Repair<br>(Sq.m/R MT/m3) |
|---|---|---|---|---|---|---|---|---|
| Abutment 2 | Scaling | | 2 | M | 0.76 | 0.38 | | 0.2888 |

**2. Scaling observed on LHS Abutment 2 , measuring 0.76 m in length and 0.38 m in width, covering an area of 0.2888 m<sup>2</sup>.**

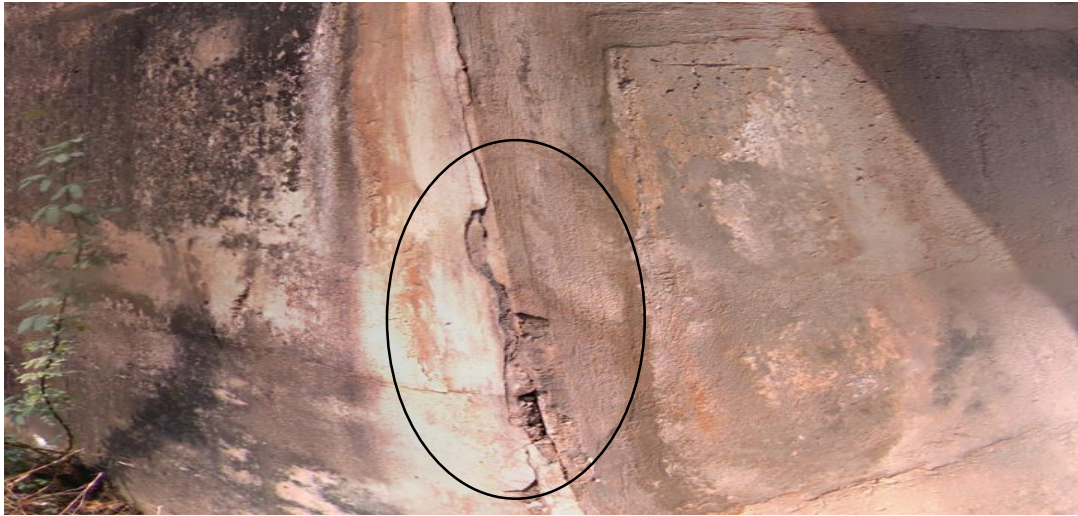
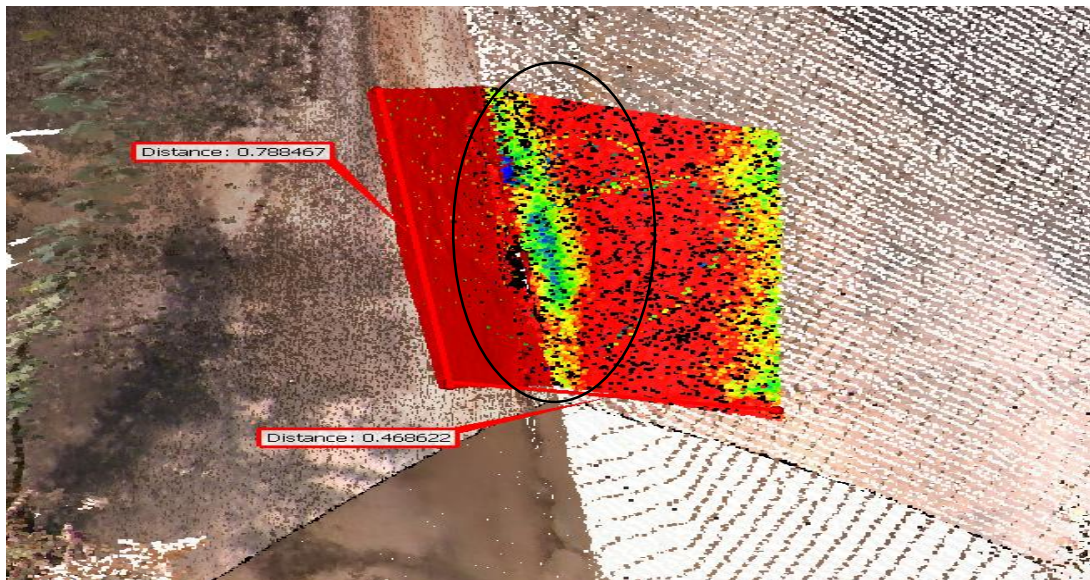
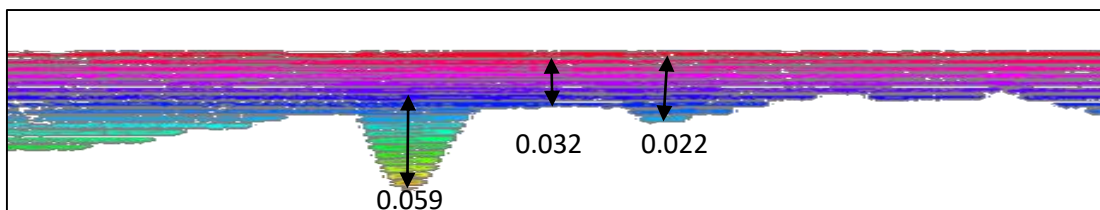
| Element Name | Observation | Location of Distress | Photo No. | Units | Distress Details | | | Area of Repair<br>(Sq.m/RMT/m3) |
|---|---|---|---|---|---|---|---|---|
| Abutment 1 | Hollow Section | | 3 | M | 0.78 | 0.46 | 0.031 | 0.0111 |

**3. Hollow section observed on RHS Abutment 1, measuring 0.78 m in length and 0.46 m in width, Depth ranges from 0.019 m (min) to 0.058 m (max), with an average depth of 0.031 m. The calculated volume of the distress is 0.0111 m<sup>3</sup>.**

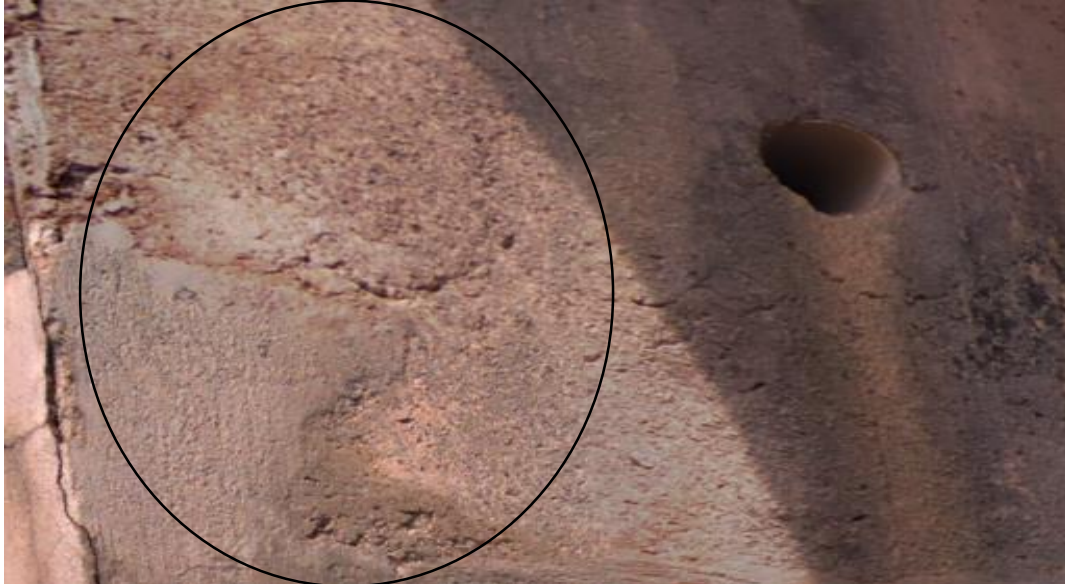
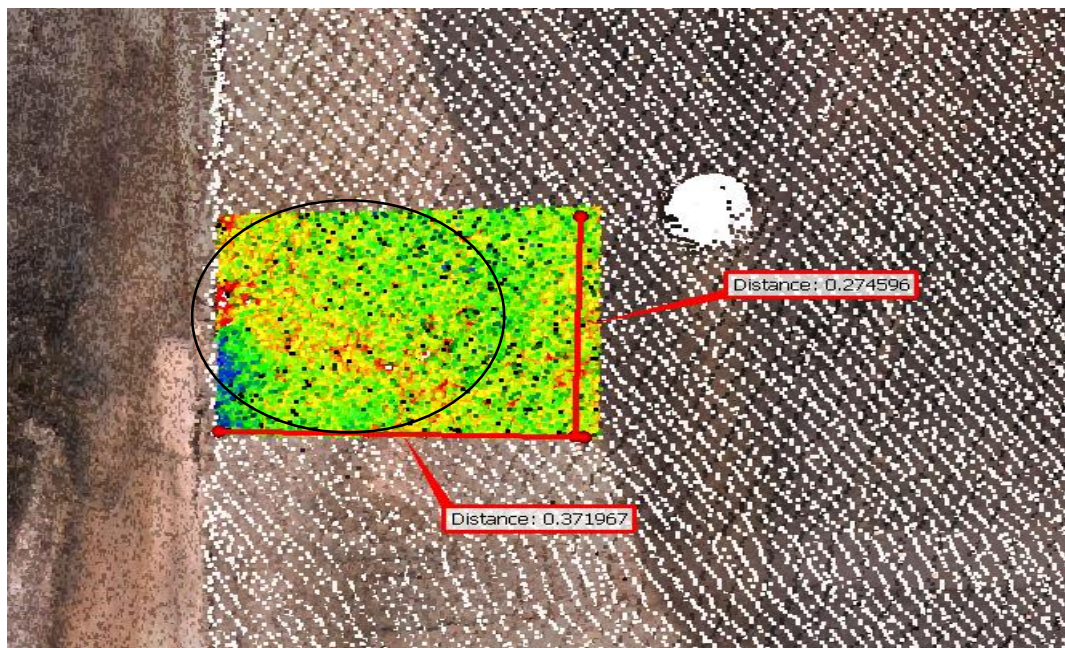
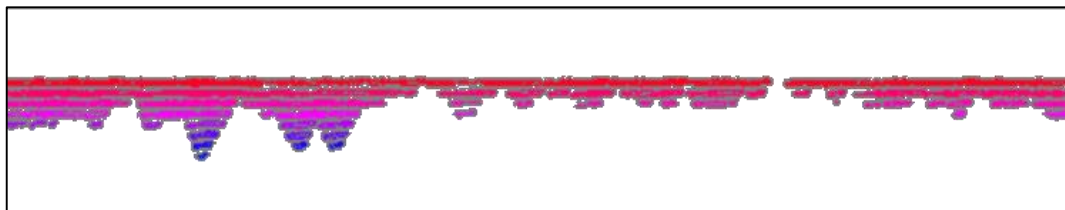
| Element Name | Observation | Location of Distress | Photo No. | Units | Distress Details | | | Area of Repair<br>(Sq.m/RMT/m3) |
|---|---|---|---|---|---|---|---|---|
| Abutment 1 | Scaling | | 4 | M | 0.37 | 0.27 | | 0.0999 |

**4. Scaling observed on RHS Abutment 1 , measuring 0.37 m in length and 0.27 m in width, covering an area of 0.0999 m<sup>2</sup>.**
