# **LIDAR Inspection Report of Box Culvert ch.939+208**

**Bridge Chainage:** 939+208

- **Bridge No:** -
- **Chainage:** 939+208
- **Structure type:** Box Culvert

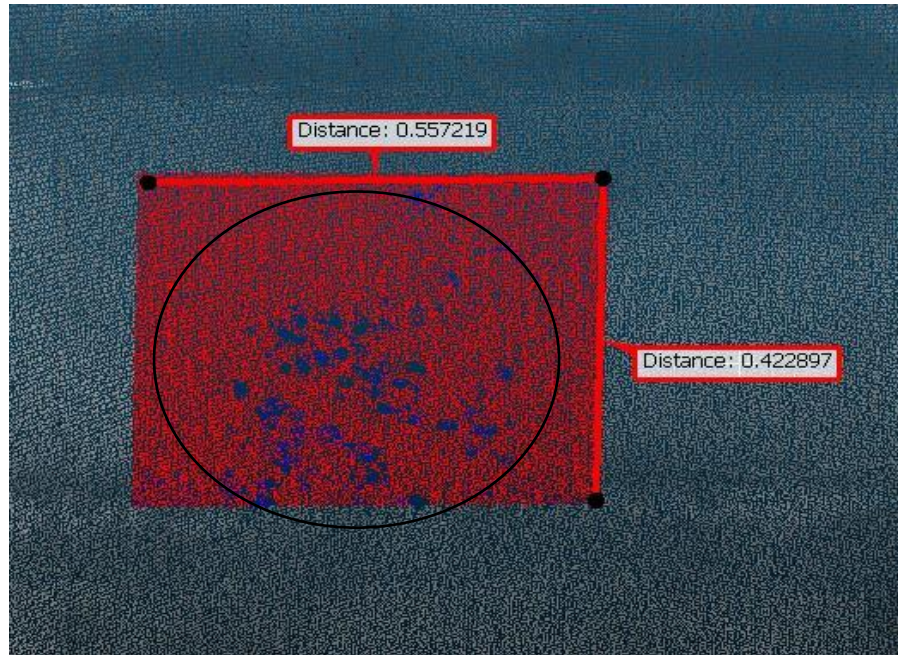
| Element Name | Observation | Location of Distress | Photo No. | Units | Distress Details | | | Area of Repair (Sq.m/R MT/m3) |
|---|---|---|---|---|---|---|---|---|
| Abutment 1 | Scalling | - | 1 | Sq m | 0.55 | 0.42 | - | 0.23 |

**1. Scaling observed on abutment 1 LHS side, measuring 0.55 m in length and 0.42 m in width, covering an area of 0.23 m<sup>2</sup>.**

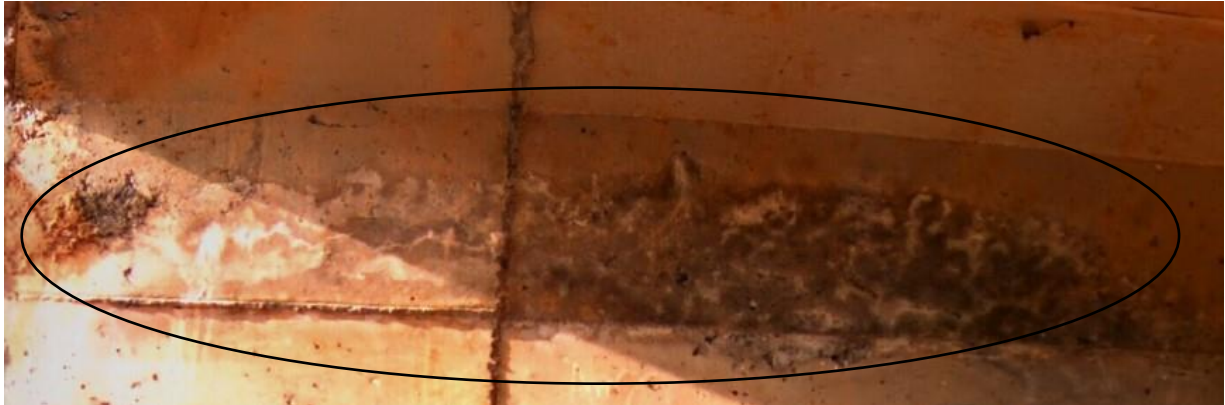
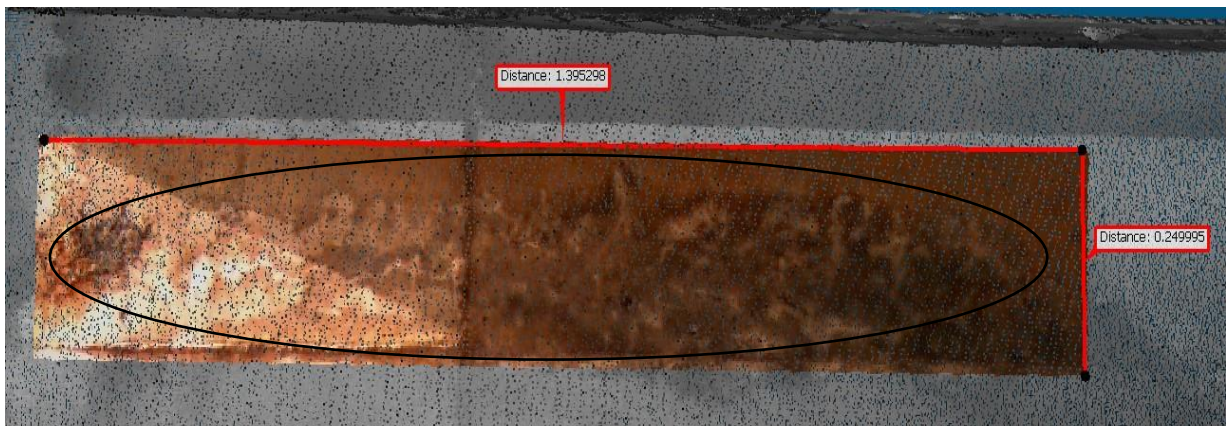
| Element Name | Observation | Location of Distress | Photo No. | Units | Distress Details | | | Area of Repair (Sq.m/R MT/m3) |
|---|---|---|---|---|---|---|---|---|
| Abutment 2 | Efflorescence | - | 2 | Sq m | 1.39 | 0.24 | - | 0.33 |

**2. Efflorescence observed on abutment 2 RHS side, measuring 1.39 m in length and 0.24 m in width, covering an area of 0.33 m<sup>2</sup>.**
