# **LIDAR Inspection Report of Box Culvert ch.939+350**

**Bridge Chainage:** 939+350

- **Bridge No:** -
- **Chainage:** 939+350
- **Structure type:** Box Culvert

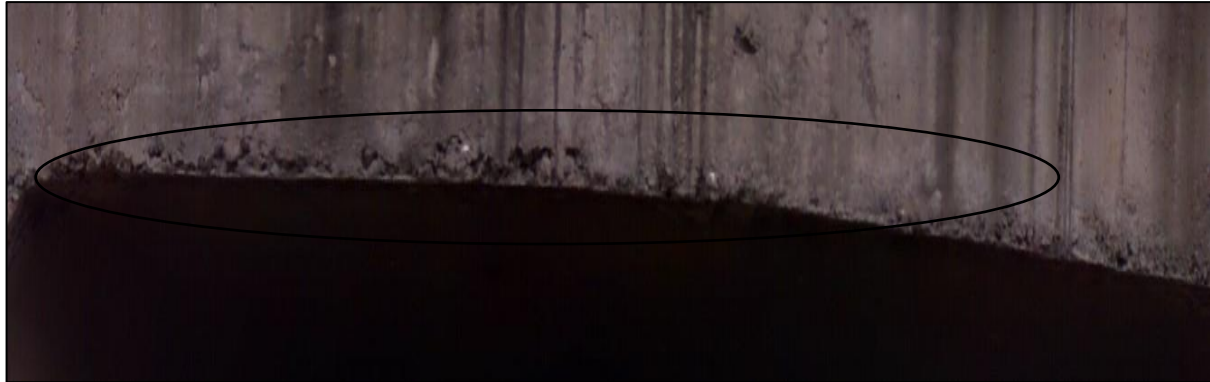
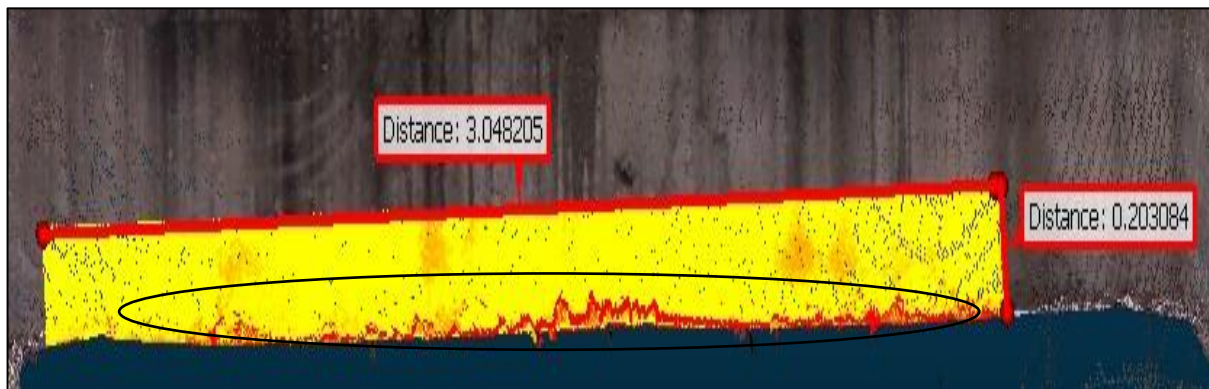
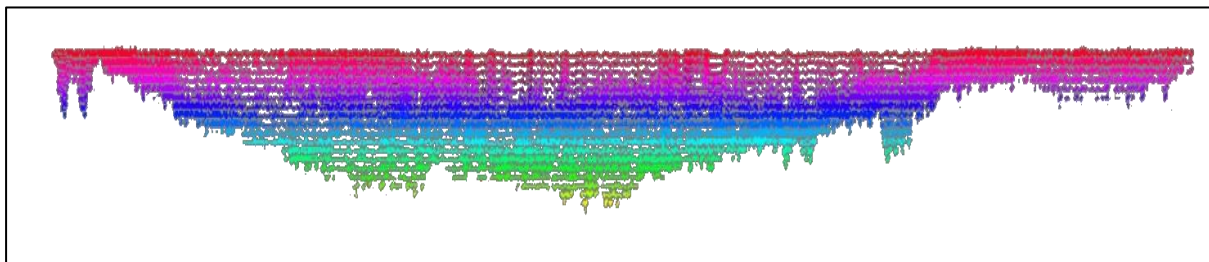
| Element Name | Observation | Location of Distress | Photo No. | Units | Distress Details | | | Area of Repair (Sq.m/R MT/m3) |
|---|---|---|---|---|---|---|---|---|
| Parapet Wall | HoneyCombing | - | 1 | Sq m | 3.04 | 0.20 | - | 0.60 |

**1.Honeycombing observed on parapet wall LHS, measuring 3.04 m in length and 0.20 m in width, covering an area of 0.60 m<sup>2</sup>.**

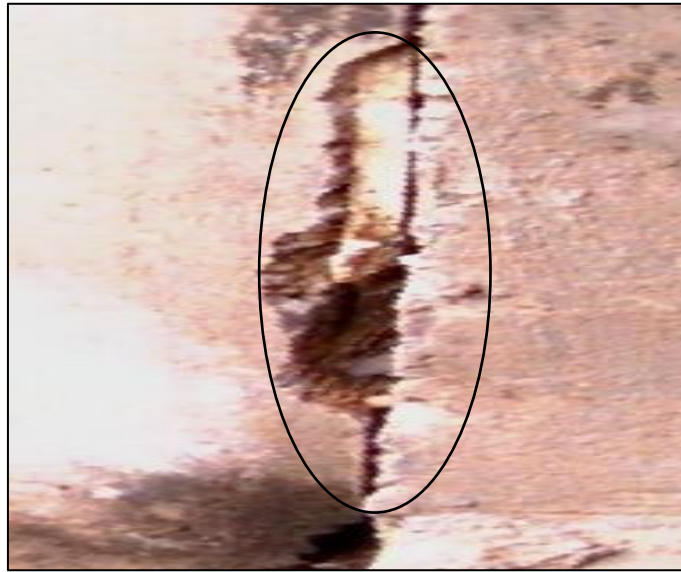
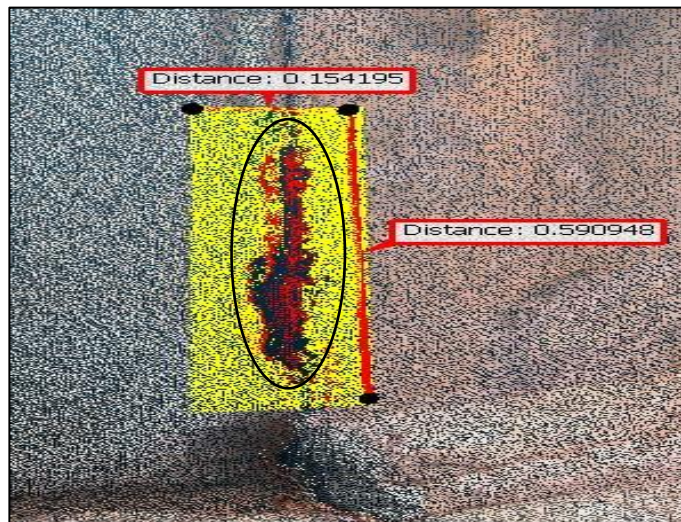
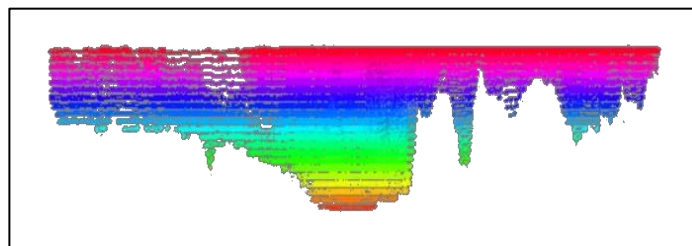
| Element Name | Observation | Location of Distress | Photo No. | Units | Distress Details | | | Area of Repair (Sq.m/R MT/m3) |
|---|---|---|---|---|---|---|---|---|
| Abutment 1 | Damage | - | 2 | Sq m | 0.59 | 0.15 | - | 0.08 |

**2.Damage observed on Abutment 1 LHS, measuring 0.59 m in length and 0.15 m in width, covering an area of 0.08 m**

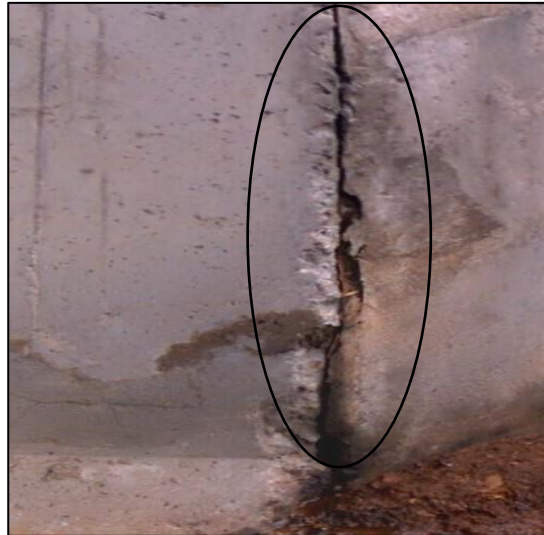
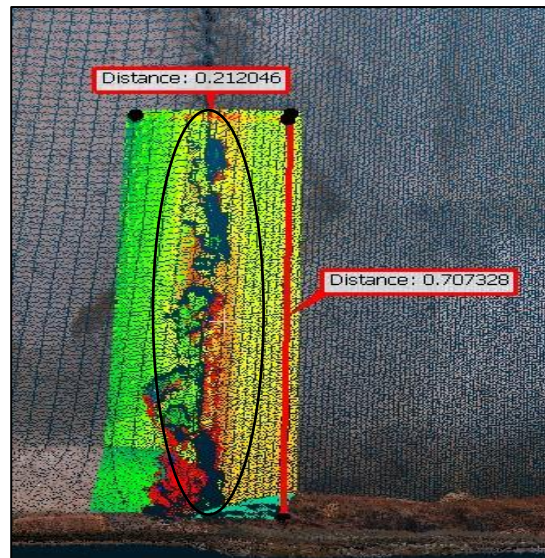
| Element Name | Observation | Location of Distress | Photo No. | Units | Distress Details | | | Area of Repair (Sq.m/R MT/m3) |
|---|---|---|---|---|---|---|---|---|
| Abutment 1 | Damage | - | 3 | Sq m | 0.70 | 0.21 | - | 0.14 |

**3.Damage observed on Abutment 1 RHS, measuring 0.70 m in length and 0.21 m in width, covering an area of 0.14 m<sup>2</sup>.**

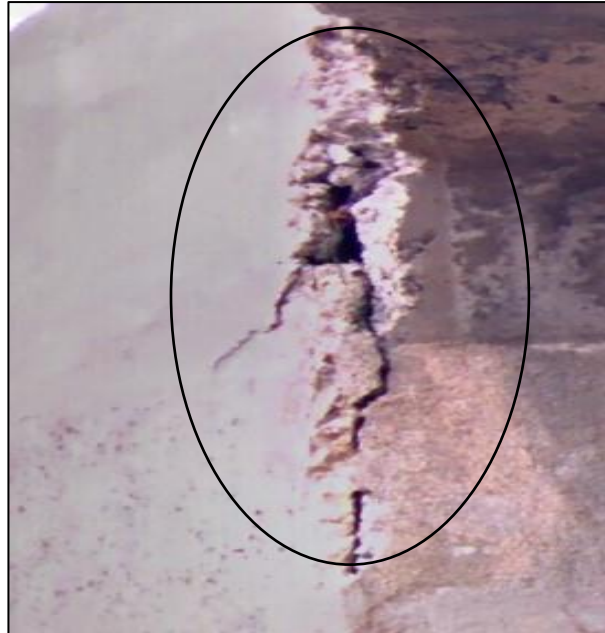
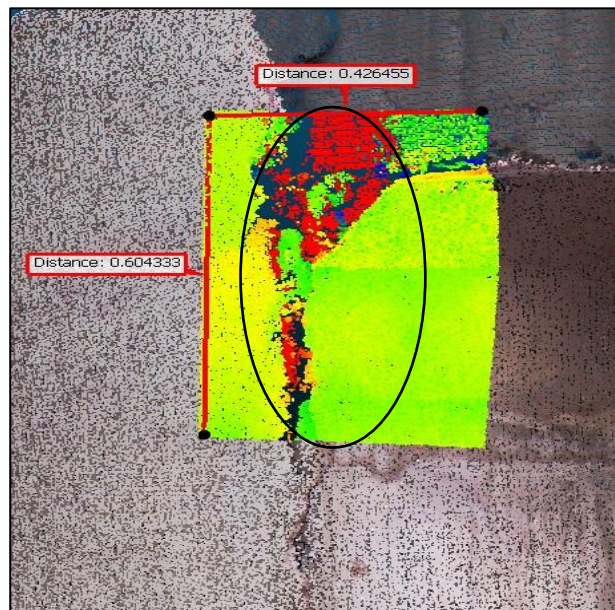
| Element Name | Observation | Location of Distress | Photo No. | Units | Distress Details | | | Area of Repair (Sq.m/R MT/m3) |
|---|---|---|---|---|---|---|---|---|
| Abutment 2 | Damage | - | 4 | Sq m | 0.60 | 0.42 | - | 0.25 |

**4.Damage observed on Abutment 2 LHS, measuring 0.60 m in length and 0.42 m in width, covering an area of 0.25 m<sup>2</sup>.**
