# **LIDAR Inspection Report of Slab Culvert ch.939+505**

**Bridge Chainage:** 939 + 505 (CKRP)

- **Bridge No:** -
- **Chainage:** 939 + 505
- **Structure type:** Slab Culvert

- **CKRP:** Chittorgarh to kota
- **State:** Rajasthan NH 27
- **Zone:** RJ-06

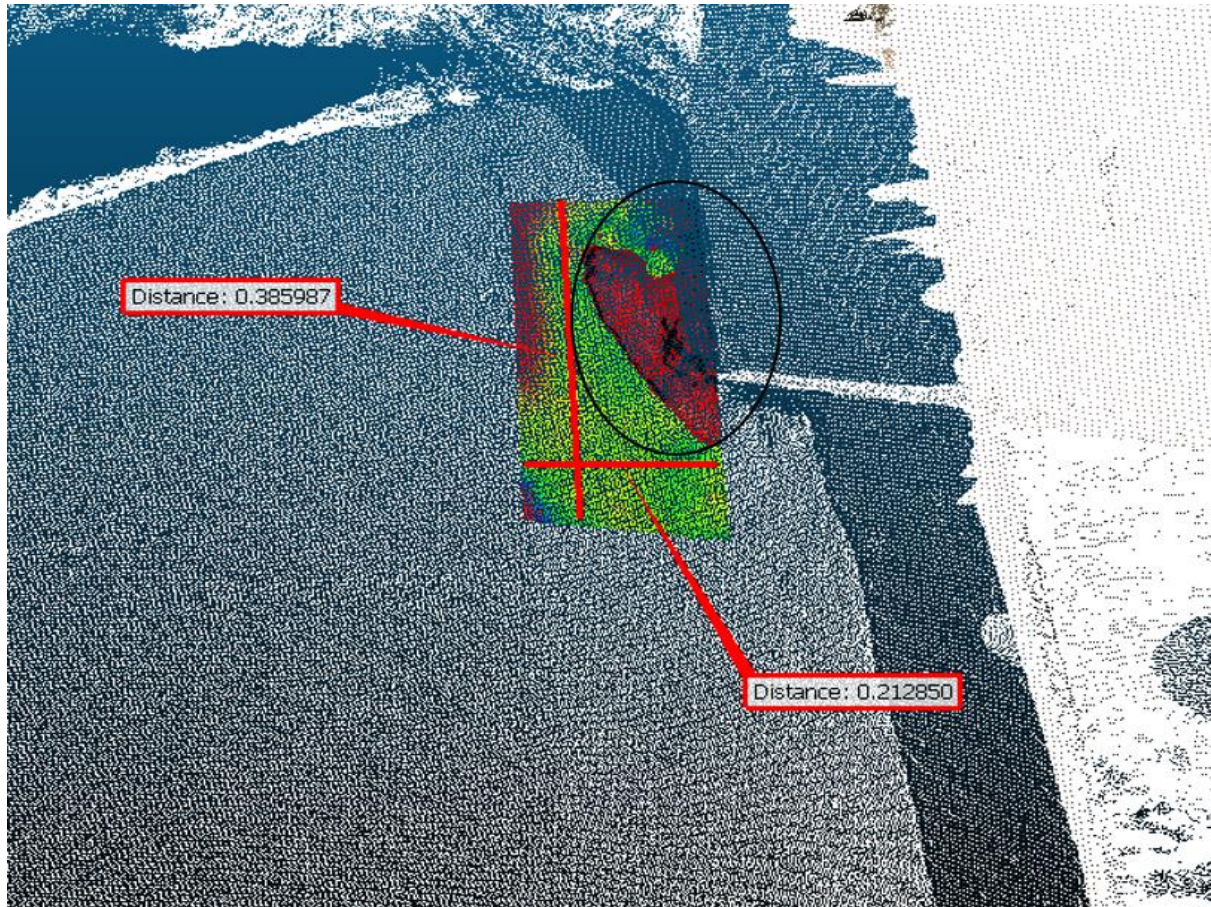
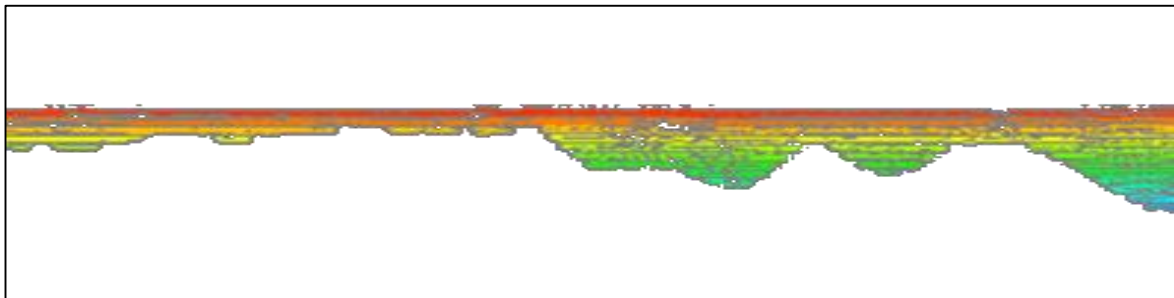
| Sl. No. | Description | Distress Notation | Observation | Location | | Distress Details | | | Area of Repair |
|---|---|---|---|---|---|---|---|---|---|
| 1 | Return wall | | DAMAGE<br>(LHS/RHS) | | | | | | |

1. Return wall damage observed on LHS, measuring 0.3859 m in length and 0.2128 m in width, covering an area of 0.0821 m<sup>2</sup>.

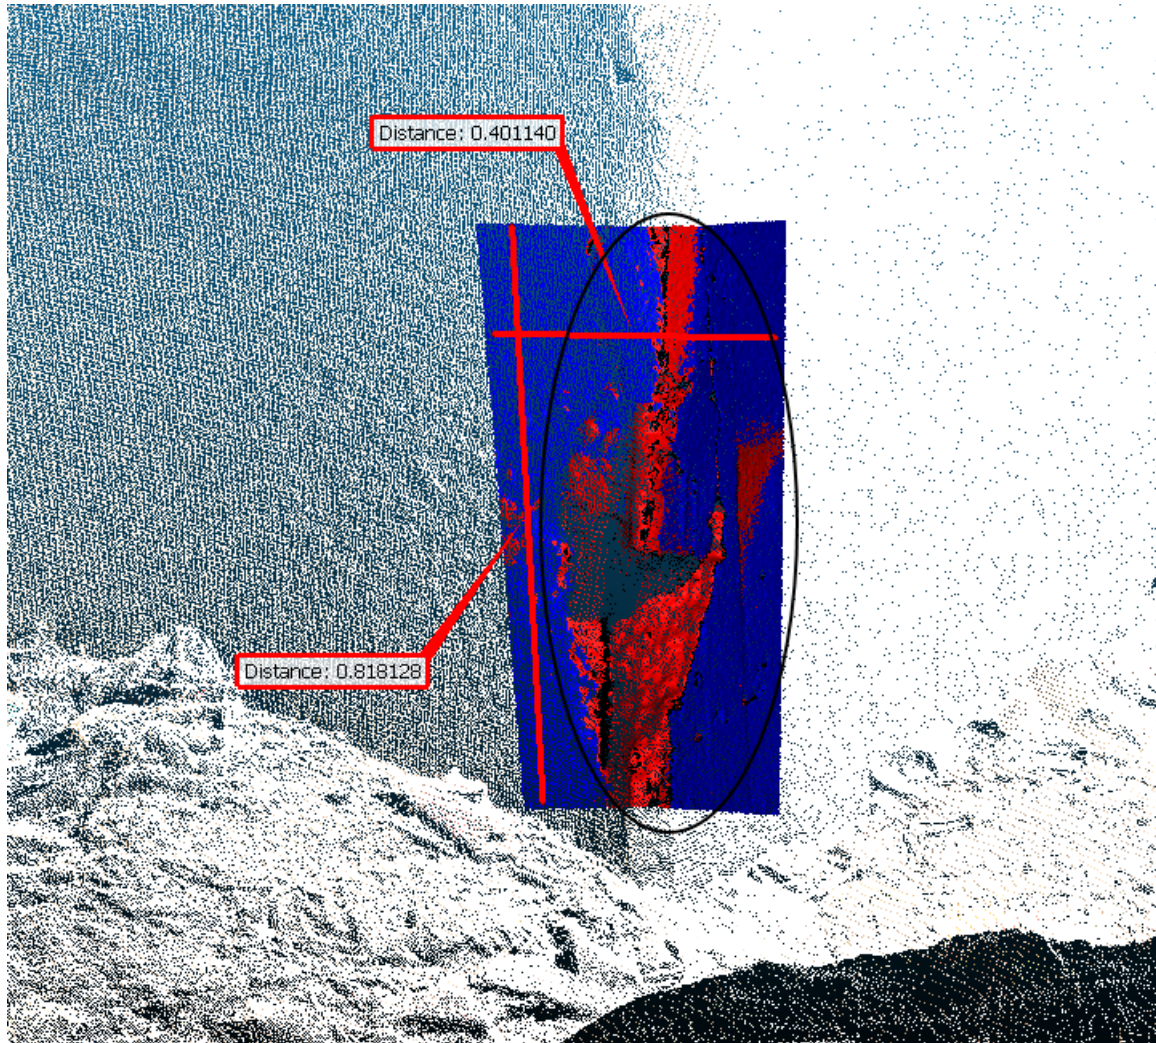
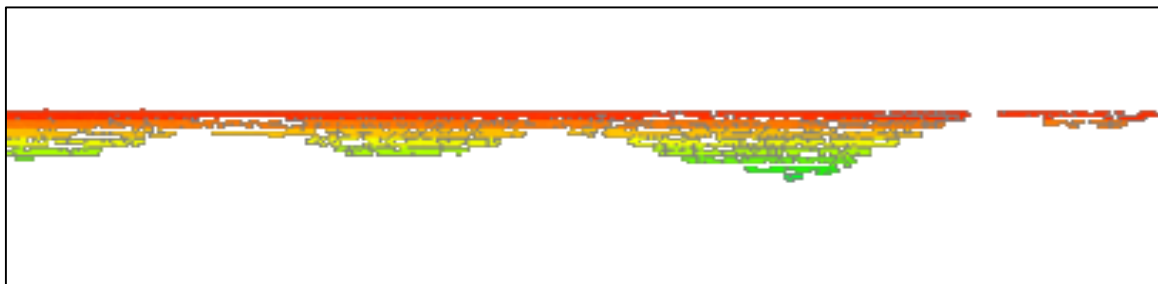
- 2. Return wall damage observed on LHS, measuring 0.8181 m in length and 0.4011 m in width, covering an area of 0.3281 m<sup>2</sup>.**
