# **LIDAR Inspection Report of Slab Culvert ch.939+630**

**Bridge Chainage:** 939+630 (CKRP)

- **Bridge No:** -
- **Chainage:** 939+630
- **Structure type:** Slab Culvert

- **CKRP:** Chittorgarh to kota
- **State:** Rajasthan NH 27
- **Zone:** RJ-06

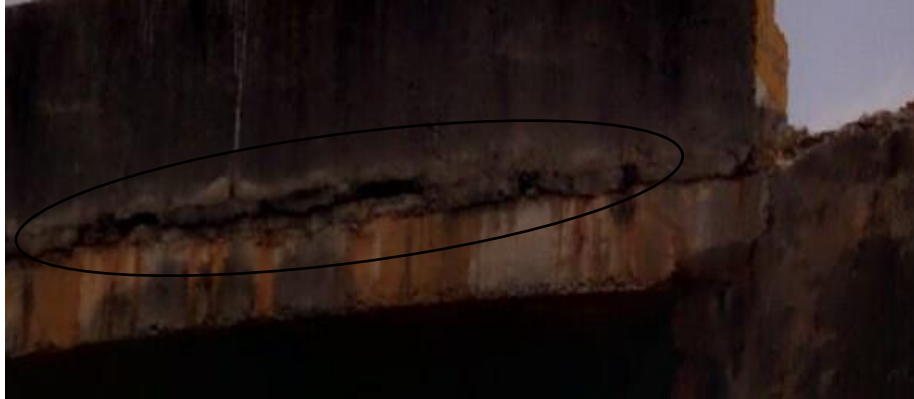
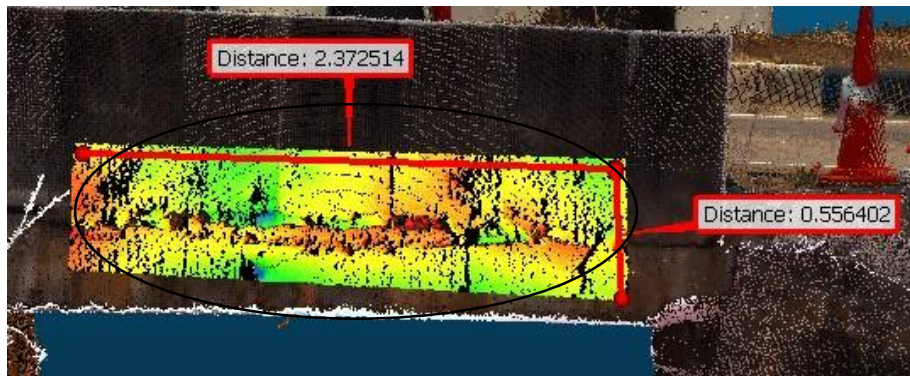
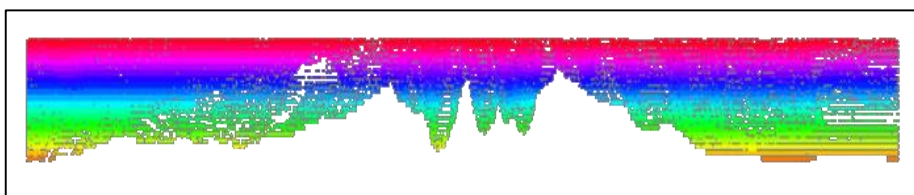
| Element Name | Observation | Location of Distress | Photo No. | Units | Distress Details | | | Area of Repair (Sq.m/R MT/m3) |
|---|---|---|---|---|---|---|---|---|
| Parapet Wall | Damage | - | 1 | M | 2.37 | 0.55 | | 1.30 |

**1. Damage observed on Parapet Wall, measuring 2.37 m in length and 0.55 m in width, covering an area of 1.300 m<sup>2</sup>.**

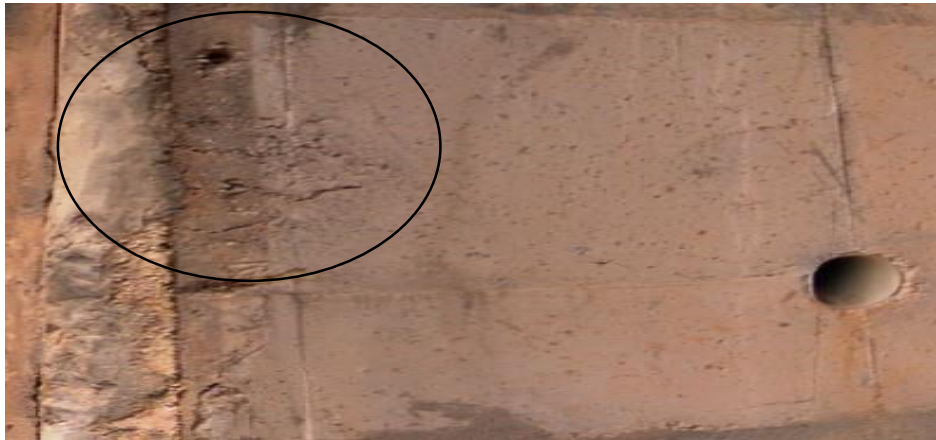
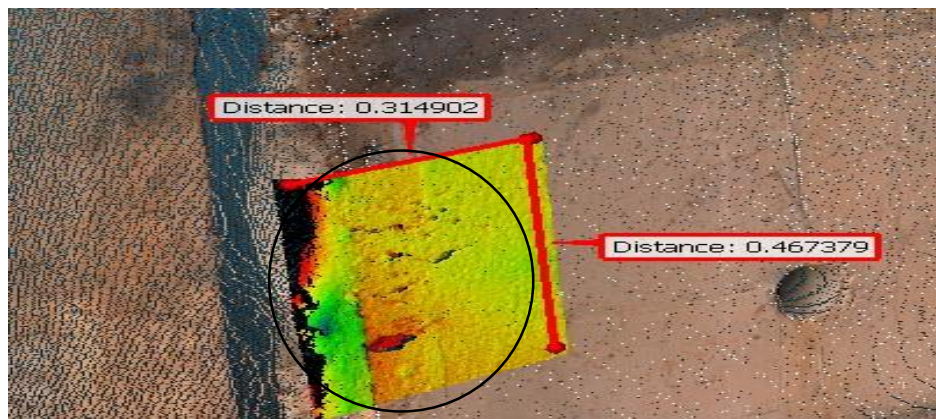
| Element Name | Observation | Location of Distress | Photo No. | Units | Distress Details | | | Area of Repair (Sq.m/R MT/m3) |
|---|---|---|---|---|---|---|---|---|
| Abutment 2 | Scaling | - | 2 | M | 0.31 | 0.46 | | 0.1426 |

**2. Scaling observed on LHS Abutment 2, measuring 0.31 m in length and 0.46 m in width, covering an area of 0.143 m<sup>2</sup>.**

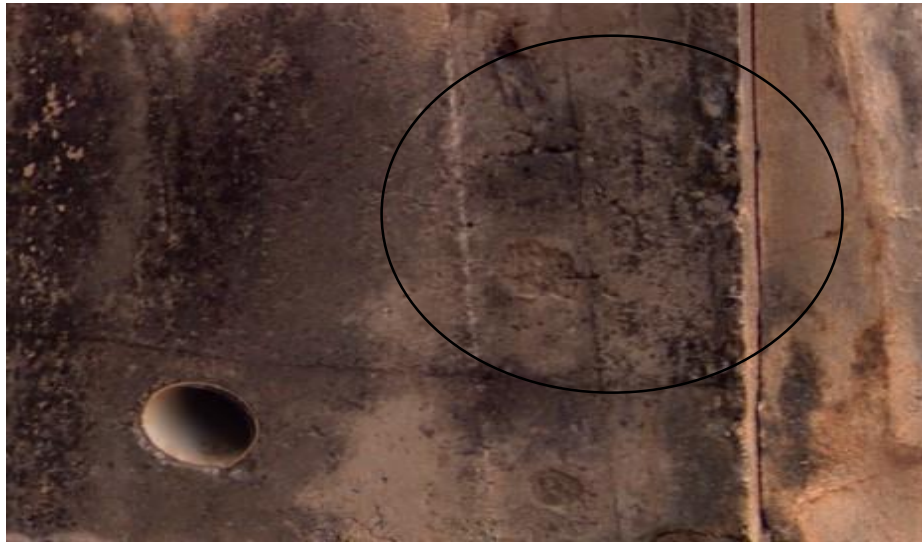
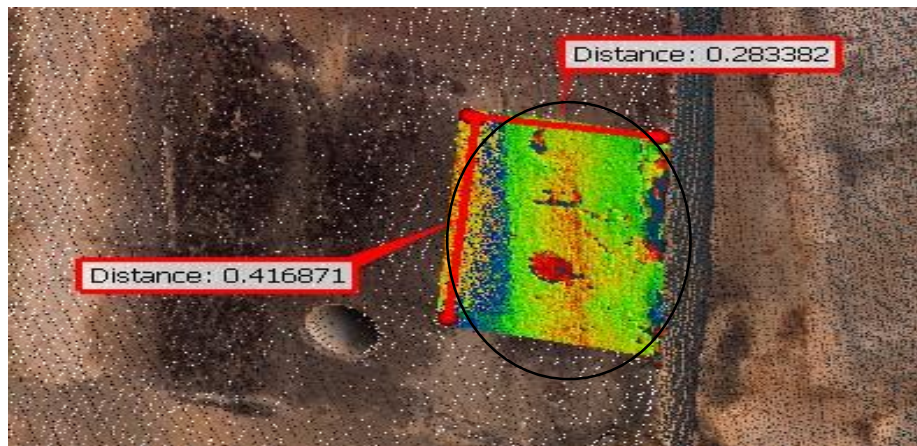
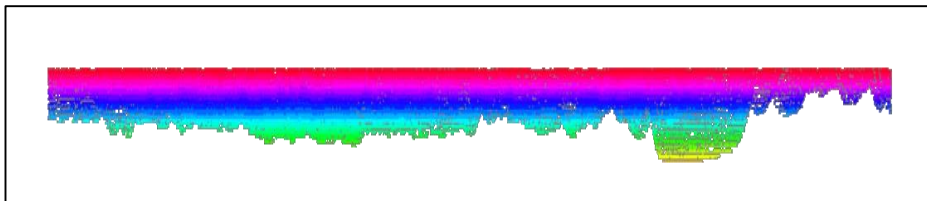
| Element Name | Observation | Location of Distress | Photo No. | Units | Distress Details | | | Area of Repair (Sq.m/R MT/m3) |
|---|---|---|---|---|---|---|---|---|
| Abutment 1 | Scaling | | 3 | M | 0.28 | 0.41 | | 0.1148 |

**3. Scaling observed on LHS Abutment 1 , measuring 0.28 m in length and 0.41 m in width, covering an area of 0.115 m<sup>2</sup>**

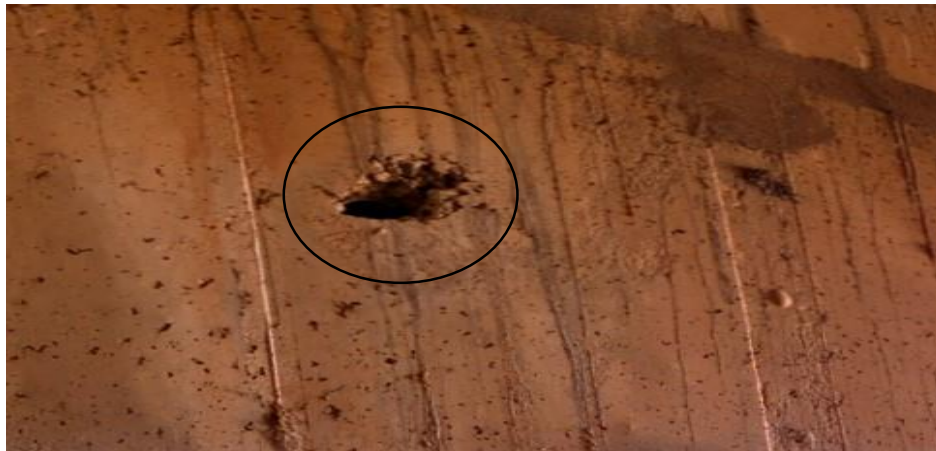
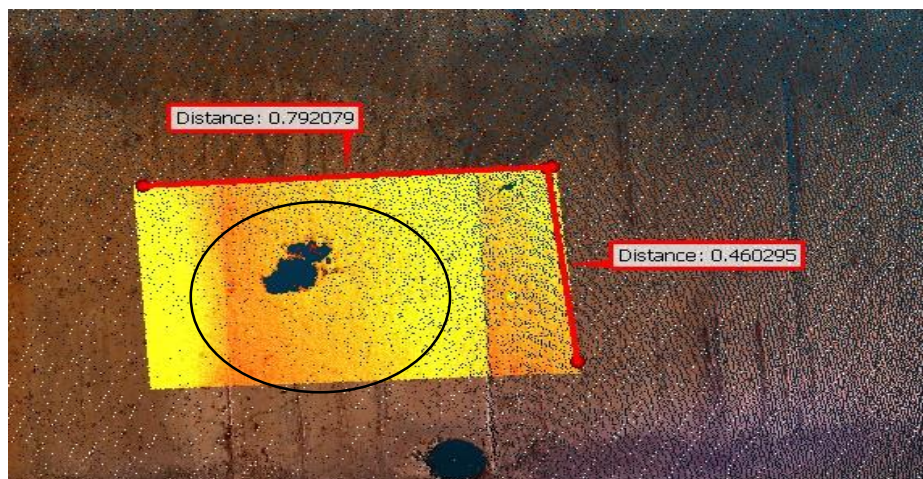
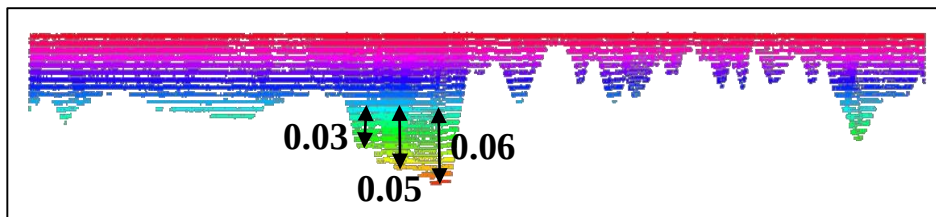
| Element Name | Observation | Location of Distress | Photo No. | Units | Distress Details | | | Area of Repair (Sq.m/R MT/m3) |
|---|---|---|---|---|---|---|---|---|
| Abutment 1 | Damage | | 4 | M | 0.79 | 0.46 | 0.050 | 0.018 |

**4. Damage observed on LHS Abutment 1 Wall ,measuring 0.79 m in length and 0.46 m in width, Depth ranges from 0.03 (min) to 0.065 m (max), with an average depth of 0.050 m. The calculated volume of the distress is 0.018 m<sup>3</sup>.**

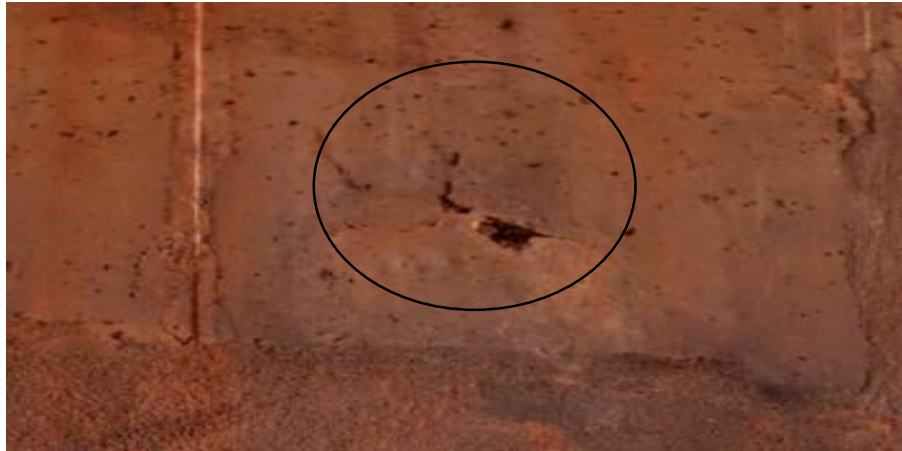
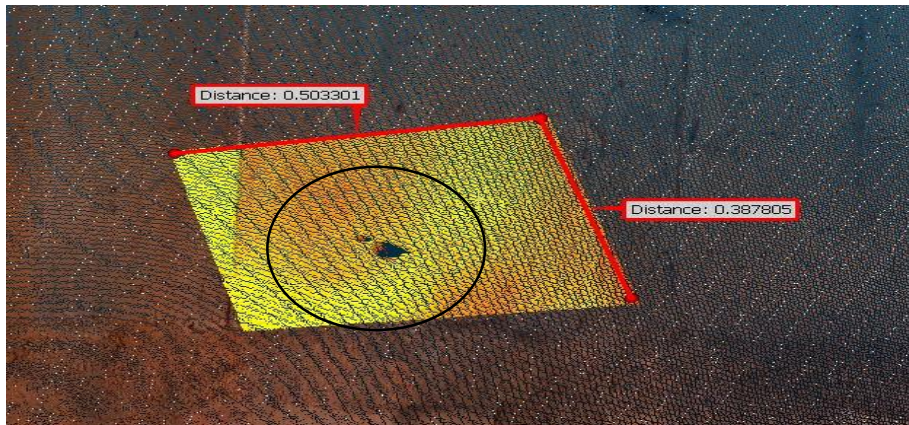
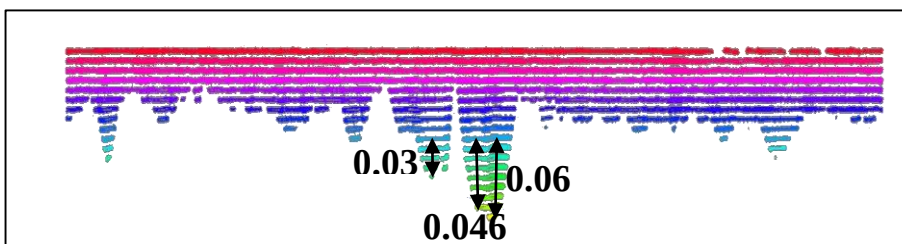
| Element Name | Observation | Location of Distress | Photo No. | Units | Distress Details | | | Area of Repair (Sq.m/R MT/m3) |
|---|---|---|---|---|---|---|---|---|
| Abutment 1 | Damage | | 5 | M | 0.50 | 0.38 | 0.046 | 0.008 |

**5. Damage observed on LHS Abutment 1 Wall , measuring 0.50 m in length and 0.38 m in width, Depth ranges from 0.038 (min) to 0.06 m (max), with an average depth of 0.46 m. The calculated volume of the distress is 0.008 m<sup>3</sup>.**

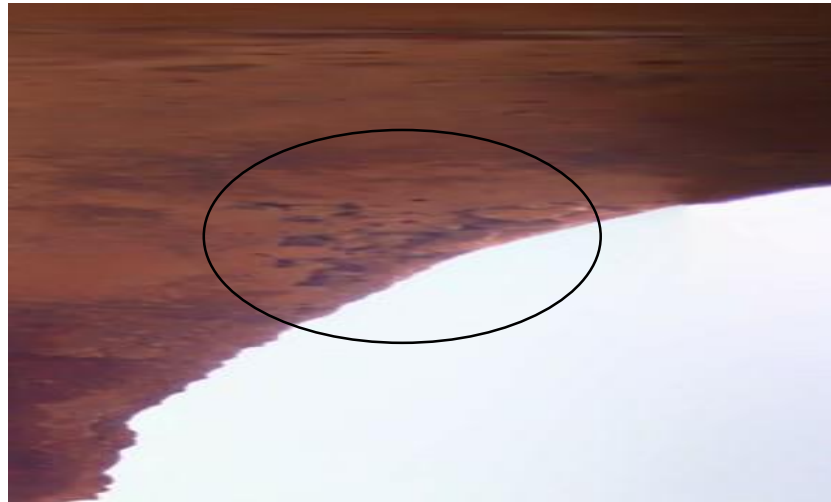
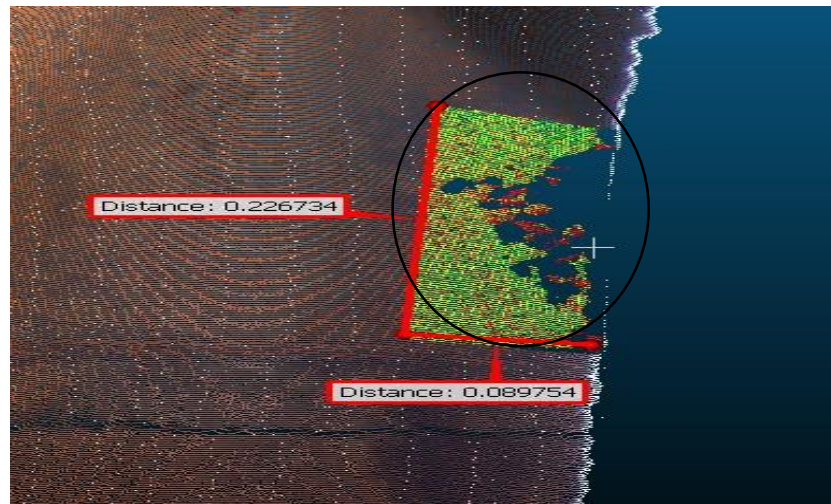
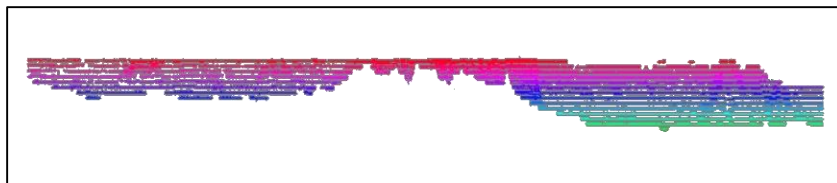
| Element Name | Observation | Location of Distress | Photo No. | Units | Distress Details | | | Area of Repair (Sq.m/R MT/m3) |
|---|---|---|---|---|---|---|---|---|
| Top Slab | Honeycombing | - | 6 | M | 0.22 | 0.08 | | 0.017 |

**6. Honeycombing observed on RHS Top Slab, measuring 0.22 m in length and 0.08 m in width, covering an area of 0.017 m<sup>2</sup>**

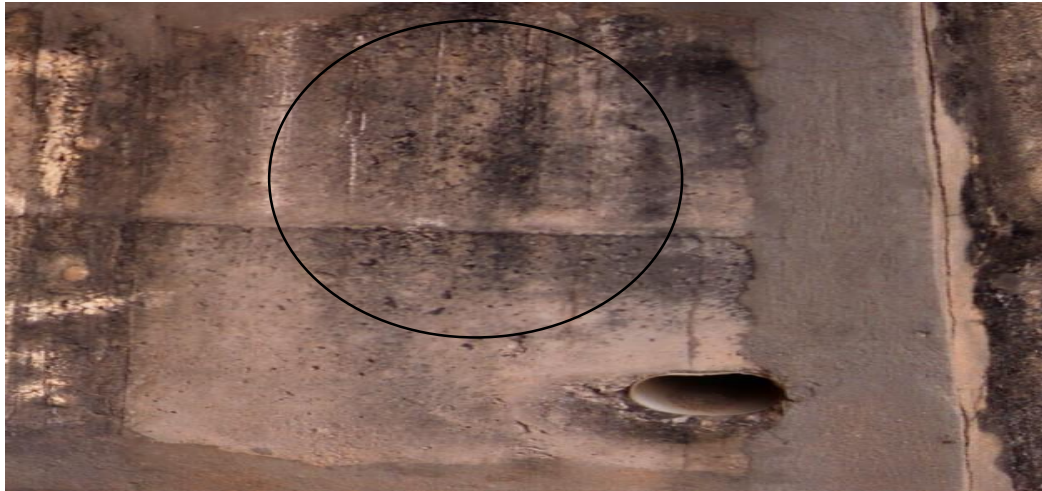
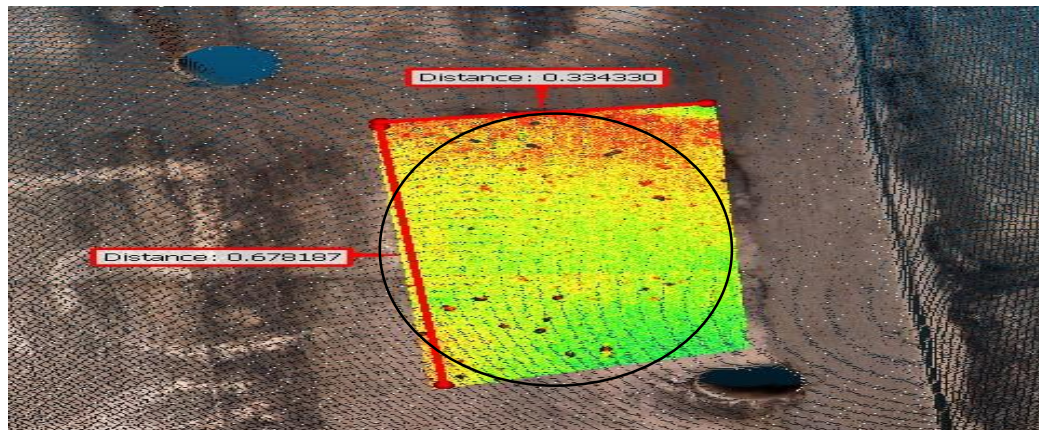
| Element Name | Observation | Location of Distress | Photo No. | Units | Distress Details | | | Area of Repair (Sq.m/R MT/m3) |
|---|---|---|---|---|---|---|---|---|
| Abutment 2 | Scaling | - | 7 | M | 0.67 | 0.33 | | 0.2211 |

**7. Scaling observed on RHS Abutment 2 Wall , measuring 0.67 m in length and 0.33 m in width, covering an area of 0.221 m<sup>2</sup>.**

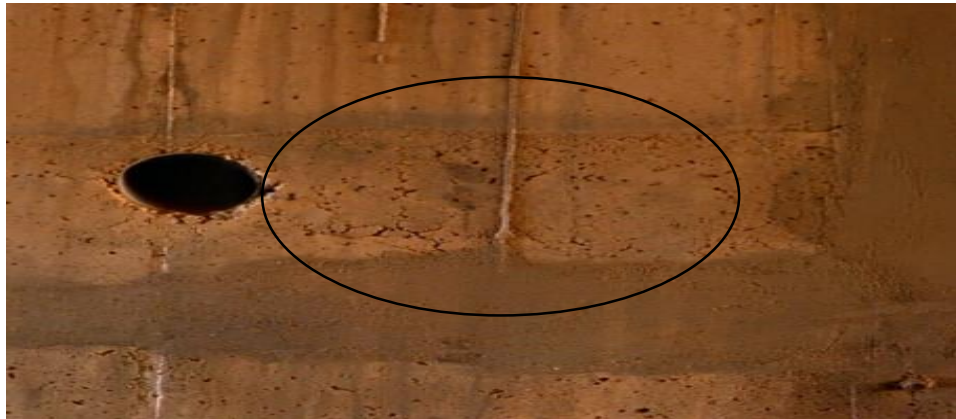
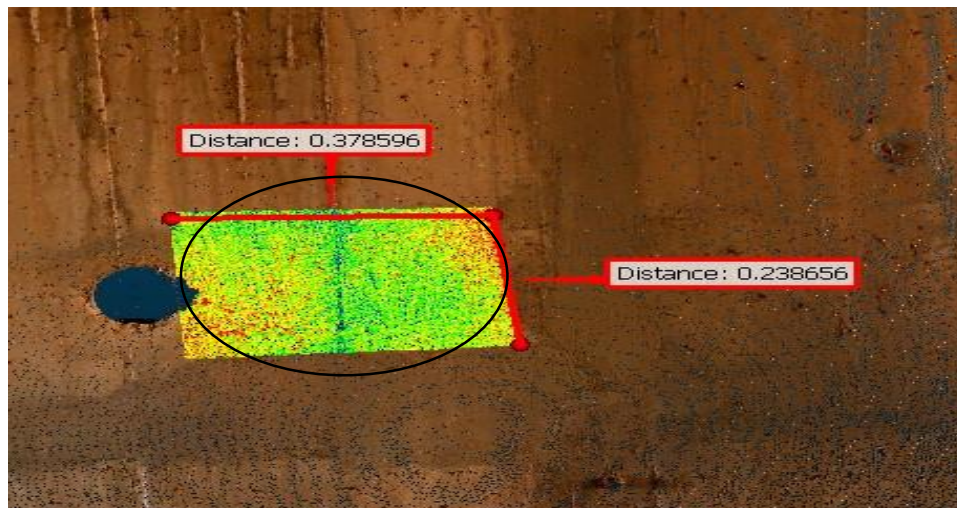
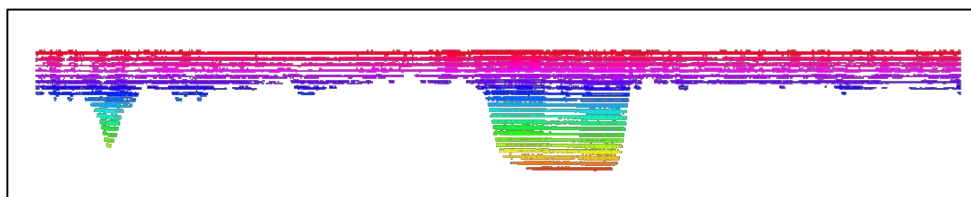
| Element Name | Observation | Location of Distress | Photo No. | Units | Distress Details | | | Area of Repair (Sq.m/R MT/m3) |
|---|---|---|---|---|---|---|---|---|
| Abutment 2 | Scaling | | 8 | M | 0.37 | 0.23 | | 0.0851 |

**8. Scaling observed on RHS Abutment 2 Wall , measuring 0.37 m in length and 0.23 m in width, covering an area of 0.085 m<sup>2</sup>.**
