# **LIDAR Inspection Report of MNB ch.940+500**

**Bridge No:** MNB - 941/2

**Bridge Chainage:** 940+500 (CKRP)

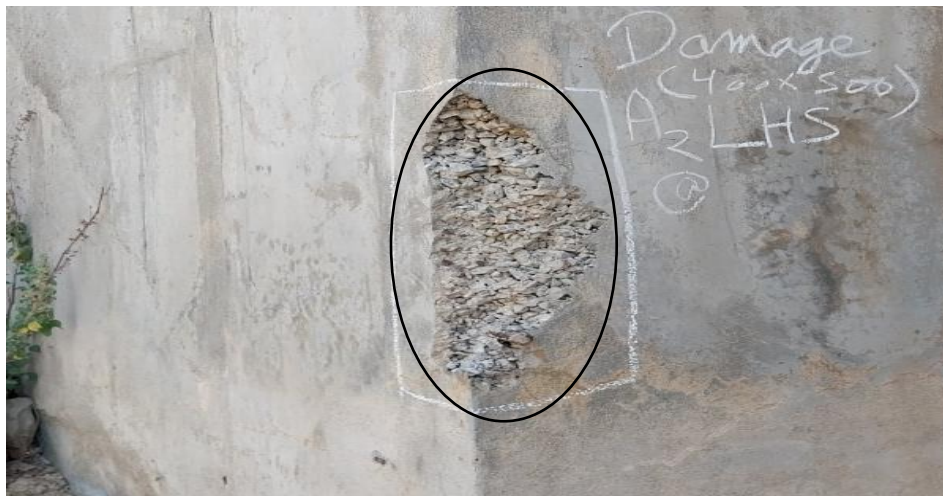
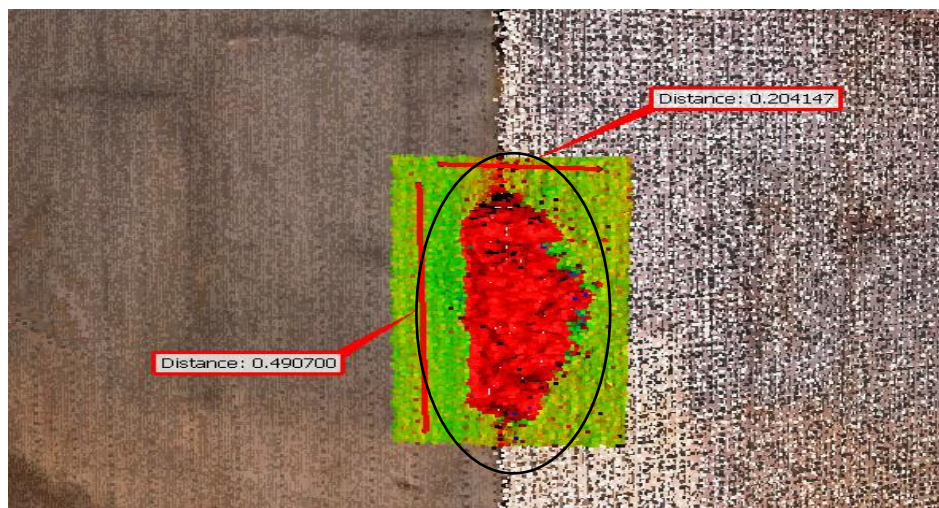
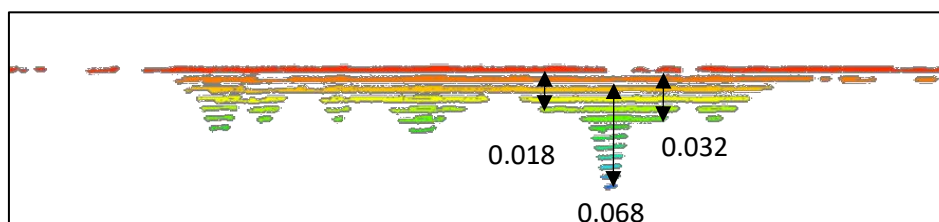
| Element Name | Observation | Location of Distress | Photo No. | Units | Distress Details | | | Area of Repair (Sq./RMT /m3) |
|---|---|---|---|---|---|---|---|---|
| Abutment 2 | Damage | | 1 | M | 0.49 | 0.20 | 0.032 | 0.0031 |

**1. Damage observed on Abutment 2 LHS, measuring 0.49 m in length and 0.20 m in width, Depth ranges from 0.018 m min to 0.068 m max, with an average depth of 0.032 m. The calculated volume of the distress is 0.0031m<sup>3</sup>.**

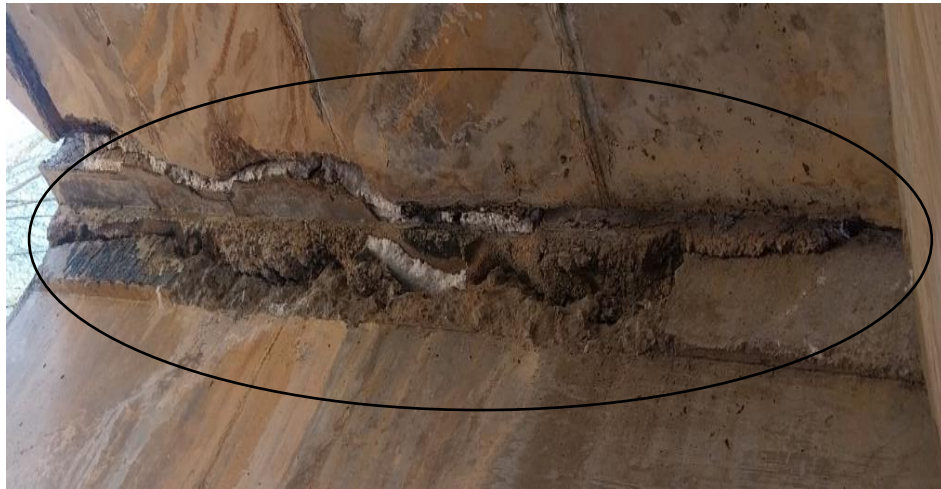
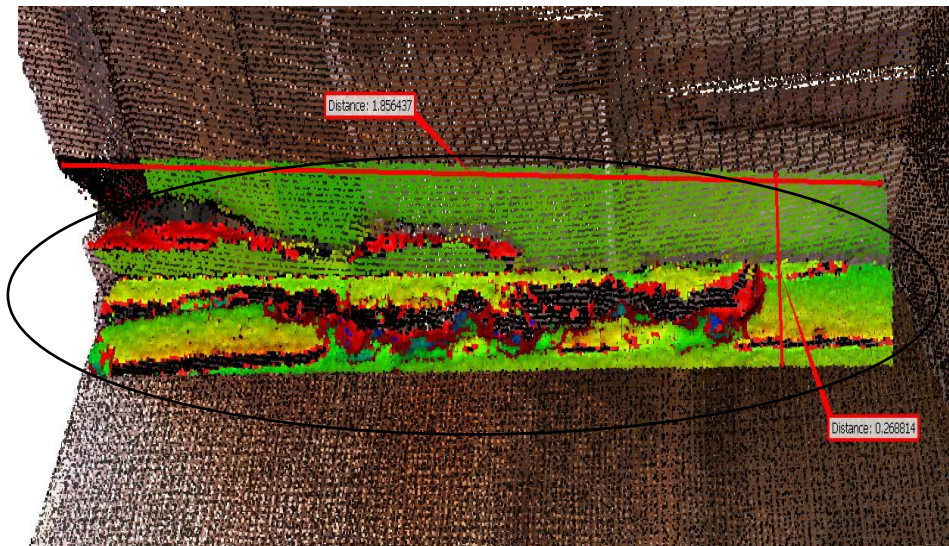
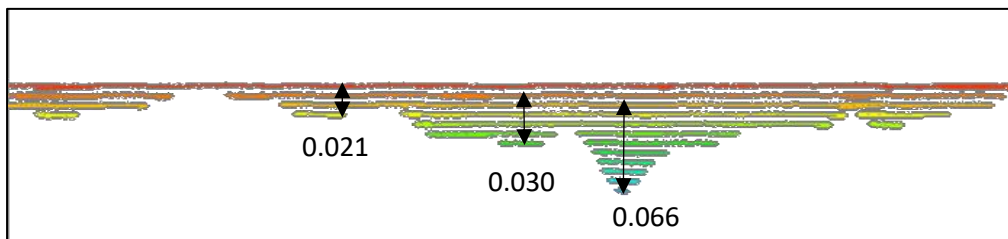
| Element Name | Observation | Location of Distress | Photo No. | Units | Distress Details | | | Area of Repair (Sq./RMT /m3) |
|---|---|---|---|---|---|---|---|---|
| Dirt wall | Damage | | 2 | M | 1.85 | 0.26 | 0.030 | 0.0144 |

**2. Dirt wall damage observed on Abutment 2 LHS, measuring 1.85 m in length and 0.26 m in width, Depth ranges from 0.021 m min to 0.066 m max, with an average depth of 0.030 m. The calculated volume of the distress is 0.0144m<sup>3</sup>.**

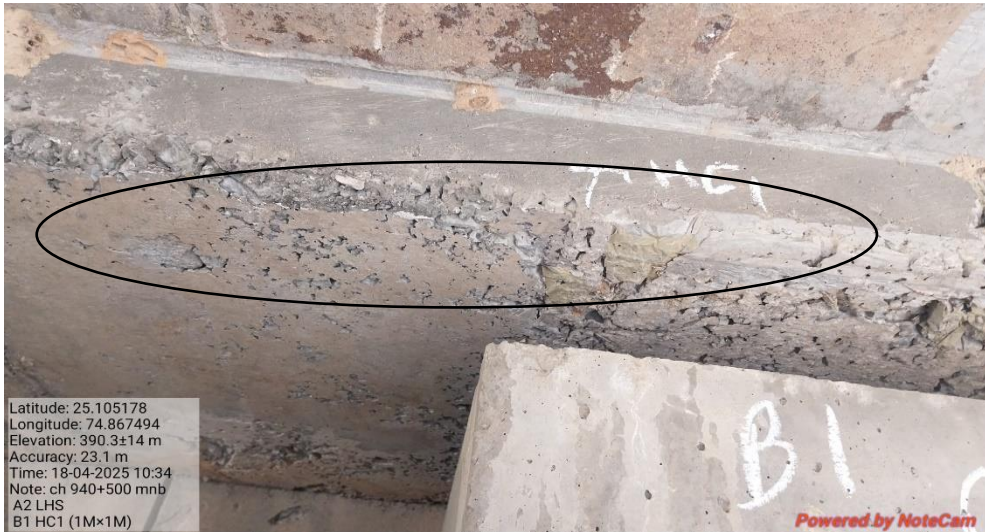
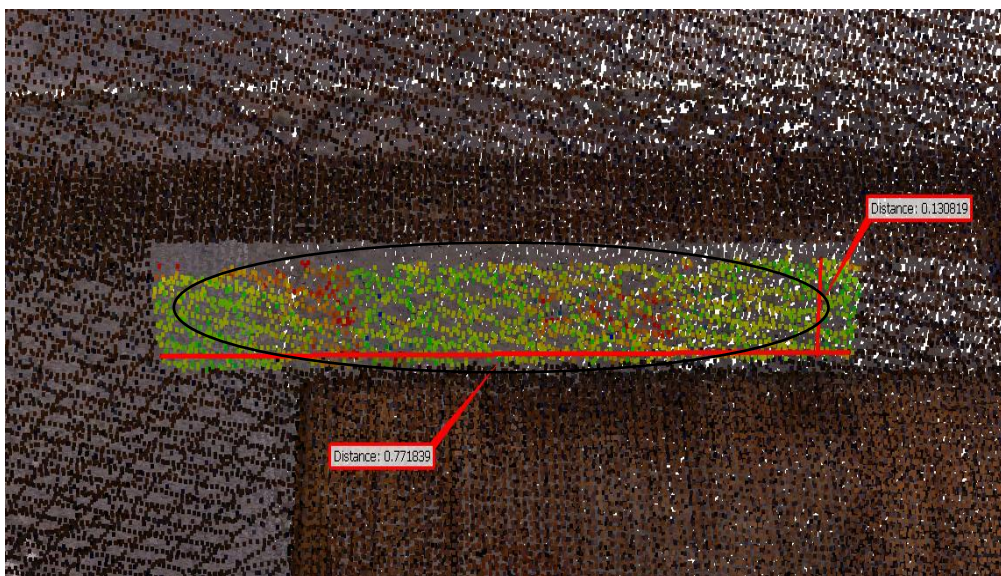
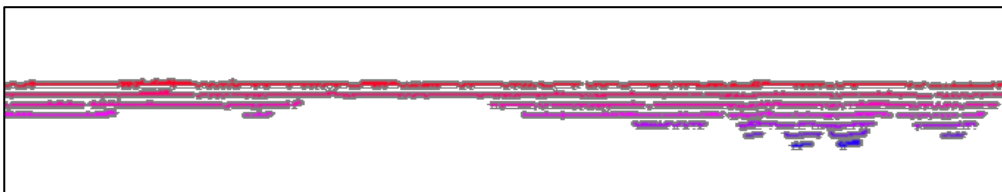
| Element Name | Observation | Location of Distress | Photo No. | Units | Distress Details | | | Area of Repair (Sq./RMT /m3) |
|---|---|---|---|---|---|---|---|---|
| Bearing | Honey Combing | | 3 | M | 0.77 | 0.13 | | 0.1001 |

- 3. Honeycombing observed at Abutment 2 LHS Bearing 1, measuring 0.77 m in length and 0.13 m in width, covering an area of 0.100 m<sup>2</sup>.**

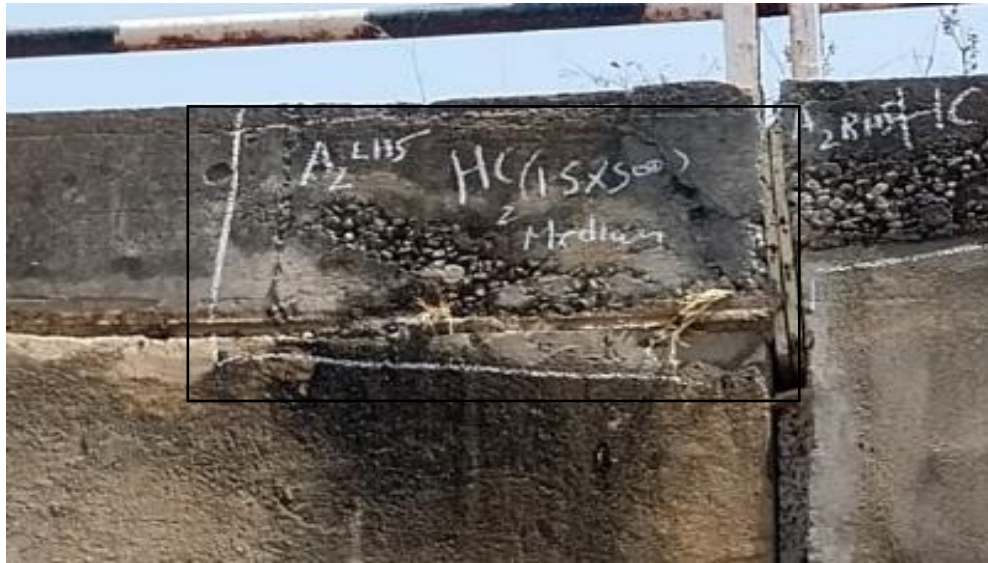
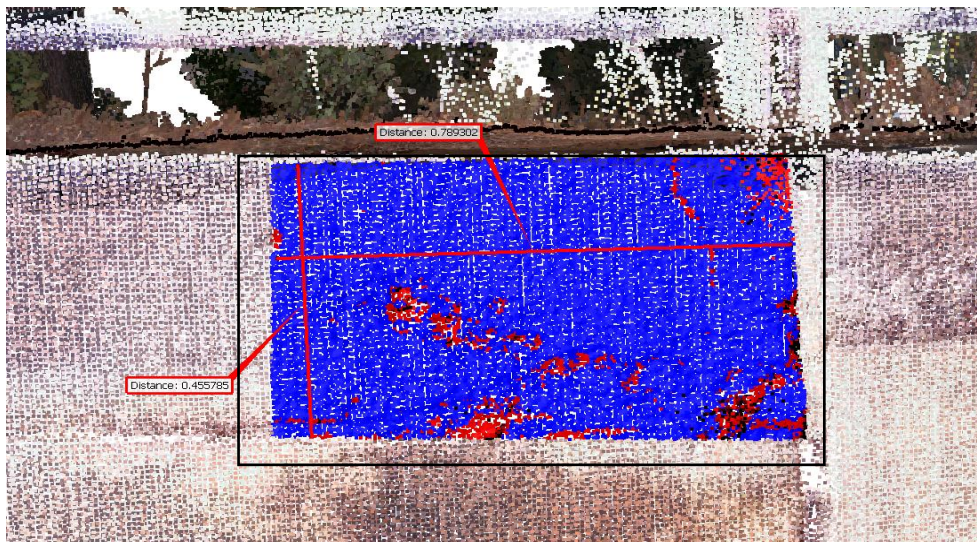
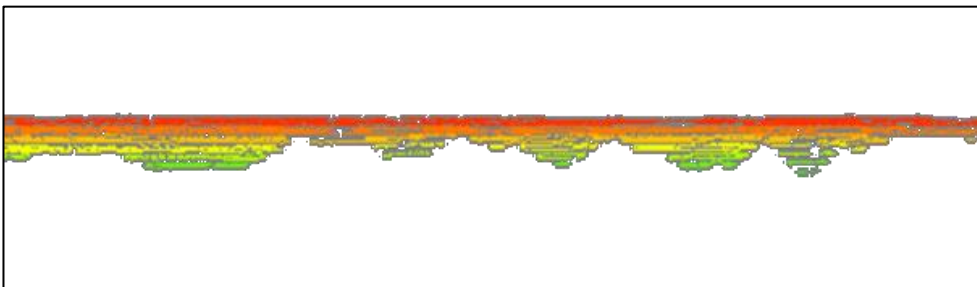
| Element Name | Observation | Location of Distress | Photo No. | Units | Distress Details | | | Area of Repair (Sq./RMT /m3) |
|---|---|---|---|---|---|---|---|---|
| Median | Honey Combing | | 4 | M | 0.78 | 0.45 | | 0.351 |

4. Honeycombing observed on Abutment 2 LHS Median, measuring 0.78 m in length and 0.45 m in width, covering an area of 0.351 m<sup>2</sup>.

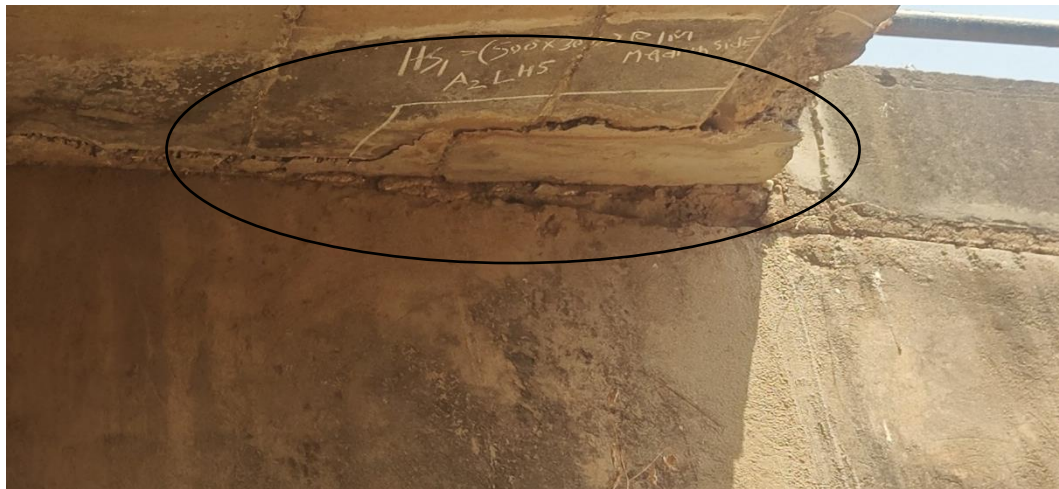
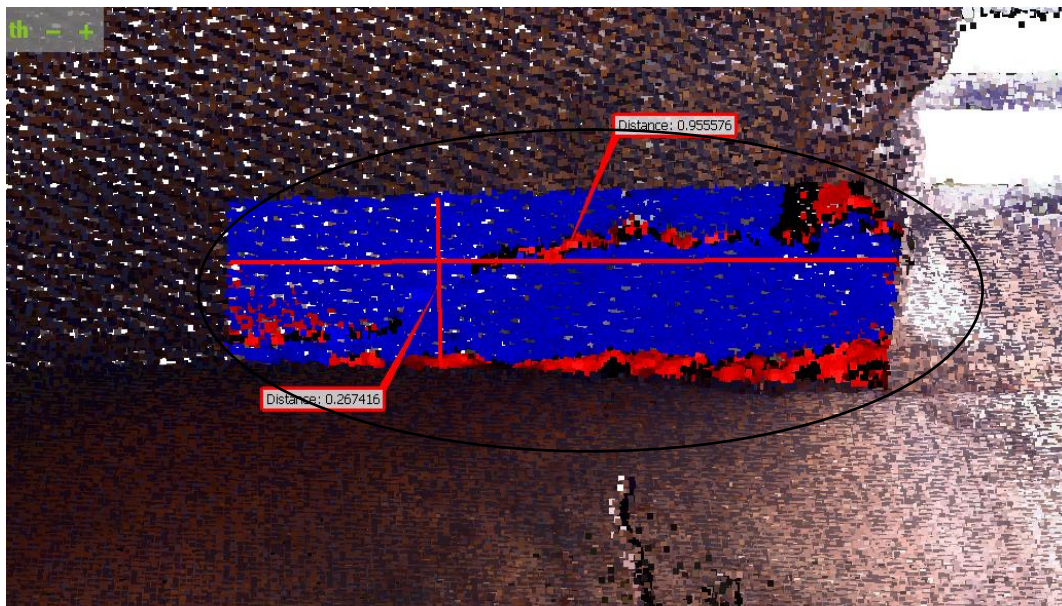
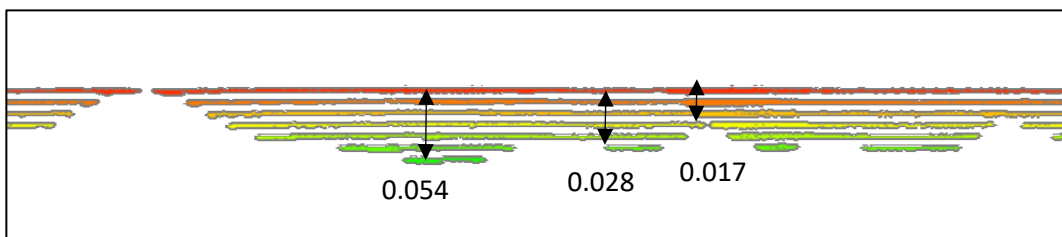
| Element Name | Observation | Location of Distress | Photo No. | Units | Distress Details | | | Area of Repair (Sq./RMT /m3) |
|---|---|---|---|---|---|---|---|---|
| Dirt wall | Hollow Section | | 5 | M | 0.95 | 0.26 | 0.028 | 0.0069 |

5. Hollow section observed on Abutment 2 LHS dirt wall, measuring 0.95 m in length and 0.26 m in width, Depth ranges from 0.017 m min to 0.054 m max, with an average depth of 0.028 m. The calculated volume of the distress is 0.0069m<sup>3</sup>.

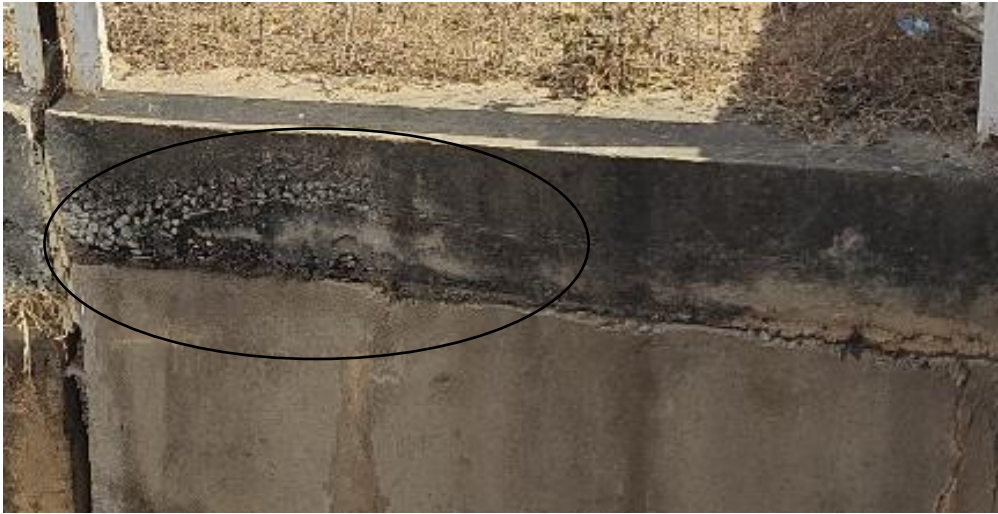
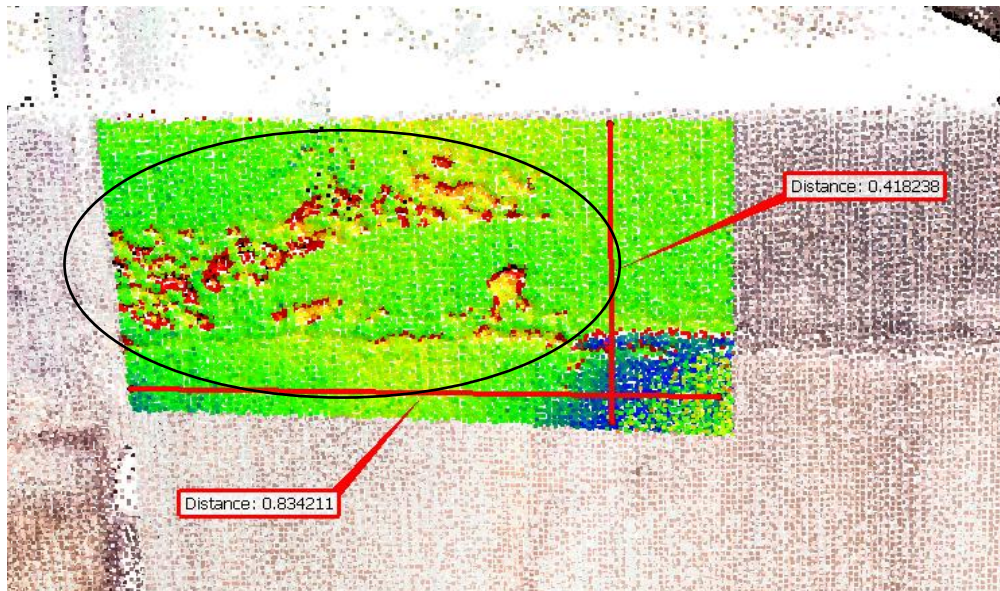
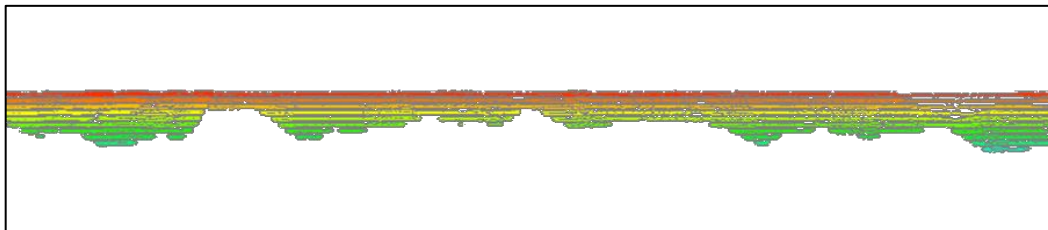
| Element Name | Observation | Location of Distress | Photo No. | Units | Distress Details | | | Area of Repair (Sq./RM T) |
|---|---|---|---|---|---|---|---|---|
| Median | Honey Combing | | 7 | M | 0.83 | 0.41 | | 0.3403 |

- 7. Honey combing observed on RHC Abutment 2 Median, measuring 0.83 m in length and 0.41 m in width, covering an area of 0.34 m<sup>2</sup>.**

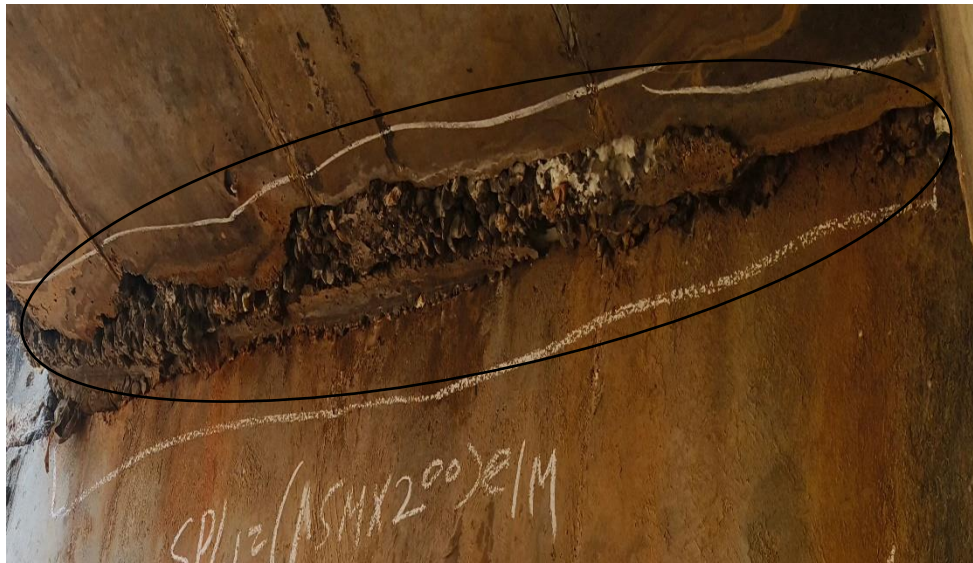
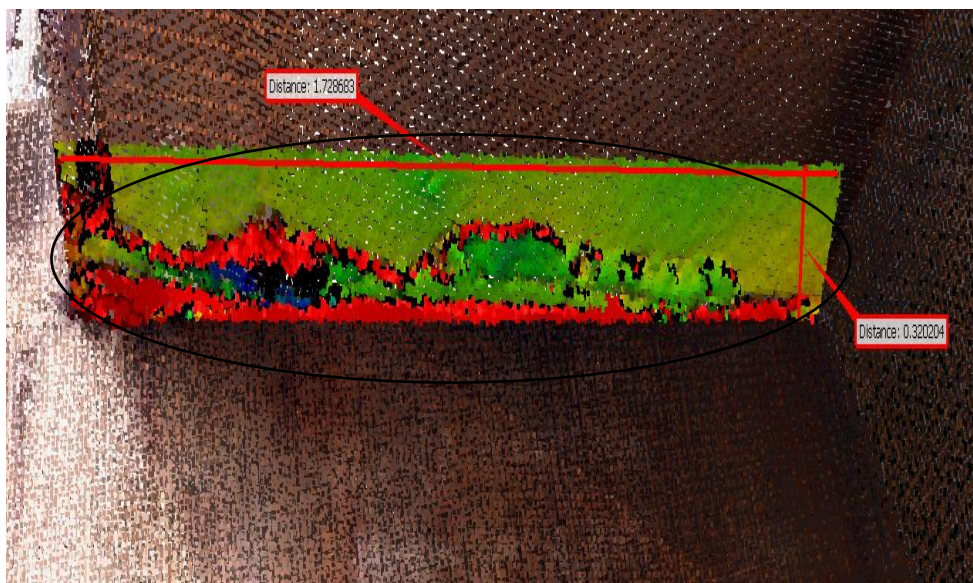
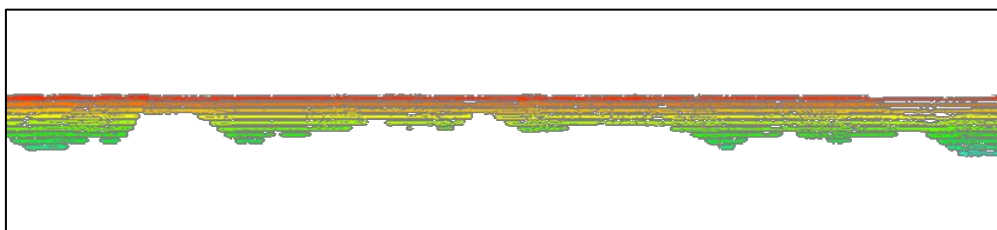
| Element Name | Observation | Location of Distress | Photo No. | Units | Distress Details | | | Area of Repair (Sq./RM T) |
|---|---|---|---|---|---|---|---|---|
| Dirt Wall | Spalling | | 8 | M | 1.72 | 0.32 | | 0.5504 |

- 8. Spalling observed on RHS Abutment 2 Dirt Wall, measuring 1.72 m in length and 0.32 m in width, covering an area of 0.55 m<sup>2</sup>.**

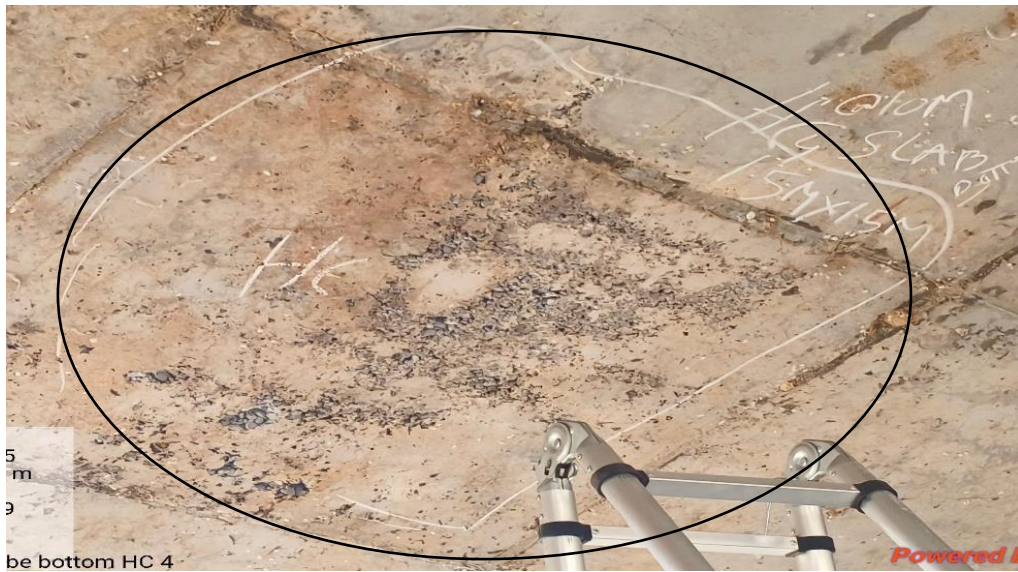
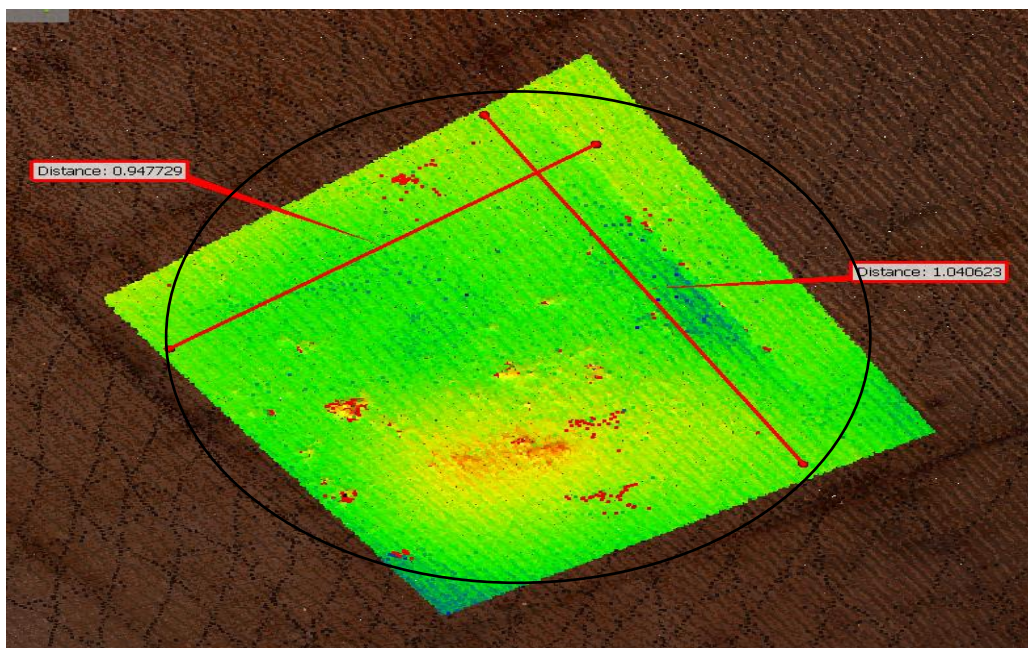
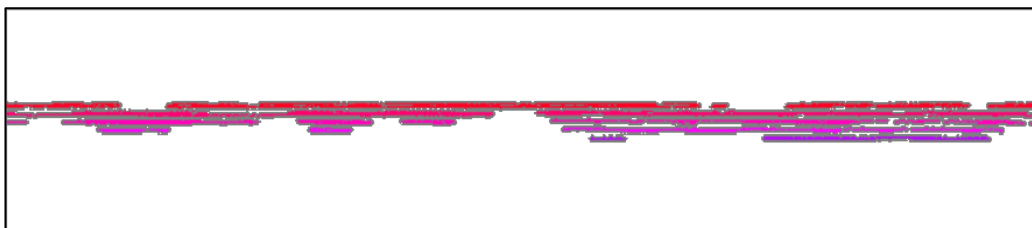
| Element Name | Observation | Location of Distress | Photo No. | Units | Distress Details | | | Area of Repair (Sq./RM T) |
|---|---|---|---|---|---|---|---|---|
| Slab Bottom | Honey Combing | | 9 | M | 1.04 | 0.94 | | 0.9776 |

- 9. Honey combing observed on RHS Abutment 2 Slab Bottom, measuring 1.04 m in length, covering an area of 0.94 m<sup>2</sup>.**

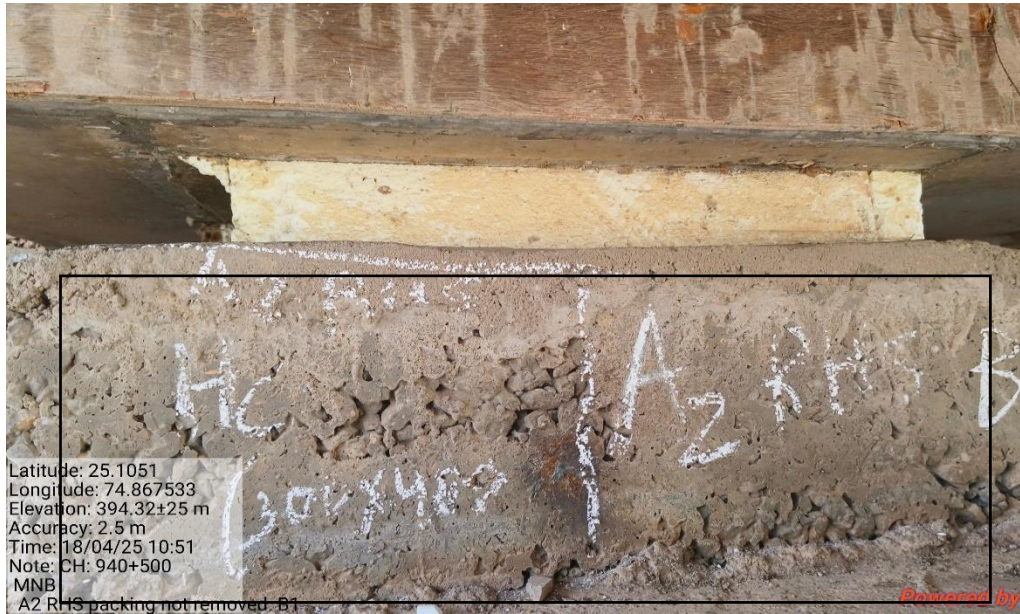
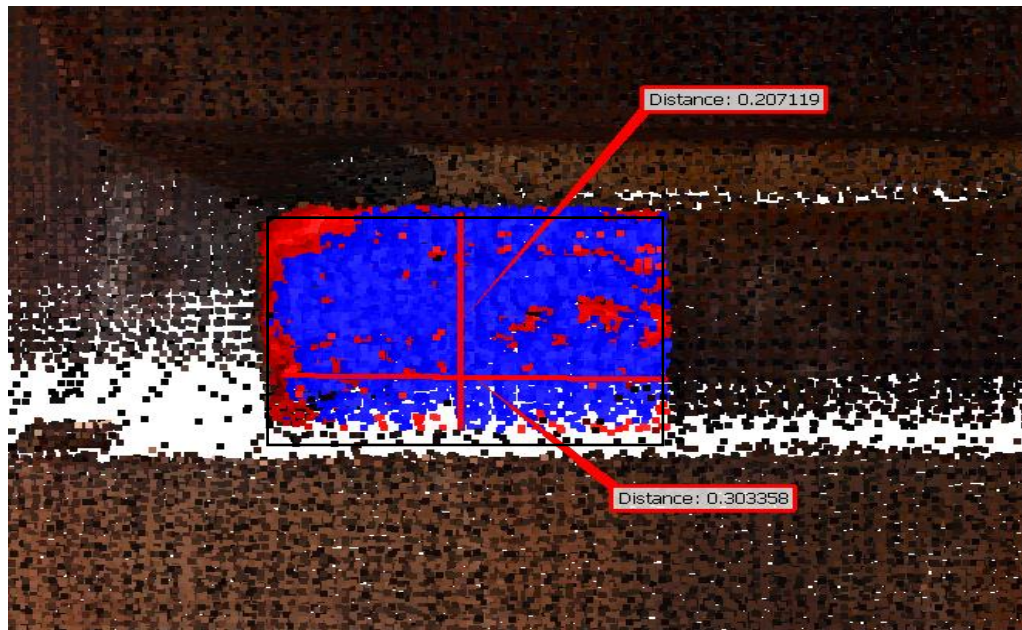
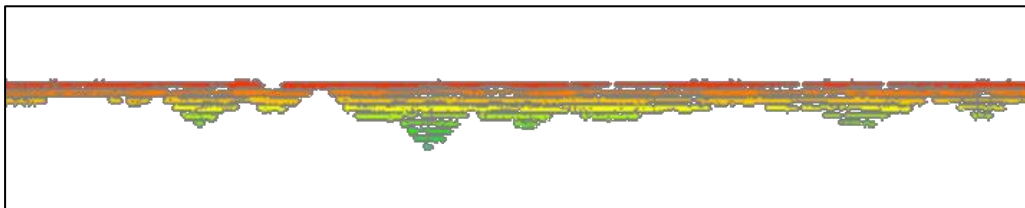
| Element Name | Observation | Location of Distress | Photo No. | Units | Distress Details | | | Area of Repair (Sq./RM T) |
|---|---|---|---|---|---|---|---|---|
| Bearing | Honey Combing | | 10 | M | 0.30 | 0.20 | | 0.06 |

**10. Honey combing observed on RHS Abutment 2 Bearing 1 , measuring 0.30 m in length and 0.20 m in width, covering an area of 0.06 m<sup>2</sup>.**
