# **Satellite Structural Inspection Interferometric Synthetic Aperture Radar (InSAR) Based**

State – Rajasthan  
Bridge No. – 899/1  
Bridge Chainage – 940+500

Project - Chittorgarh to Kota  
Zone – RJ 06  
Structure Type – MNB

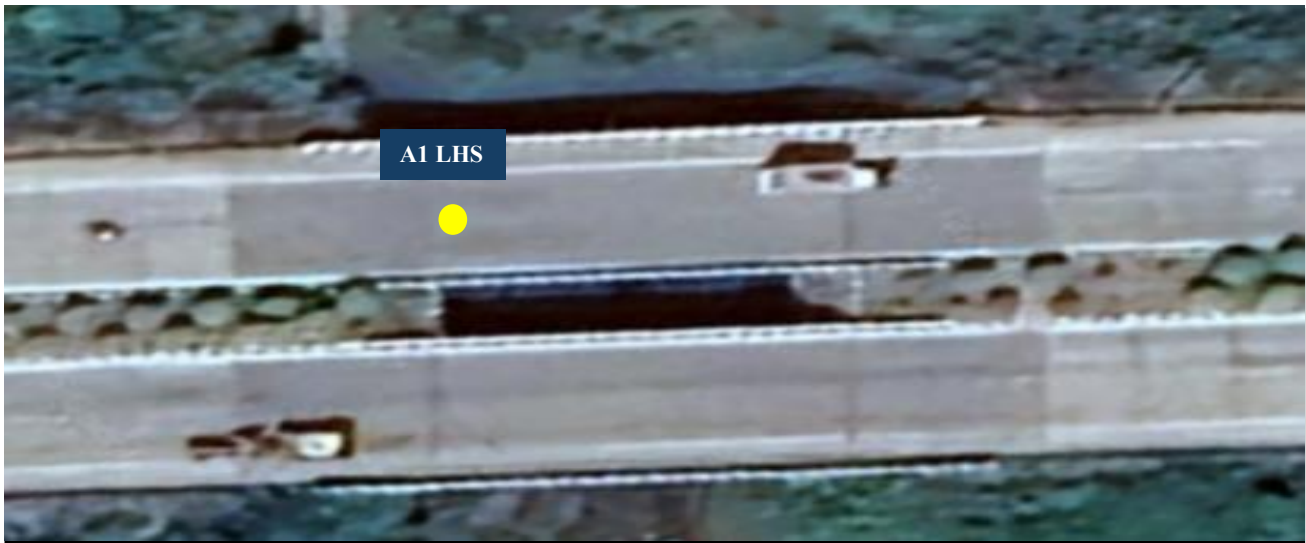
A1 LHS (25.10506978645167, 74.86748886229618)

- Vertical Displacement (VV)** remains consistently positive, generally ranging from +3 mm to +18 mm, indicating a steady upward movement over the entire monitoring period. The magnitude gradually increases, reflecting progressive vertical displacement with no downward settlement phase.
- Horizontal Displacement (VH)** shows significant variability, fluctuating between -7 mm and +17 mm. The behaviour includes alternating positive and negative shifts, indicating cyclic lateral movement rather than a unidirectional trend.

- January 2025:** VH registers a high initial peak (+17 mm) while VV remains low (+3 mm). This marks the first instance of significant lateral movement without corresponding vertical displacement.
- June 2025:** This phase demonstrates opposing-direction movements, signalling strong environmental influence near the end of the monitoring cycle.

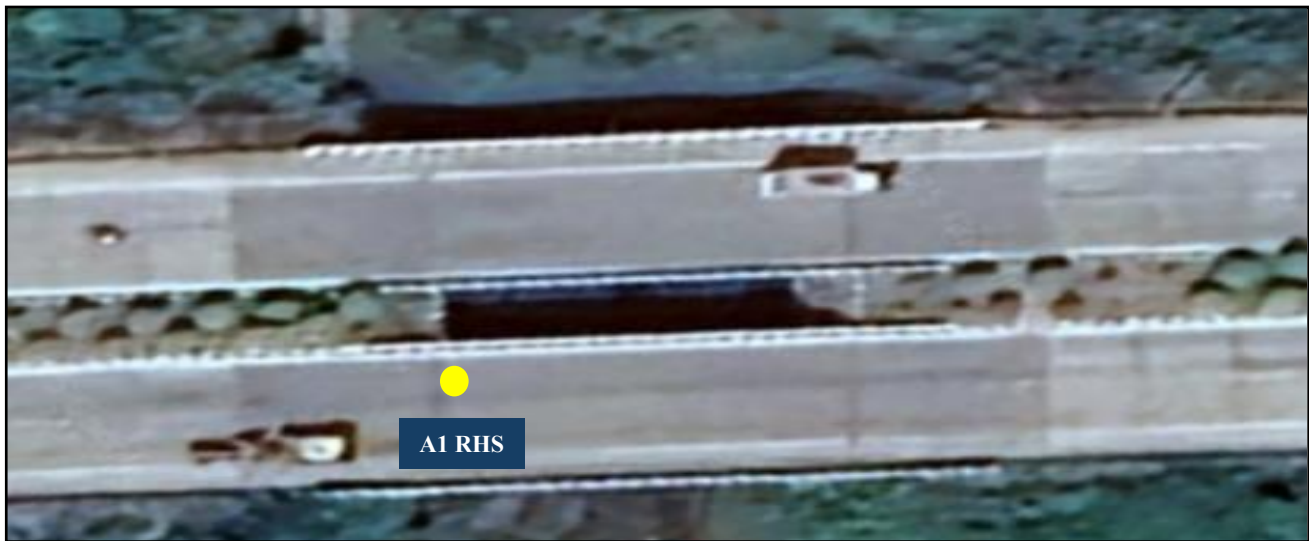
A1 RHS (25.105019995548236, 74.86760419728361)

- **Horizontal displacement (VH)** shows **significant positive variation**, fluctuating between **0 mm and +22 mm**, with multiple upward peaks
- **Vertical displacement (VV)** remains consistently negative, generally ranging from **-2 mm to -17 mm**, indicating continuous downward movement.

- **March 2025:** VH increases sharply, peaking near +15 mm to +17 mm, while VV briefly rises toward 0 mm.
- **May 2025:** VV reaches one of its more negative values (-12 mm), while VH climbs to +11 mm, showing opposing-direction behaviour downward vertical movement alongside upward lateral displacement.
- **June 2025:** VH rises to its maximum peak (+22 mm on 04-Jun), indicating the strongest lateral movement in the dataset.

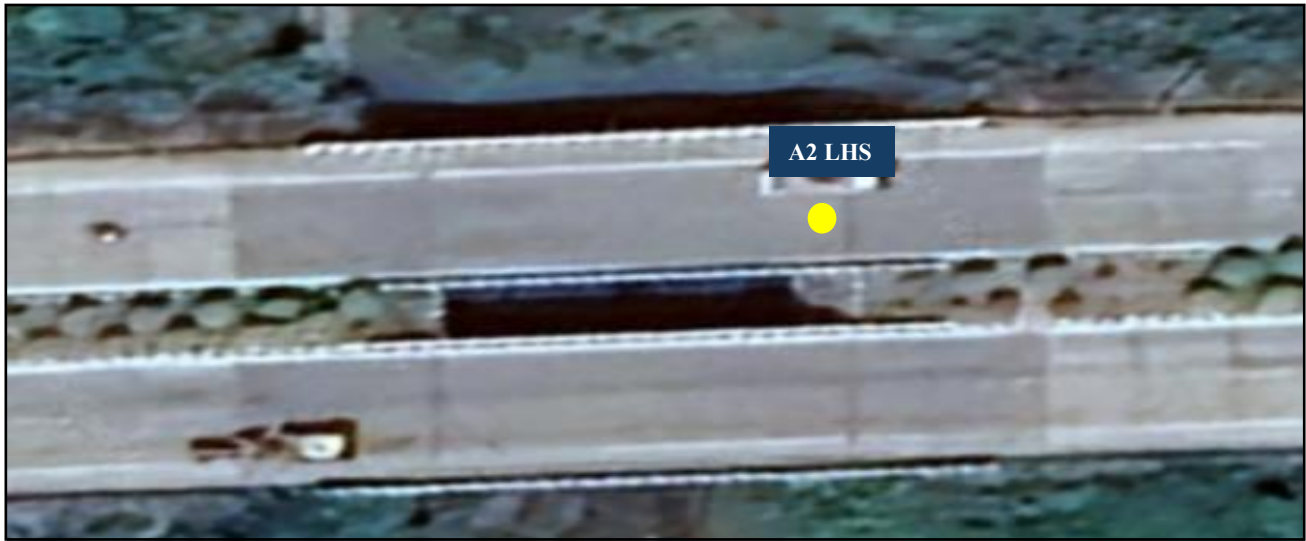
A2 LHS (25.105213694192717, 74.86757670464125)

- **Horizontal displacement (VH)** shows a clear upward trend, increasing from around +3 mm in late January to +22 mm by late June.
- **Vertical Displacement (VV)** remains consistently negative, ranging from approximately -2 mm to -15 mm, indicating ongoing downward settlement.

- **April 2025:** VV drops sharply to around -14 to -15 mm, marking the largest negative vertical movement in the dataset.
- **June 2025:** VH reaches its overall maximum value (+22 mm), marking the strongest lateral displacement recorded.
