# **LIDAR Inspection Report of MNB ch.941+300**

**Bridge No:** MNB - 942/1

**Bridge Chainage:** 941+300 (CKRP)

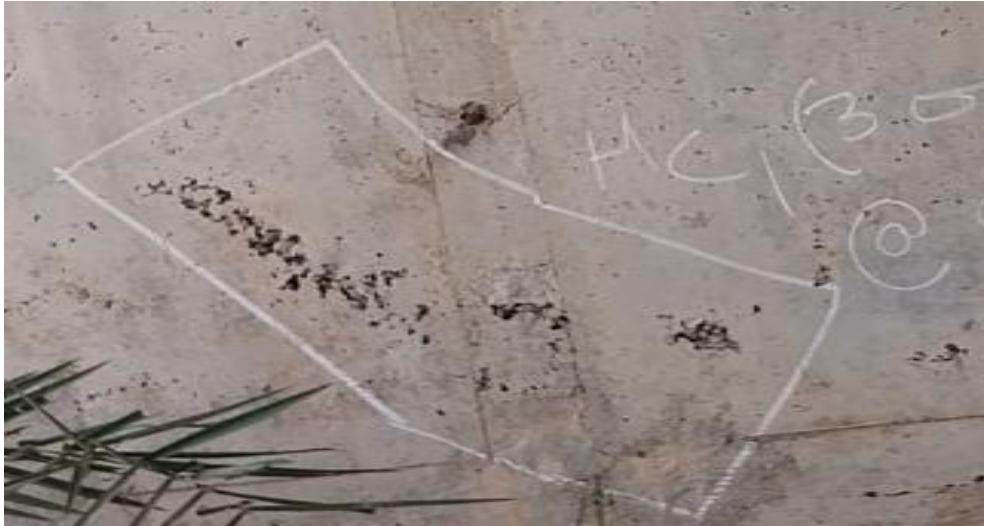
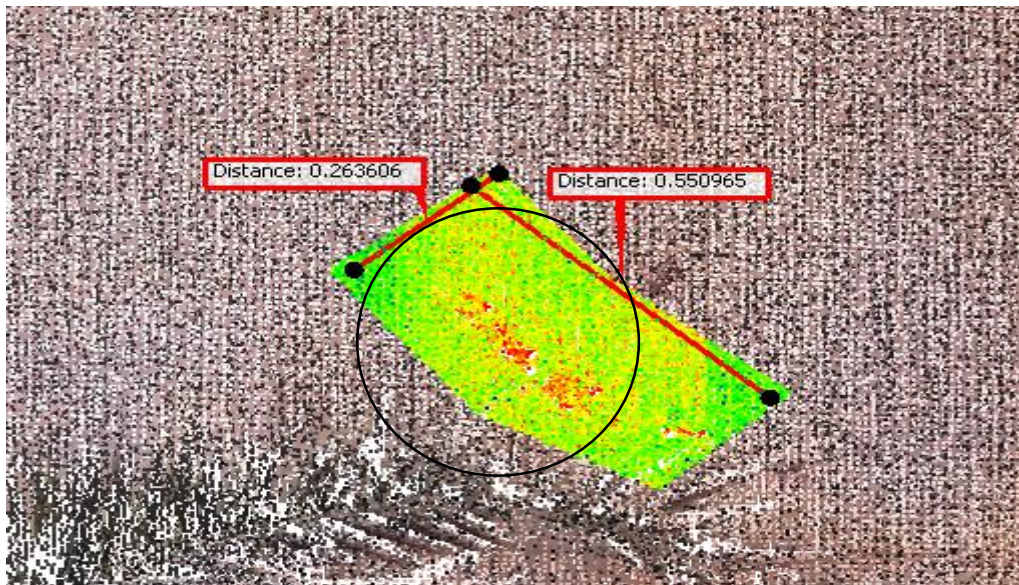
| Element Name | Observation | Location of Distress | Photo No. | Units | Distress Details | | | Area of Repair (Sq./RM T/m3) |
|---|---|---|---|---|---|---|---|---|
| Abutment 2 | Honeycombing | | 1 | | 0.61 | 0.17 | | 0.103 |

1. **Honeycombing observed on LHS A2, measuring 0.61 m in length and 0.17 m in width, covering an area of 0.103 m<sup>2</sup>**

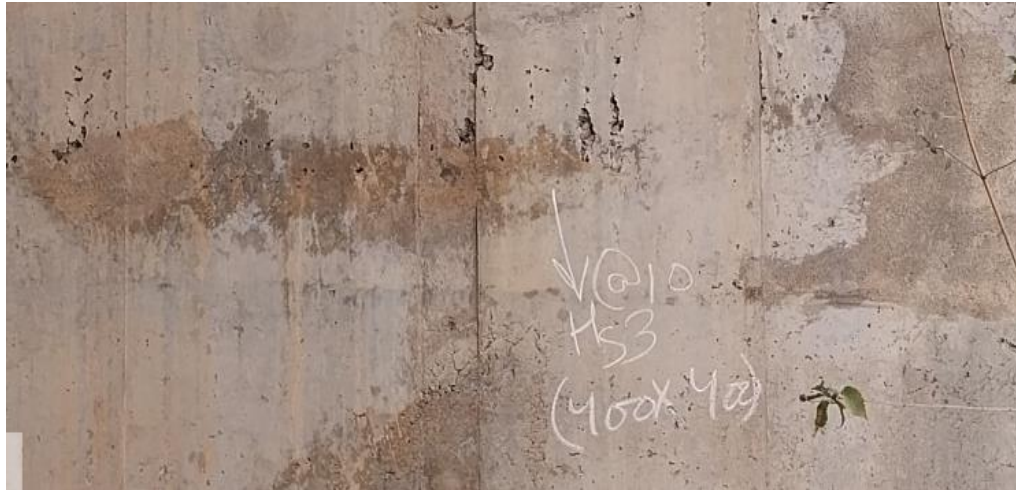
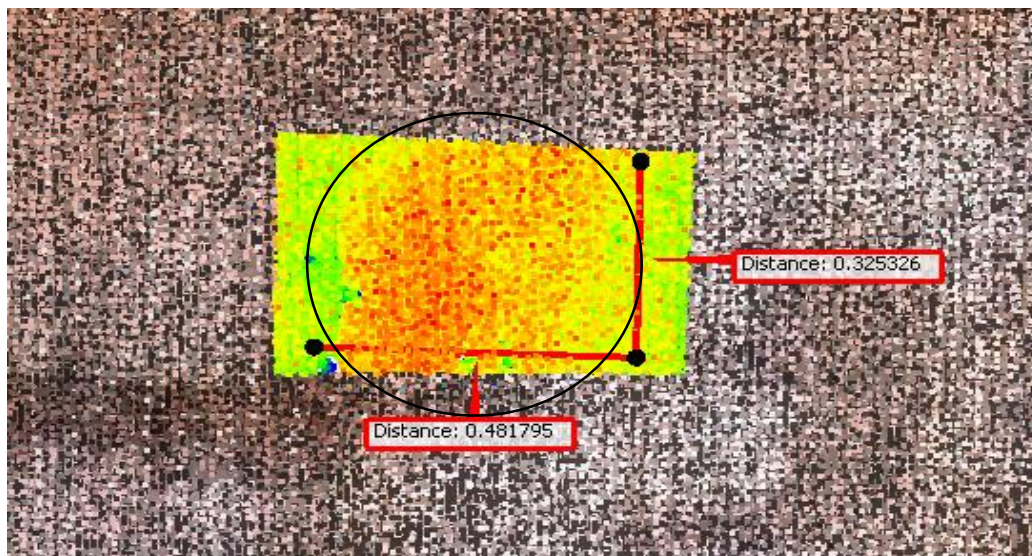
| Element Name | Observation | Location of Distress | Photo No. | Units | Distress Details | | | Area of Repair (Sq./RM T/m3) |
|---|---|---|---|---|---|---|---|---|
| Abutment 1 | Honeycombing | | 2 | | 1.18 | 0.41 | | 0.483 |

2. **Honeycombing observed on LHS A1, measuring 1.18 m in length and 0.41 m in width, covering an area of 0.483 m<sup>2</sup>.**

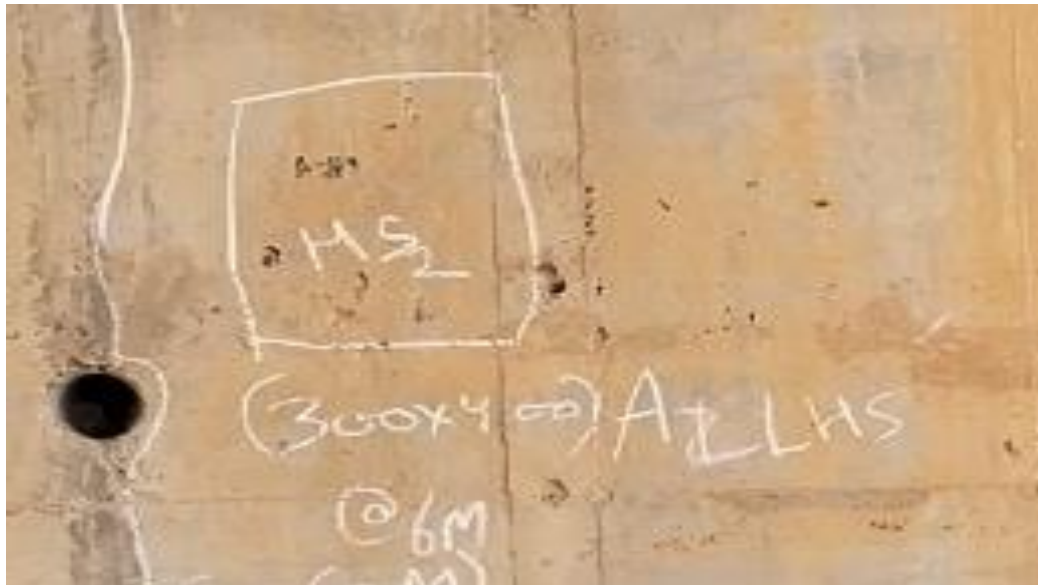
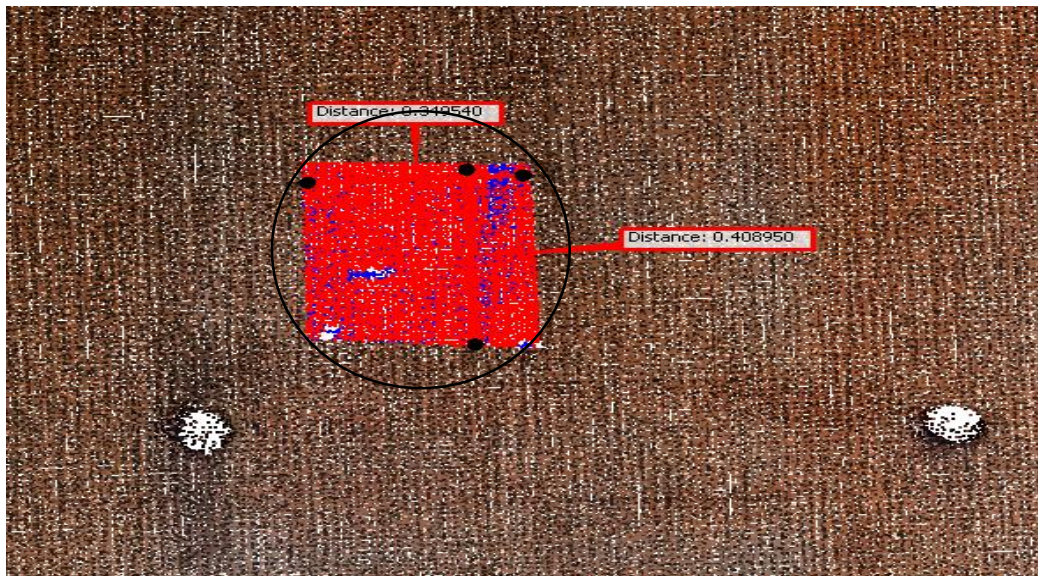
| Element Name | Observation | Location of Distress | Photo No. | Units | Distress Details | | | Area of Repair (Sq./RM T/m3) |
|---|---|---|---|---|---|---|---|---|
| Abutment 1 | Hollow section | | 3 | | 0.44 | 0.29 | 0.026 | 0.0033 |

3. Hollow section observed at A1 (LHS), measuring 0.44 m in length and 0.29 m in width. Depth ranges from 0.024 m (min) to 0.028 m (max), with an average depth of 0.026 m. The calculated volume of the distress is 0.0033 m<sup>3</sup>.

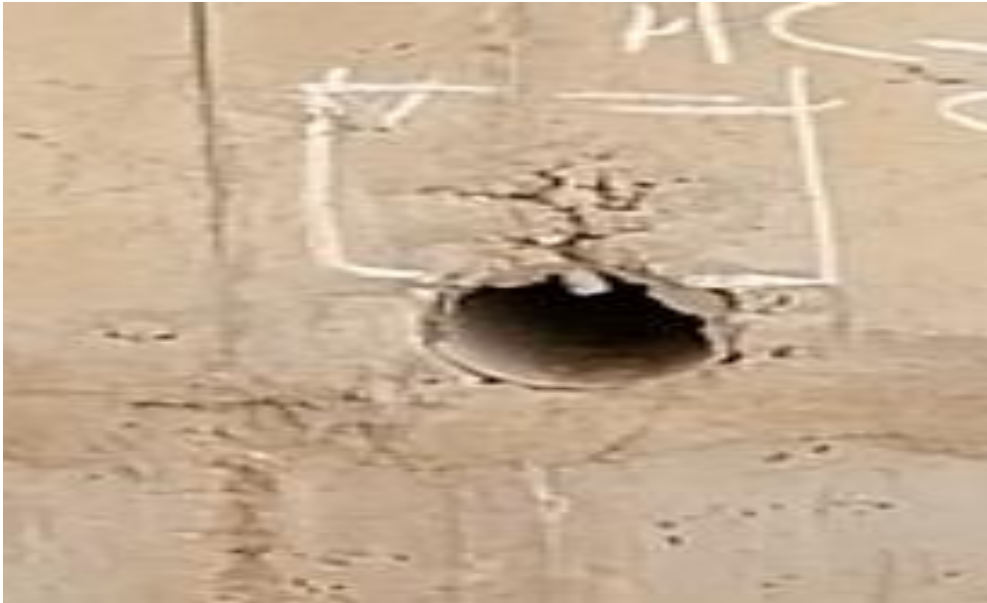
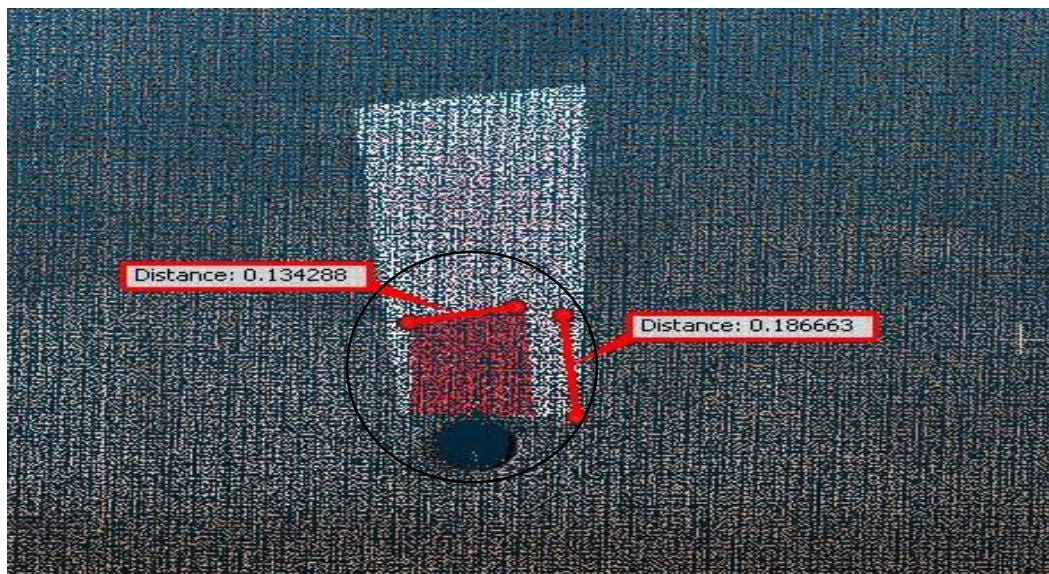
| Element Name | Observation | Location of Distress | Photo No. | Units | Distress Details | | | Area of Repair (Sq./RM T/m3) |
|---|---|---|---|---|---|---|---|---|
| Abutment 1 | Honeycombing | | 4 | | 0.18 | 0.13 | | 0.023 |

4. Honeycombing observed on LHS A1, measuring 0.18 m in length and 0.13 m in width, covering an area of 0.023 m<sup>2</sup>.

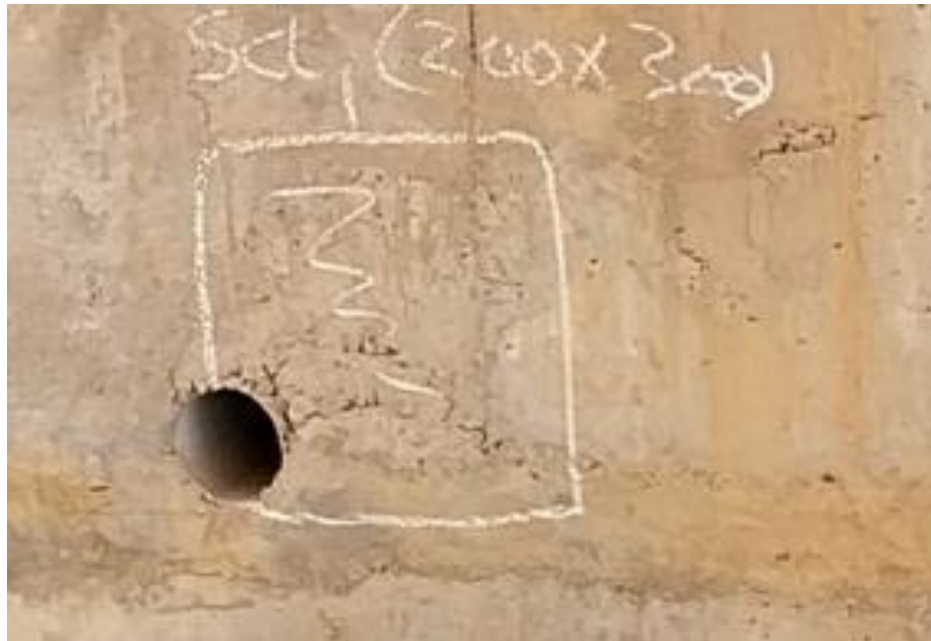
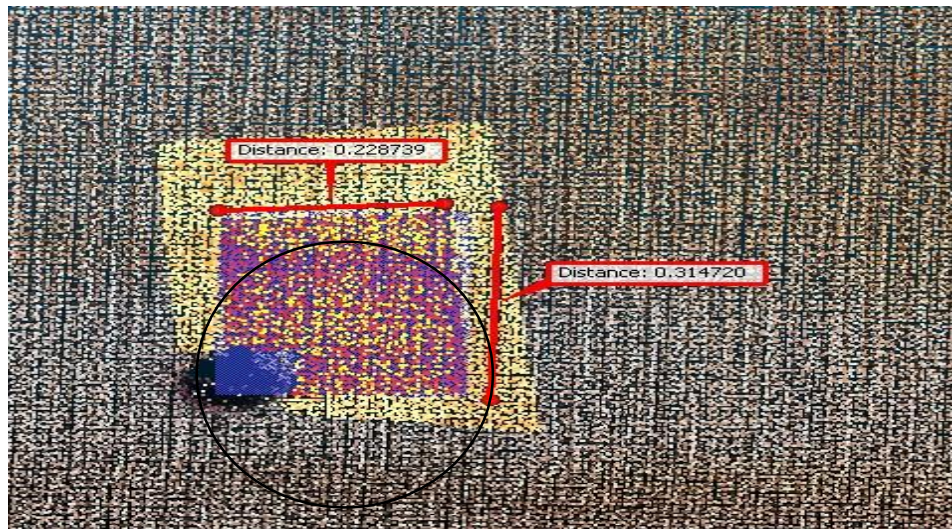
| Element Name | Observation | Location of Distress | Photo No. | Units | Distress Details | | | Area of Repair (Sq./RM T/m3) |
|---|---|---|---|---|---|---|---|---|
| Abutment 1 | Scaling | | 5 | | 0.31 | 0.22 | | 0.068 |

5. **Scaling observed on LHS A1, measuring 0.31 m in length and 0.22 m in width, covering an area of 0.068 m<sup>2</sup>.**

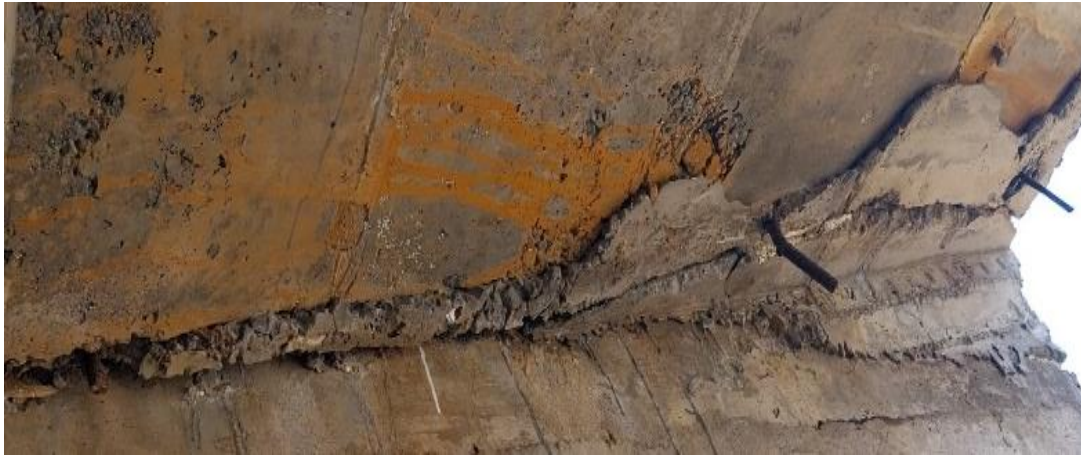
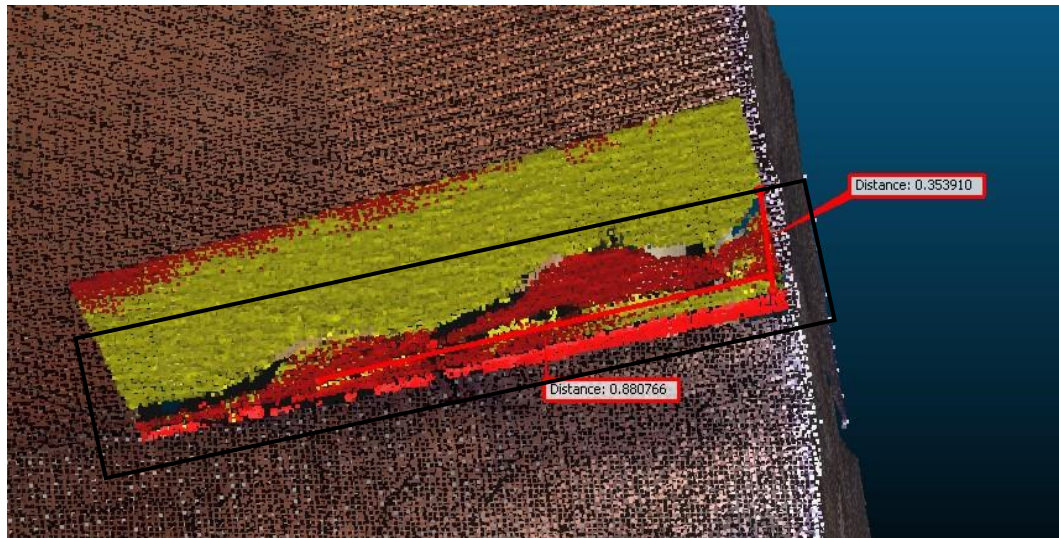
| Element Name | Observation | Location of Distress | Photo No. | Units | Distress Details | | | Area of Repair (Sq./RM T/m3) |
|---|---|---|---|---|---|---|---|---|
| Abutment 1 | Scaling | | 6 | | 0.88 | 0.35 | | 0.308 |

6. Spalling observed on LHS A1 cantilever portion, measuring 0.88 m in length and 0.35 m in width, covering an area of 0.308 m<sup>2</sup>.

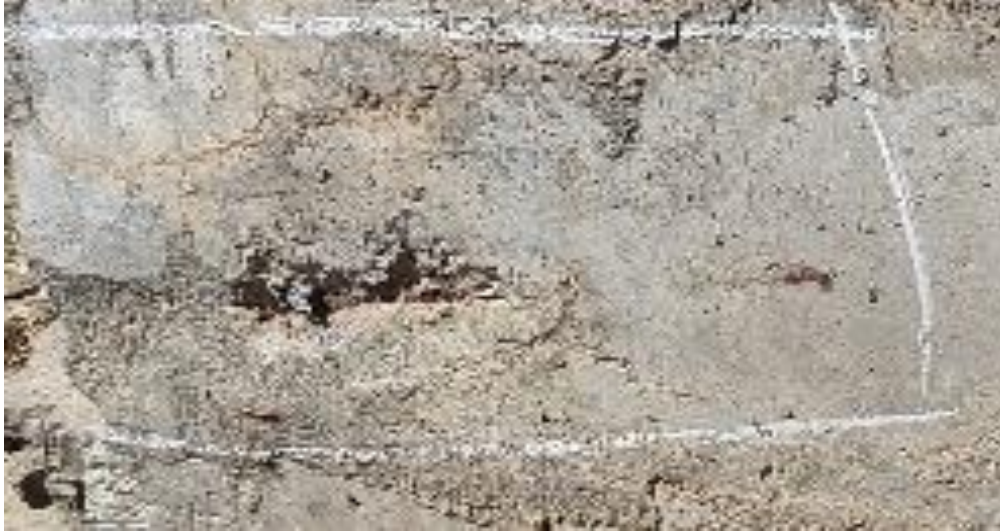
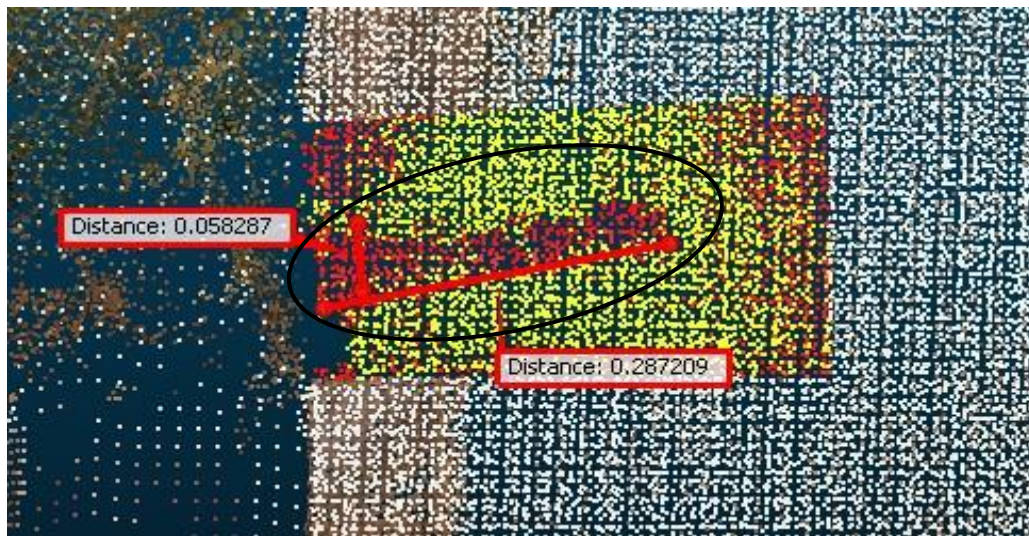
7. Steel exposure observed on A1 RHS, measuring 0.05 m in length and 0.28 m in width, covering an area of 0.014 m<sup>2</sup>.

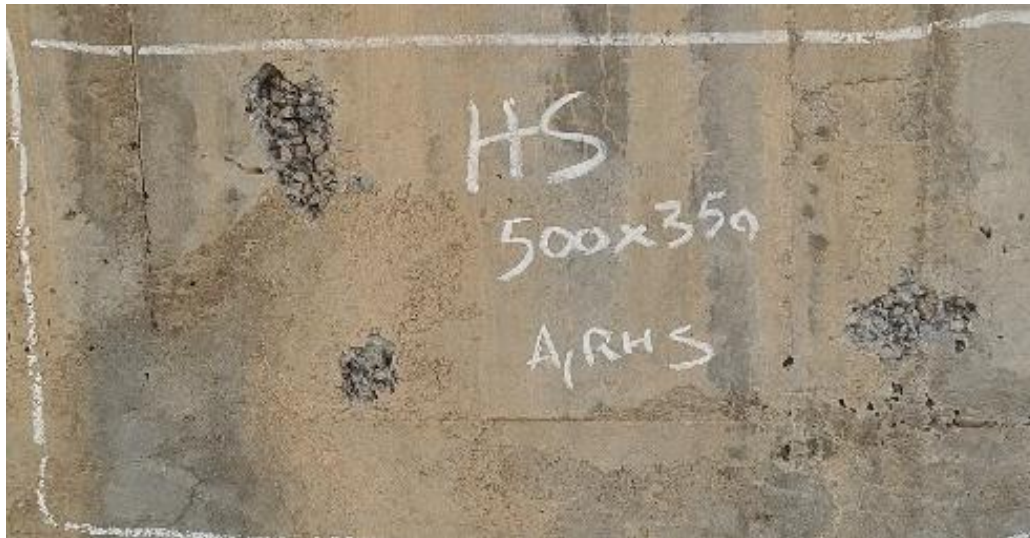
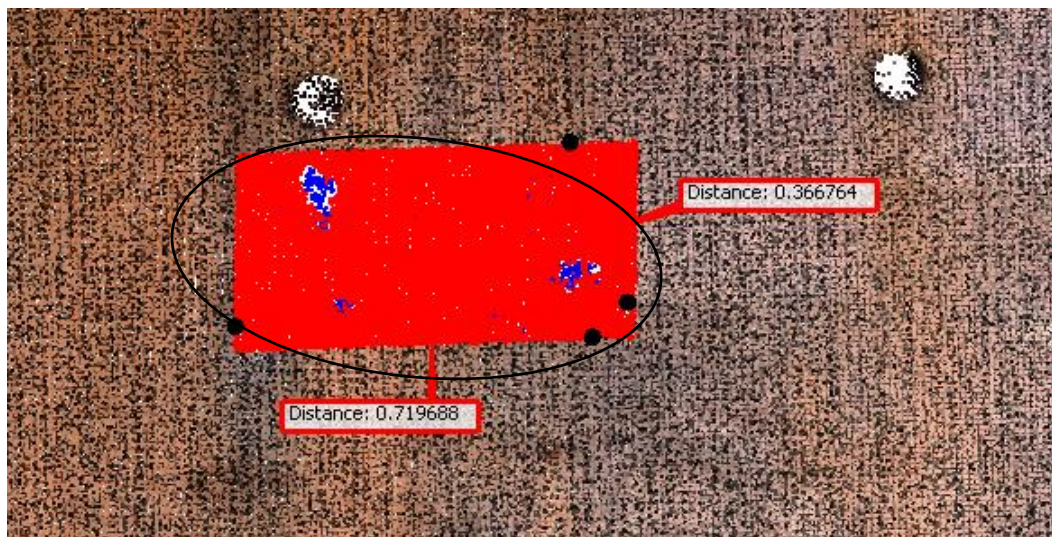
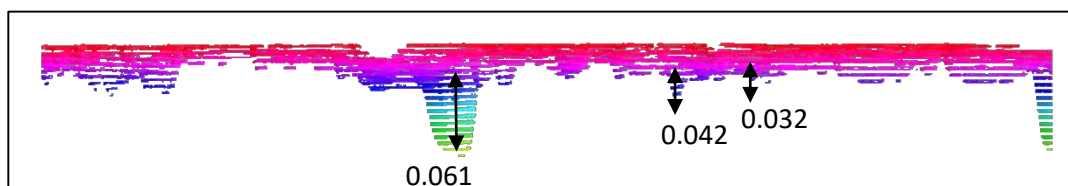
| Element Name | Observation | Location of Distress | Photo No. | Units | Distress Details | | | Area of Repair (Sq./RM T/m3) |
|---|---|---|---|---|---|---|---|---|
| Abutment 1 | Hollow Section | | 8 | | 0.56 | 0.37 | 0.042 | 0.0087 |

8. **Hollow section observed at A1 (RHS), measuring 0.56 m in length and 0.37 m in width. Depth ranges from 0.032 m (min) to 0.061 m (max), with an average depth of 0.042 m. The calculated volume of the distress is 0.0087 m<sup>3</sup>.**

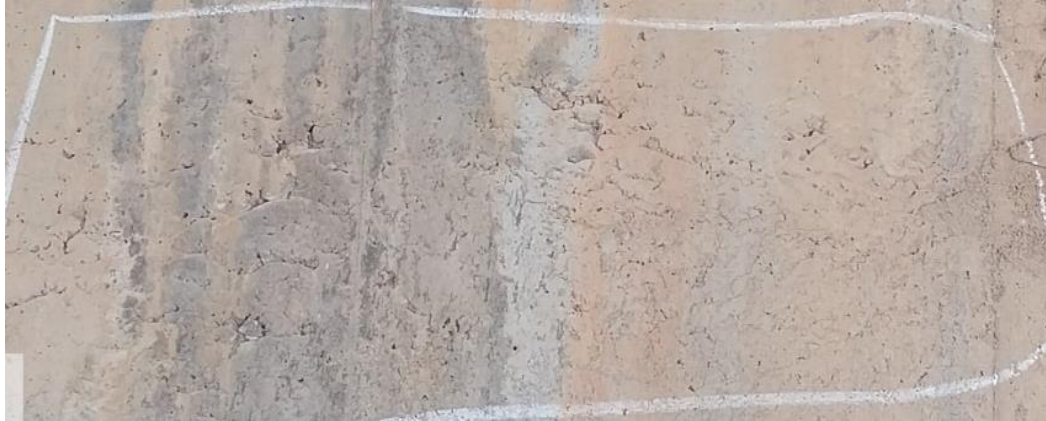
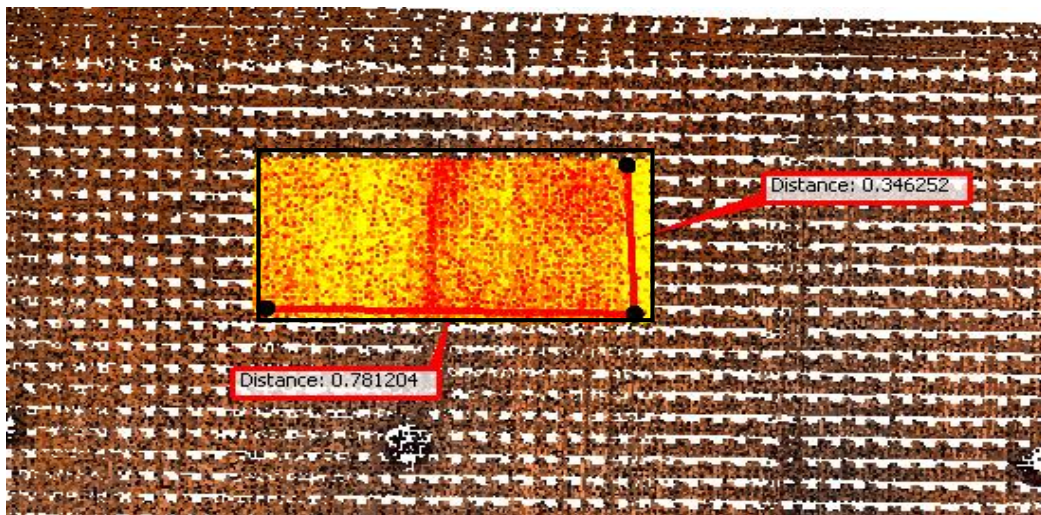
| Element Name | Observation | Location of Distress | Photo No. | Units | Distress Details | | | Area of Repair (Sq./RM T/m3) |
|---|---|---|---|---|---|---|---|---|
| Abutment 2 | Scaling | | 9 | | 0.61 | 0.49 | | 0.298 |

9. Scaling observed on RHS A2, measuring 0.61 m in length and 0.49 m in width, covering an area of 0.298 m<sup>2</sup>.

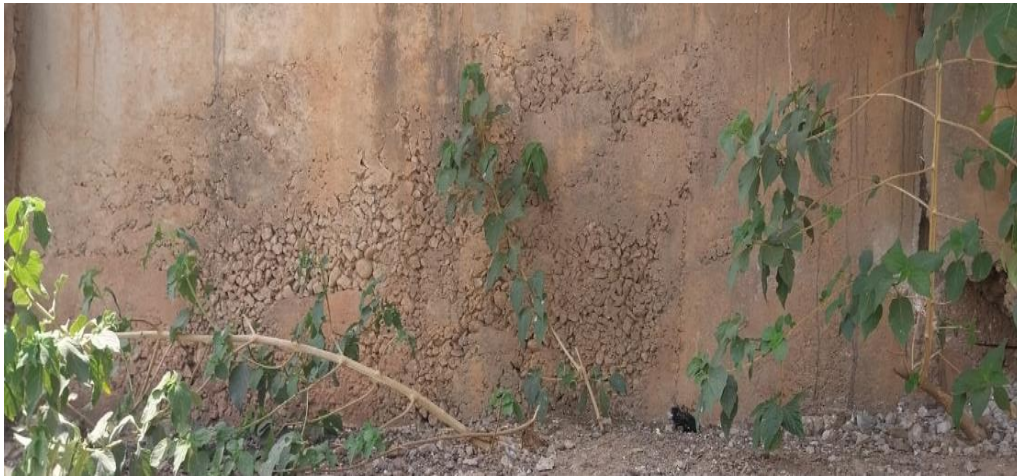
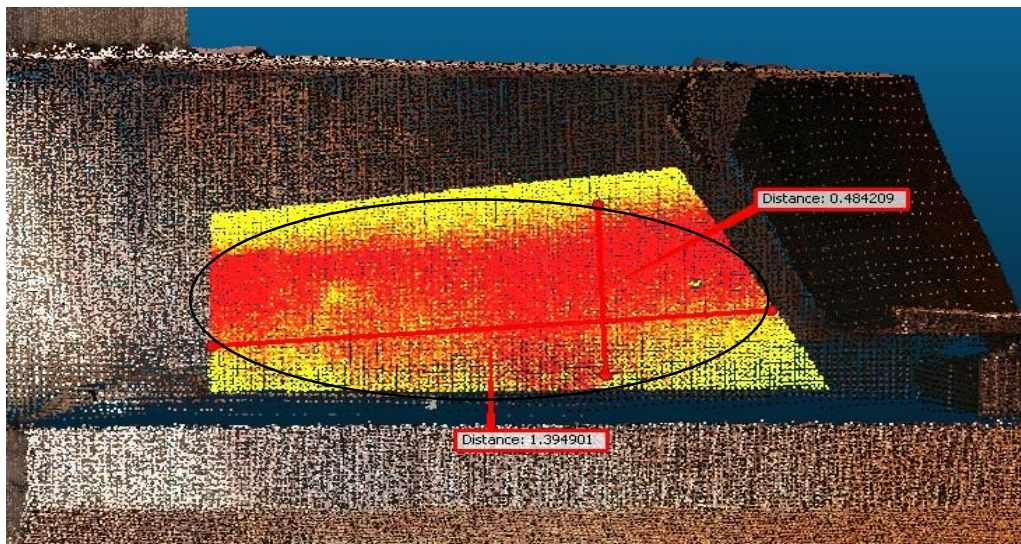
| Element Name | Observation | Location of Distress | Photo No. | Units | Distress Details | | | Area of Repair (Sq./RM T/m3) |
|---|---|---|---|---|---|---|---|---|
| Abutment 1<br>Dirt Wall | Honeycombing | | 10 | | 1.39 | 0.48 | | 0.667 |

**10. Honeycombing observed on A1 dirt wall, measuring 1.39 m in length and 0.48 m in width, covering an area of 0.667 m<sup>2</sup>.**

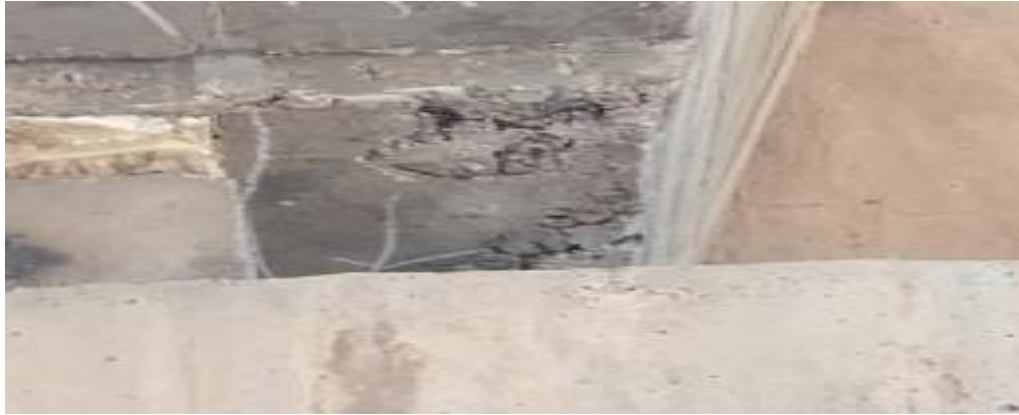
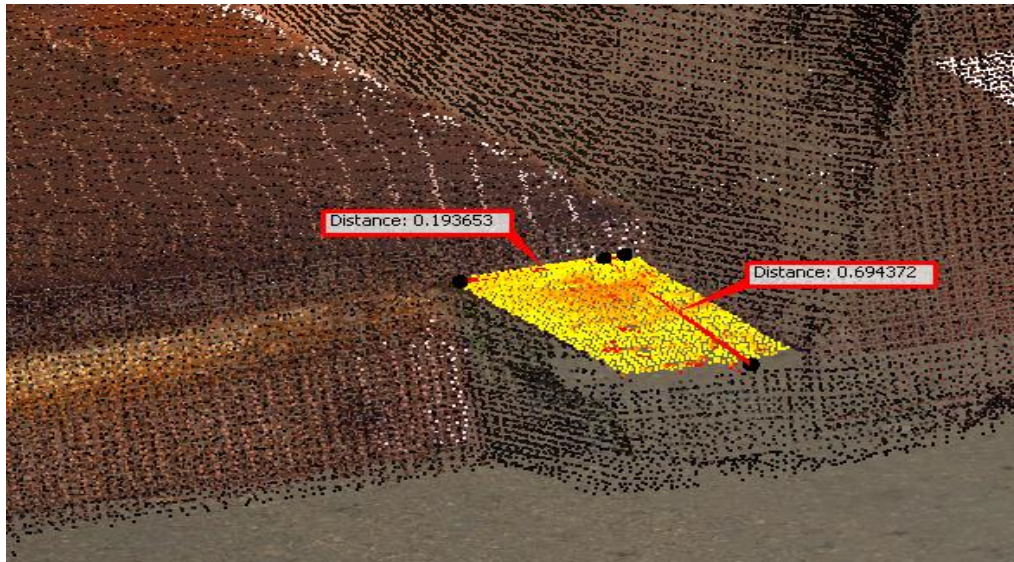
| Element Name | Observation | Location of Distress | Photo No. | Units | Distress Details | | | Area of Repair (Sq./RM T/m3) |
|---|---|---|---|---|---|---|---|---|
| Abutment 2 | Honeycombing | | 11 | | 0.64 | 0.17 | | 0.1088 |

**11. Honeycombing observed on RHS A2, measuring 0.64 m in length and 0.17 m in width, covering an area of 0.1088 m<sup>2</sup>.**
