# **LIDAR Inspection Report of VUP ch.942+650**

**Bridge Chainage:** 942+650 (CKRP)

## **CH: 942+650– VUP**

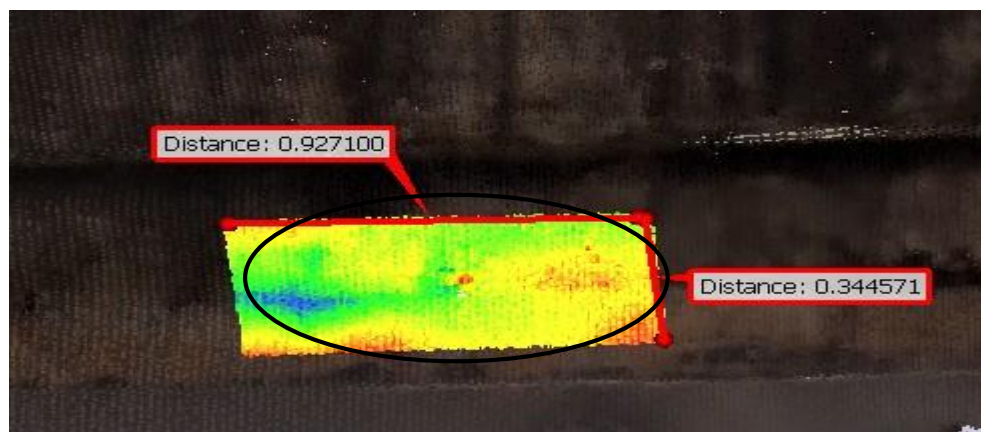
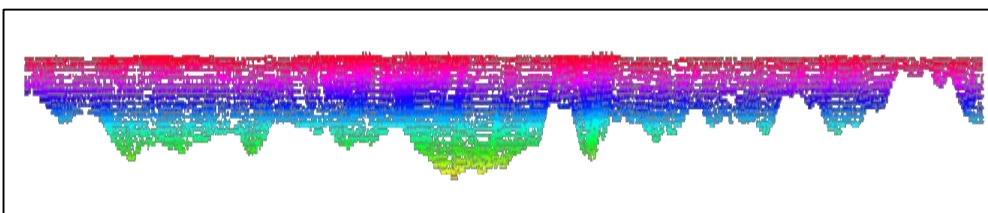
| Element Name | Observation | Location of Distress | Photo No. | Units | Distress Details | | | Area of Repair (Sq.m/ RMT/ m3) |
|---|---|---|---|---|---|---|---|---|
| Deck Slab | Scaling | - | 1 | M | 0.92 | 0.34 | | 0.3128 |

**1. Scaling observed on LHS deck slab, measuring 0.92 m in length and 0.34 m in width, covering an area of 0.3128 m<sup>2</sup>.**

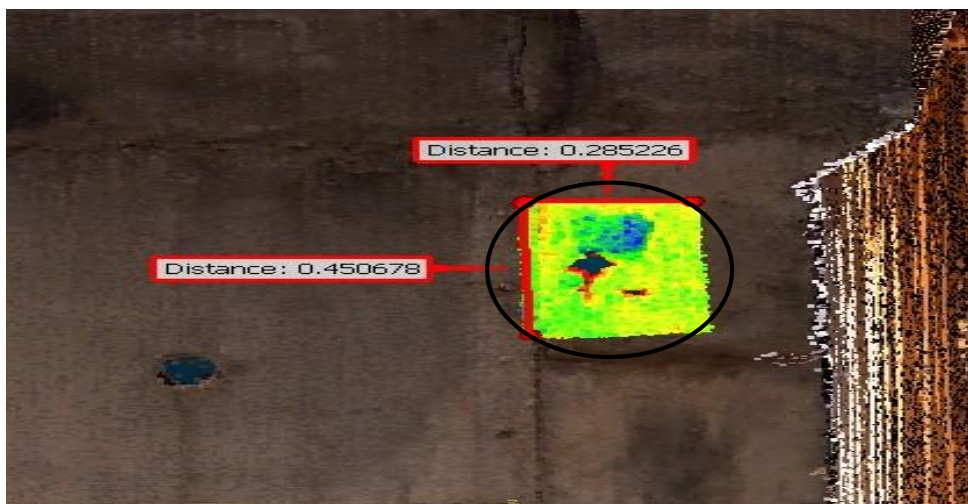
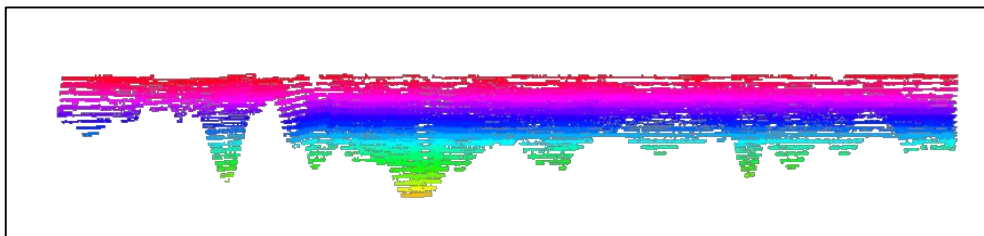
| Element Name | Observation | Location of Distress | Photo No. | Units | Distress Details | | | Area of Repair (Sq.m/ RMT/ m3) |
|---|---|---|---|---|---|---|---|---|
| Abutment 2 | Steel Expose | - | 2 | M | 0.28 | 0.45 | | 0.126 |

**2. Steel Expose observed on LHS Abutment 2 wall, measuring 0.28 m in length and 0.45 m in width, covering an area of 0.126 m<sup>2</sup>.**

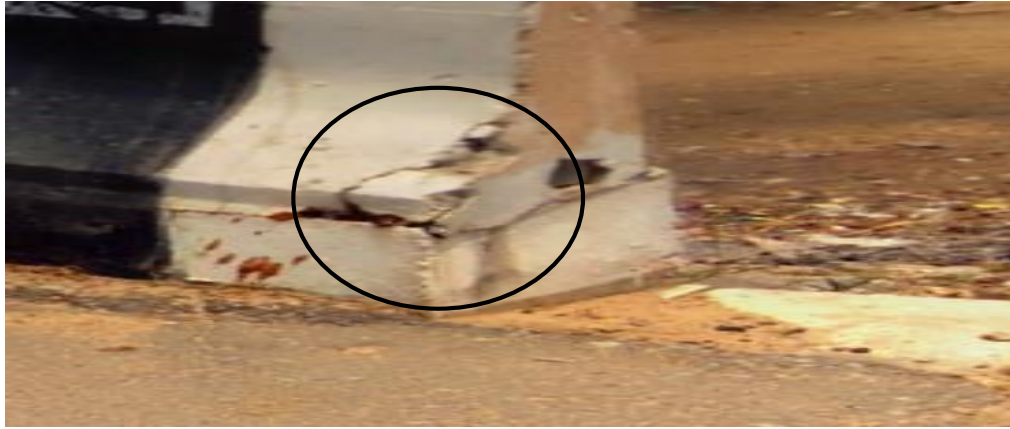
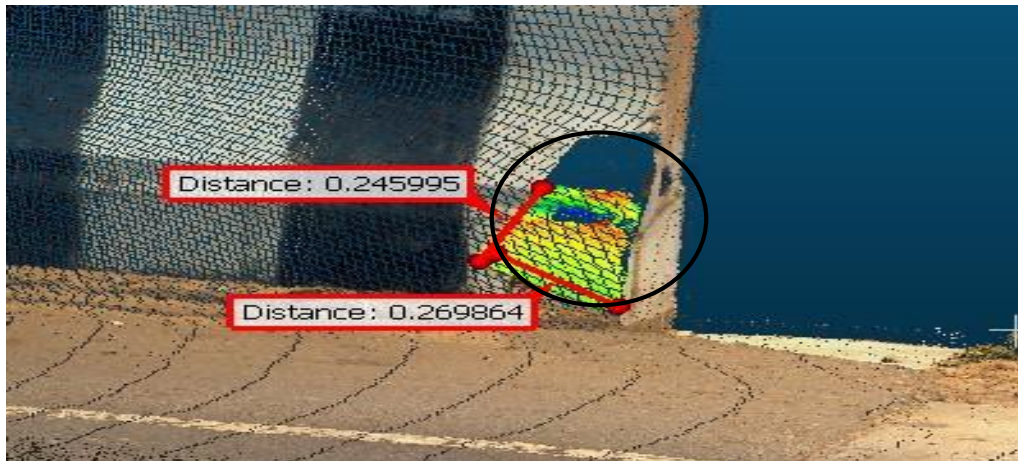
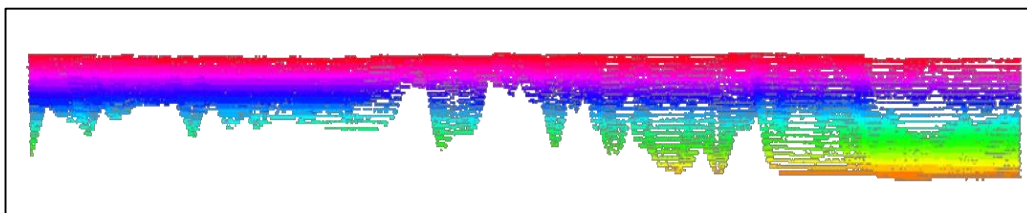
| Element Name | Observation | Location of Distress | Photo No. | Units | Distress Details | | | Area of Repair (Sq.m/ RMT/ m3) |
|---|---|---|---|---|---|---|---|---|
| Crash Barrier | Damage | - | 3 | M | 0.24 | 0.26 | | 0.06 |

**3. Damage observed on LHS Abutment 2 Crash Barrier, measuring 0.24 m in length and 0.26 m in width, covering an area of 0.0624 m<sup>2</sup>.**

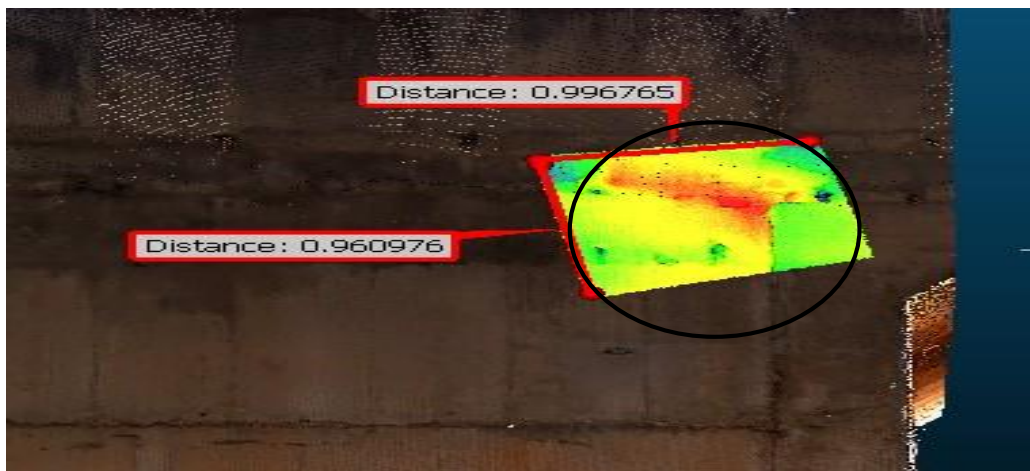
| Element Name | Observation | Location of Distress | Photo No. | Units | Distress Details | | | Area of Repair (Sq.m/ RMT/ m3) |
|---|---|---|---|---|---|---|---|---|
| Abutment 1 | Damage | - | 4 | M | 0.99 | 0.96 | | 0.9504 |

**4. Damage observed on RHS Abutment 1, measuring 0.99 m in length and 0.96 m in width, covering an area of 0.9504 m<sup>2</sup>.**

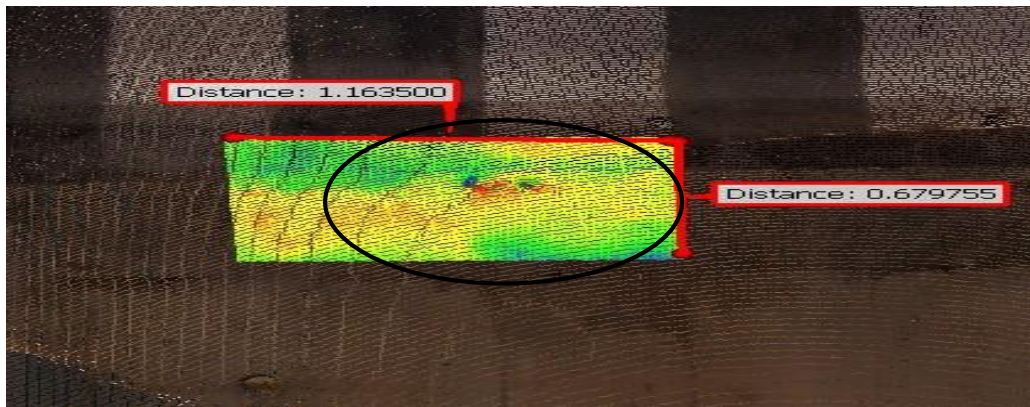
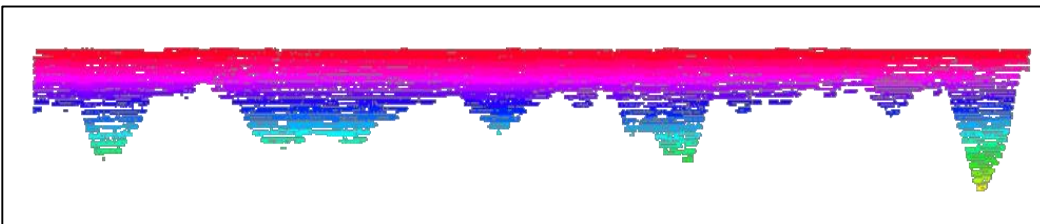
| Element Name | Observation | Location of Distress | Photo No. | Units | Distress Details | | | Area of Repair (Sq.m/ RMT/ m3) |
|---|---|---|---|---|---|---|---|---|
| Abutment 1 | Damage | - | 5 | M | 1.16 | 0.67 | | 0.7772 |

**5. Damage observed on RHS Abutment 1, measuring 1.16 m in length and 0.67 m in width, covering an area of 0.7772 m<sup>2</sup>.**
