# **LIDAR Inspection Report of MNB ch.943+240**

**Bridge No:** 944/1

**Bridge Chainage:** 943+240

- **Bridge No:** 944/1
- **Chainage:** 943+240
- **Structure type:** MNB

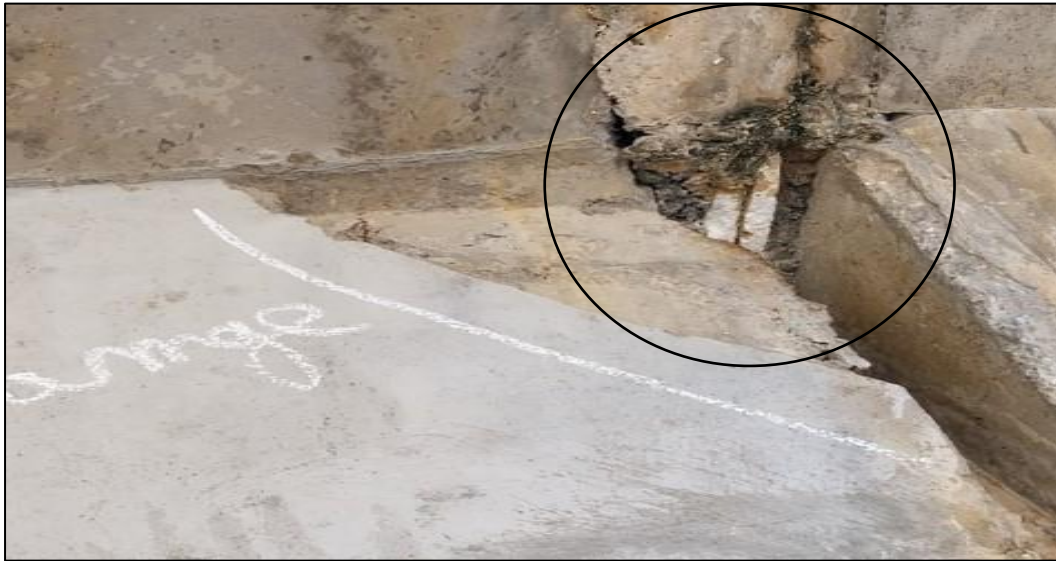
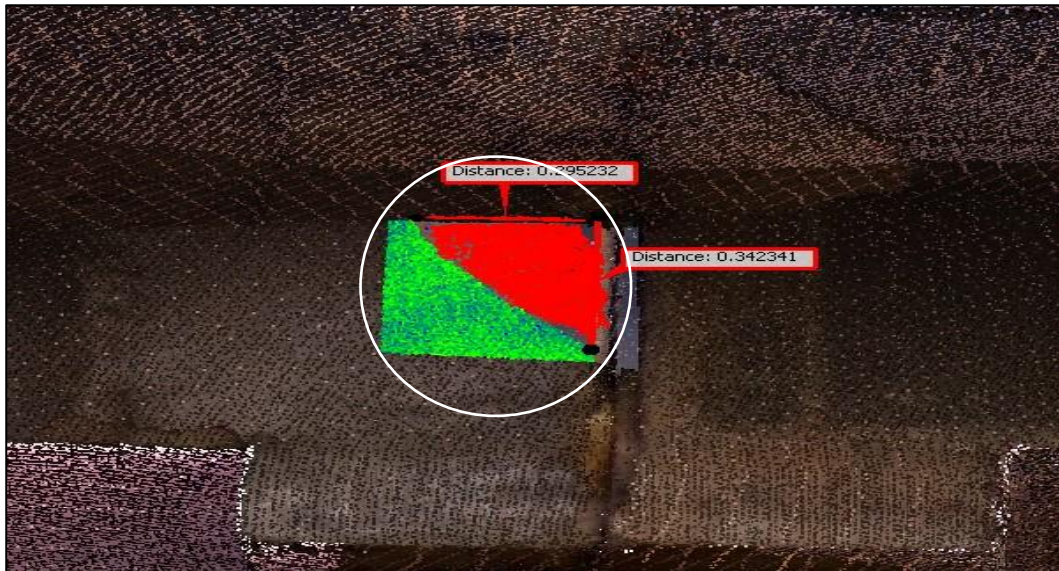
| Element Name | Observation | Location of Distress | Photo No. | Units | Distress Details | | | Area of Repair (Sq./RM T/m3) |
|---|---|---|---|---|---|---|---|---|
| Pier | Damage | - | 1 | Cu m | 0.342 | 0.295 | 0.011 | 0.00110 |

1. Toe Side Damage observed on A1-P1 span (LHS), measuring 0.342 m in length and 0.295 m in width, covering an area of 0.00110 m<sup>2</sup>, with an average depth of 0.011 m.

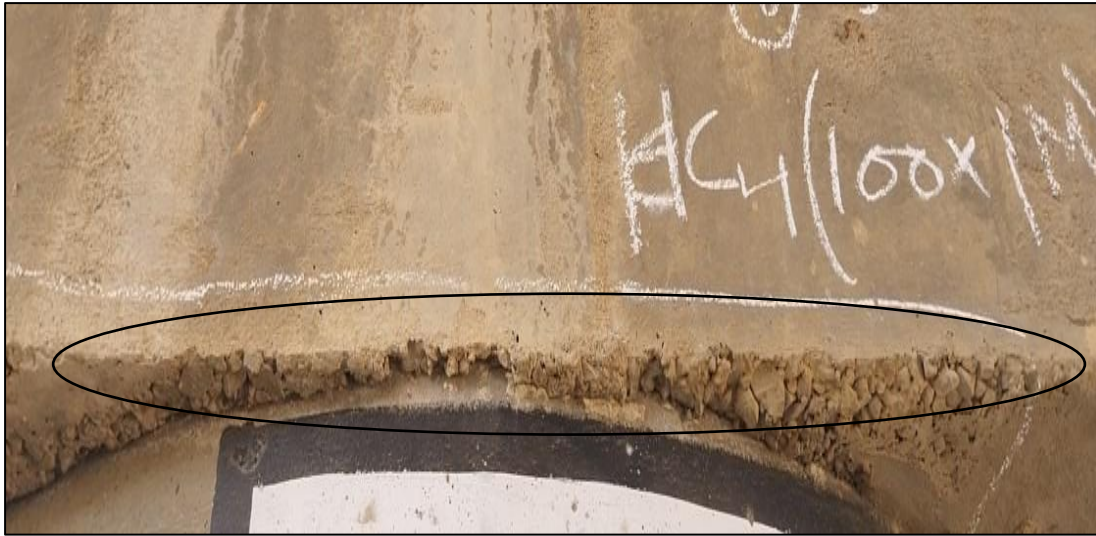
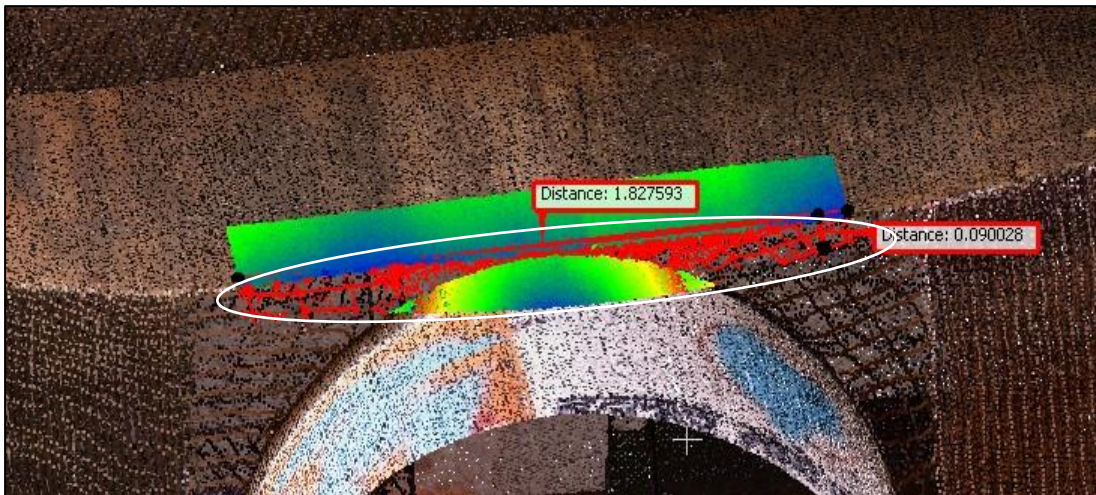
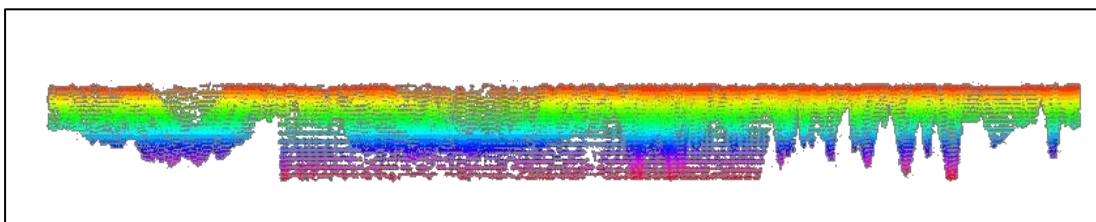
| Element Name | Observation | Location of Distress | Photo No. | Units | Distress Details | | | Area of Repair (Sq./RM T/m3) |
|---|---|---|---|---|---|---|---|---|
| Pier | Honeycombing | - | 2 | Sq m | 1.827 | 0.090<br>0 | - | 0.1644 |

- 2. Honeycombing observed on P1 (LHS), measuring 1.827 m in length and 0.0900 m in width, covering an area of 0.1644 m<sup>2</sup>.**

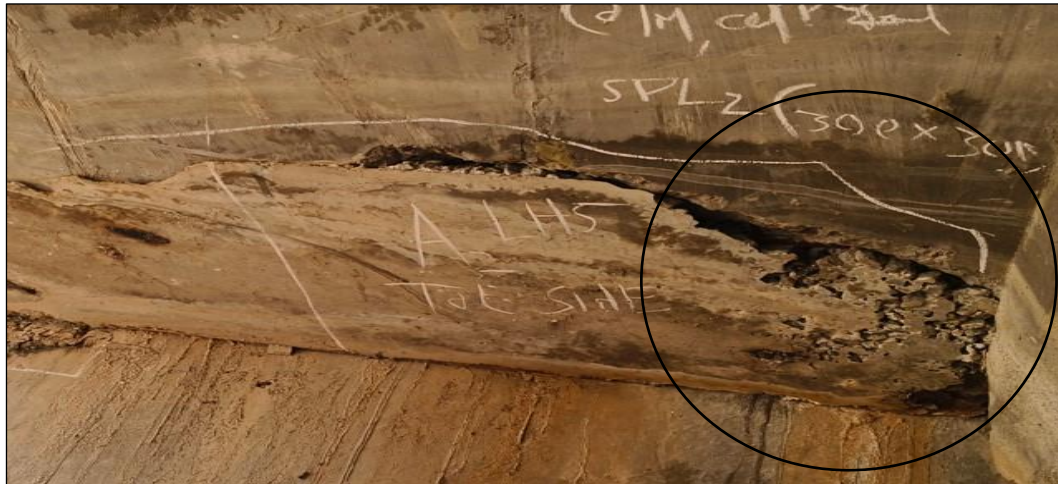
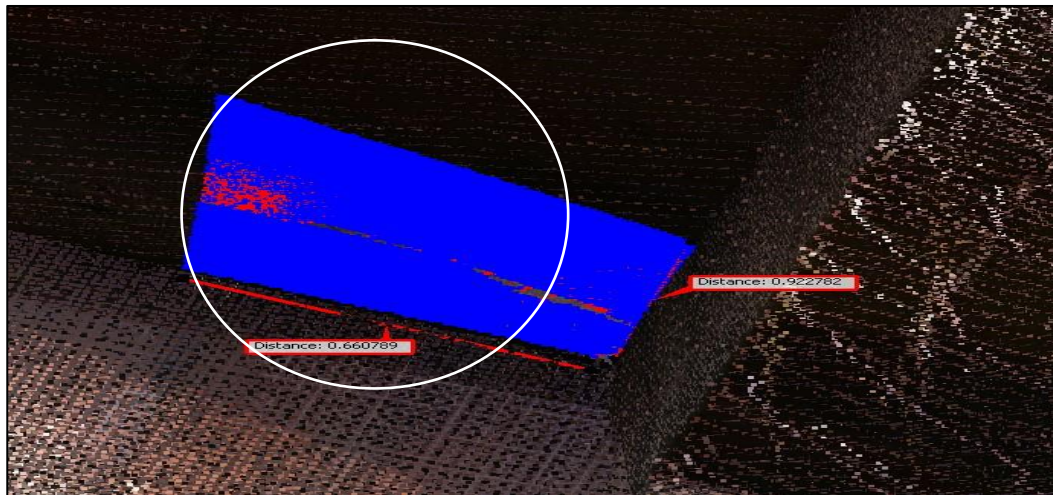
| Element Name | Observation | Location of Distress | Photo No. | Units | Distress Details | | | Area of Repair (Sq./RM T/m3) |
|---|---|---|---|---|---|---|---|---|
| Slab Bottom | Spalling | - | 3 | Cu m | 0.922 | 0.660 | 0.017 | 0.0103 |

**3.Spalling (SPL) observed on A2 (LHS) slab bottom, measuring 0.922 m in length and 0.660 m in width, covering an area of 0.0103 m<sup>2</sup>, with an average depth of 0.017 m.**

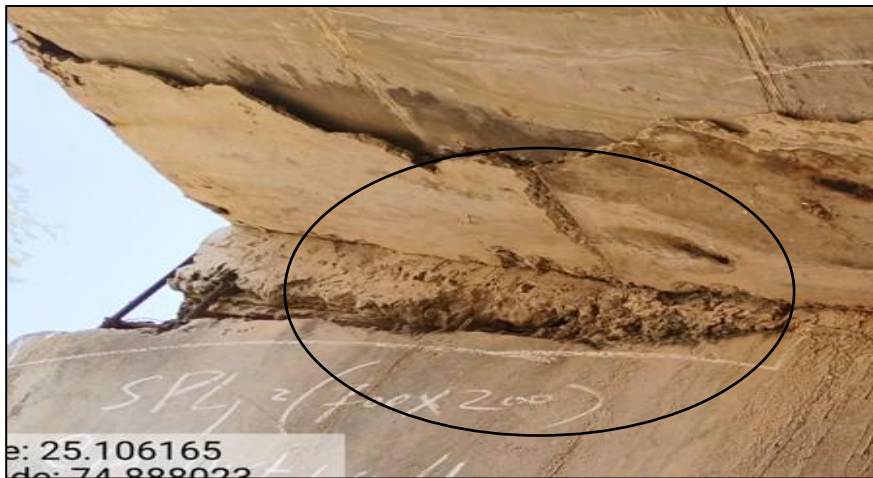
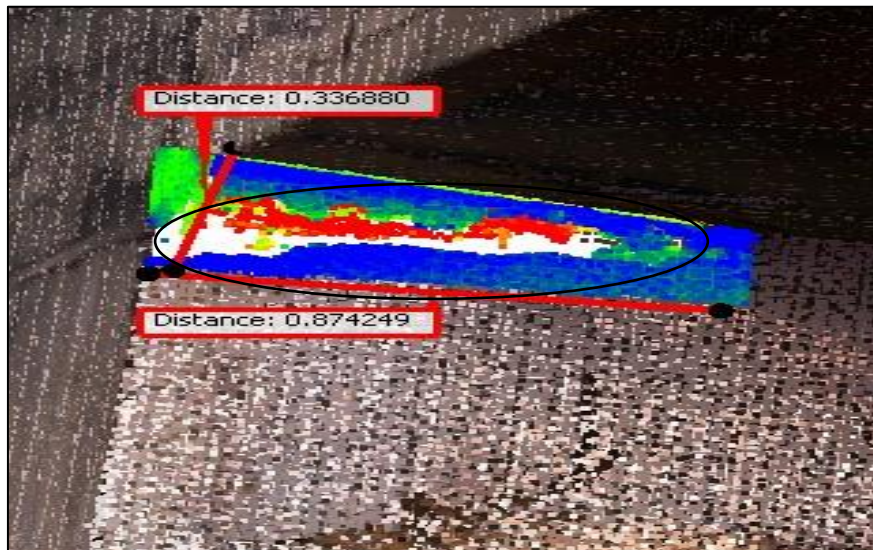
| Element Name | Observation | Location of Distress | Photo No. | Units | Distress Details | | | Area of Repair (Sq./RM T/m3) |
|---|---|---|---|---|---|---|---|---|
| Dirt Wall | Spalling | - | 4 | Cu m | 0.874 | 0.336 | 0.041 | 0.0120 |

**4. Spalling (SPL-1) observed on A2 (LHS) toe side dirt wall and approach, measuring 0.874 m in length and 0.336 m in width, covering an area of 0.0120 m<sup>2</sup>, with an average depth of 0.041 m.**

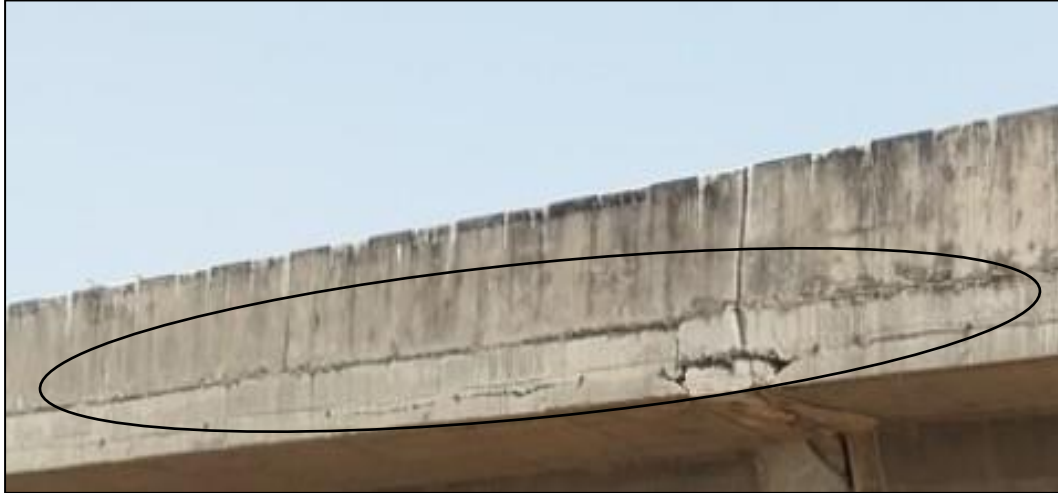
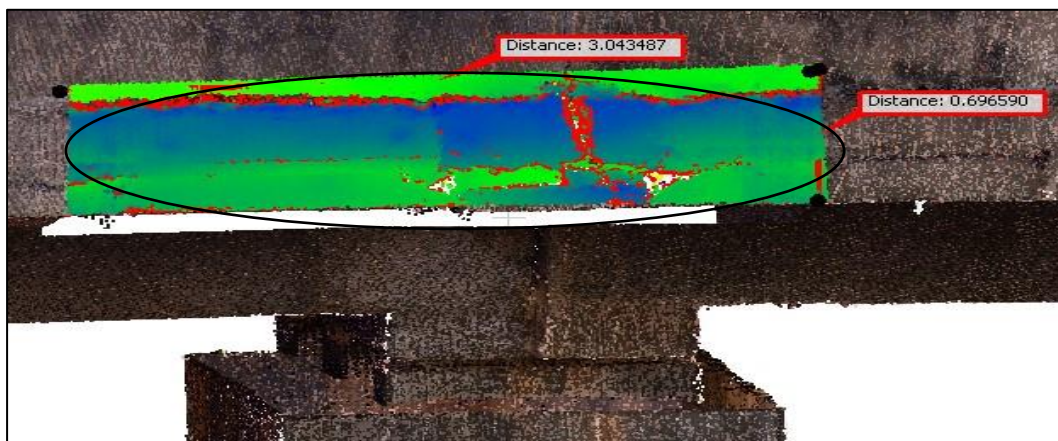
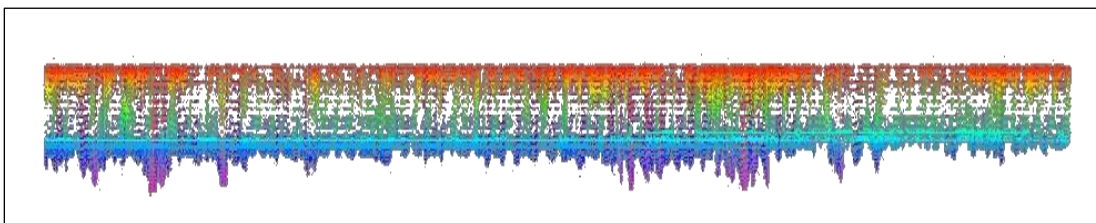
| Element Name | Observation | Location of Distress | Photo No. | Units | Distress Details | | | Area of Repair (Sq./RM T/m3) |
|---|---|---|---|---|---|---|---|---|
| Crash Barriar | Expansion & Damage | - | 5 | Sq m | 3.04 | 0.696 | - | 2.115 |

**5.Expansion & Crash Barrier Damage observed on P1 (LHS), measuring 3.04 m in length and 0.696 m in width, covering an area of 2.115 m<sup>2</sup>.**

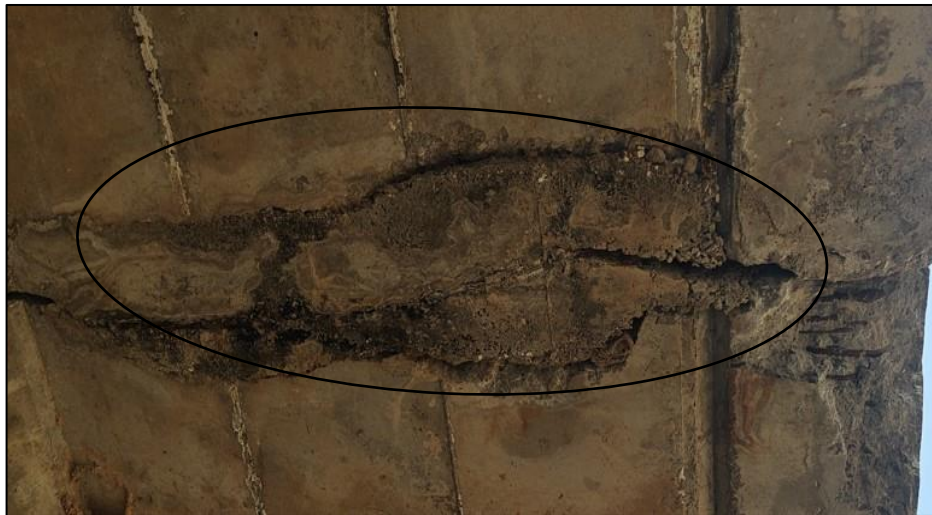
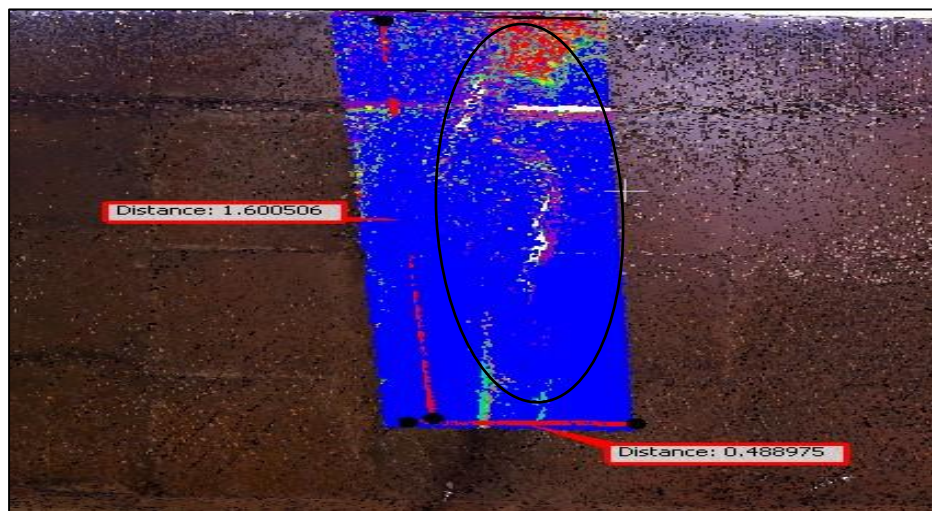
| Element Name | Observation | Location of Distress | Photo No. | Units | Distress Details | | | Area of Repair (Sq./RM T) |
|---|---|---|---|---|---|---|---|---|
| Pier | Spalling | - | 6 | Cu m | 1.600 | 0.488 | 0.016 | 0.012 |

6. Toe Side SPL (Spalling) observed on P1 (RHS), measuring 1.600 m in length and 0.488 m in width, covering an area of 0.012 m<sup>2</sup>, with an average depth of 0.016 m.

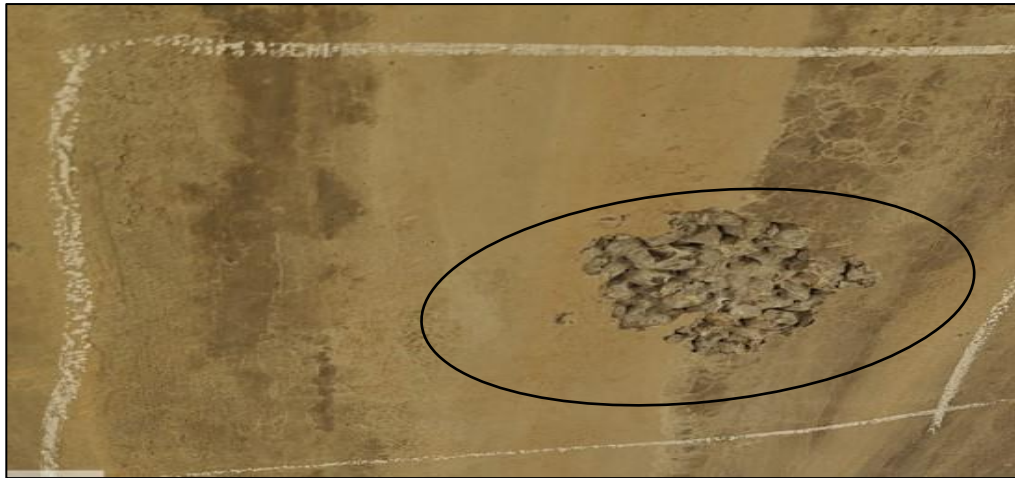
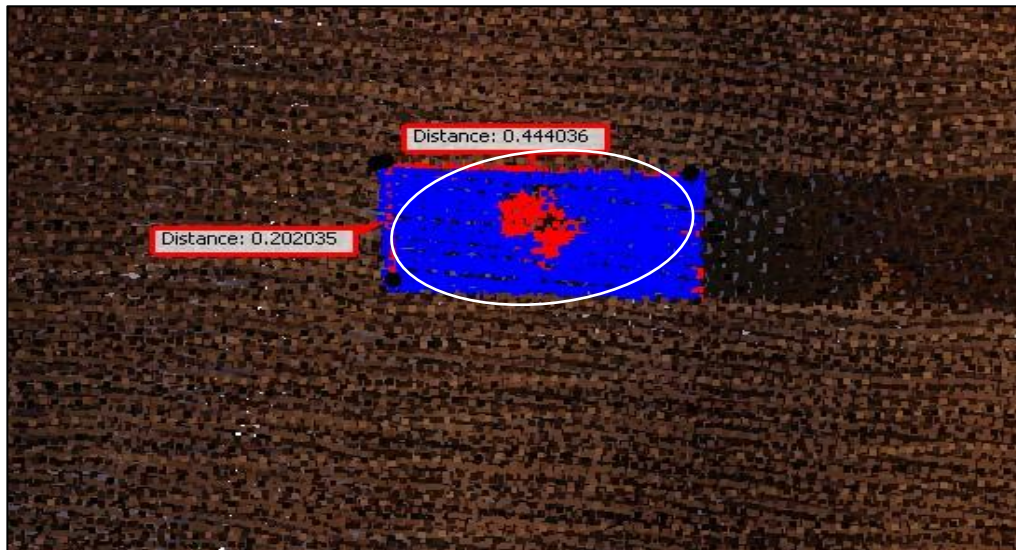
| Element Name | Observation | Location of Distress | Photo No. | Units | Distress Details | | | Area of Repair (Sq./RM T) |
|---|---|---|---|---|---|---|---|---|
| Pier | Hollow Section | - | 7 | Cu m | 0.444 | 0.202 | 0.019 | 0.0017 |

7. HS (Honeycombing) observed on P1 (RHS), measuring 0.444 m in length and 0.202 m in width, covering an area of 0.0017 m<sup>2</sup>, with an average depth of 0.019 m.

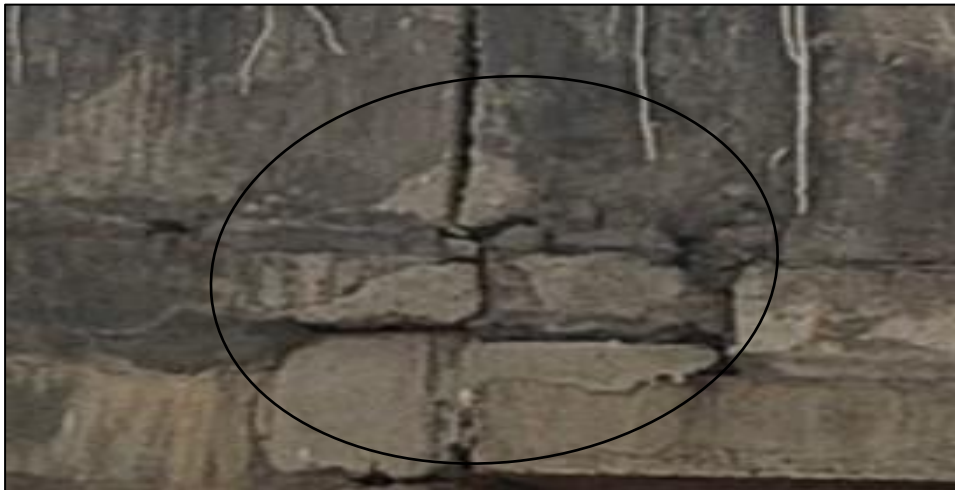
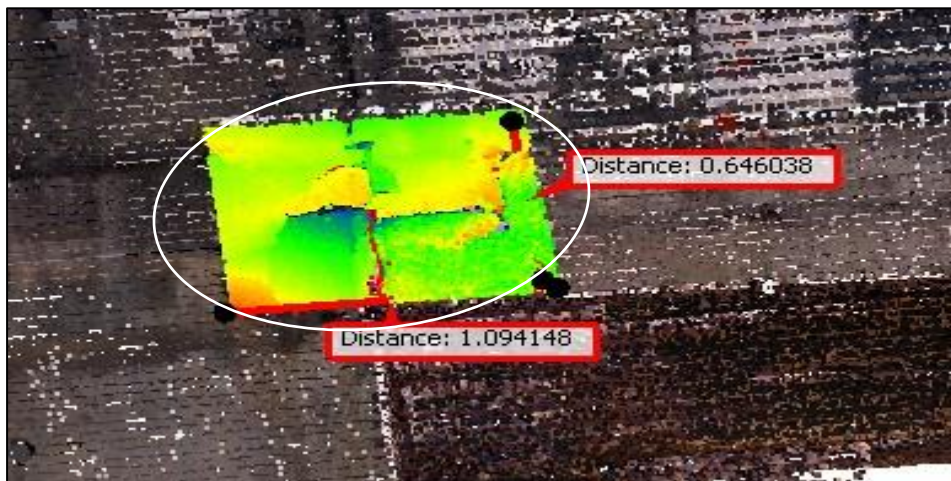
| Element Name | Observation | Location of Distress | Photo No. | Units | Distress Details | | | Area of Repair (Sq./RM T) |
|---|---|---|---|---|---|---|---|---|
| Expansion Joint | Damage | - | 8 | Sq m | 1.094 | 0.646 | - | 0.706 |

**8.Expansion Joint Damage observed on A1 (RHS), measuring 1.094 m in length and 0.646 m in width, covering an area of 0.706 m<sup>2</sup>.**
