# **LIDAR Inspection Report of MNB ch.943+400**

**Bridge No:** MNB – 944/2

**Bridge Chainage:** 943 + 400 (CKRP)

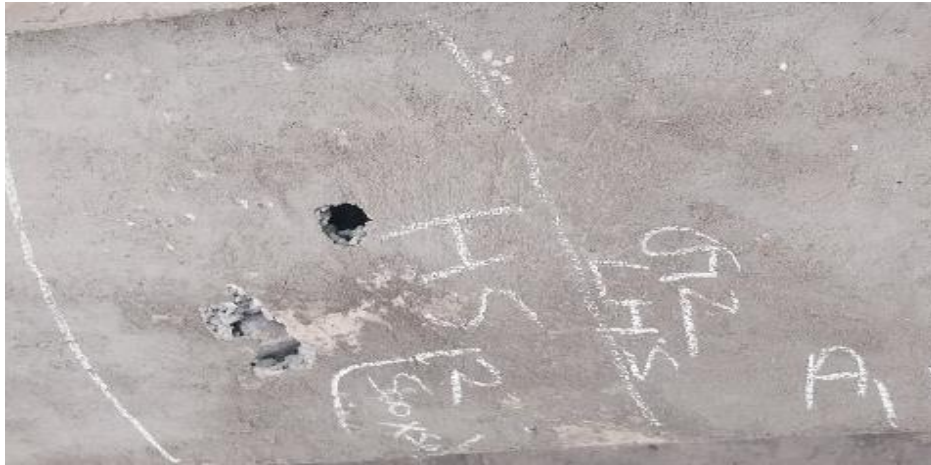
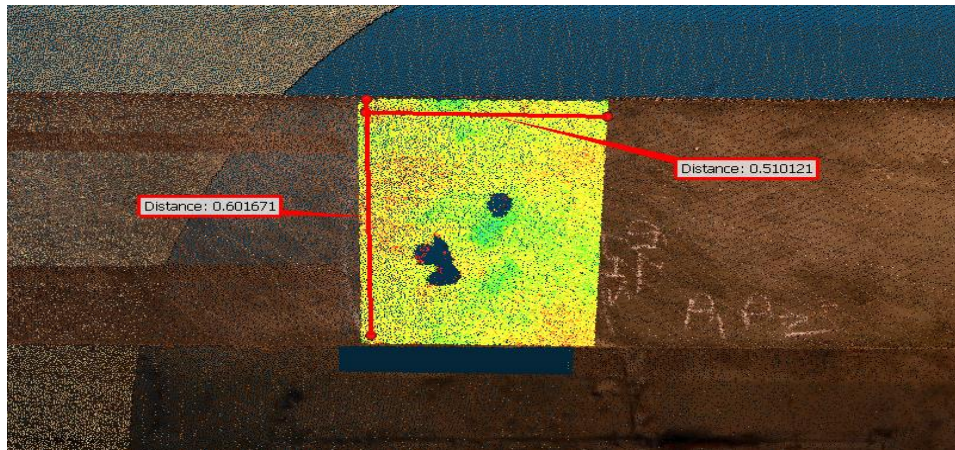
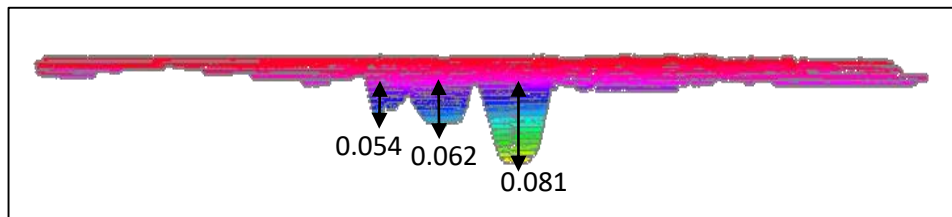
| Element Name | Observation | Location of Distress | Photo No. | Units | Distress Details | | | Area of Repair (Sq.m/R MT/m3) |
|---|---|---|---|---|---|---|---|---|
| Girder 2 | Hollow Section | | 1 | M | 0.60 | 0.51 | 0.062 | 0.0189 |

- 1. Hollow section observed on LHS between Abutment 1 and Abutment 2 at Span Girder 2, measuring 0.60 m in length and 0.51 m in width, covering an area of 0.306 m<sup>2</sup>. Depth ranges from 0.054 m (min) to 0.081 m (max), with an average depth of 0.062 m. The calculated volume of the distress is 0.0189 m<sup>3</sup>.**

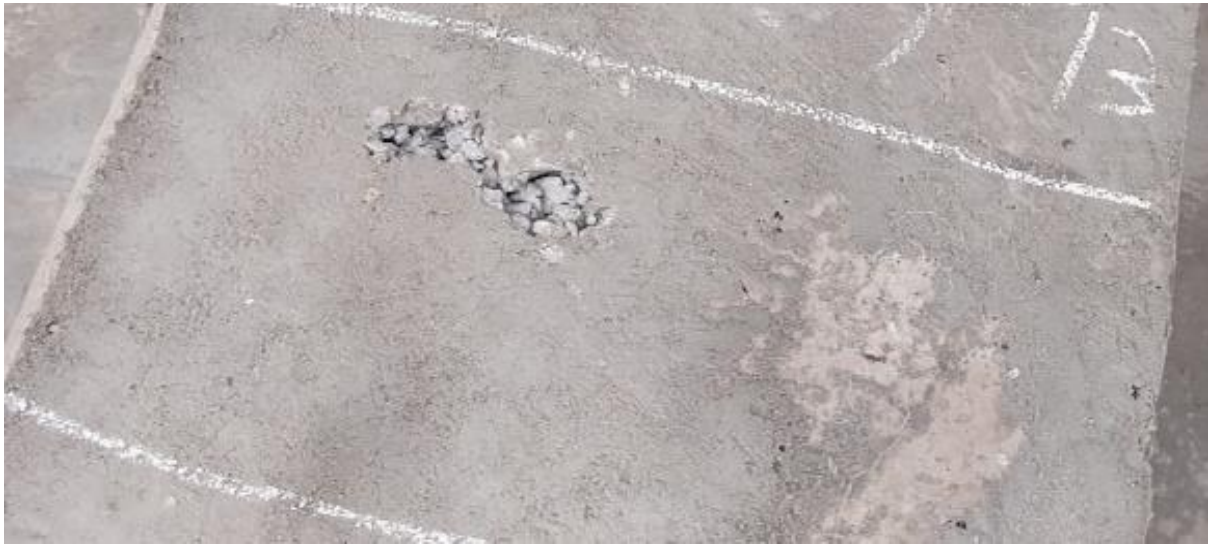
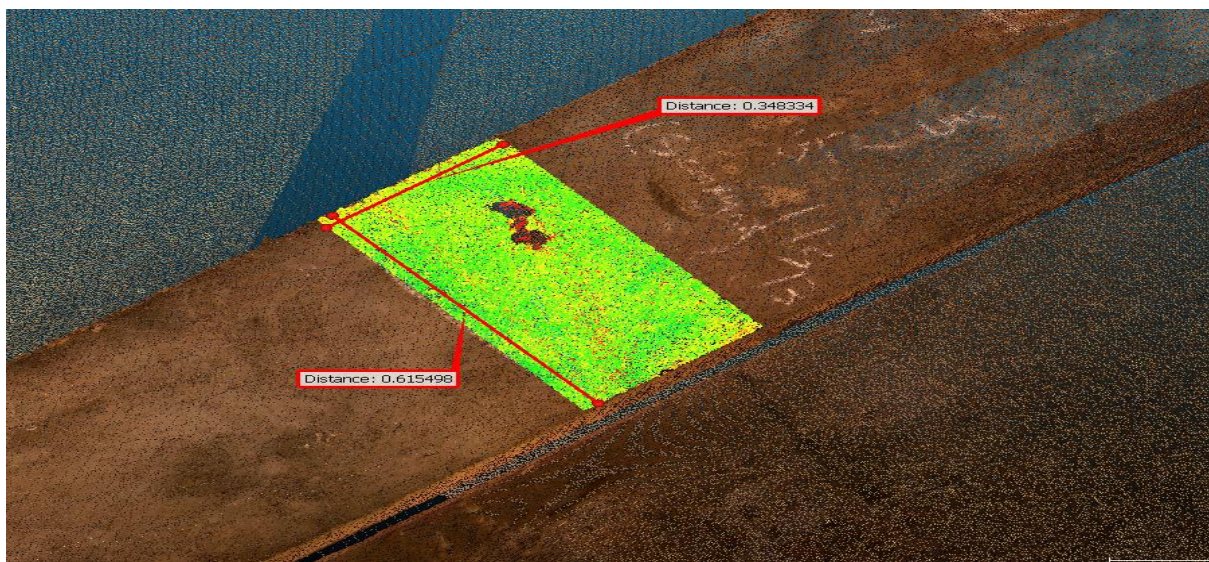
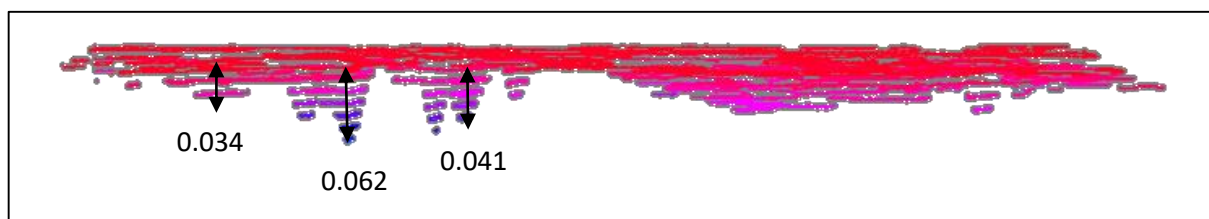
| Element Name | Observation | Location of Distress | Photo No. | Units | Distress Details | | | Area of Repair (Sq.m/R MT/m3) |
|---|---|---|---|---|---|---|---|---|
| Girder 2 | Hollow Section | | 2 | M | 0.61 | 0.38 | 0.041 | 0.0095 |

**2. Hollow section observed on LHS between Abutment 1 and Abutment 2 at Span Girder 2, measuring 0.61 m in length and 0.38 m in width. Depth ranges from 0.034 m (min) to 0.062 m (max), with an average depth of 0.041 m. The calculated volume of the distress is 0.0095 m<sup>3</sup>.**

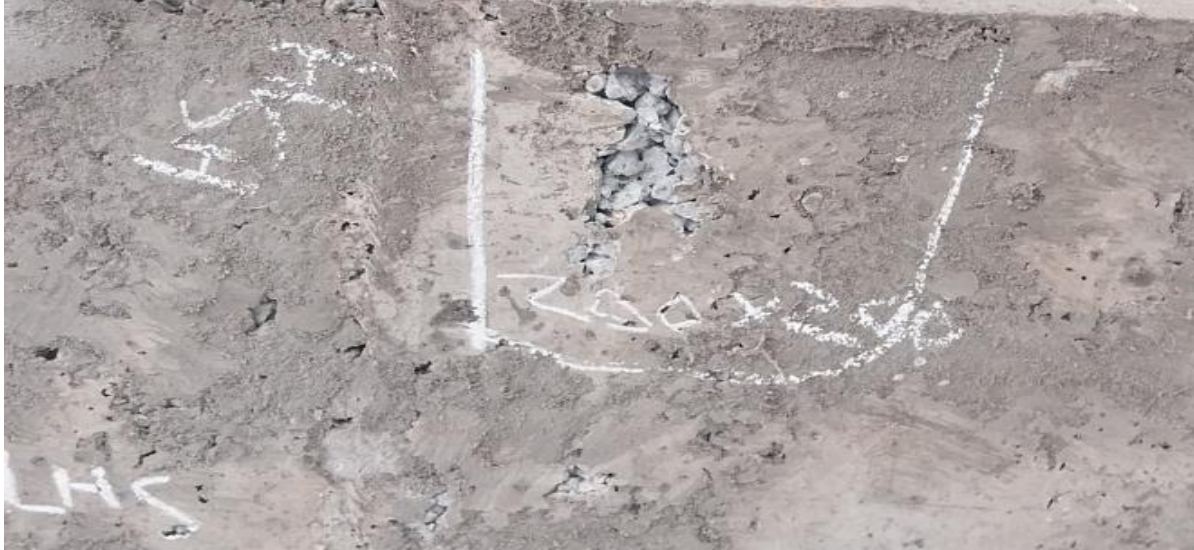
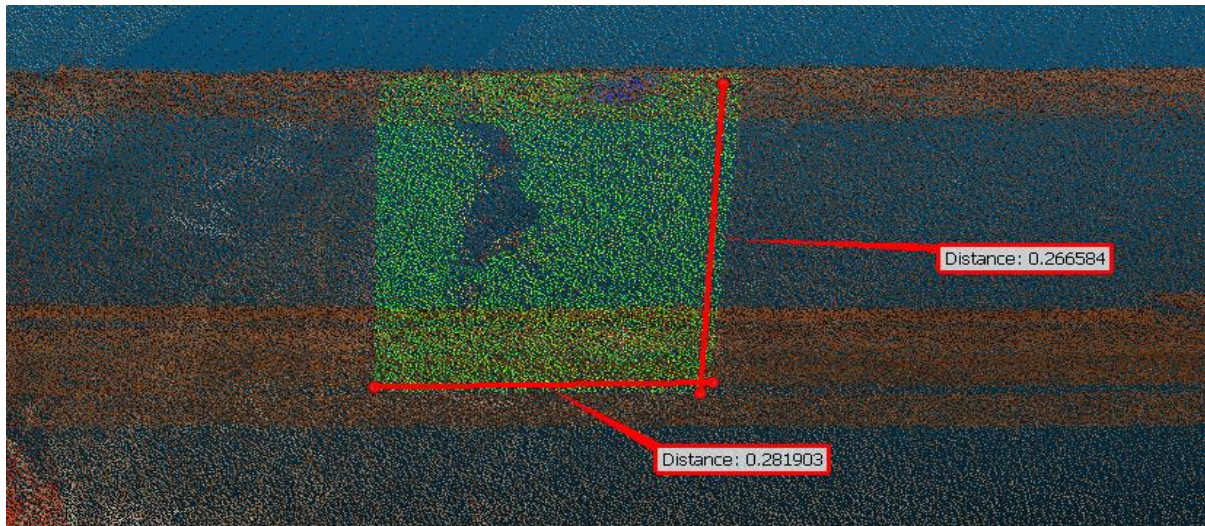
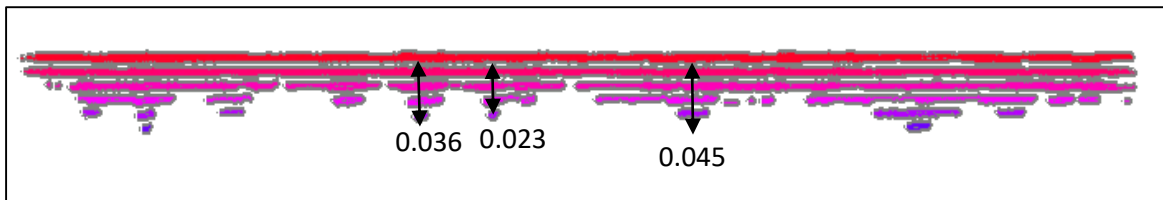
| Element Name | Observation | Location of Distress | Photo No. | Units | Distress Details | | | Area of Repair (Sq.m/R MT/m3) |
|---|---|---|---|---|---|---|---|---|
| Girder 2 | Hollow Section | | 3 | M | 0.28 | 0.26 | 0.09 | 0.006 |

**3. Hollow section observed on LHS at Abutment 1–2, Span Girder 2, measuring 0.28 m in length and 0.26 m in width. Depth ranges from 0.023 m (min) to 0.045 m (max), with an average depth of 0.036 m. The calculated volume of the distress is 0.006 m<sup>3</sup>.**

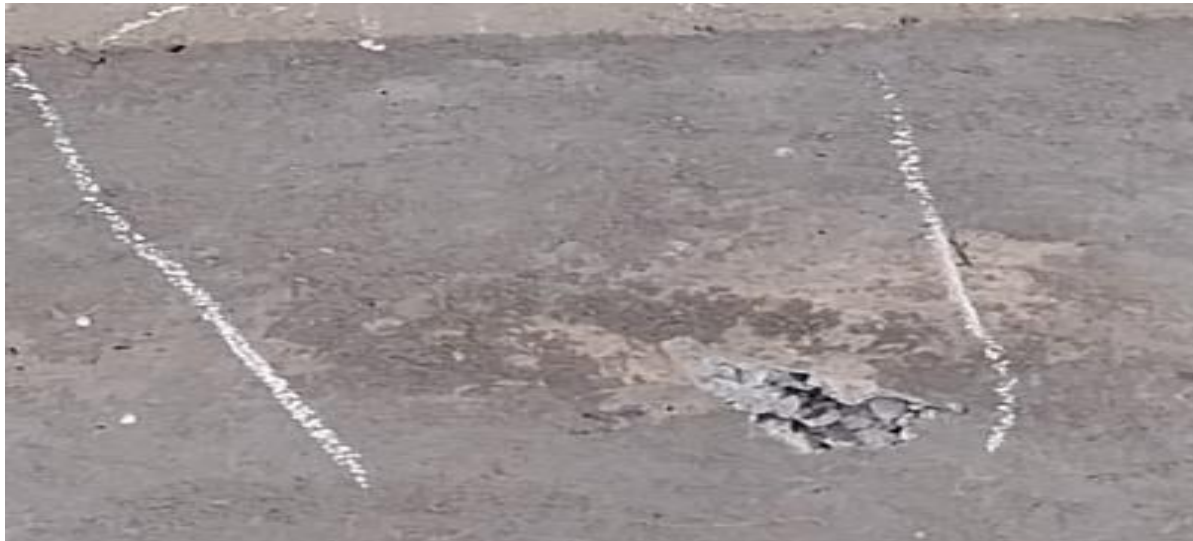
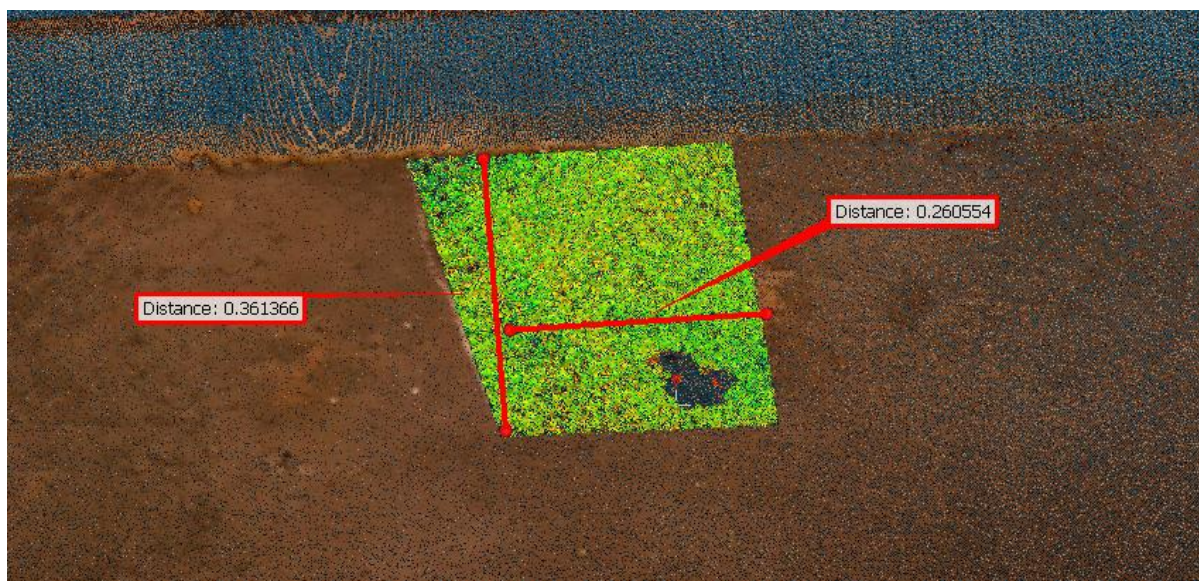
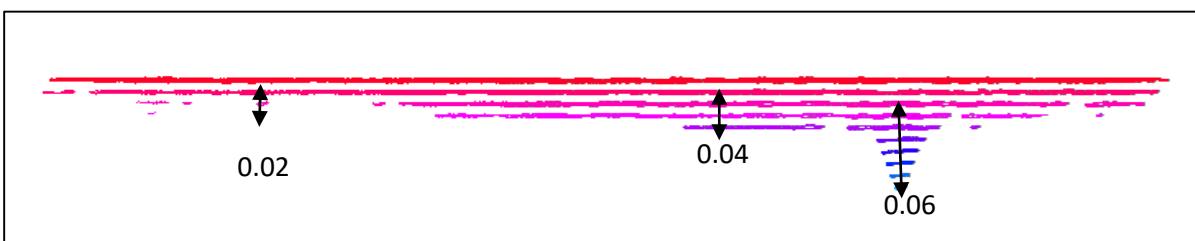
| Element Name | Observation | Location of Distress | Photo No. | Units | Distress Details | | | Area of Repair (Sq.m/R MT/m3) |
|---|---|---|---|---|---|---|---|---|
| Girder 2 | Hollow Section | | 4 | M | 0.36 | 0.26 | 0.04 | 0.0037 |

**4. Hollow section observed on LHS between Abutment 1 and Abutment 2 at Span Girder 2 (HS S24), measuring 0.36 m in length and 0.26 m in width. Depth ranges from 0.02 m (min) to 0.06 m (max), with an average depth of 0.04 m. The calculated volume of the distress is 0.0037 m<sup>3</sup>.**

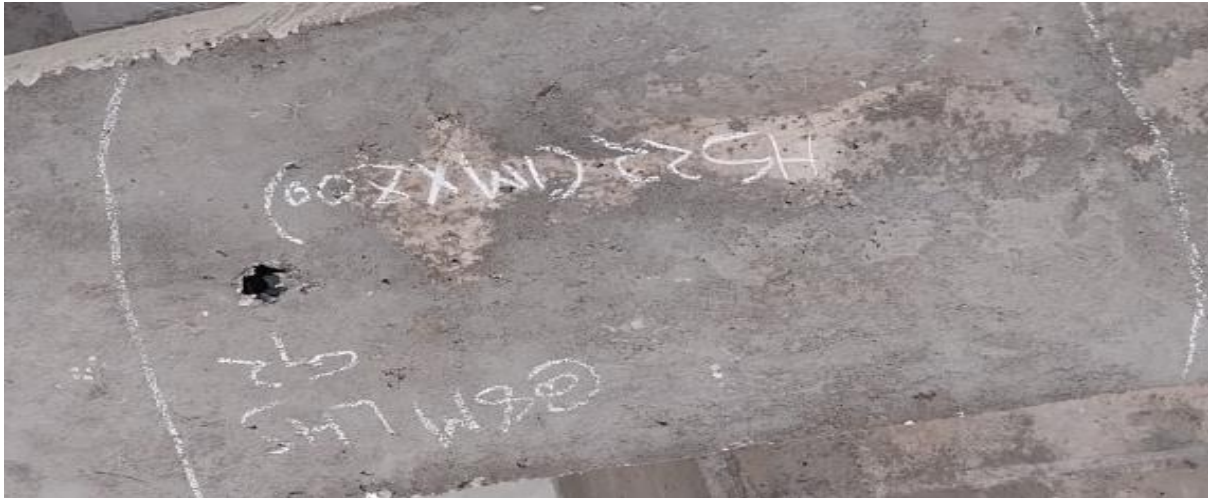
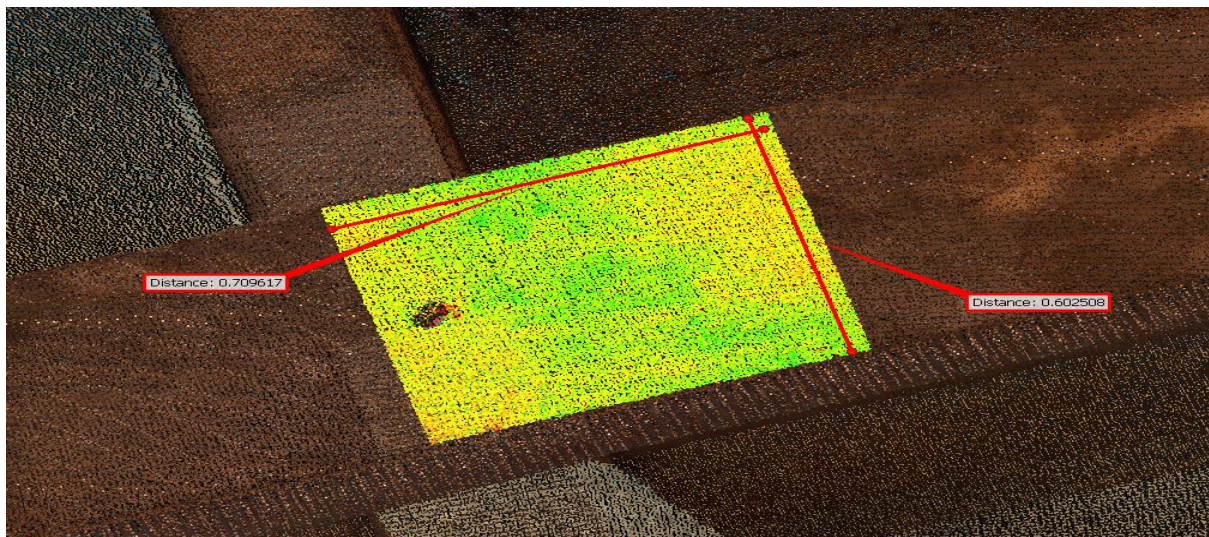
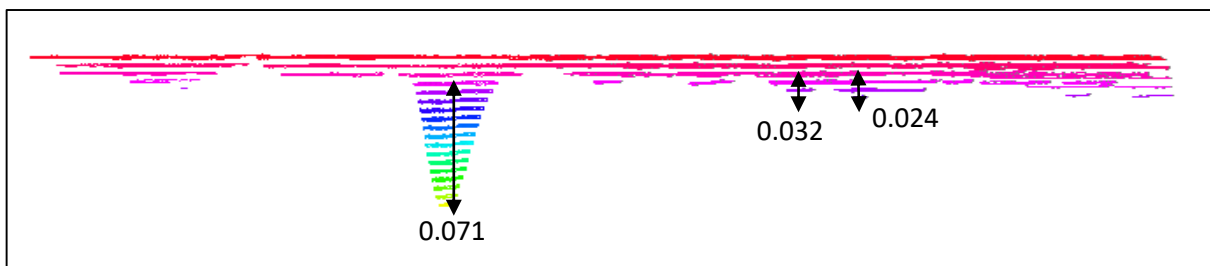
| Element Name | Observation | Location of Distress | Photo No. | Units | Distress Details | | | Area of Repair (Sq.m/R MT/m3) |
|---|---|---|---|---|---|---|---|---|
| Girder 2 | Hollow Section | | 5 | M | 0.70 | 0.60 | 0.032 | 0.0134 |

**5. Hollow section observed on LHS between Abutment 1 and Abutment 2 at Span Girder 2 (HS 22), measuring 0.70 m in length and 0.60 m in width. Depth ranges from 0.024 m (min) to 0.071 m (max), with an average depth of 0.032 m. The calculated volume of the distress is 0.0134 m<sup>3</sup>.**

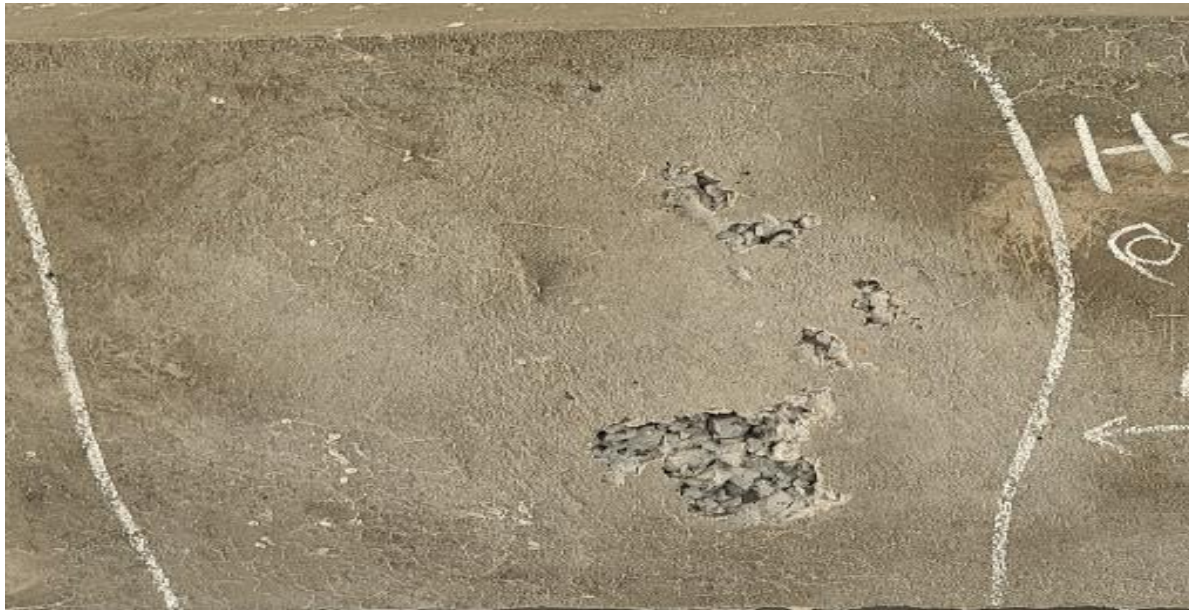
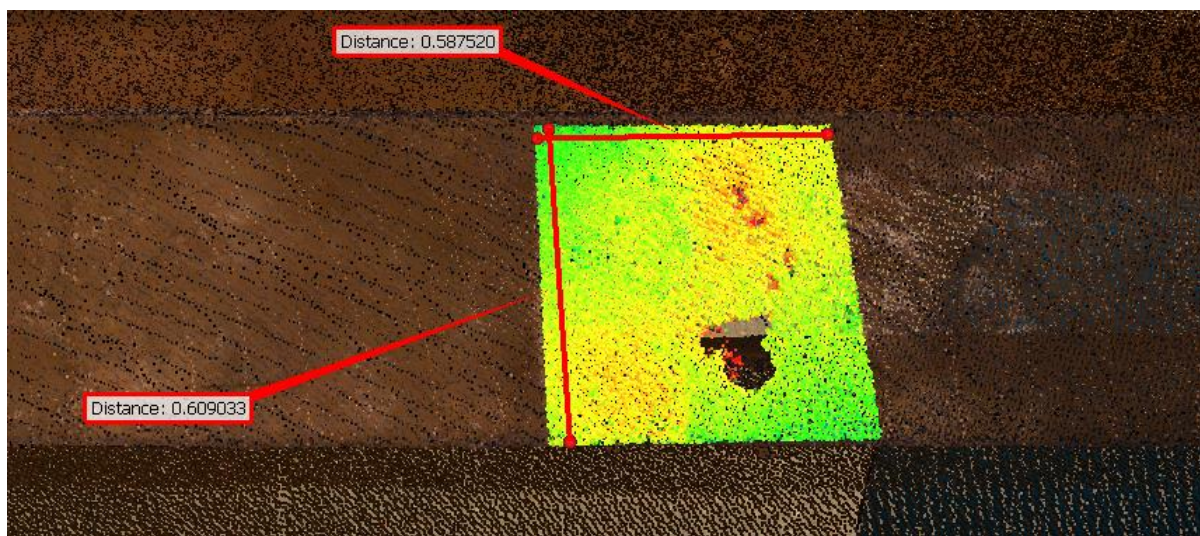
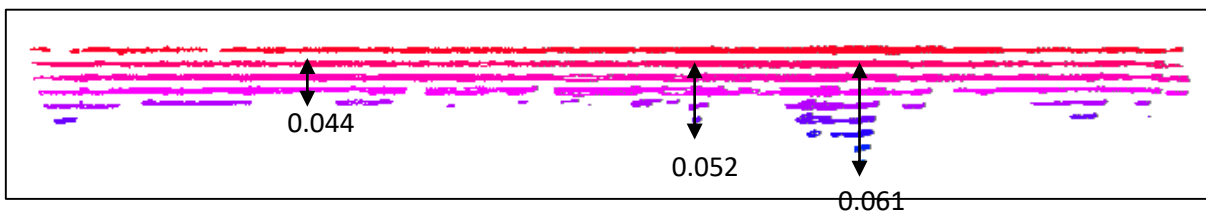
| Element Name | Observation | Location of Distress | Photo No. | Units | Distress Details | | | Area of Repair (Sq.m/R MT/m3) |
|---|---|---|---|---|---|---|---|---|
| Girder 2 | Hollow Section | | 6 | M | 0.60 | 0.58 | 0.052 | 0.0180 |

**6. Hollow section observed on RHS between Abutment 1 and Abutment 2 at Span Girder 2 (HS 3), measuring 0.60 m in length and 0.58 m in width. Depth ranges from 0.044 m (min) to 0.061 m (max), with an average depth of 0.052 m. The calculated volume of the distress is 0.045 m<sup>3</sup>.**

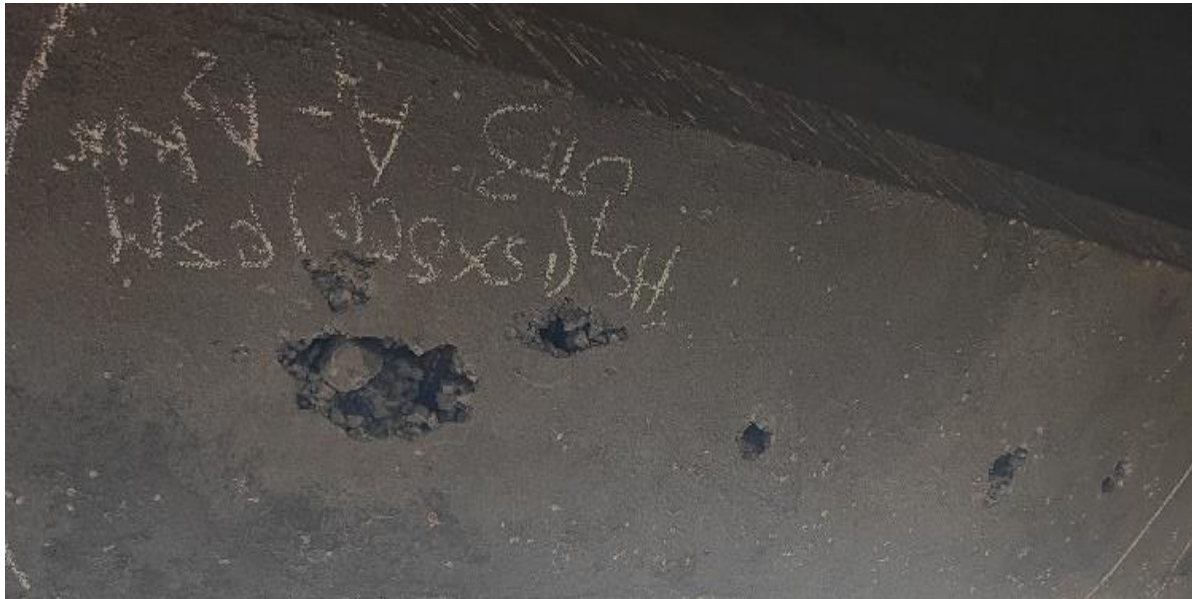
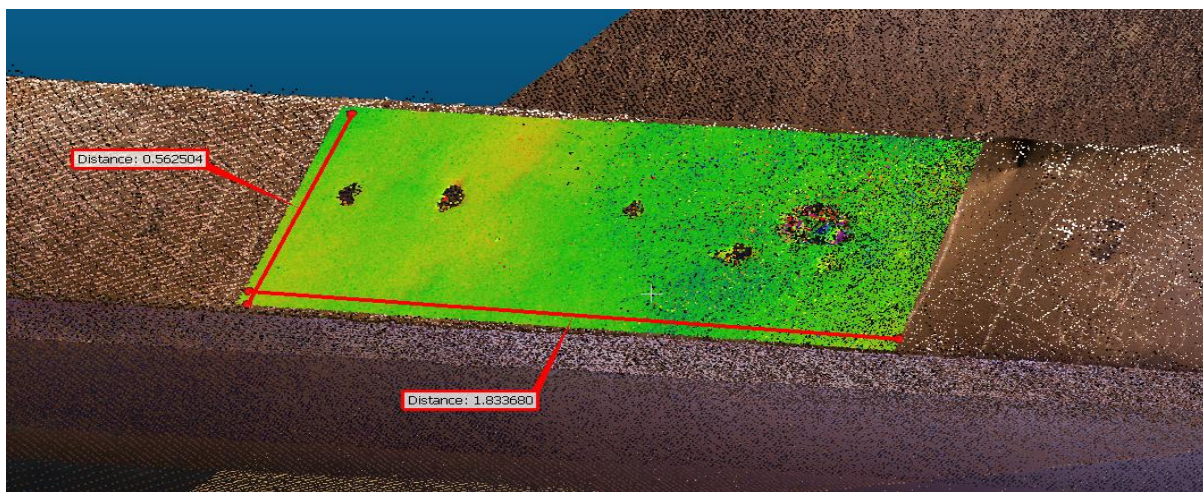
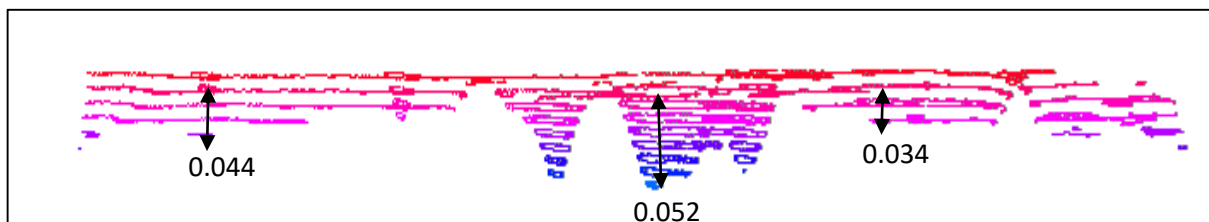
| Element Name | Observation | Location of Distress | Photo No. | Units | Distress Details | | | Area of Repair (Sq.m/R MT/m3) |
|---|---|---|---|---|---|---|---|---|
| Girder 3 | Hollow Section | | 7 | M | 1.83 | 0.56 | 0.044 | 0.0450 |

**7. Hollow section observed on RHS between Abutment 1 and Abutment 2 at Span Girder 3 (HS 7), measuring 1.83 m in length and 0.56 m in width. Depth ranges from 0.034 m (min) to 0.052 m (max), with an average depth of 0.044 m. The calculated volume of the distress is 0.0450 m<sup>3</sup>.**

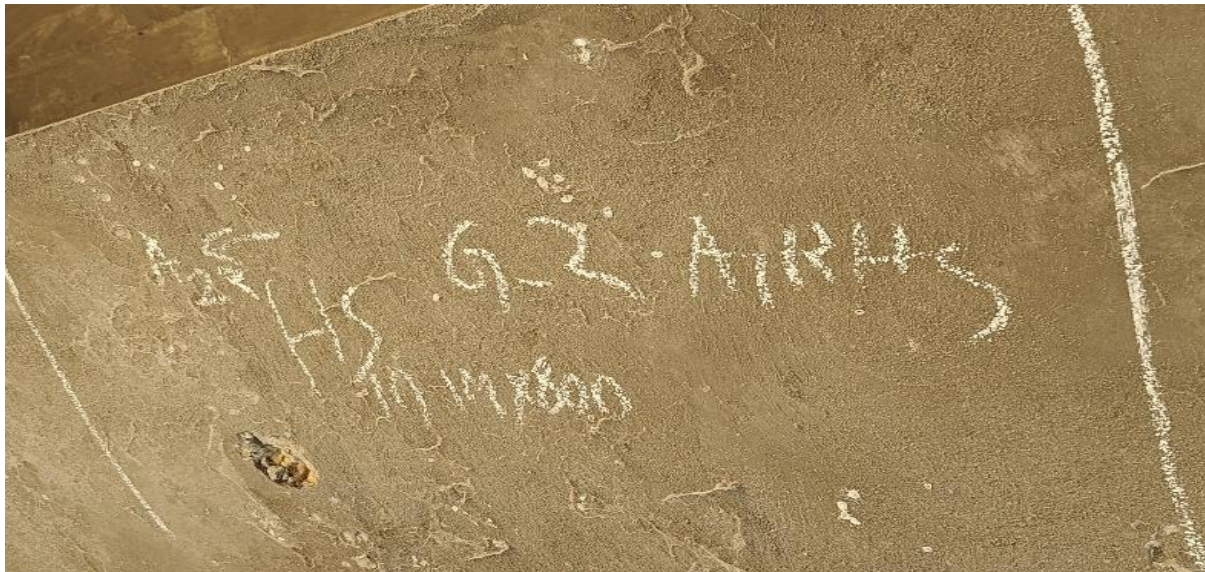
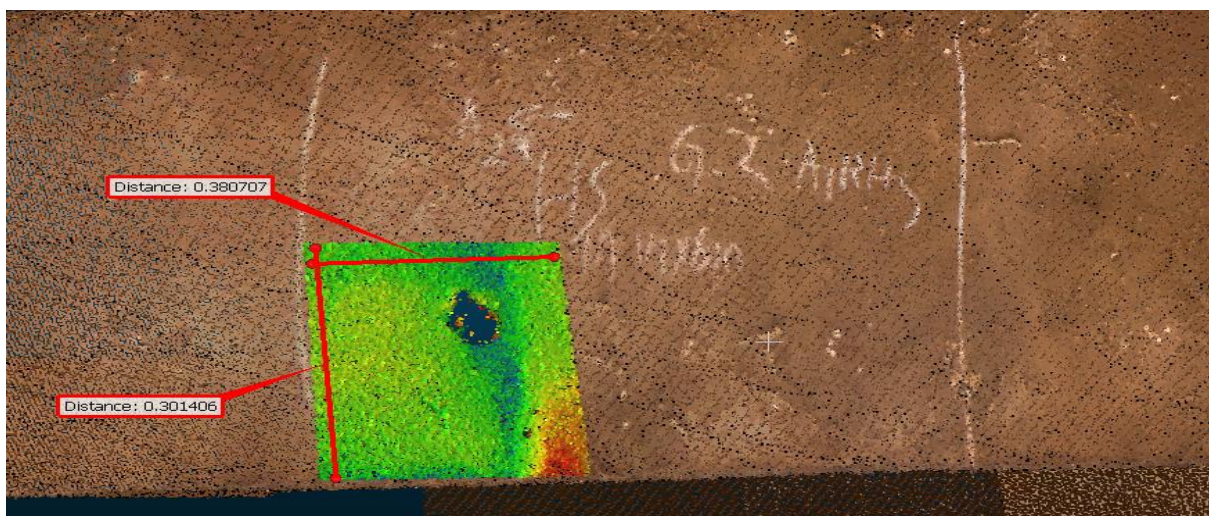
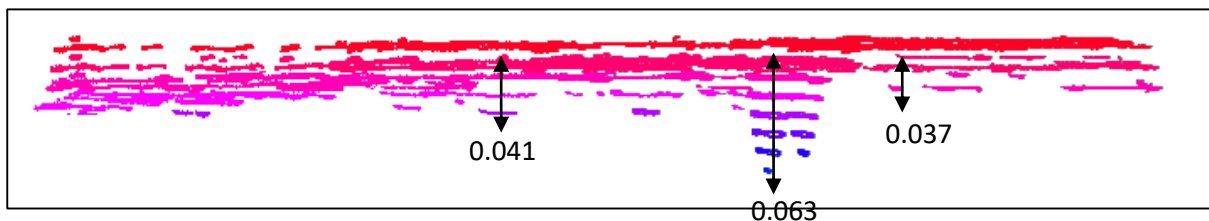
| Element Name | Observation | Location of Distress | Photo No. | Units | Distress Details | | | Area of Repair (Sq.m/R MT/m3) |
|---|---|---|---|---|---|---|---|---|
| Girder 3 | Hollow Section | | 8 | M | 0.38 | 0.30 | 0.037 | 0.0042 |

**8. Hollow section observed on RHS between Abutment 1 and Abutment 2 at Span Girder 3 (HS 10), measuring 0.38 m in length and 0.30 m in width. Depth ranges from 0.037 m (min) to 0.063 m (max), with an average depth of 0.11 m. The calculated volume of the distress is 0.0042 m<sup>3</sup>.**

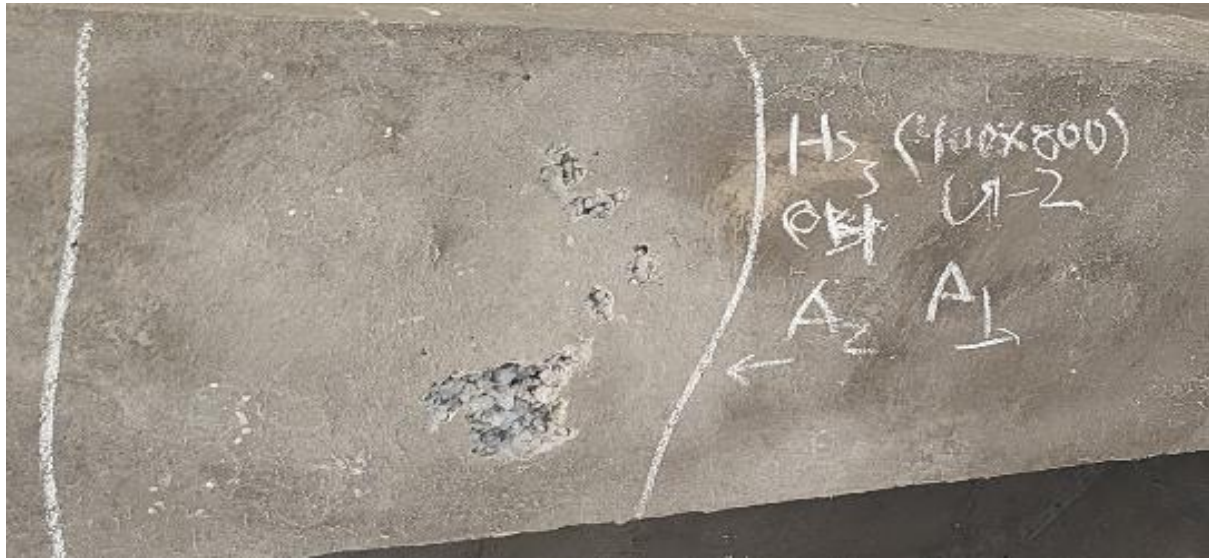
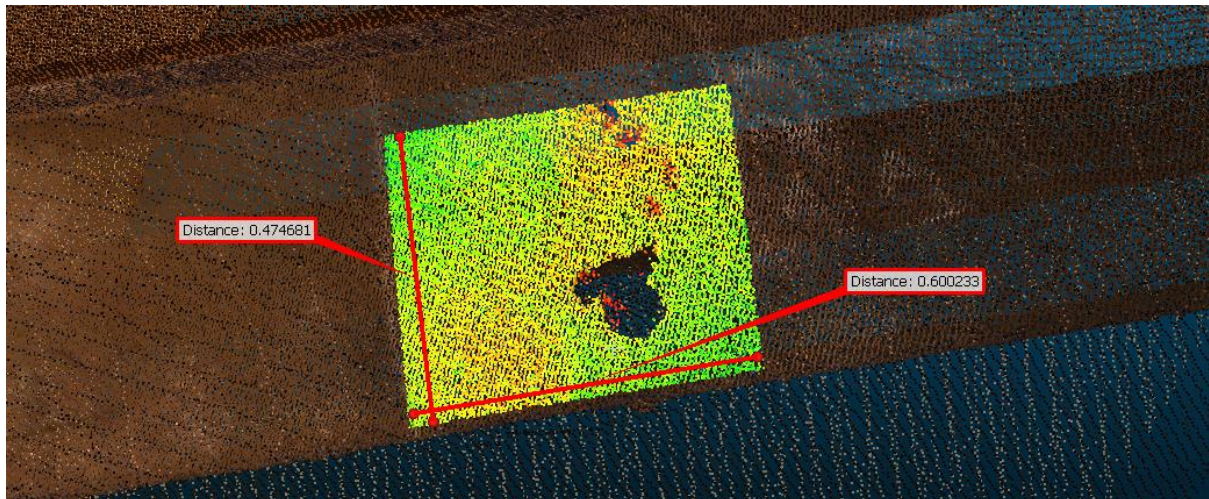
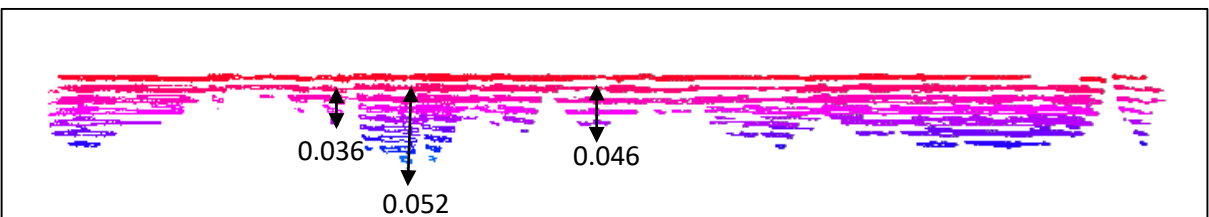
| Element Name | Observation | Location of Distress | Photo No. | Units | Distress Details | | | Area of Repair (Sq.m/R MT/m3) |
|---|---|---|---|---|---|---|---|---|
| Girder 2 | Hollow Section | | 9 | M | 0.60 | 0.47 | 0.046 | 0.0129 |

**9. Hollow section observed on RHS between Abutment 1 and Abutment 2 at Span Girder 2 (HS 3), measuring 0.60 m in length and 0.47 m in width. Depth ranges from 0.036 m (min) to 0.052 m (max), with an average depth of 0.046 m. The calculated volume of the distress is 0.0129 m<sup>3</sup>.**

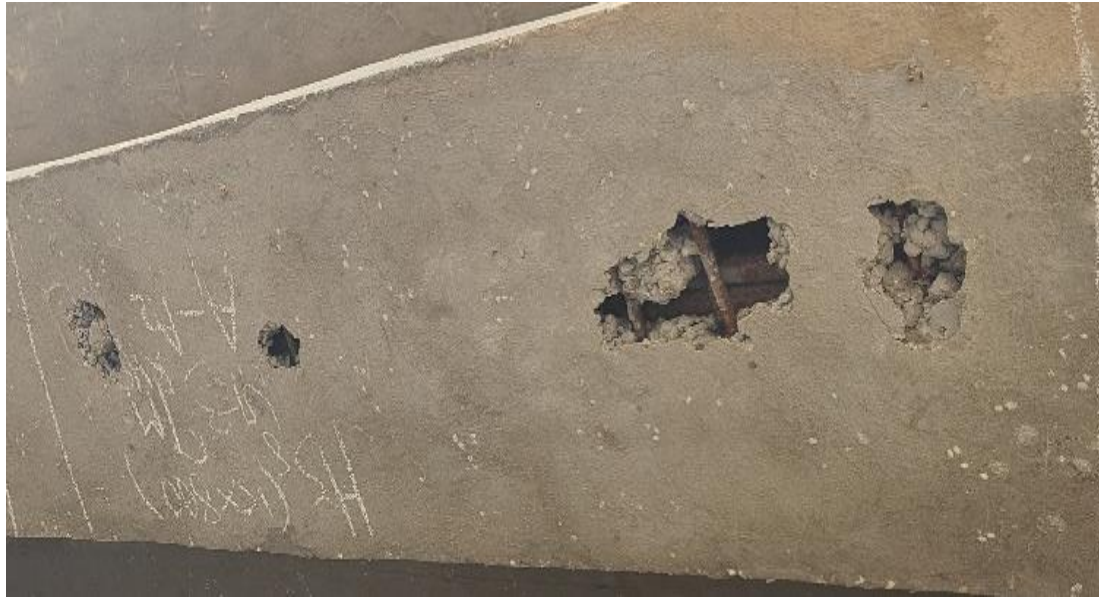
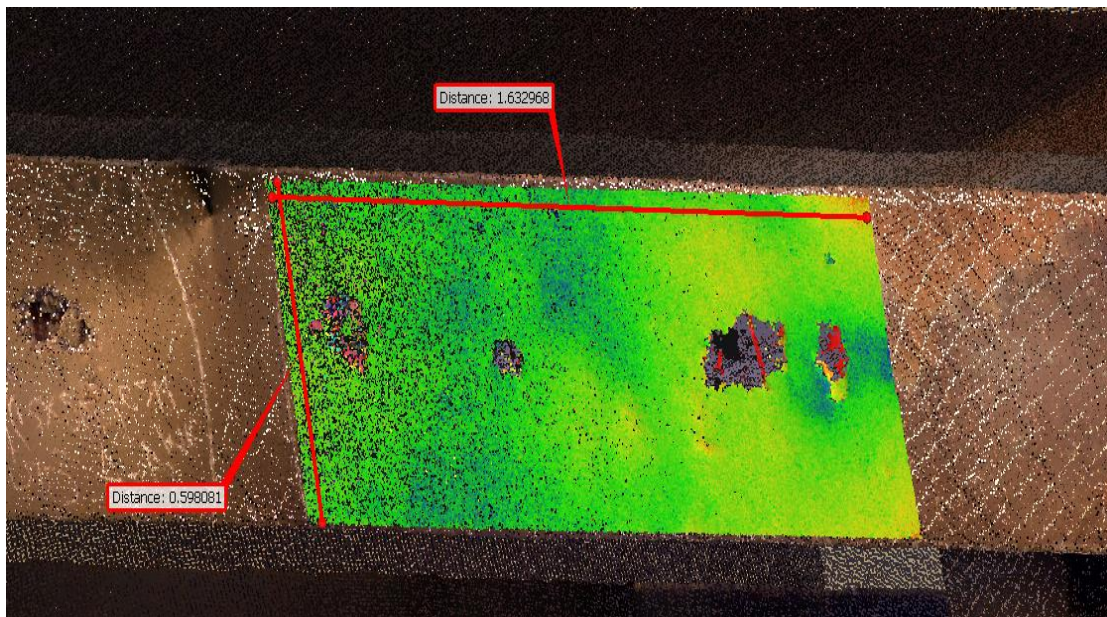
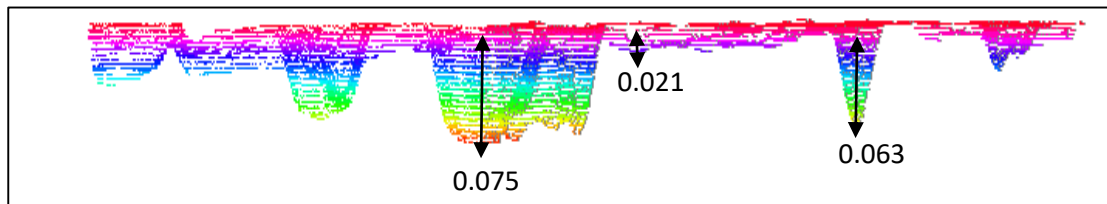
| Element Name | Observation | Location of Distress | Photo No. | Units | Distress Details | | | Area of Repair (Sq.m/R MT/m3) |
|---|---|---|---|---|---|---|---|---|
| Girder 3 | Hollow Section | | 10 | M | 0.59 | 1.63 | 0.063 | 0.0605 |

**10. Hollow section observed on RHS between Abutment 1 and Abutment 2 at Span Girder 3 (HS 8), measuring 0.59 m in length and 1.63 m in width. Depth ranges from 0.021 m (min) to 0.075 m (max), with an average depth of 0.063 m. The calculated volume of the distress is 0.105 m<sup>3</sup>.**
