# **LIDAR Inspection Report of Slab Culvert ch.945 + 950**

**Bridge Chainage:** 945 + 950 (CKRP)

- **CKRP:** Chittorgarh to kota
- **State:** Rajasthan NH 27
- **Zone:** RJ-06

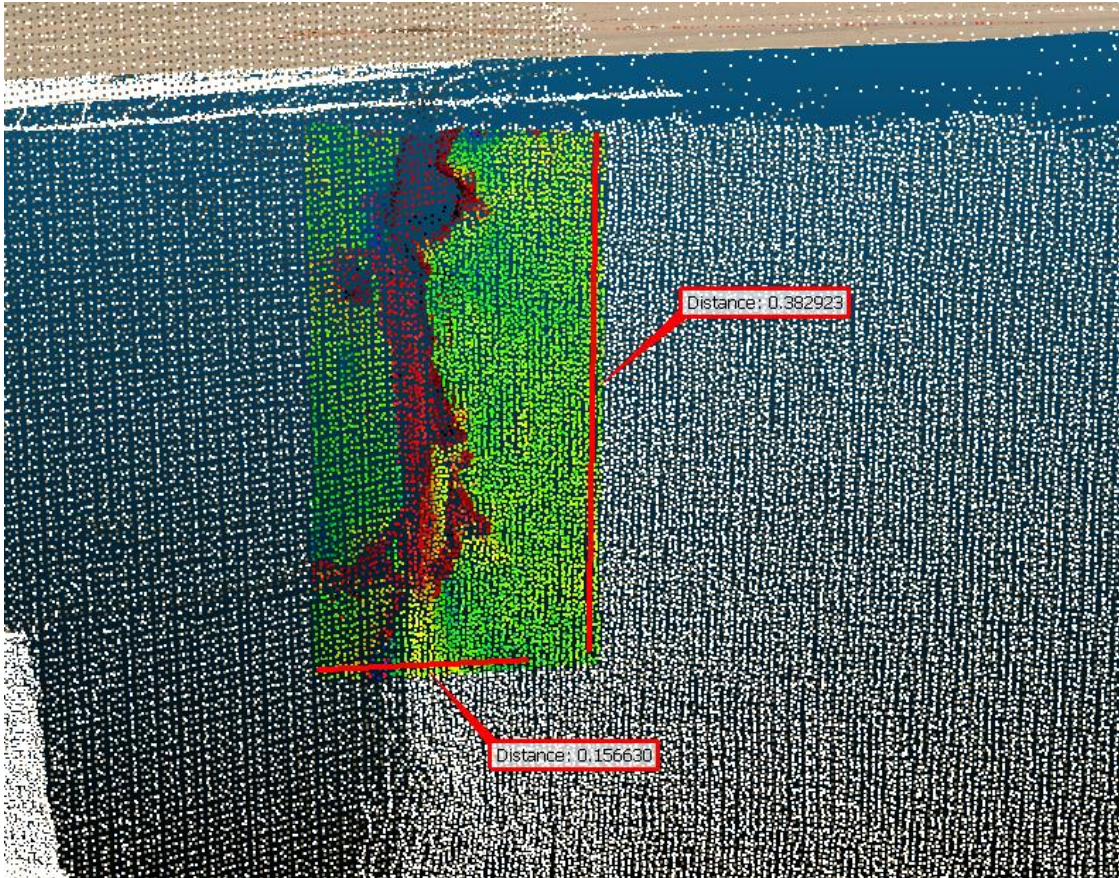
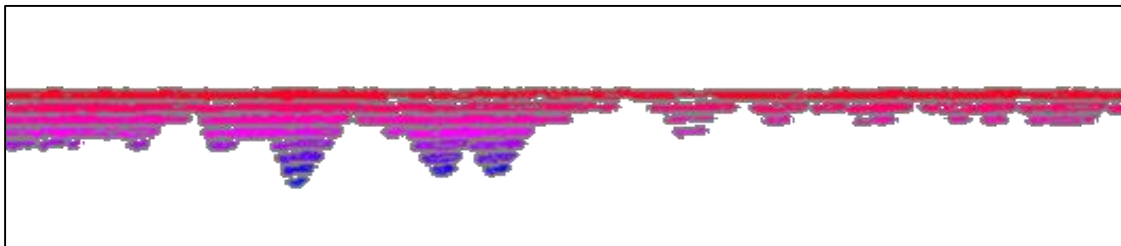
| Sr. No. | Description | Distress Notation | Observation | Location | | Distress Details | | | Area of Repair |
|---|---|---|---|---|---|---|---|---|---|
| 1 | Return wall | | DAMAGE (LHS) | | | | | | |

**1. Return wall damage observed on LHS, measuring 0.3829 m in length and 0.1566 m in width, covering an area of 0.06 m<sup>2</sup>.**
