# **LIDAR Inspection Report of MNB ch.946+350**

**Bridge No:** MNB - 947/2

**Bridge Chainage:** 946+350 (CKRP)

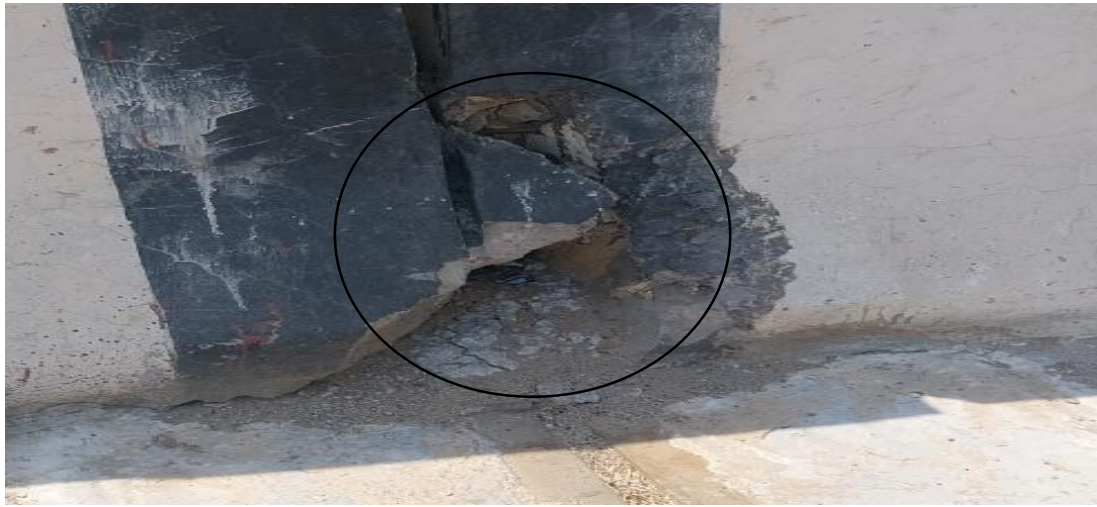
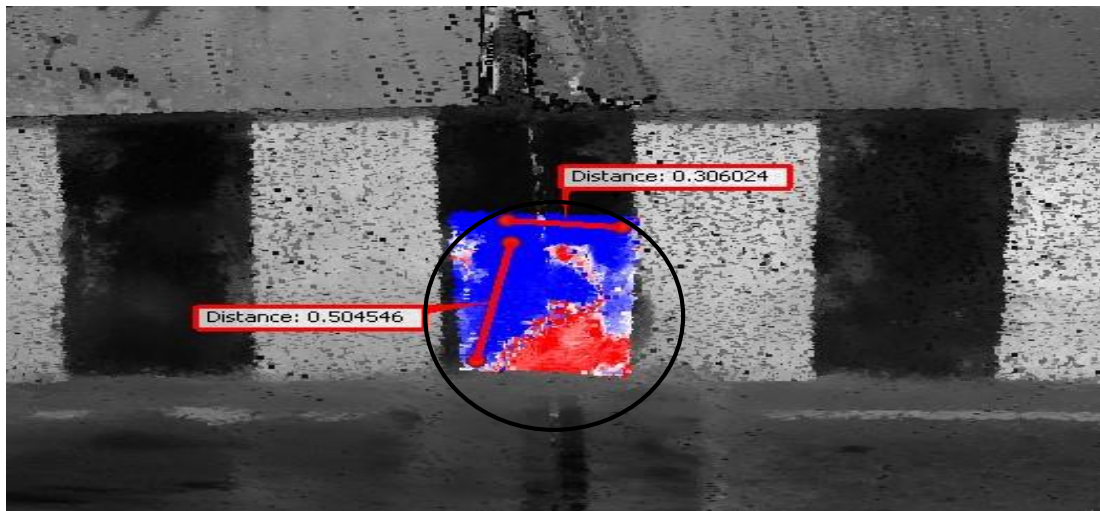
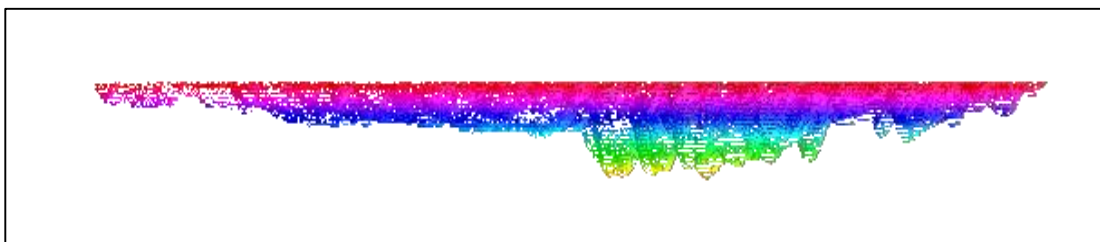
| Element Name | Observation | Location of Distress | Photo No. | Units | Distress Details | | | Area of Repair (Sq./RM T/m3) |
|---|---|---|---|---|---|---|---|---|
| Cross Barrier | Damage | | 1 | | 0.50 | 0.30 | | 0.15 |

| Sr. No. | Description | Distress Notation | Observation | Location | | Distress Details | | | Area of Repair |
|---|---|---|---|---|---|---|---|---|---|
| 9 | Crash barrier | | Damaged (LHS) | | | | | | |

1. Crash Barrier damage observed on LHS median side, measuring 0.50 m in length and 0.30 m in width, covering an area of 0.15 m<sup>2</sup>.

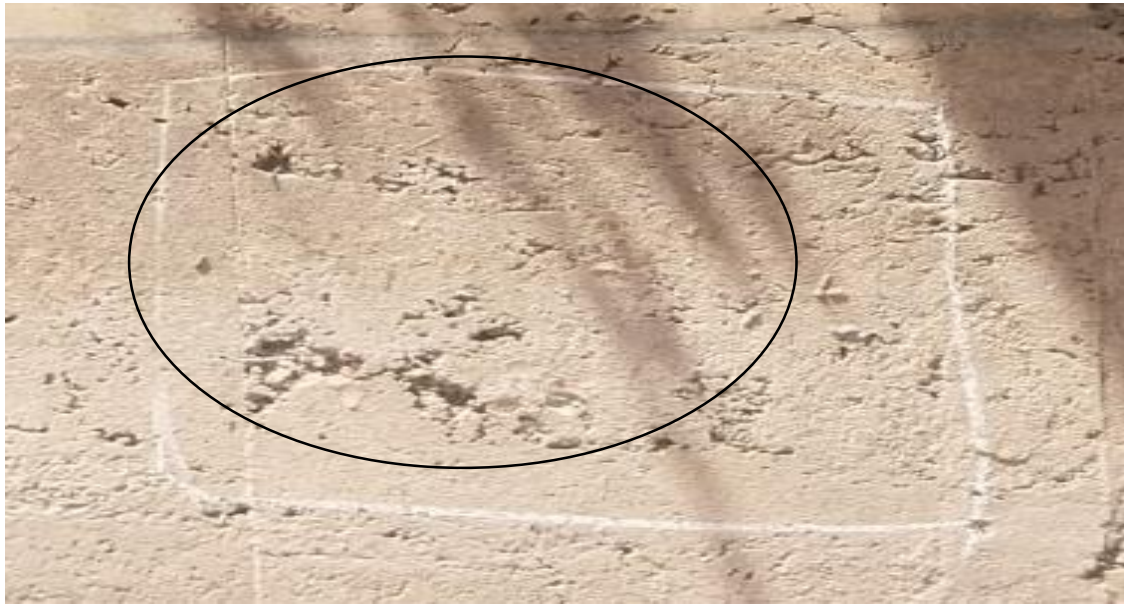
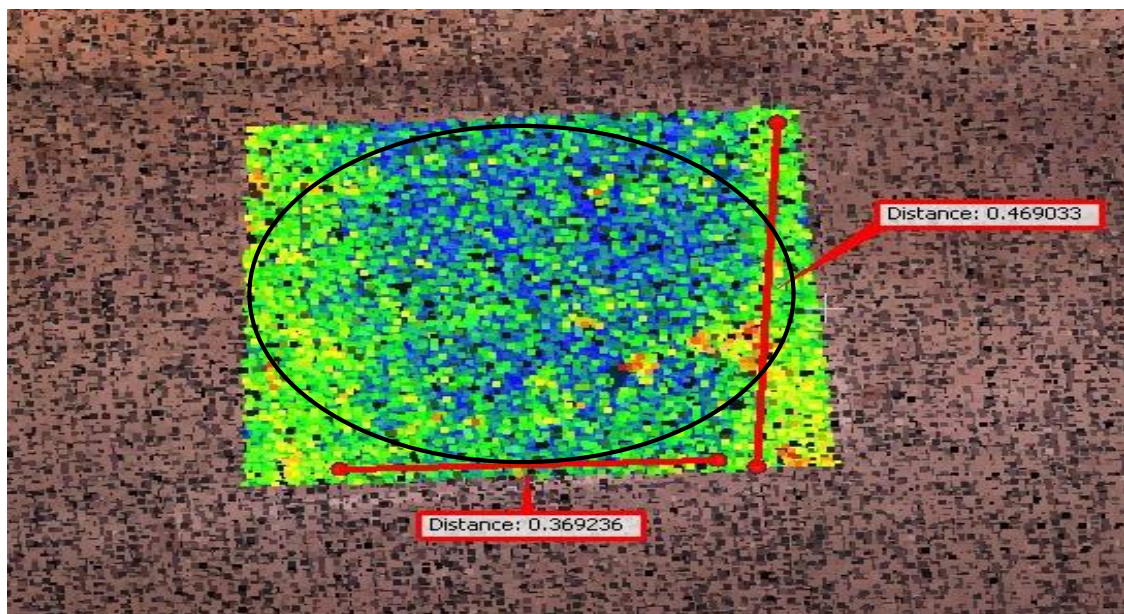
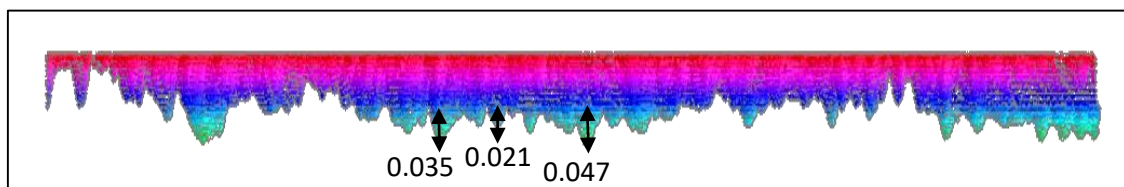
| Element Name | Observation | Location of Distress | Photo No. | Units | Distress Details | | | Area of Repair (Sq./RM T/m3) |
|---|---|---|---|---|---|---|---|---|
| Abutment 1 | Hollow section | | 2 | | 0.46 | 0.36 | 0.035 | 0.0057 |

2. Hollow section observed on LHS Abutment 1, measuring 0.46 m in length and 0.36 m in width. Depth ranges from 0.021 m (min) to 0.047 m (max), with an average depth of 0.035 m. The calculated volume of the distress is 0.0057 m<sup>3</sup>.

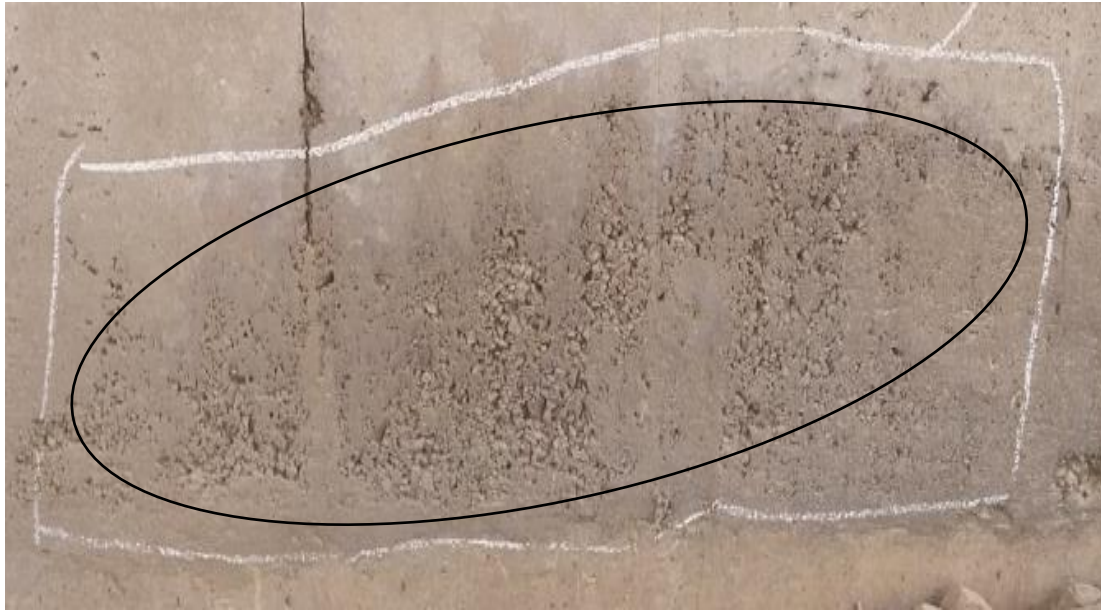
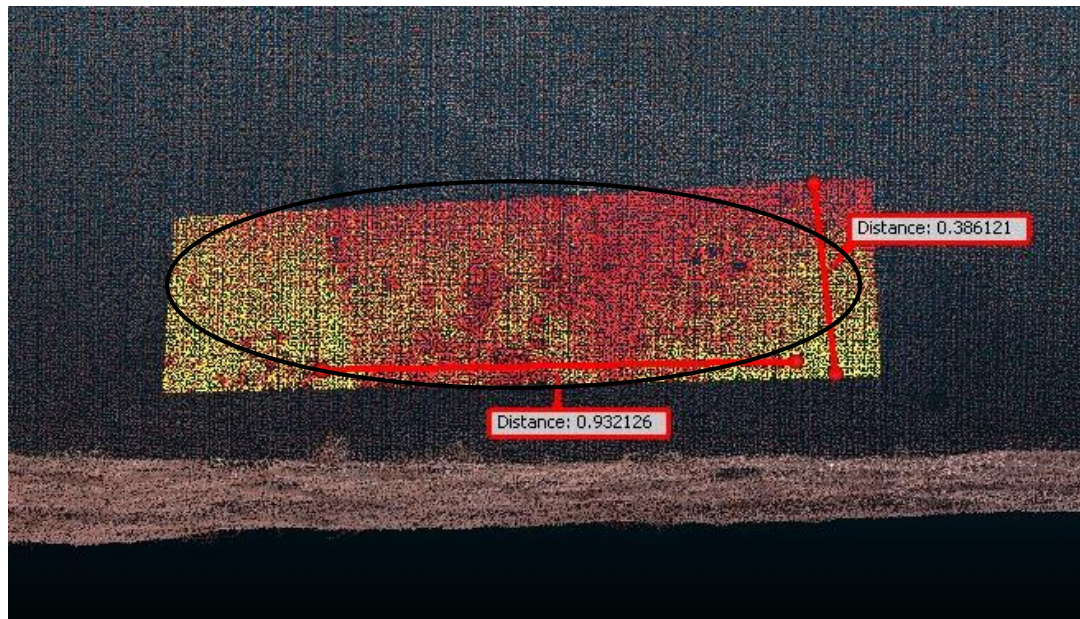
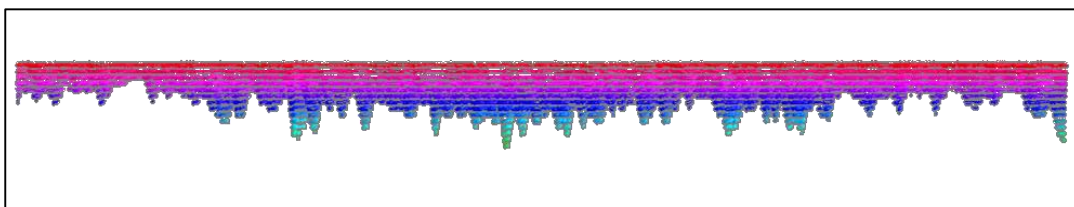
| Element Name | Observation | Location of Distress | Photo No. | Units | Distress Details | | | Area of Repair (Sq./RM T/m3) |
|---|---|---|---|---|---|---|---|---|
| Abutment 1 | Honey Combing | | 3 | | 0.93 | 0.38 | | 0.353 |

**3. Honey Combing observed on LHS Abutment 1, measuring 0.93 m in length and 0.38 m in width, covering an area of 0.353 m<sup>2</sup>.**

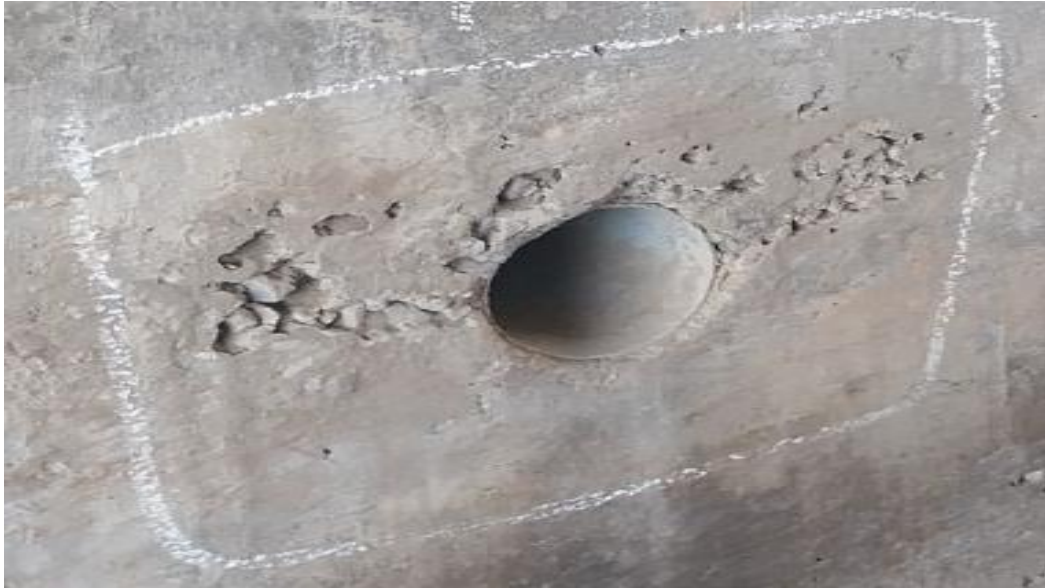
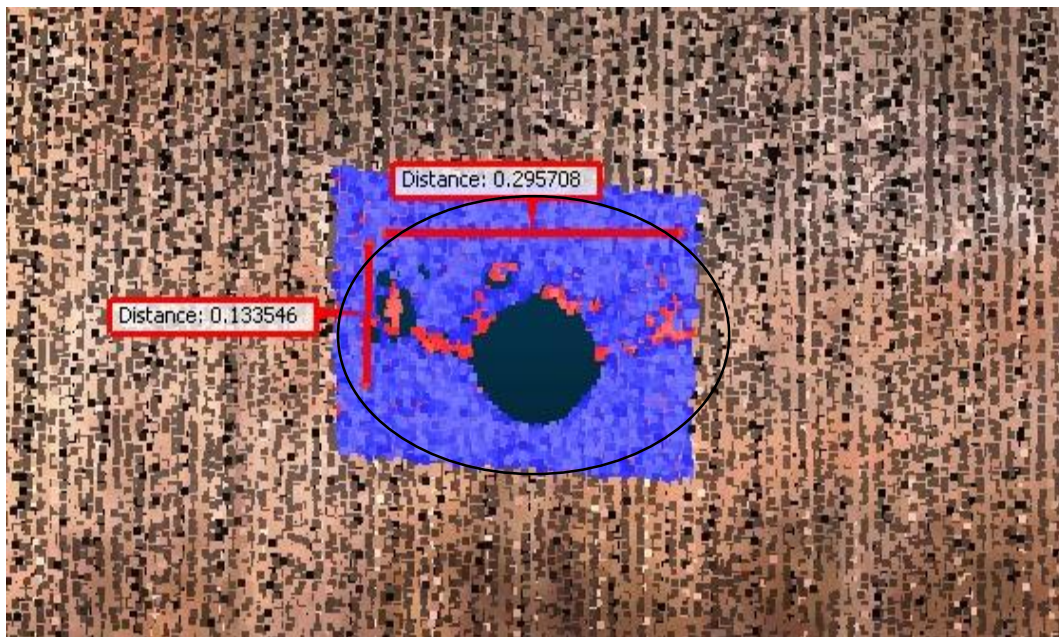
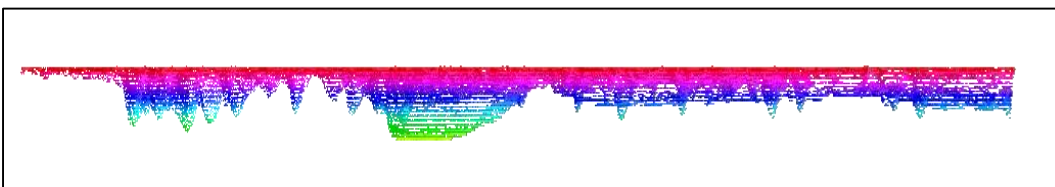
| Element Name | Observation | Location of Distress | Photo No. | Units | Distress Details | | | Area of Repair (Sq./RM T/m3) |
|---|---|---|---|---|---|---|---|---|
| Abutment 2 | Honey Combing | | 4 | | 0.29 | 0.13 | | 0.037 |

**4.Honey Combing observed on LHS Abutment 2, measuring 0.29 m in length and 0.13 m in width, covering an area of 0.037 m<sup>2</sup>**

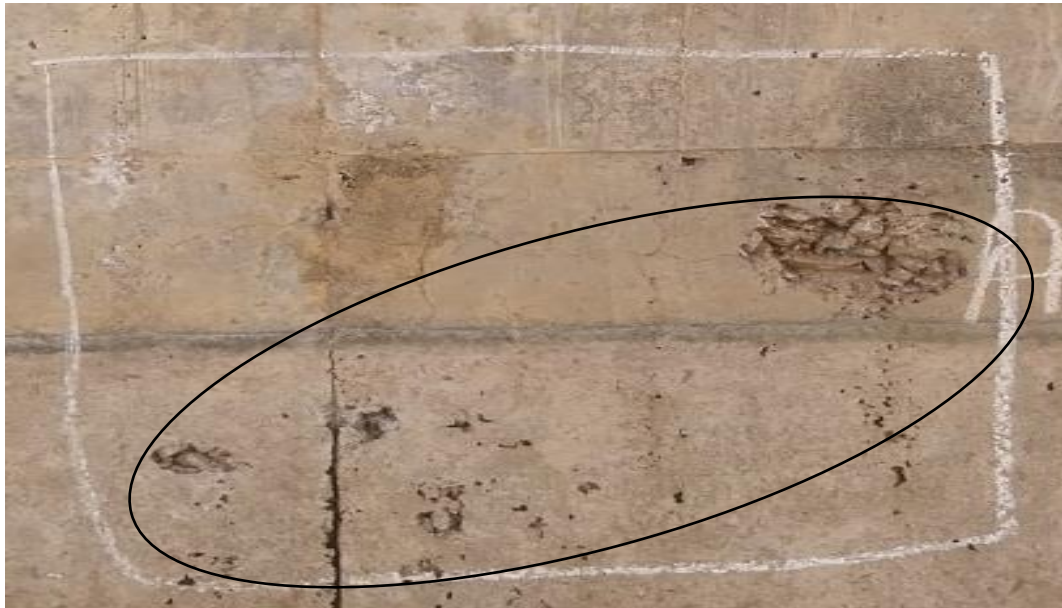
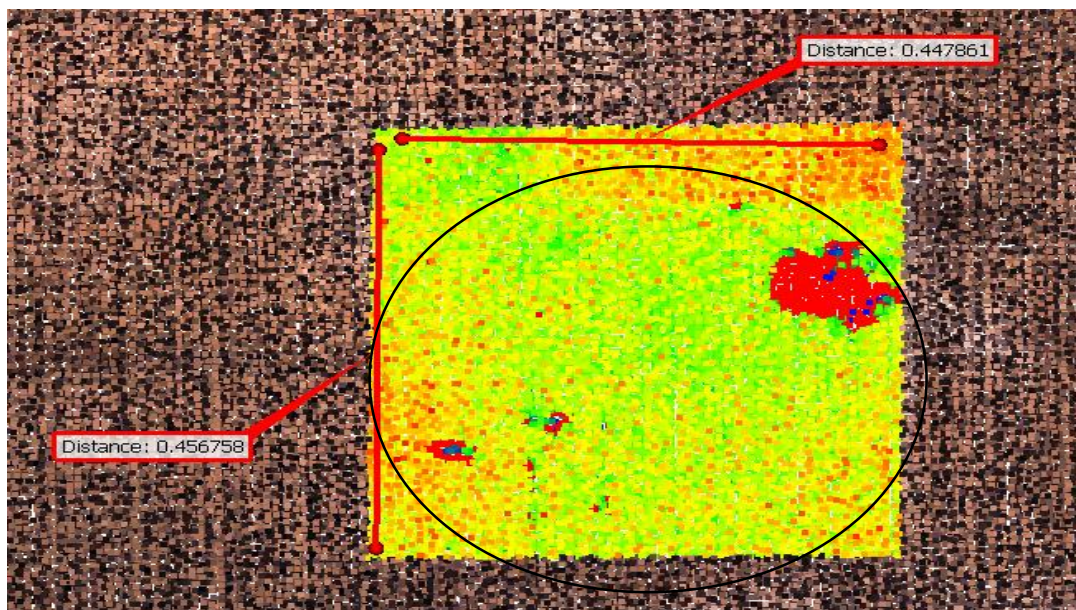
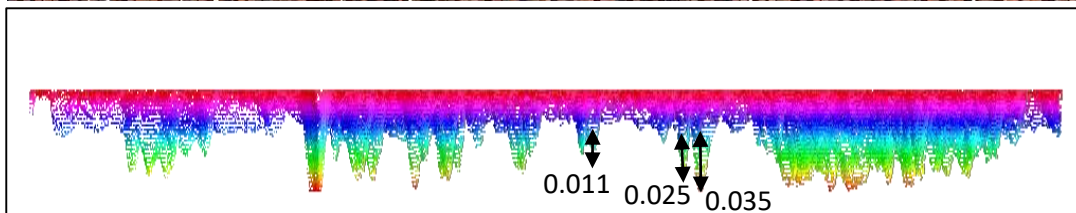
| Element Name | Observation | Location of Distress | Photo No. | Units | Distress Details | | | Area of Repair (Sq./RM T/m3) |
|---|---|---|---|---|---|---|---|---|
| Abutment 1 | Hollow section | | 5 | | 0.45 | 0.44 | 0.025 | 0.0049 |

**5. Hollow Section observed on LHS Abutment 1, measuring 0.45 m in length and 0.44 m in width. Depth ranges from 0.011 m (min) to 0.035 m (max), with an average depth of 0.025 m. The calculated volume of the distress is 0.0049 m<sup>3</sup>.**

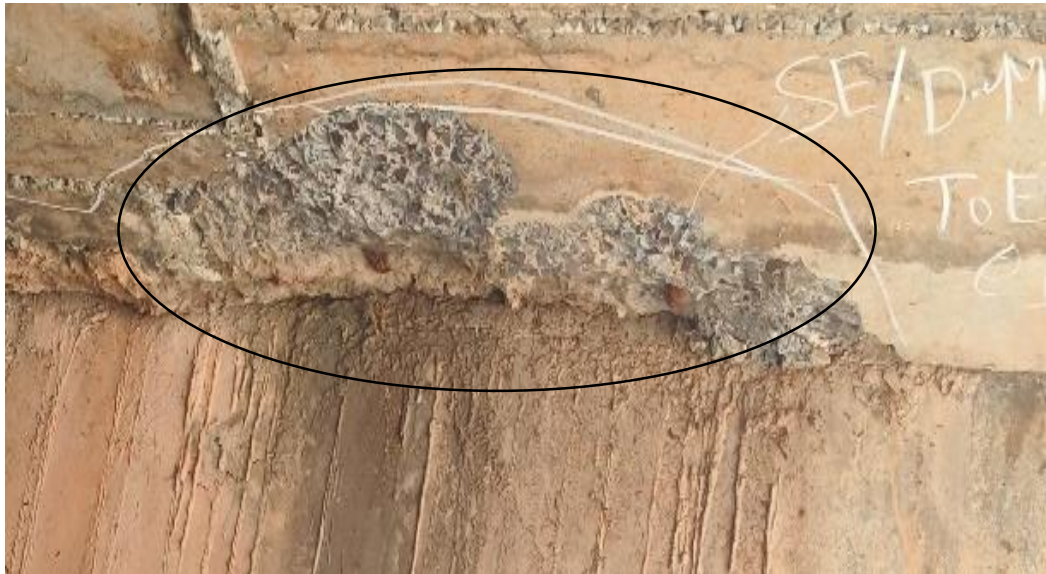
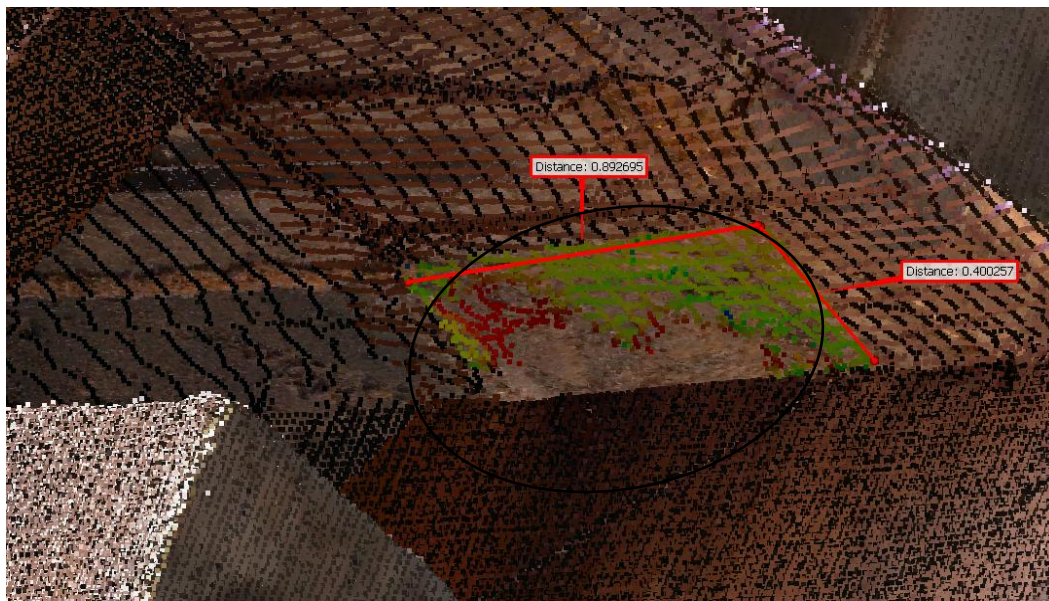
| Element Name | Observation | Location of Distress | Photo No. | Units | Distress Details | | | Area of Repair (Sq./RM T) |
|---|---|---|---|---|---|---|---|---|
| Slab Bottom | Steel Exposed | | 6 | | 0.89 | 0.40 | | 0.356 |

**6. Steel Exposed observed on Abutment 2 RHS Bearing 3 at toe side of approach slab bottom, measuring 0.89 m in length and 0.40 m in width, covering an area of 0.356 m<sup>2</sup>.**

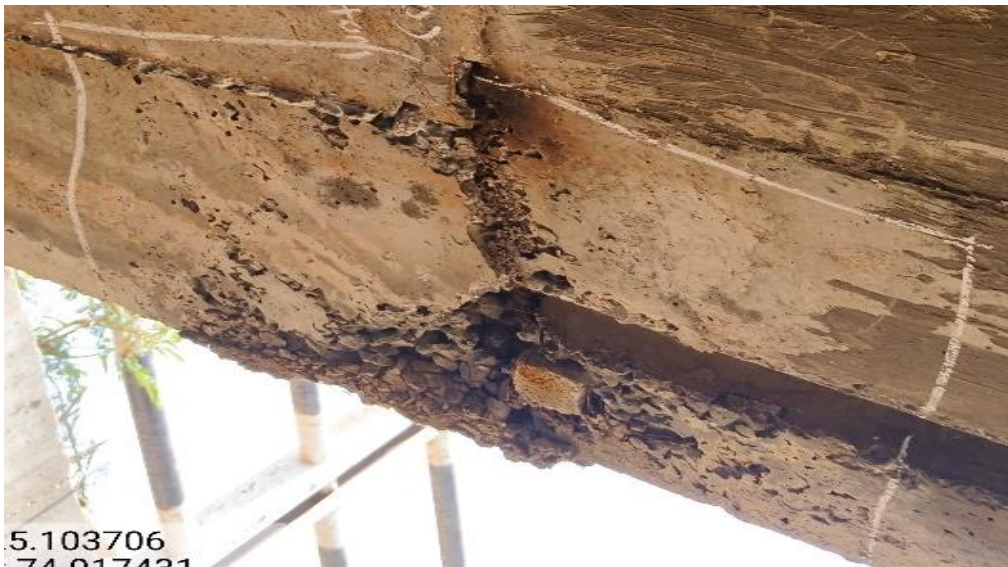
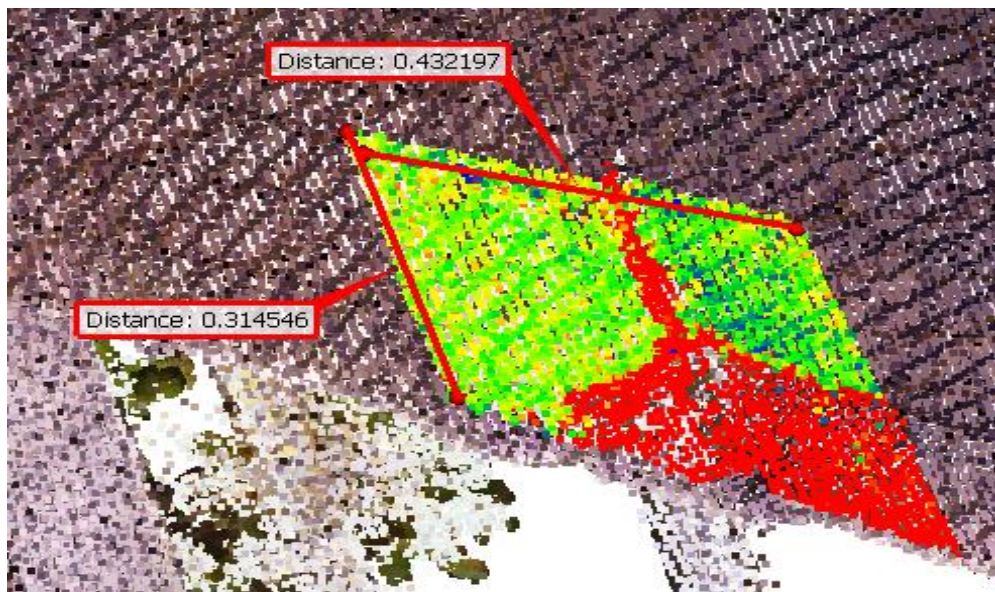
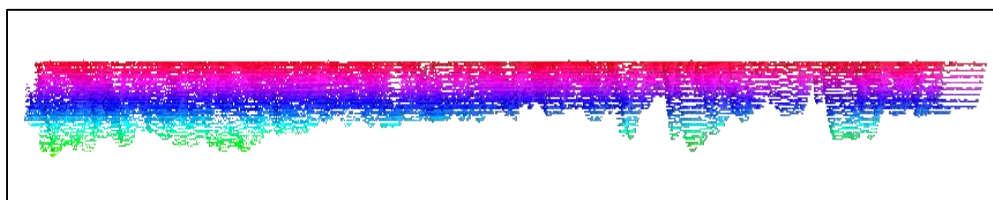
| Element Name | Observation | Location of Distress | Photo No. | Units | Distress Details | | | Area of Repair (Sq./RM T) |
|---|---|---|---|---|---|---|---|---|
| Slab Bottom | Spalling | | 7 | | 0.31 | 0.43 | | 0.1333 |

**7. Spalling observed on Abutment 1 RHS at approach slab bottom, measuring 0.31 m in length and 0.43 m in width, covering an area of 0.1333 m<sup>2</sup>.**

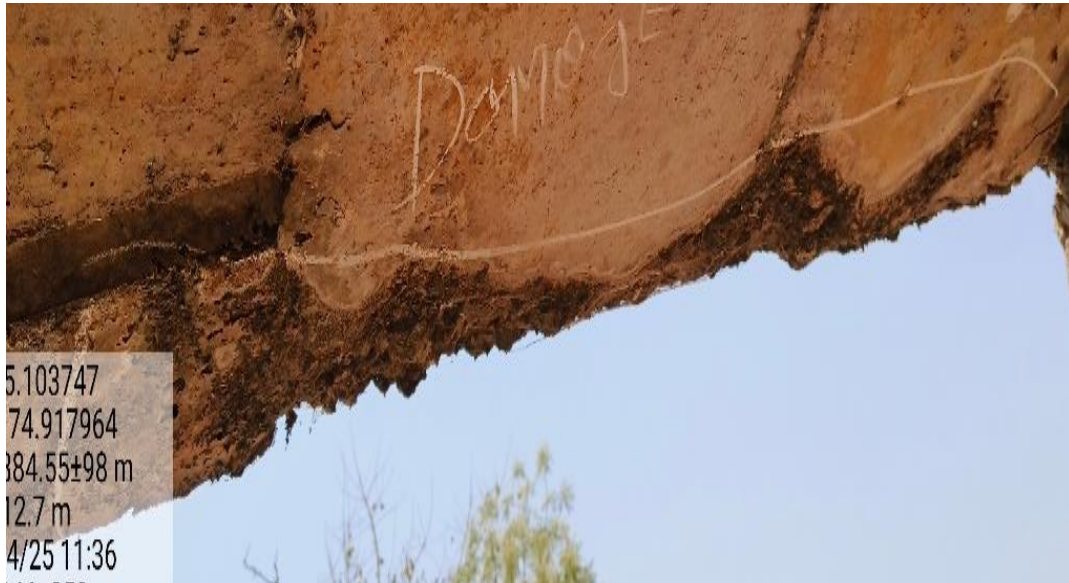
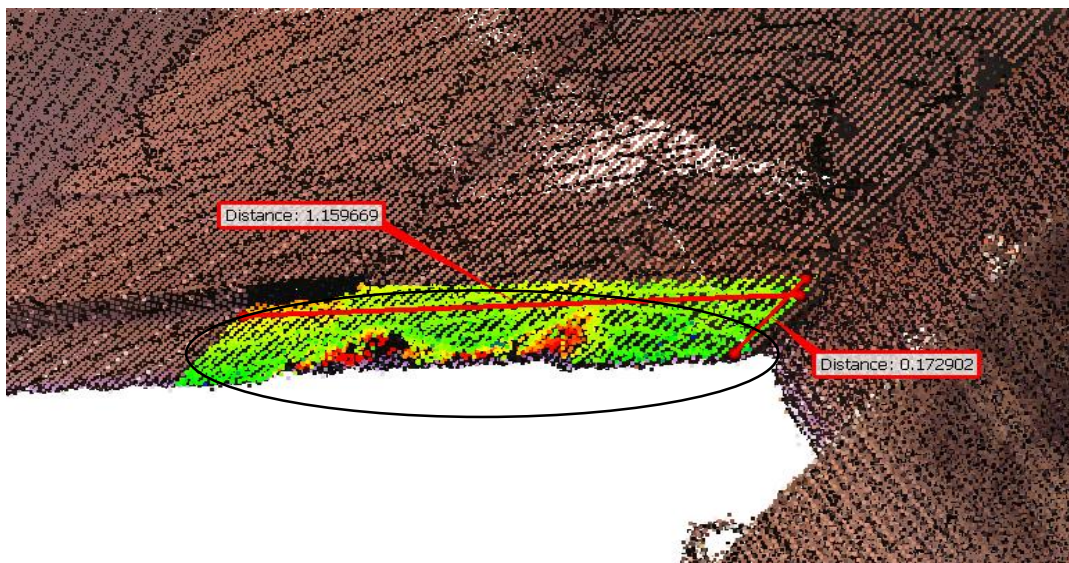
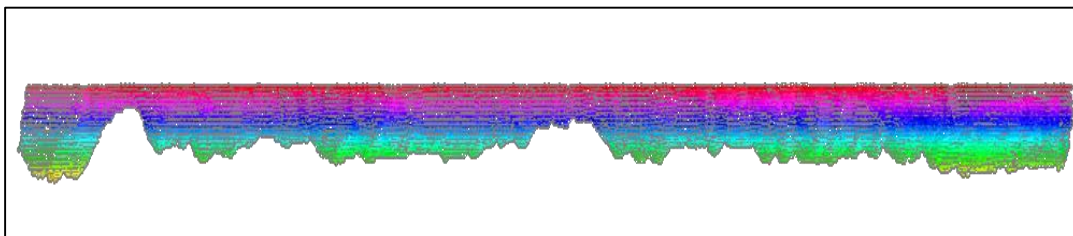
| Element Name | Observation | Location of Distress | Photo No. | Units | Distress Details | | | Area of Repair (Sq./RM T) |
|---|---|---|---|---|---|---|---|---|
| Bearing | Damage | | 8 | | 1.15 | 0.17 | | 0.1955 |

**8. Damage observed on Abutment 1 RHS Bearing 3 toe end side, measuring 1.15 m in length and 0.17 m in width, covering an area of 0.1955 m<sup>2</sup>.**

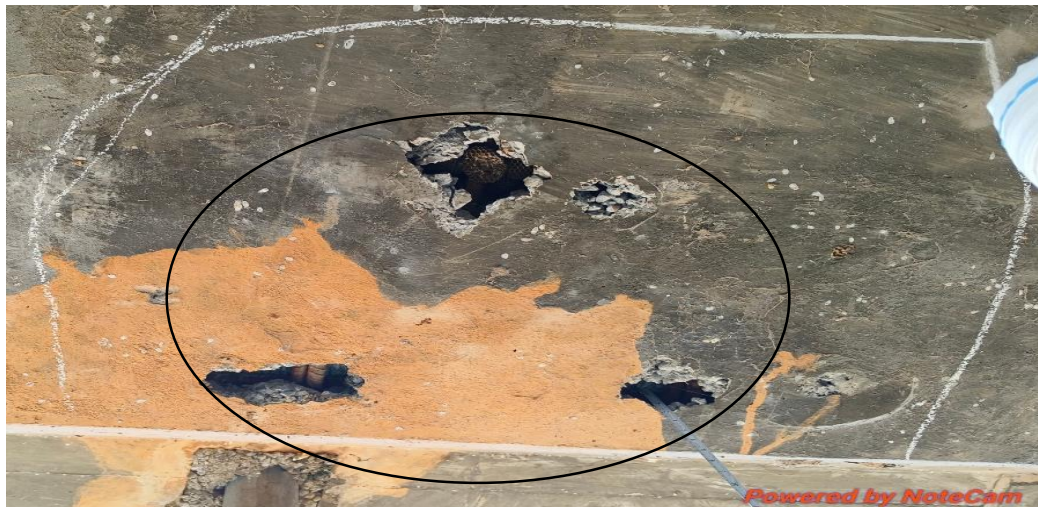
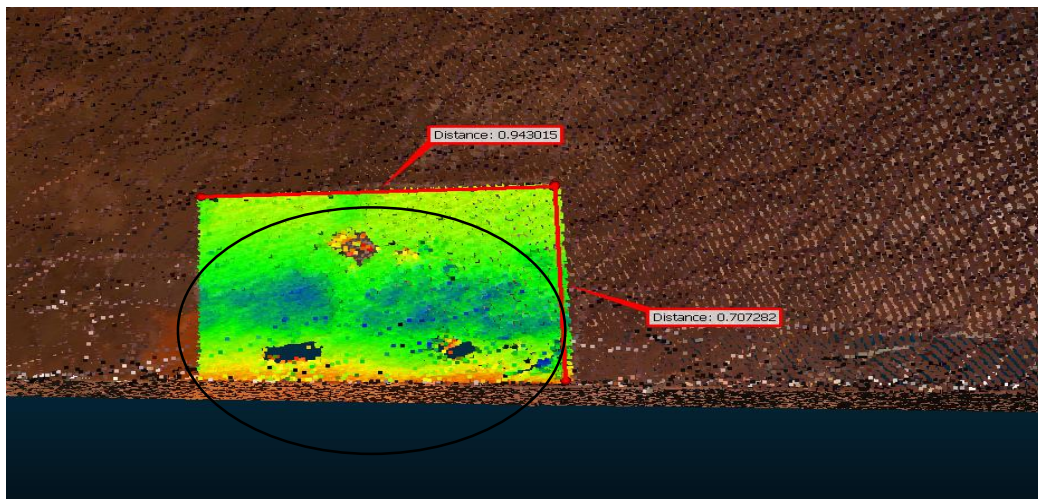
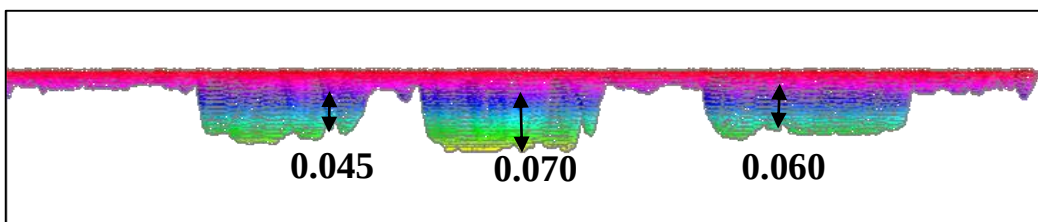
| Element Name | Observation | Location of Distress | Photo No. | Units | Distress Details | | | Area of Repair (Sq./RM T) |
|---|---|---|---|---|---|---|---|---|
| Slab Bottom | Hollow section | | 9 | | 0.94 | 0.70 | 0.060 | 0.039 |

**9. Hollow Section observed on Abutment 1 RHS slab bottom, measuring 0.94 m in length and 0.70 m in width, Depth ranges from 0.045 (min) to 0.070 m (max), with an average depth of 0.060 m. The calculated volume of the distress is 0.039 m<sup>3</sup>.**

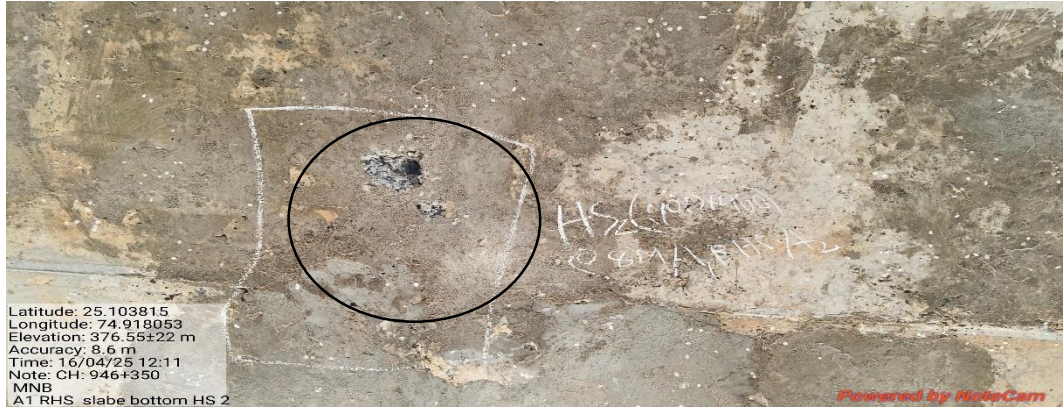
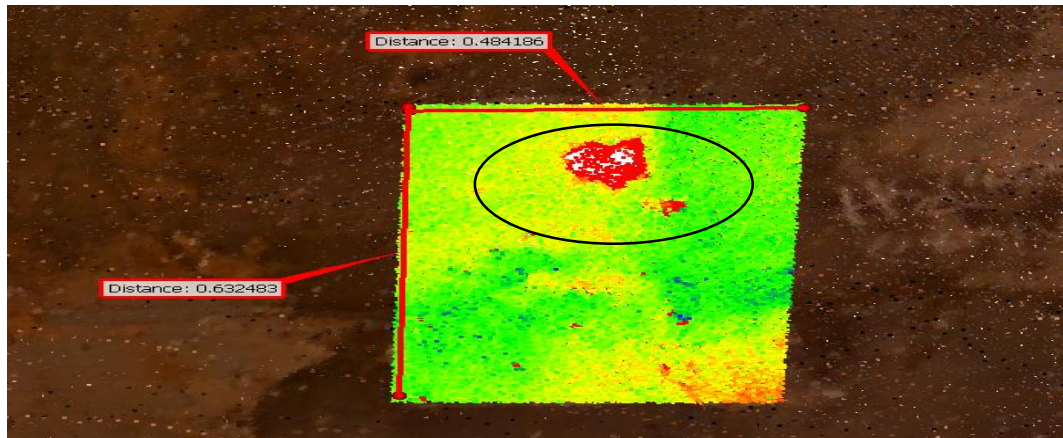
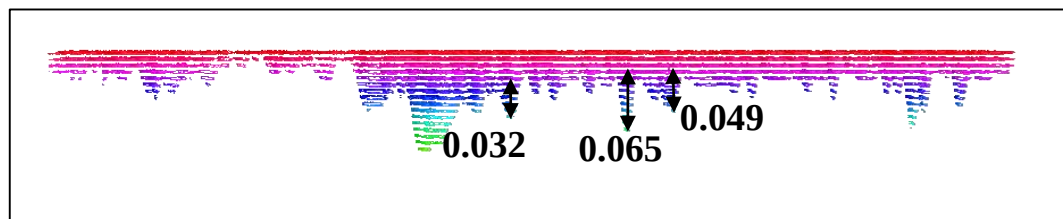
| Element Name | Observation | Location of Distress | Photo No. | Units | Distress Details | | | Area of Repair (Sq./RM T) |
|---|---|---|---|---|---|---|---|---|
| Slab Bottom | Hollow section | | 10 | | 0.48 | 0.63 | 0.049 | 0.014 |

**10. Hollow Section observed on Abutment 1 RHS slab bottom, measuring 0.48 m in length and 0.63 m in width, Depth ranges from 0.032(min) to 0.065 m (max), with an average depth of 0.049 m. The calculated volume of the distress is 0.014 m<sup>3</sup>.**

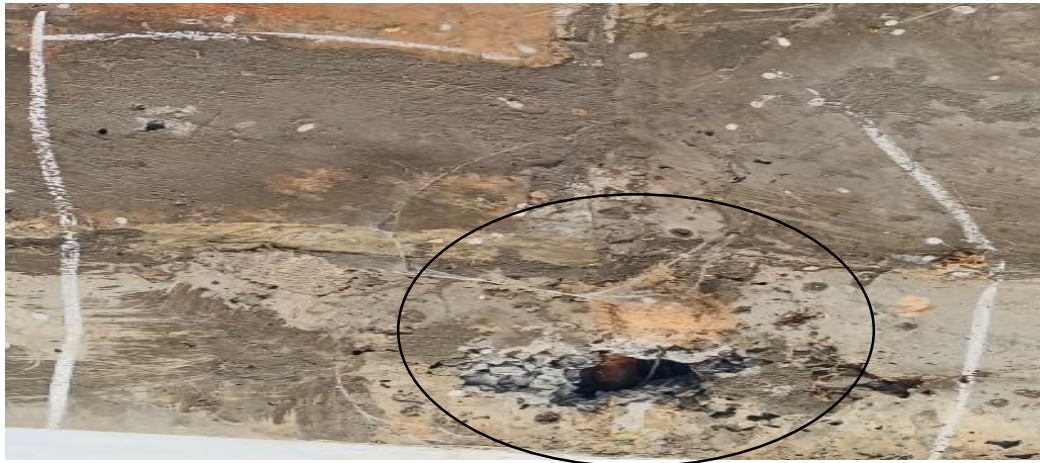
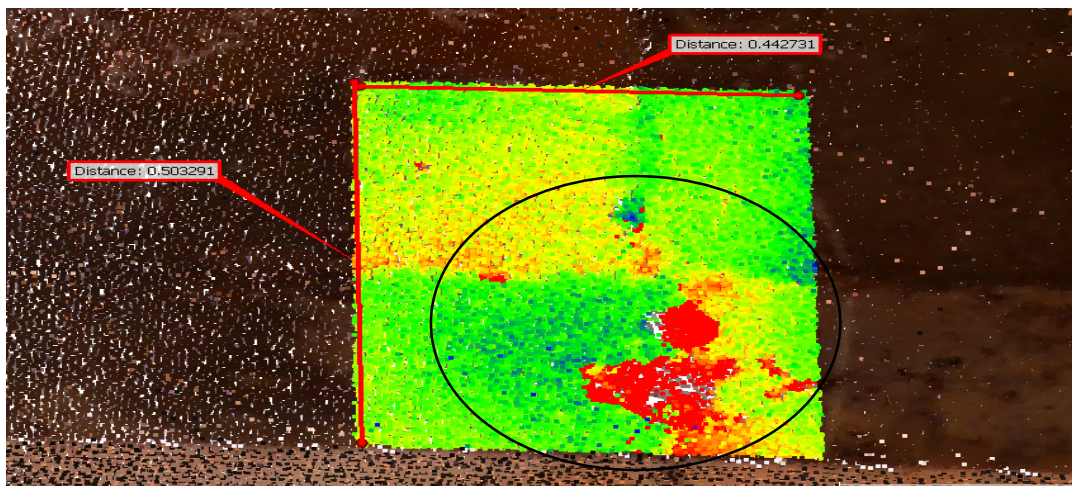
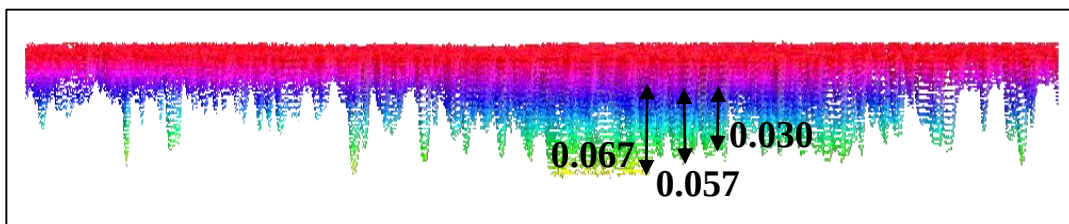
| Element Name | Observation | Location of Distress | Photo No. | Units | Distress Details | | | Area of Repair (Sq./RM T) |
|---|---|---|---|---|---|---|---|---|
| Slab Bottom | Hollow section | | 11 | | 0.50 | 0.44 | 0.057 | 0.012 |

**11. Hollow Section observed on Abutment 1 RHS slab bottom, measuring 0.50 m in length and 0.44 m in width, Depth ranges from 0.030 (min) to 0.067 m (max), with an average depth of 0.057m. The calculated volume of the distress is 0.012 m<sup>3</sup>.**
