# **LIDAR Inspection Report of MNB ch.946+200**

**Bridge No:** MNB - 947/1

**Bridge Chainage:** 946+200 (CKRP)

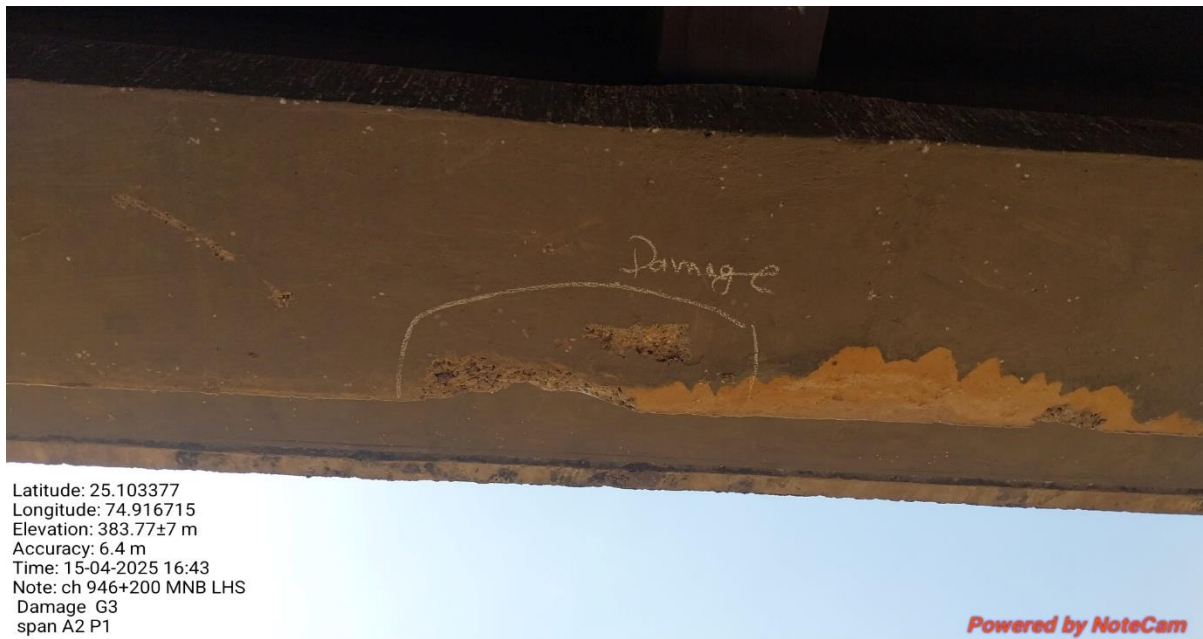
| Element Name | Observation | Location of Distress | Photo No. | Units | Distress Details | | | Area of Repair (Sq.m/R MT/m3) |
|---|---|---|---|---|---|---|---|---|
| Girder 3 | Damage | - | 2 | M | 0.38 | 0.12 | 0.036 | 0.0016 |

2. **Damage observed on Girder 3, span A2–P1, measuring 0.38 m in length and 0.12 m in width. Depth ranges from 0.029 m (min) to 0.041 m (max), with an average depth of 0.036 m. The calculated volume of the distress is 0.00164 m<sup>3</sup>.**

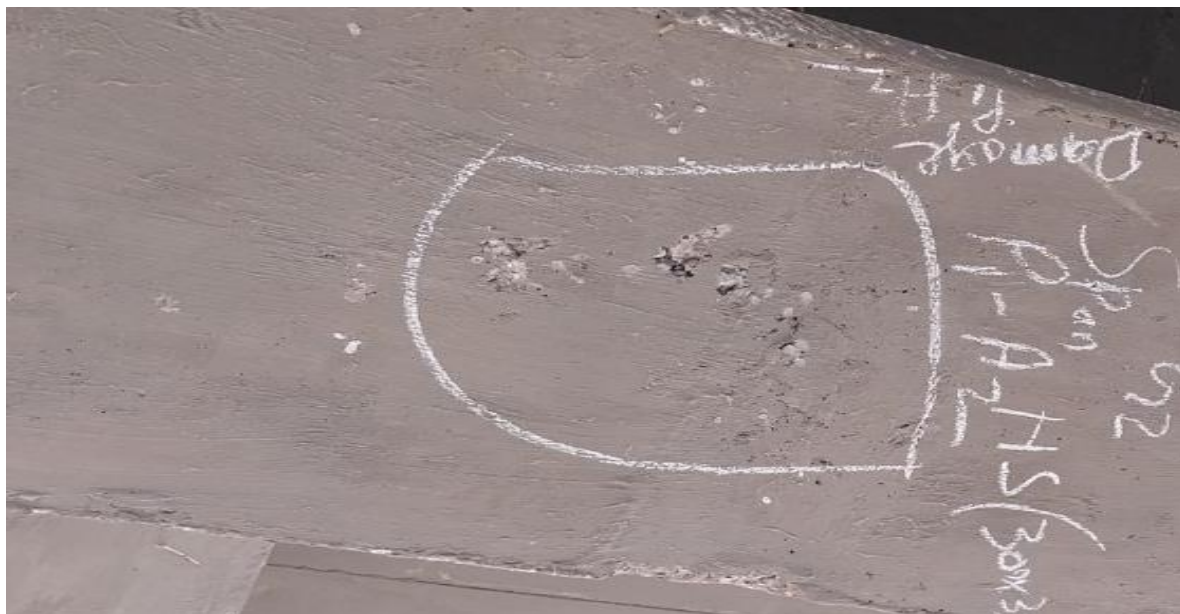
| Element Name | Observation | Location of Distress | Photo No. | Units | Distress Details | | | Area of Repair (Sq.m/R MT/m3) |
|---|---|---|---|---|---|---|---|---|
| Girder 2 | Hollow section | - | 3 | M | 0.36 | 0.35 | 0.034 | 0.0042 |

**3. Hollow section observed on Girder 2, span A2–P1, measuring 0.36 m in length and 0.35 m in width. Depth ranges from 0.024 m (min) to 0.046 m (max), with an average depth of 0.034 m. The calculated volume of the distress is 0.0042 m<sup>3</sup>.**

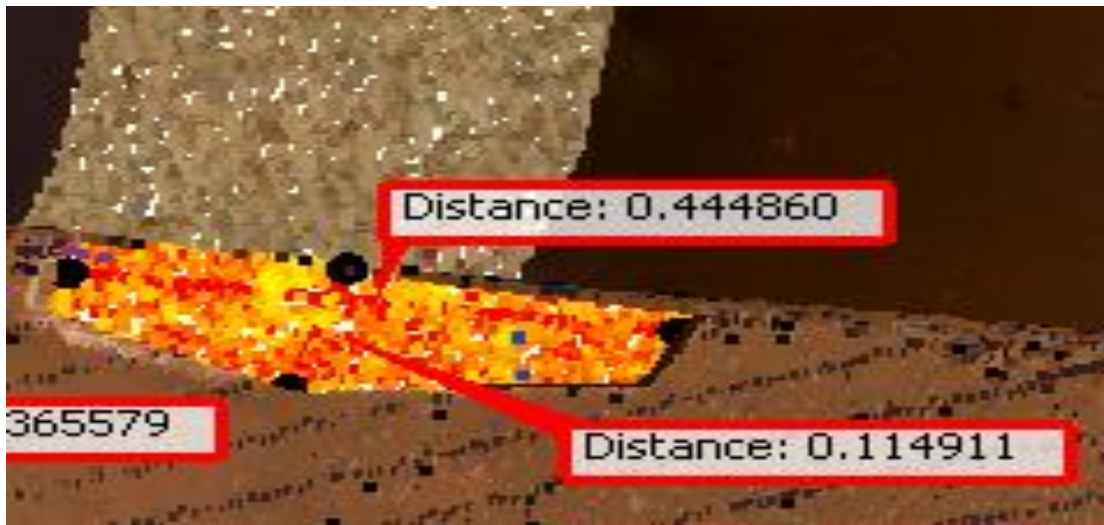
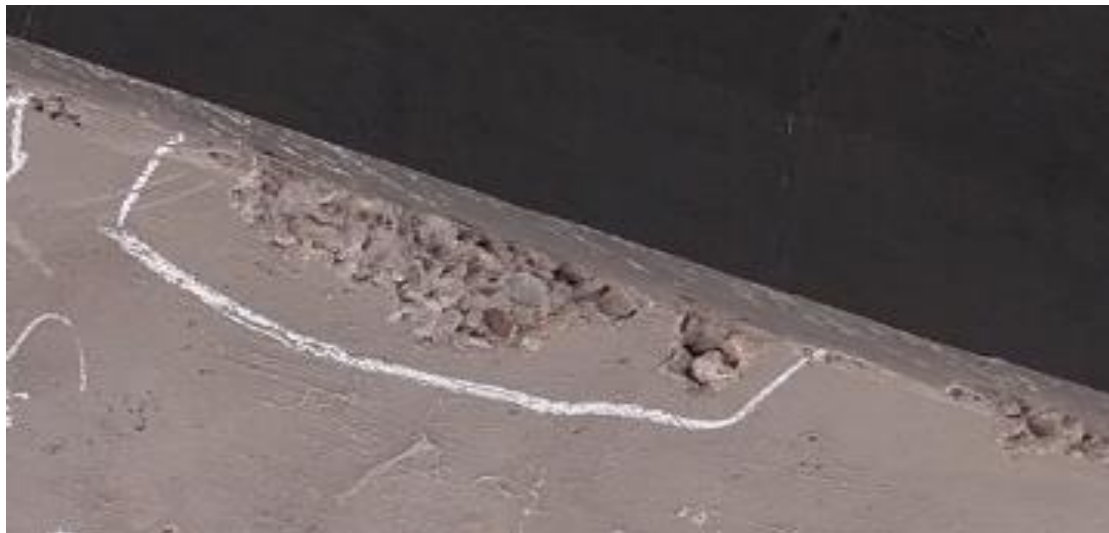
| Element Name | Observation | Location of Distress | Photo No. | Units | Distress Details | | | Area of Repair (Sq.m/R MT/m3) |
|---|---|---|---|---|---|---|---|---|
| Girder 2 | Damage | - | 4 | M | 0.44 | 0.11 | | 0.0484 |

**4. Damage observed on girder 2 span A2P1 measuring 0.44 m in length and 0.11 m in width, covering an area of 0.0484 m<sup>2</sup>.**

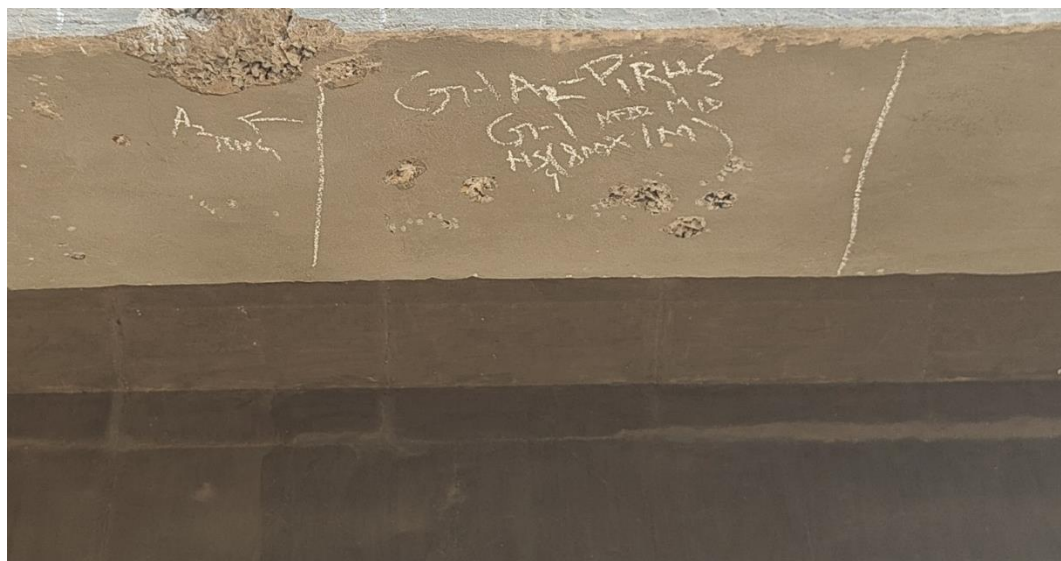
| Element Name | Observation | Location of Distress | Photo No. | Units | Distress Details | | | Area of Repair (Sq.m/R MT/m3) |
|---|---|---|---|---|---|---|---|---|
| Girder 1 | Hollow Section | - | 6 | M | 0.94 | 0.62 | 0.042 | 0.0244 |

**6. Hollow section on A2–P1 Girder 1, measuring 0.94 m in length and 0.62 m in width. Depth ranges from 0.033 m (min) to 0.053 m (max), with an average depth of 0.042 m. The calculated volume of the distress is 0.0244 m<sup>3</sup>.**

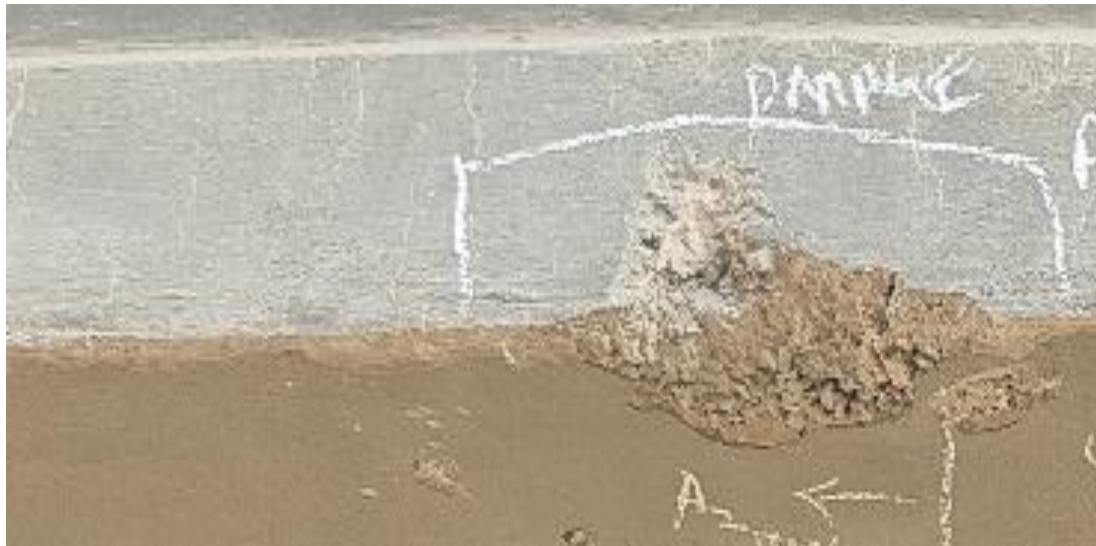
| Element Name | Observation | Location of Distress | Photo No. | Units | Distress Details | | | Area of Repair (Sq.m/R MT/m3) |
|---|---|---|---|---|---|---|---|---|
| Girder | Damage | - | 7 | M | 0.28 | 0.12 | 0.049 | 0.00164 |

**7. Damage observed on A2–P1 Girder 1 measuring 0.28 m in length and 0.12 m in width. Depth ranges from 0.039 m (min) to 0.058 m (max), with an average depth of 0.049 m. The calculated volume of the distress is 0.0164 m<sup>3</sup>.**

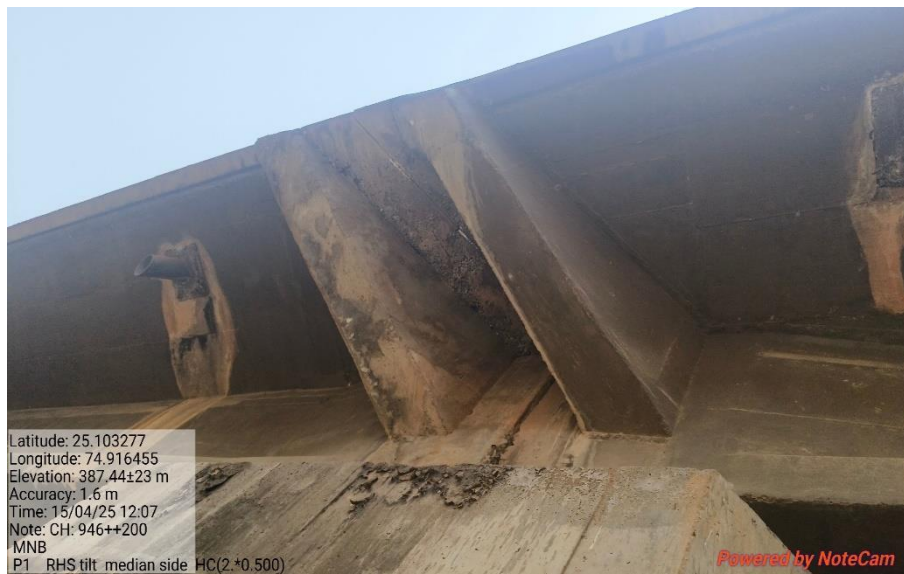
| Element Name | Observation | Location of Distress | Photo No. | Units | Distress Details | | | Area of Repair (Sq./RM T) |
|---|---|---|---|---|---|---|---|---|
| Pier 1 | Honeycombing | - | 8 | M | 1.74 | 0.54 | - | 0.939 |

**8. Honeycombing observed on P1 median side, measuring 1.74 m in length and 0.54 m in width, covering an area of 0.9396 m<sup>2</sup>.**

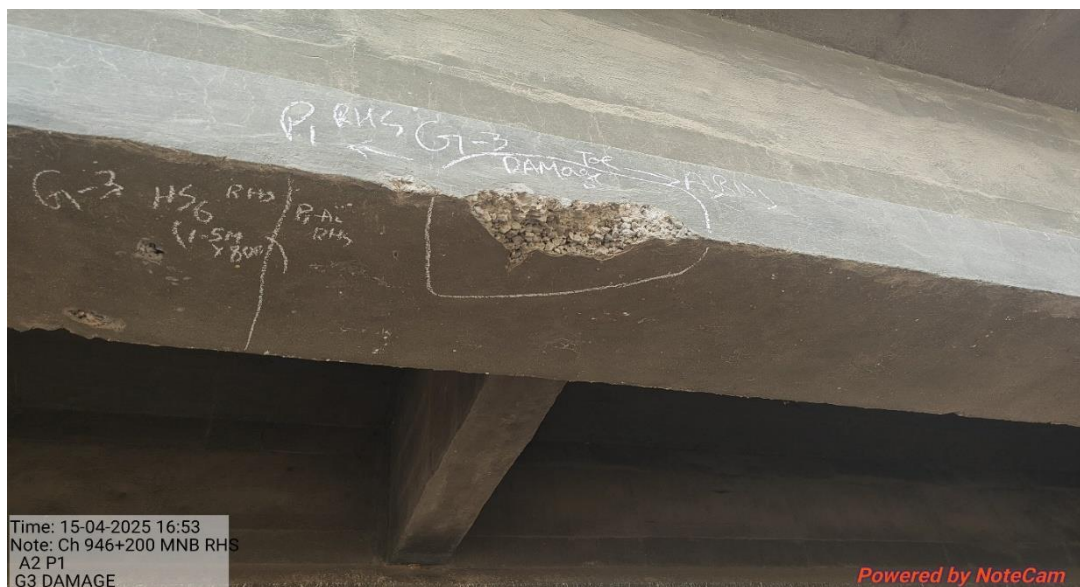
| Element Name | Observation | Location of Distress | Photo No. | Units | Distress Details | | | Area of Repair (Sq./RM T) |
|---|---|---|---|---|---|---|---|---|
| Girder 3 | Damage | - | 13 | M | 0.52 | 0.19 | 0.032 | 0.0031 |

**13. Damage observed on A2–P1 Girder 3, measuring 0.52 m in length and 0.19 m in width. Depth ranges from 0.024 m (min) to 0.041 m (max), with an average depth of 0.032 m. The calculated volume of the distress is 0.0177 m<sup>3</sup>.**

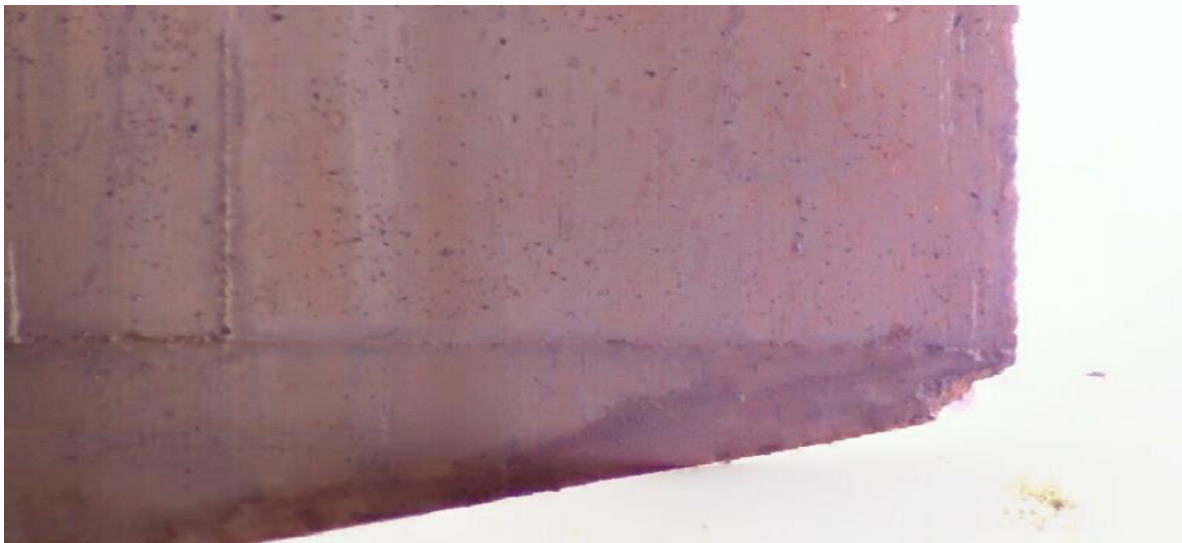
| Element Name | Observation | Location of Distress | Photo No. | Units | Distress Details | | | Area of Repair (Sq./RM T) |
|---|---|---|---|---|---|---|---|---|
| Pier Cap | Damage | - | 16 | M | 0.17 | 0.15 | 0.019 | 0.0004 |

**16. Honeycombing observed on A1-P1 span pier cap bottom HC1, measuring 0.17 m in length and 0.15 m in width. Depth ranges from 0.012 m (min) to 0.022 m (max), with an average depth of 0.019 m. The calculated volume of the distress is 0.0004 m<sup>3</sup>.**

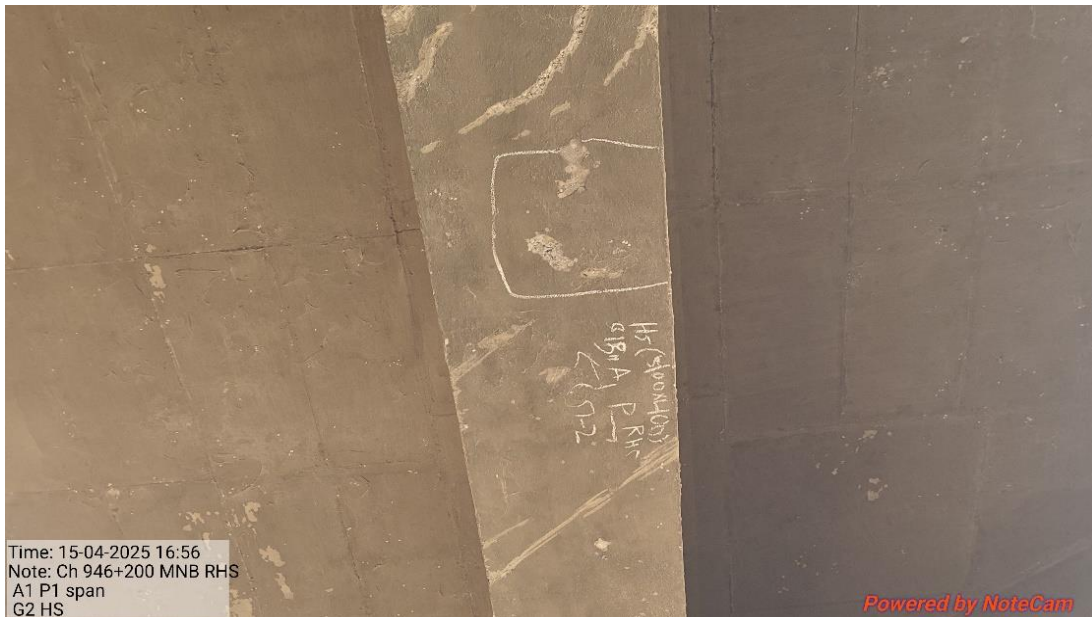
| Element Name | Observation | Location of Distress | Photo No. | Units | Distress Details | | | Area of Repair (Sq./RM T) |
|---|---|---|---|---|---|---|---|---|
| Girder 2 | Hollow Section | - | 18 | M | 0.45 | 0.40 | 0.023 | 0.0041 |

**18. Hollow section on A1–P1 span Girder 2, measuring 0.45 m in length and 0.40 m in width. Depth ranges from 0.017 m (min) to 0.029 m (max), with an average depth of 0.023 m. The calculated volume of the distress is 0.0126 m<sup>3</sup>.**

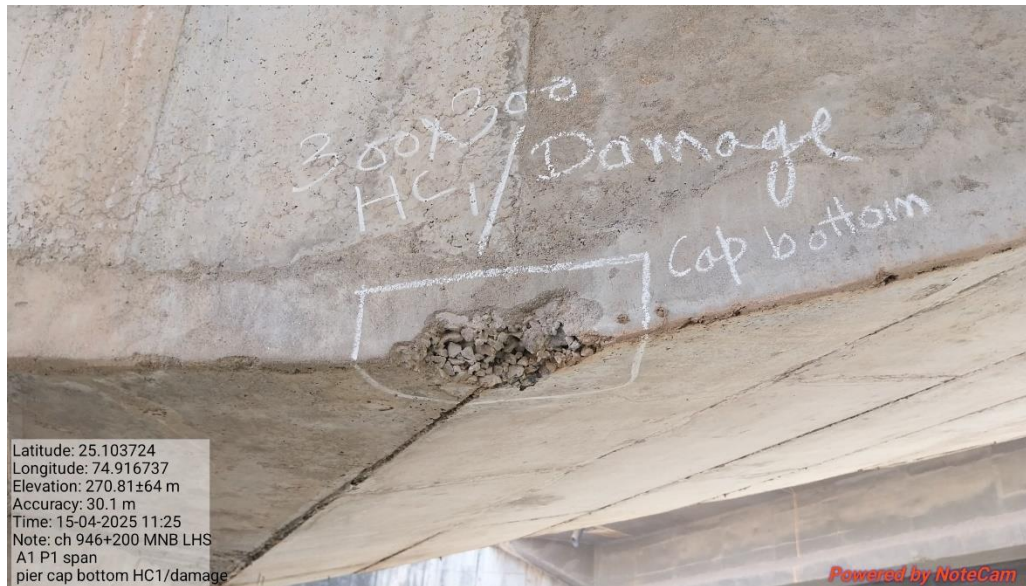
| Element Name | Observation | Location of Distress | Photo No. | Units | Distress Details | | | Area of Repair (Sq./RM T) |
|---|---|---|---|---|---|---|---|---|
| Pier Cap | honeycombing | - | 19 | M | 0.27 | 0.09 | - | 0.024 |

**19. Honeycombing observed on A1–P1 span pier cap bottom (HC1), measuring 0.27 m in length and 0.09 m in width, covering an area of 0.0243 m<sup>2</sup>.**
