# **Satellite Structural Inspection Interferometric Synthetic Aperture Radar (InSAR) Based**

Bridge No. – 903/2

Bridge Chainage – 946+200

Project - Chittorgarh to Kota

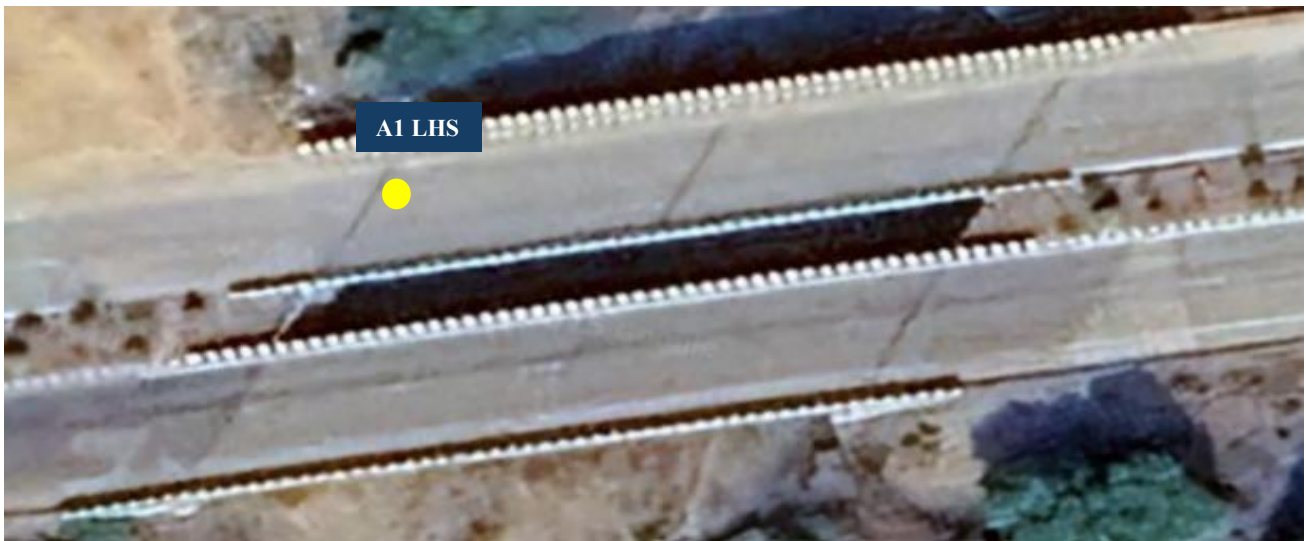
A1 LHS (25.103288253042326, 74.91634085656884)

- **Vertical Displacement (VV)** shows a generally upward trend over the monitoring period, varying from approximately -8 mm to +22 mm. The movements indicate a progressive vertical rise with intermittent drops, reflecting fluctuating but overall increasing upward displacement.
- **Horizontal displacement (VH)** fluctuates within the range of -5 mm to +17 mm, showing moderate lateral variability. The pattern indicates that horizontal movement remains active throughout the period, with noticeable peaks during late April and mid-June.

- **February 2025:** Both VH and VV experience a sharp downward dip, with VV reaching around -8 mm and VH near -5 mm marking the first significant combined downward excursion.
- **March 2025:** VV shows a sustained rise, moving from around 0 mm to +13 mm. VH also increases
- **June 2025:** A temporary decline in both VH and VV occurs, followed by another upward shift at the end of June.

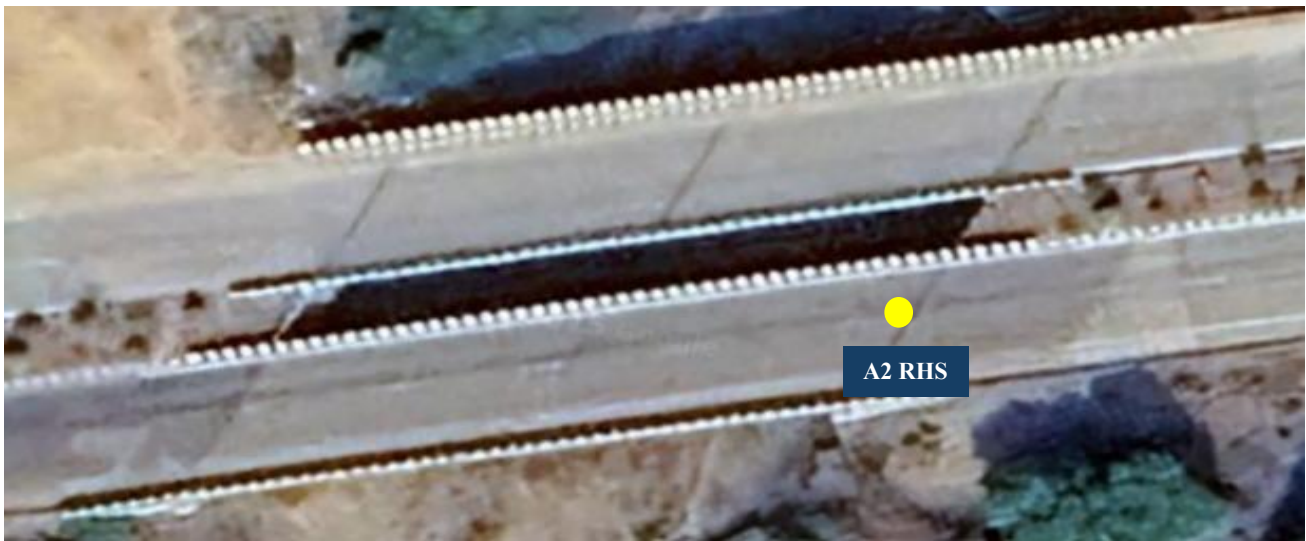
A2 RHS (25.10327646006453, 74.91671852587545)

- **Vertical Displacement (VV)** shows a clear upward-trending behaviour, fluctuating between +5 mm and +28 mm, indicating progressive vertical uplift on the RHS with several pronounced peaks
- **Horizontal Displacement (VH)** exhibits predominantly negative (southward) movement ranging from –18 mm to +5 mm, highlighting consistent lateral drift with repeated downward spikes.

- **February 2025:** VV rises to around +15 mm, representing the first major vertical uplift phase, while VH dips to –10 mm, marking a noticeable lateral shift.
- **May 2025:** VV reaches a significant peak of +27 mm, its highest recorded value within the monitoring period.
- **June 2025:** VH drops sharply to –15 mm, representing the largest lateral deviation observed. VV again approaches +20 mm, indicating sustained upward displacement rather than recovery.
