# **LIDAR Inspection Report of Box Culvert ch.946+820**

**Bridge Chainage:** 946+820

- **Bridge No:** -
- **Chainage:** 946+820
- **Structure type:** Box Culvert

- **CKRP:** Chittorgarh to kota
- **State:** Rajasthan NH 27
- **Zone:** RJ-20

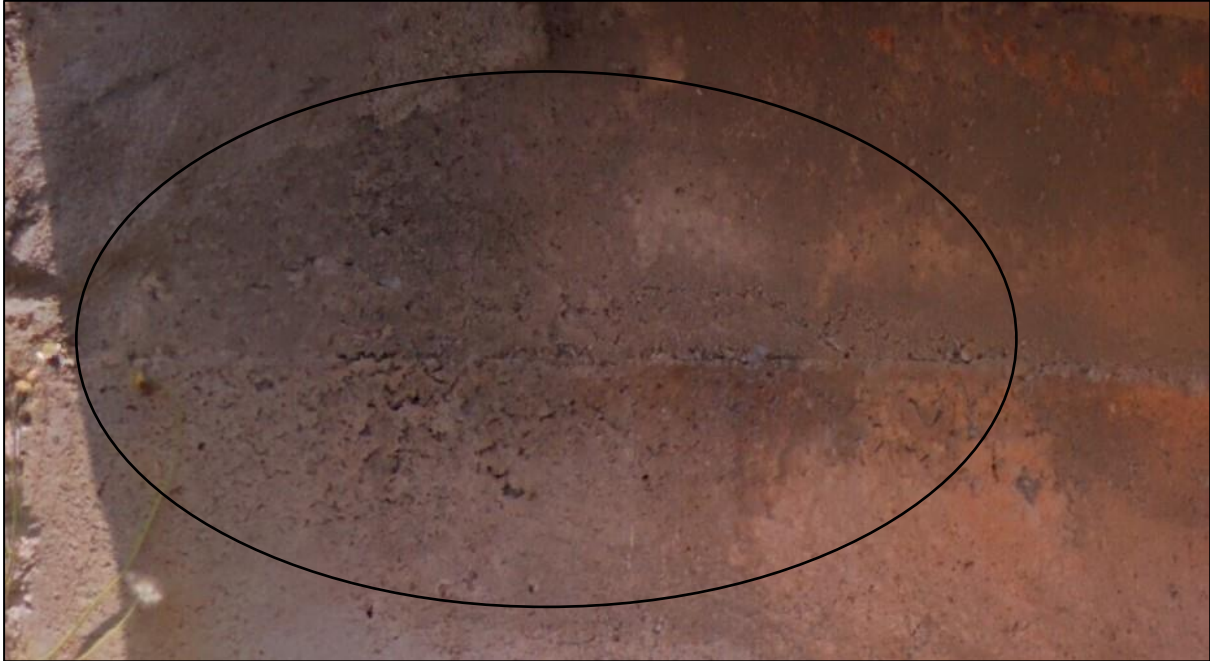
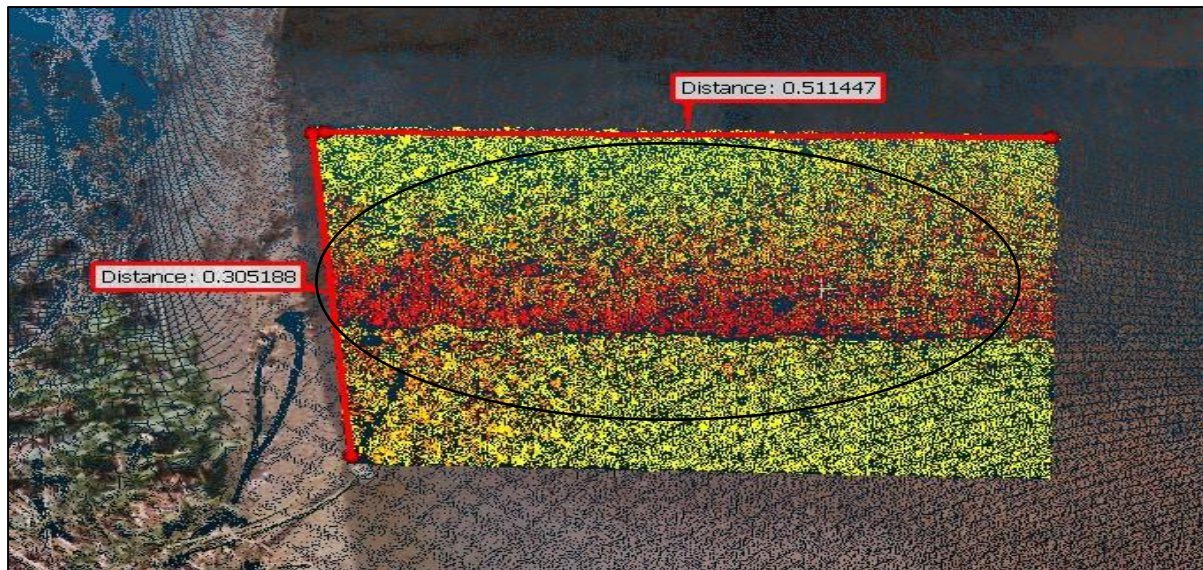
| Element Name | Observation | Location of Distress | Photo No. | Units | Distress Details | | | Area of Repair (Sq.m/R MT/m3) |
|---|---|---|---|---|---|---|---|---|
| Abutment 1 | Scalling | - | 1 | Sq m | 0.51 | 0.30 | - | 0.15 |

**1. Scaling observed on Abutment 1 RHS side, measuring 0.51 m in length and 0.30 m in width, covering an area of 0.15 m<sup>2</sup>.**

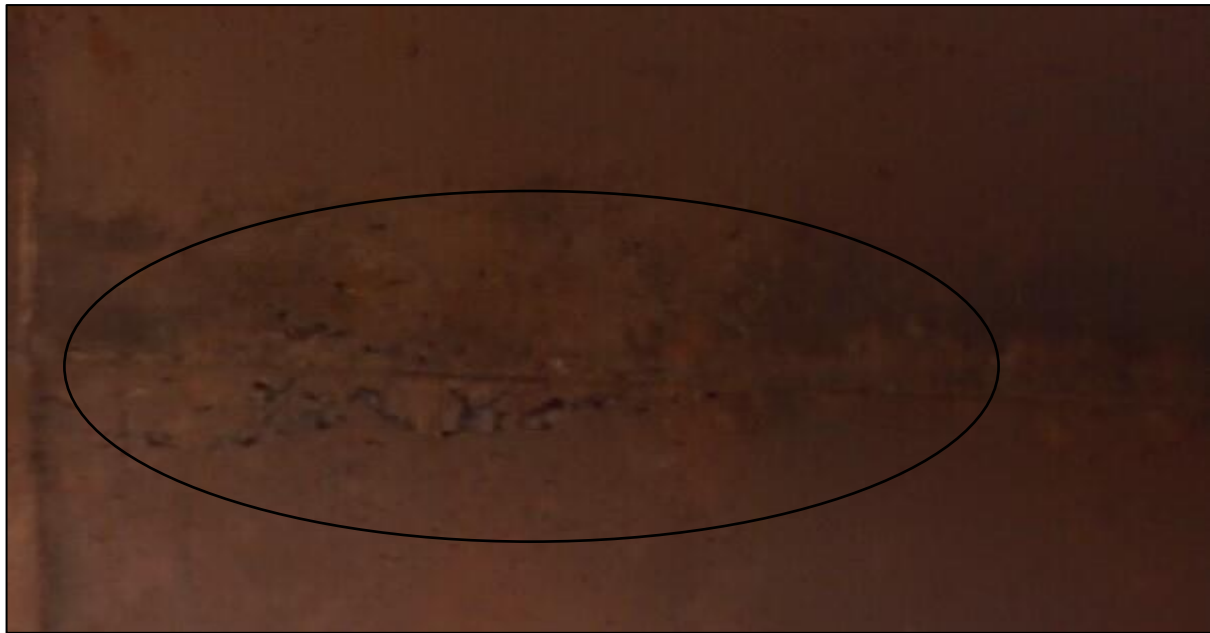
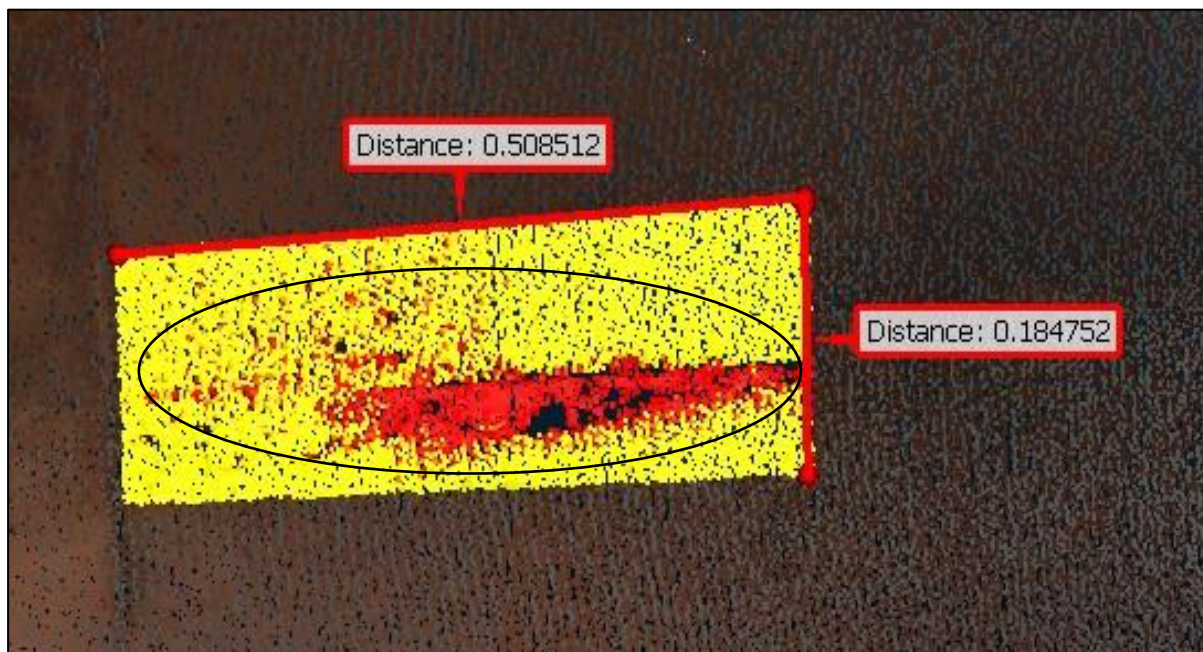
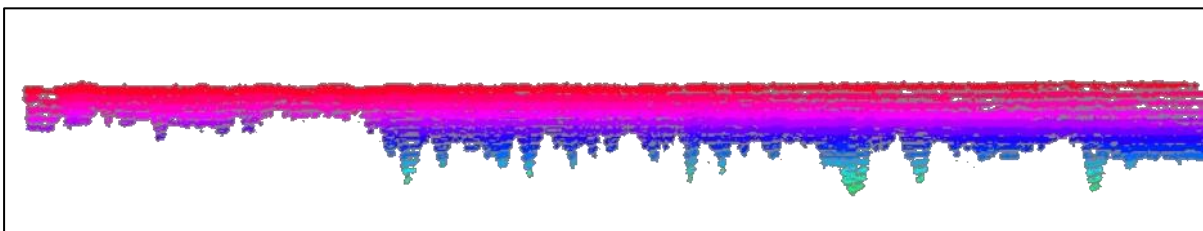
| Element Name | Observation | Location of Distress | Photo No. | Units | Distress Details | | | Area of Repair (Sq.m/R MT/m3) |
|---|---|---|---|---|---|---|---|---|
| Abutment 1 | Scalling | - | 2 | Sq m | 0.50 | 0.18 | - | 0.09 |

**2. Scaling observed on Abutment 1 RHS side, measuring 0.50 m in length and 0.18 m in width, covering an area of 0.09 m<sup>2</sup>**
