# **LIDAR Inspection Report of Slab Culvert ch.947+850**

**Bridge Chainage:** 947 + 850 (CKRP)

- **CKRP:** Chittorgarh to kota
- **State:** Rajasthan NH 27
- **Zone:** RJ-06

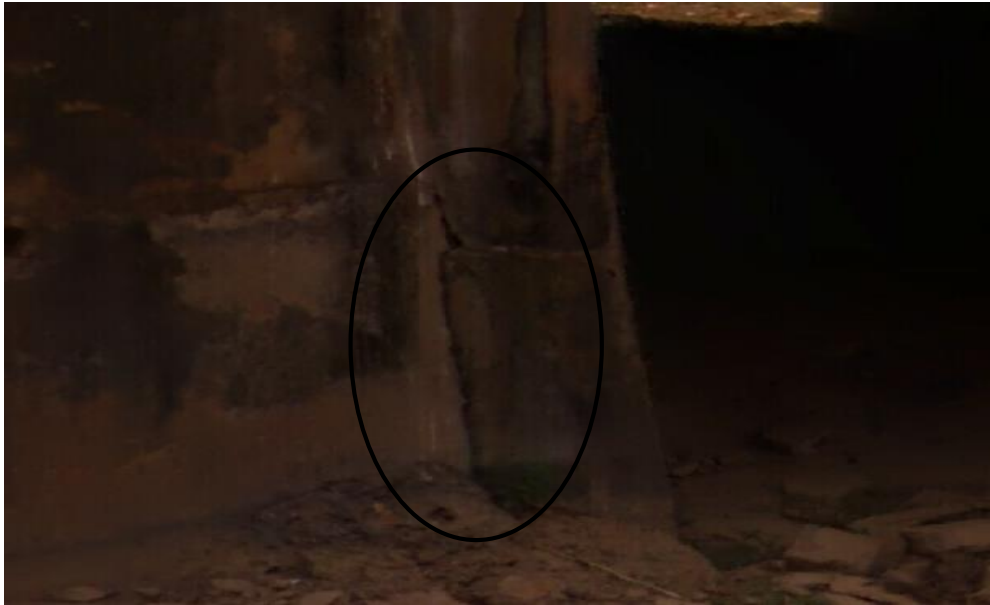
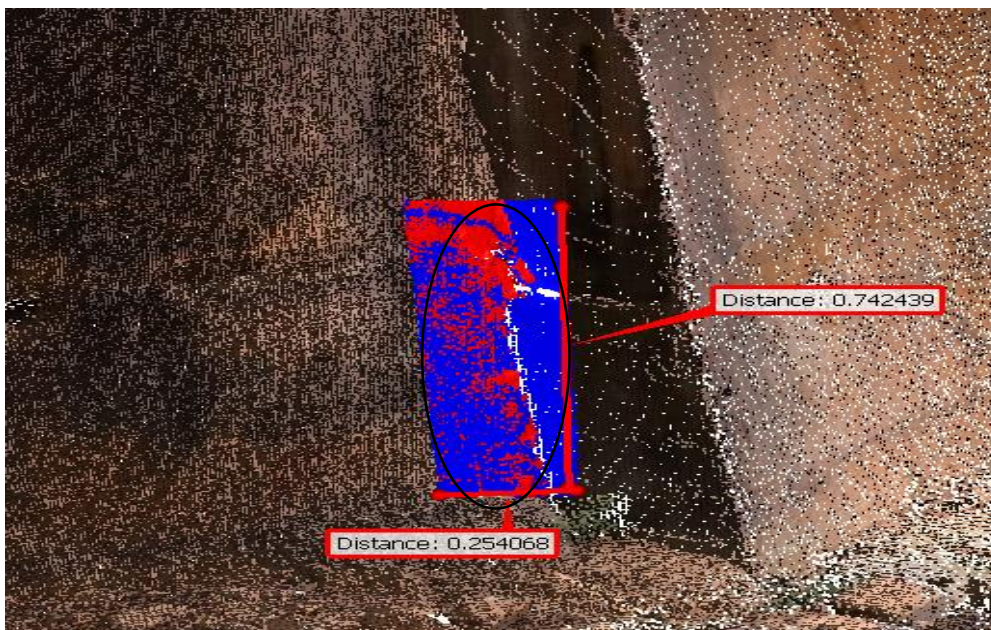
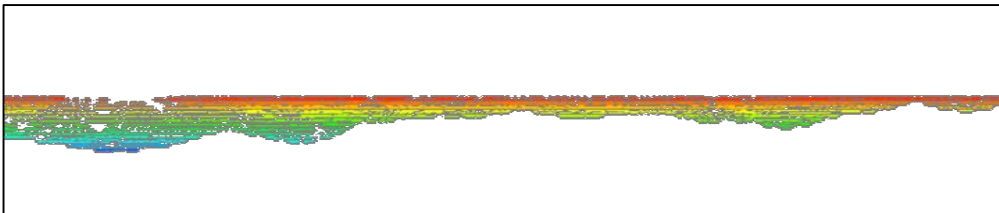
| Element Name | Observation | Location of Distress | Photo No. | Units | Distress Details | | | Area of Repair (Sq.m/R MT/m3) |
|---|---|---|---|---|---|---|---|---|
| Abutment 1 | Scaling | | 1 | M | 0.74 | 0.25 | | 0.1850 |

**1. Scaling observed on Abutment 1 LHS , measuring 0.74 m in length and 0.25 m in width, covering an area of 0.1850 m<sup>2</sup>.**

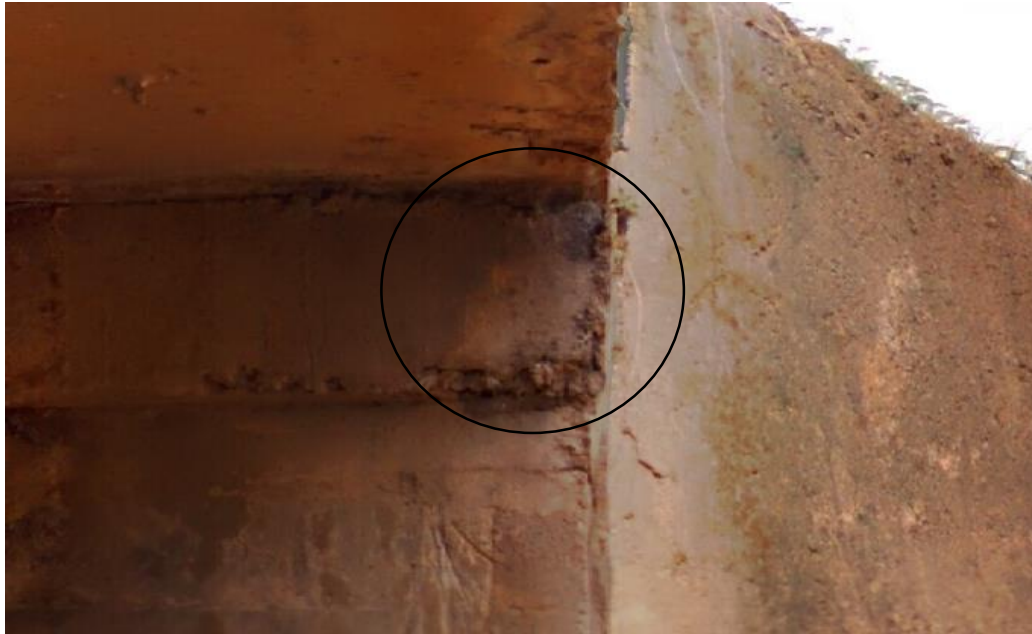
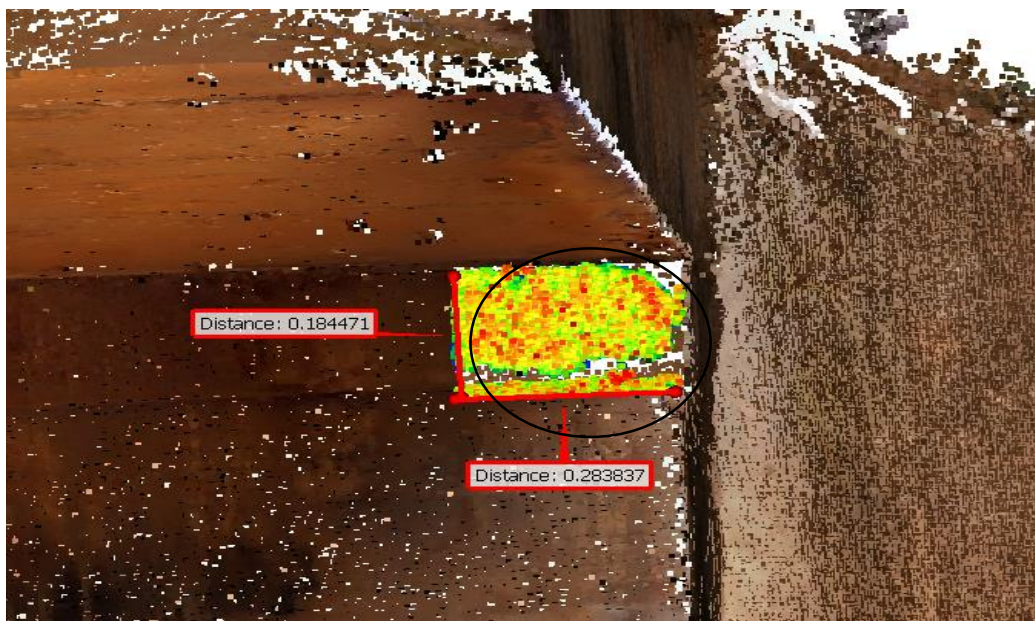
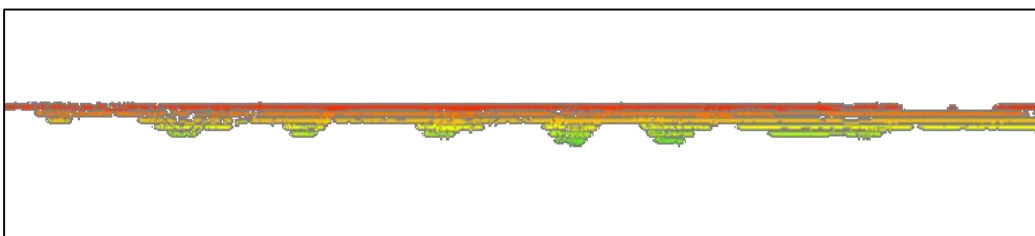
| Element Name | Observation | Location of Distress | Photo No. | Units | Distress Details | | | Area of Repair (Sq.m/R MT/m3) |
|---|---|---|---|---|---|---|---|---|
| Abutment 1 | Scaling | | 2 | M | 0.28 | 0.18 | | 0.0504 |

**2. Scaling observed on Abutment 1 LHS , measuring 0.28 m in length and 0.18 m in width, covering an area of 0.0504 m<sup>2</sup>.**

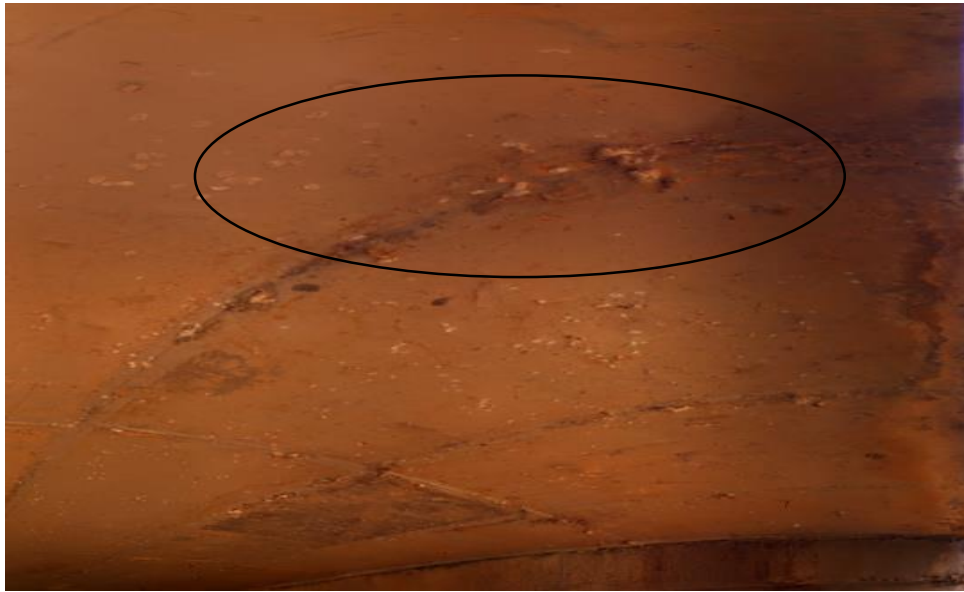
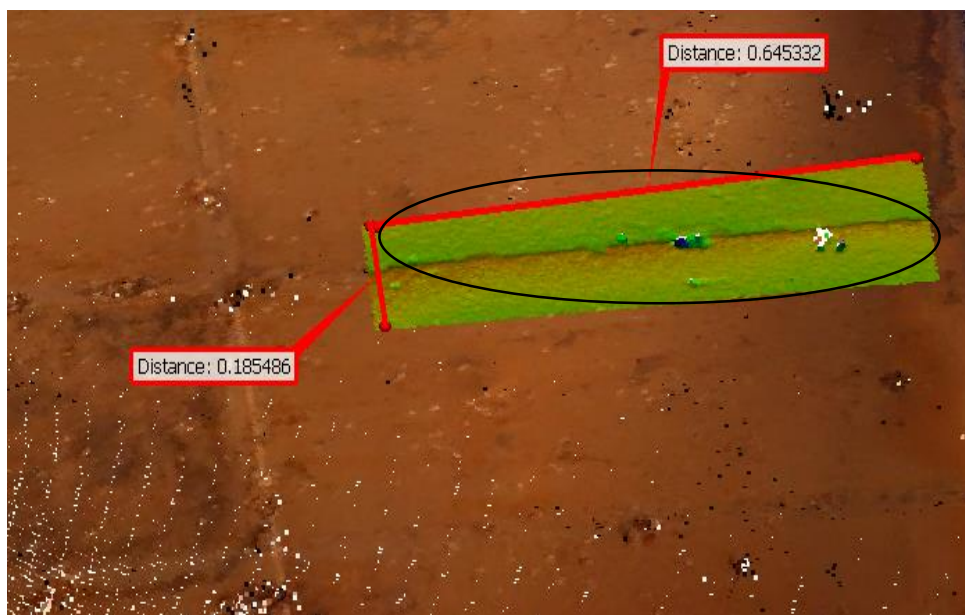
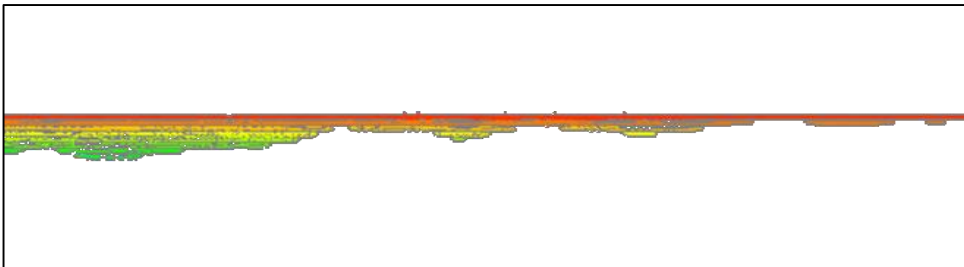
| Element Name | Observation | Location of Distress | Photo No. | Units | Distress Details | | | Area of Repair (Sq.m/R MT/m3) |
|---|---|---|---|---|---|---|---|---|
| Slab Bottom | Scaling | | 3 | M | 0.64 | 0.18 | | 0.1152 |

**3. Scaling observed on Abutment 1 LHS Slab Bottom , measuring 0.64 m in length and 0.18 m in width, covering an area of 0.1152 m<sup>2</sup>.**

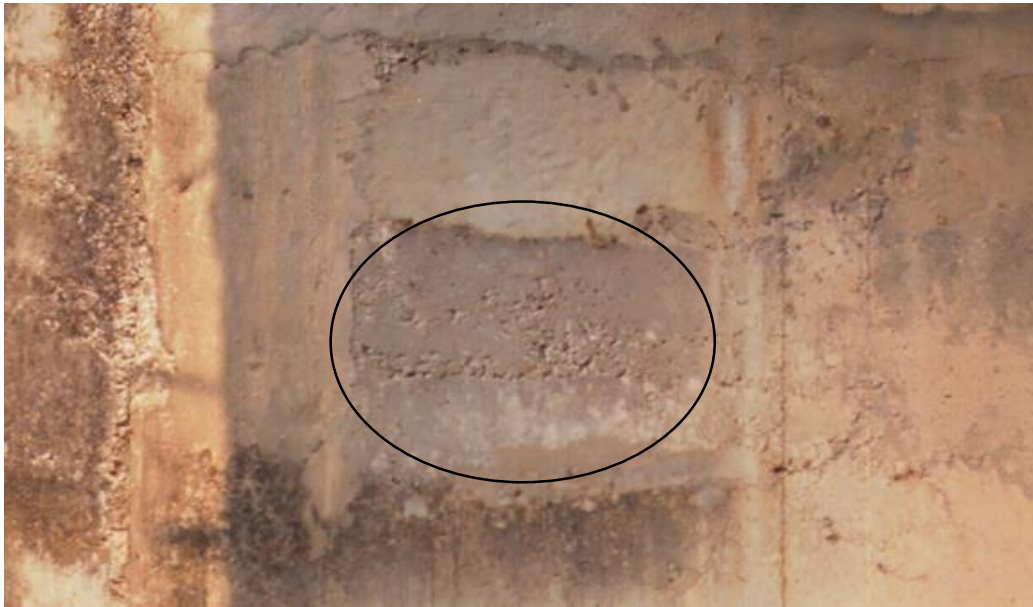
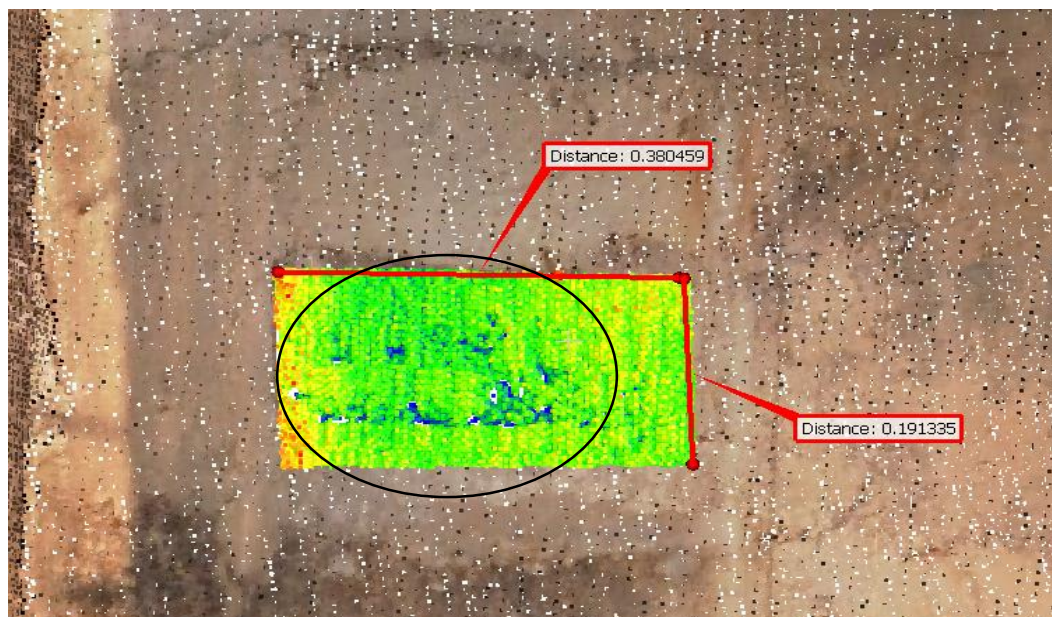
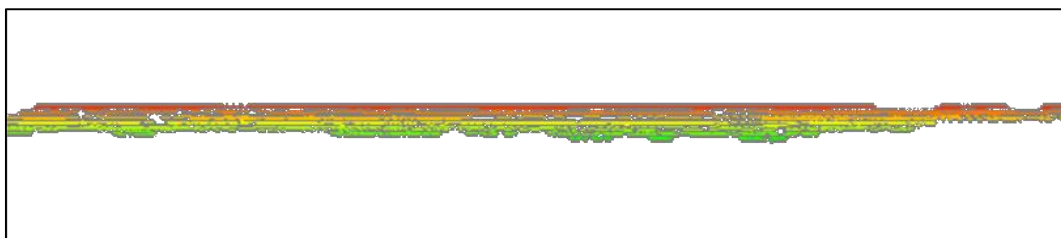
| Element Name | Observation | Location of Distress | Photo No. | Units | Distress Details | | | Area of Repair (Sq.m/ RMT/ m3) |
|---|---|---|---|---|---|---|---|---|
| Abutment 2 | Scaling | - | 4 | M | 0.38 | 0.19 | | 0.0722 |

**4. Scaling observed on Abutment 2 RHS , measuring 0.38 m in length and 0.19 m in width, covering an area of 0.0722 m<sup>2</sup>.**
