# **LIDAR Inspection Report of Slab Culvert ch.947+410**

**Bridge Chainage:** 947 +410 (CKRP)

- **Bridge No:** -
- **Chainage:** 947 +410
- **Structure type:** Slab Culvert

- **CKRP:** Chittorgarh to kota
- **State:** Rajasthan NH 27
- **Zone:** RJ-06

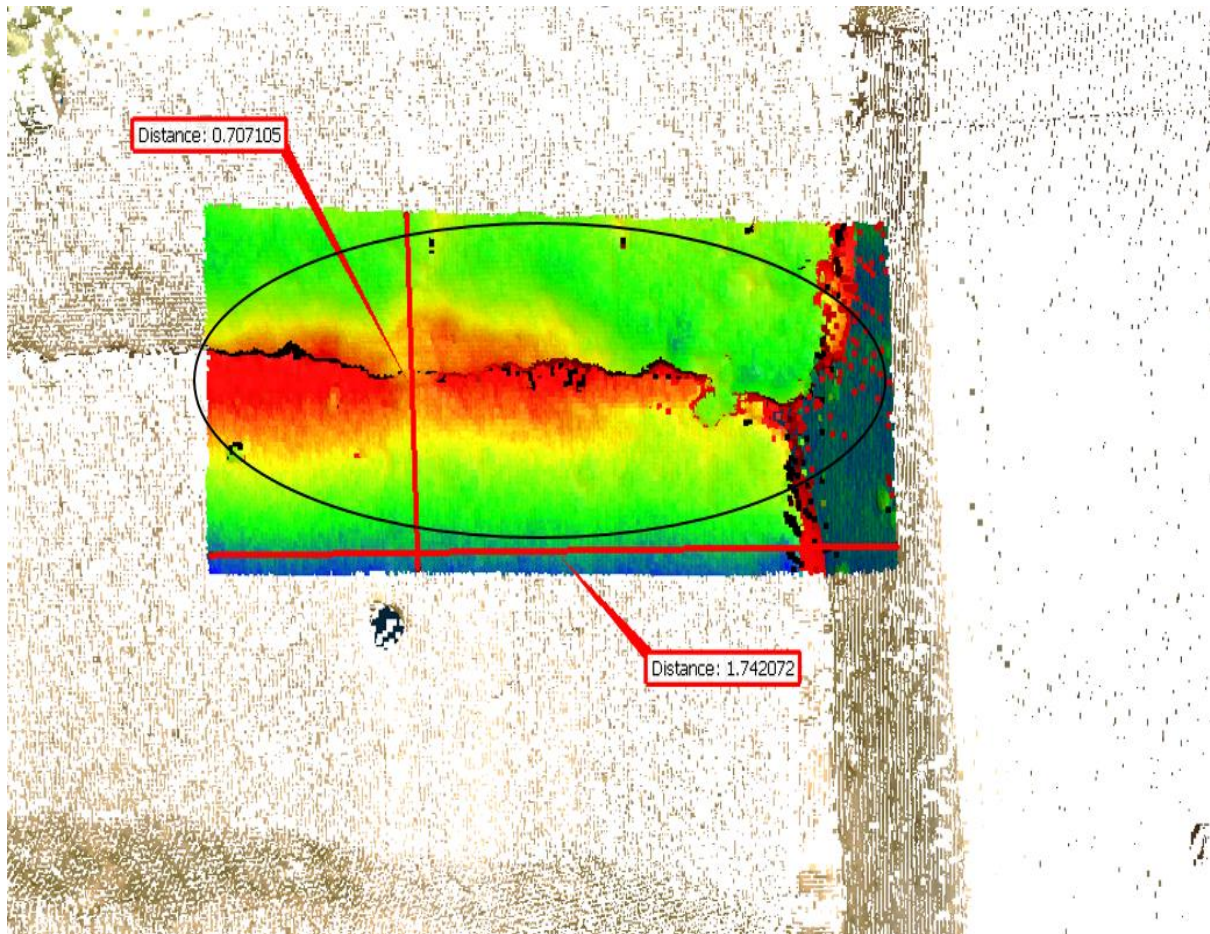
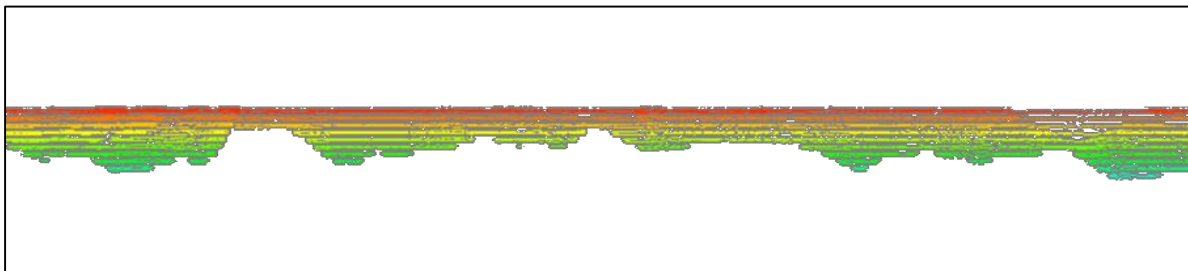
| Sr. No. | Description | Distress Notation | Observation | Location | | Distress Details | | | Area of Repair |
|---|---|---|---|---|---|---|---|---|---|
| 1 | Return wall | | Damage (LHS/RHS) | | | | | | |

- 1. Return wall damage observed on LHS, measuring 1.7420 m in length and 0.7071 m in width, covering an area of 1.23 m<sup>2</sup>.**

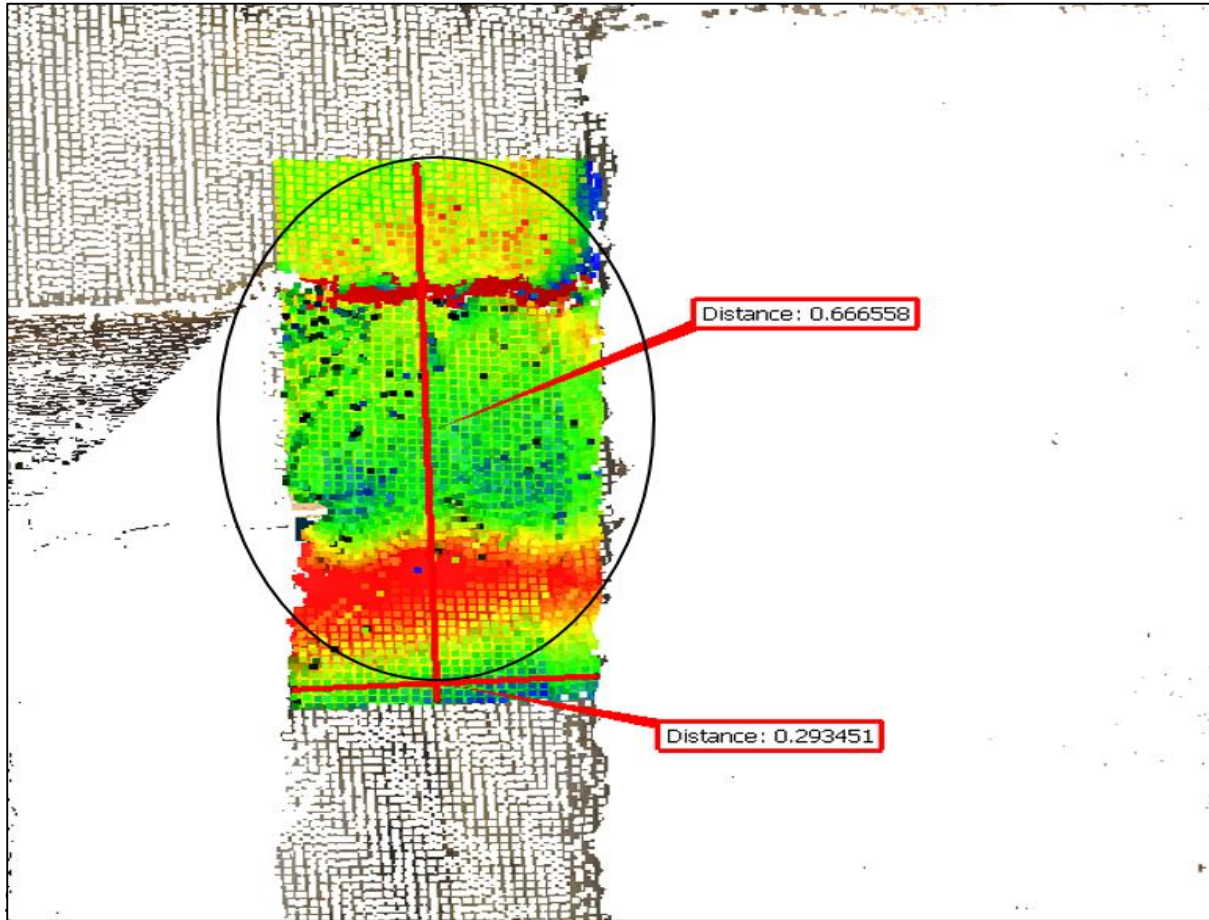
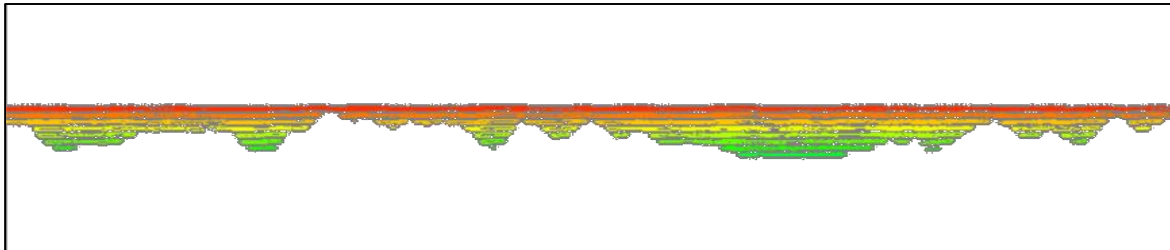
2. Return wall damage observed on RHS, measuring 0.6665 m in length and 0.2934 m in width, covering an area of 0.20 m<sup>2</sup>.
