# **LIDAR Inspection Report of VUP ch.1000+060**

**Bridge Chainage:** 1000+060(CKRP)

- **Bridge No:** -
- **Chainage:** 1000+060
- **Structure type:** VUP

- **CKRP:** Chittorgarh to kota
- **State:** Rajasthan NH 27
- **Zone:** RJ-06

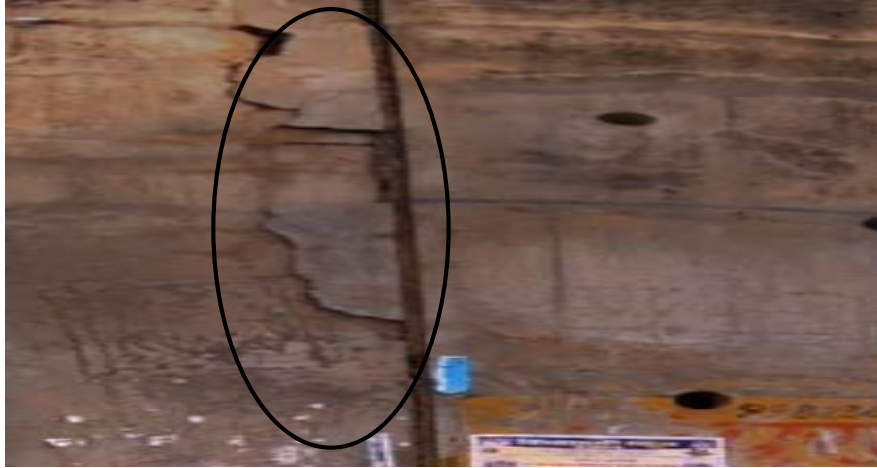
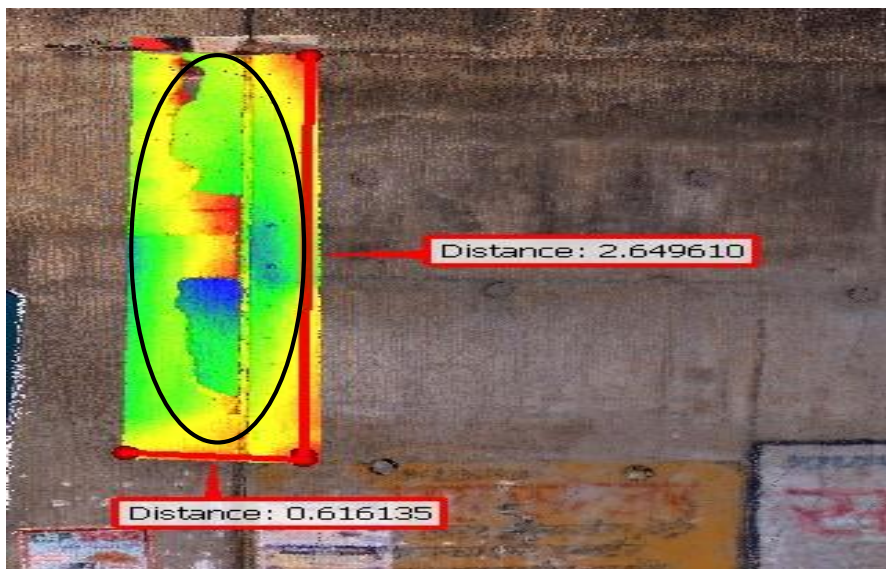
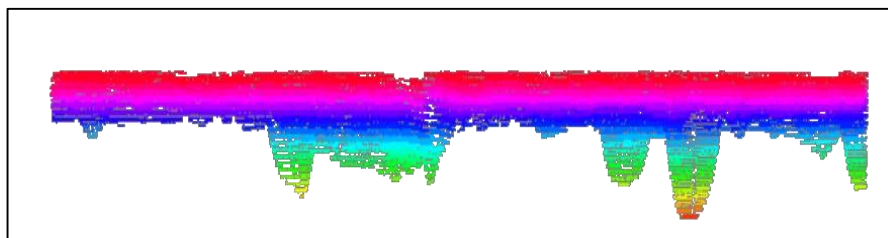
| Element Name | Observation | Location of Distress | Photo No. | Units | Distress Details | | | Area of Repair (Sq.m/ RMT/ m3) |
|---|---|---|---|---|---|---|---|---|
| Abutment 1 | Damage | - | 1 | M | 0.61 | 2.64 | | 1.61 |

**1. Wall damage observed on Abutment 1, measuring 0.61 m in length and 2.64 m in width, covering an area of 1.61 m<sup>2</sup>.**

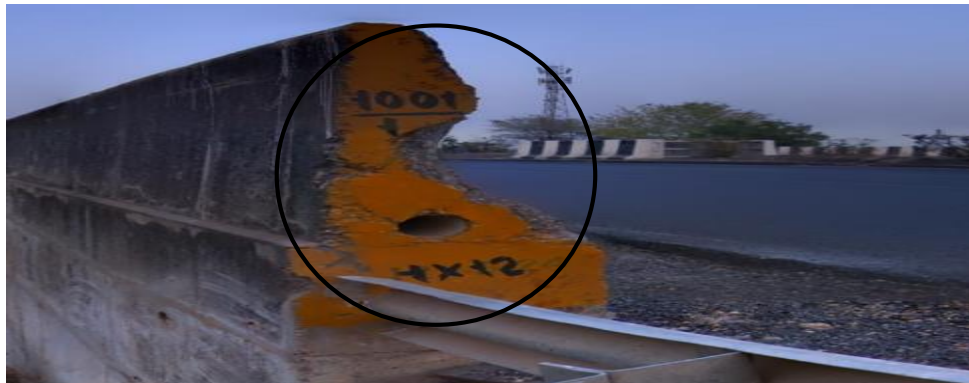
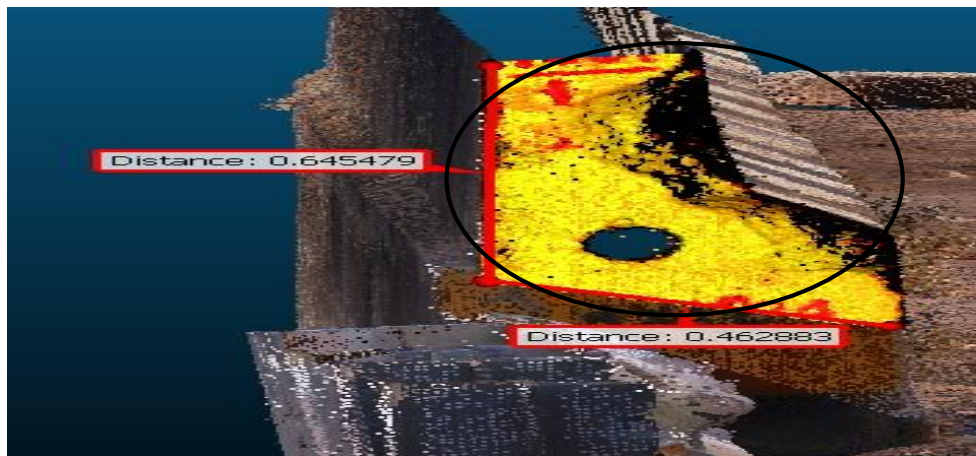
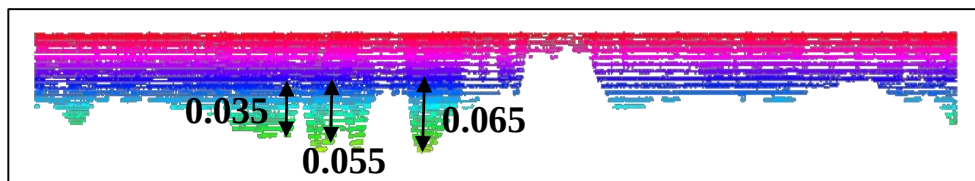
| Element Name | Observation | Location of Distress | Photo No. | Units | Distress Details | | | Area of Repair (Sq.m/ RMT/ m3) |
|---|---|---|---|---|---|---|---|---|
| Abutment 1 Side Barrier | Damage | | 2 | M | 0.46 | 0.64 | 0.055 | 0.016 |

**2. Damage observed on Abutment 1 side barrier, measuring 0.46 m in length and 0.64 m in width, Depth ranges from 0.035(min) to 0.065 m (max), with an average depth of 0.055 m. The calculated volume of the distress is 0.016 m<sup>3</sup>.**

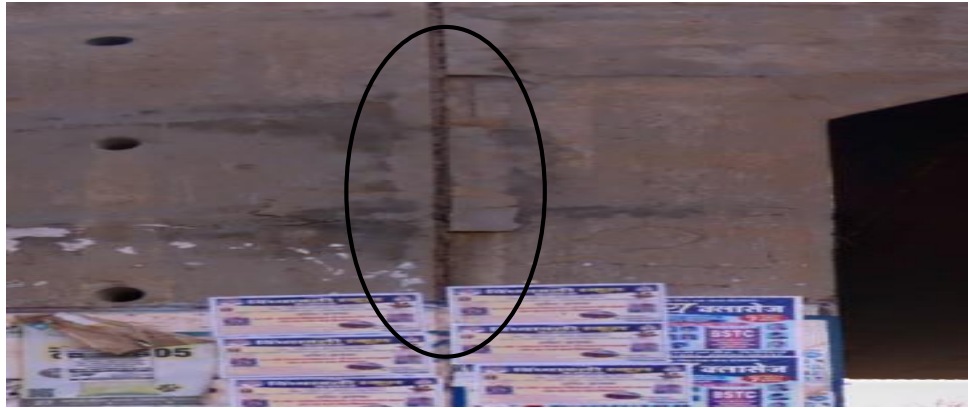
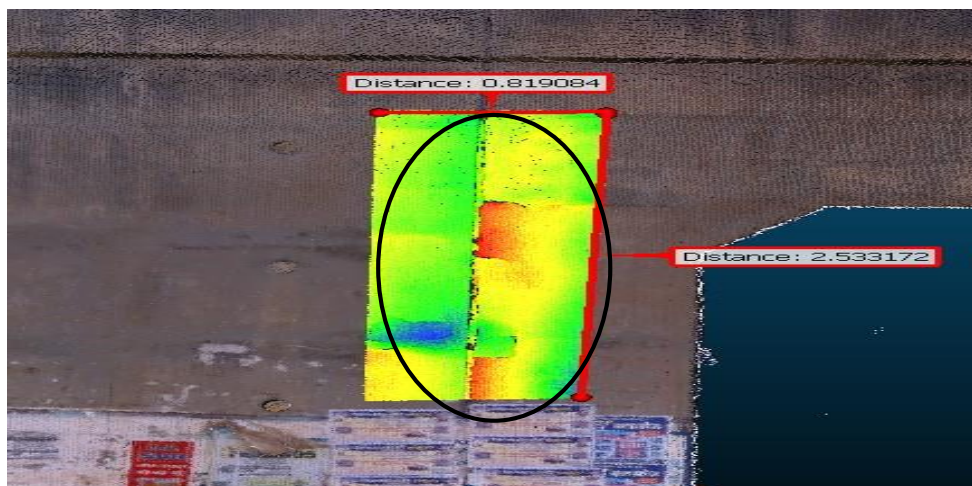
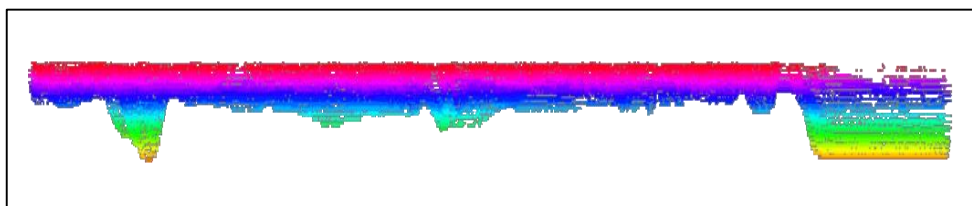
| Element Name | Observation | Location of Distress | Photo No. | Units | Distress Details | | | Area of Repair (Sq.m/ RMT/ m3) |
|---|---|---|---|---|---|---|---|---|
| Abutment 1 | Damage | - | 3 | M | 0.81 | 2.53 | | 2.04 |

**3. Wall damage observed on Abutment 1, measuring 0.81 m in length and 2.53 m in width, covering an area of 2.04 m<sup>2</sup>.**

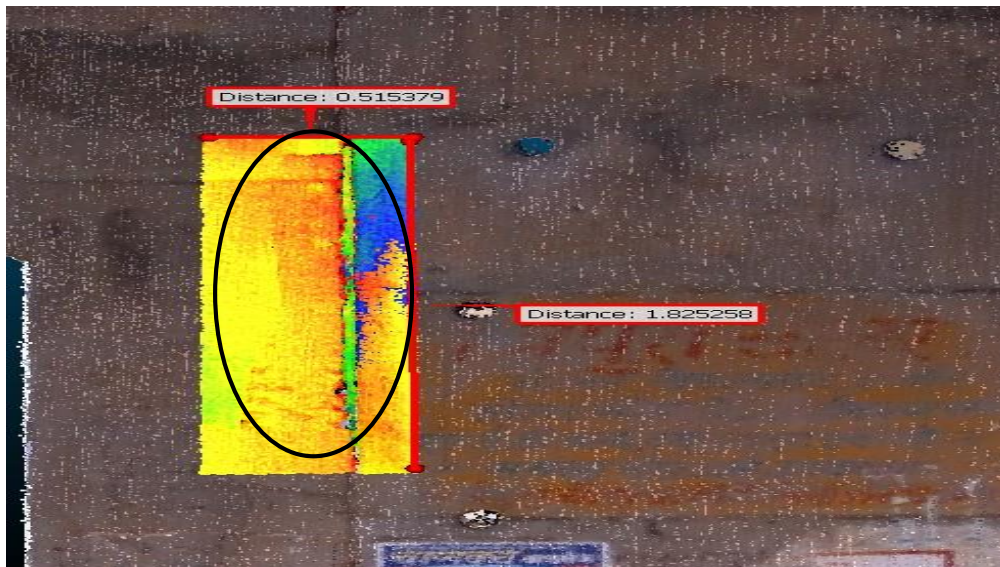
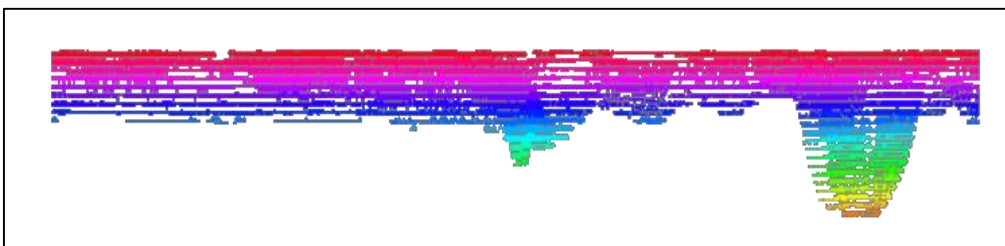
| Element Name | Observation | Location of Distress | Photo No. | Units | Distress Details | | | Area of Repair (Sq.m/ RMT/ m3) |
|---|---|---|---|---|---|---|---|---|
| Abutment 2 | Scaling | | 4 | M | 0.51 | 1.82 | | 0.9282 |

**4. Scaling observed on Abutment 2 wall, measuring 0.51 m in length and 1.82 m in width, covering an area of 0.9282 m<sup>2</sup>.**
