# **LIDAR Inspection Report of Box Culvert ch.1000+970**

**Bridge Chainage:** 1000+970

- **Bridge No:** -
- **Chainage:** 1000+970
- **Structure type:** Box Culvert

- **CKRP:** Chittorgarh to kota
- **State:** Rajasthan NH 27
- **Zone:** RJ-20

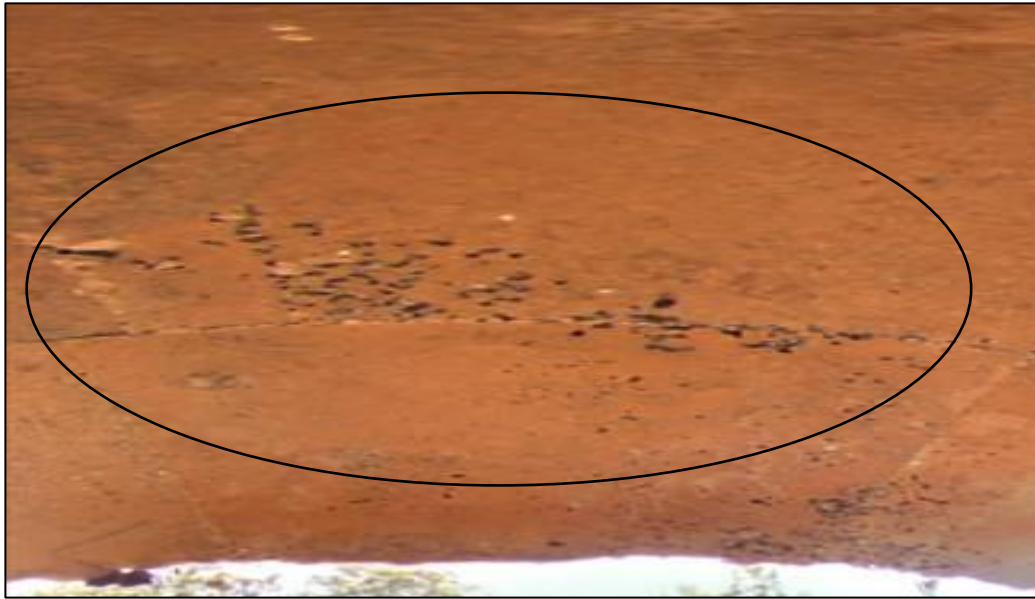
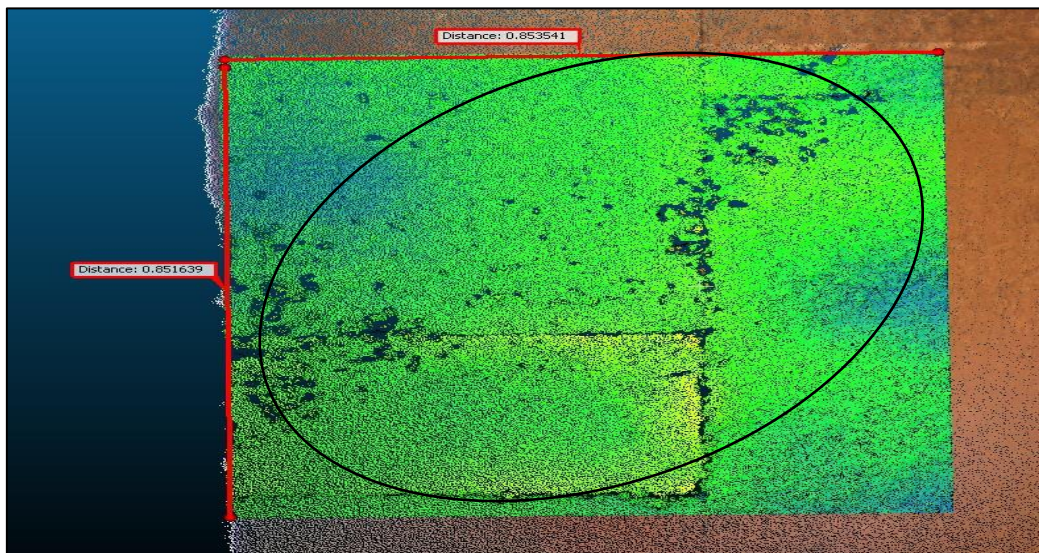
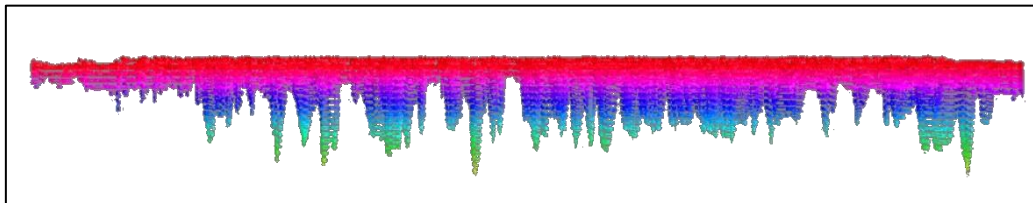
| Element Name | Observation | Location of Distress | Photo No. | Units | Distress Details | | | Area of Repair (Sq.m/R MT/m3) |
|---|---|---|---|---|---|---|---|---|
| Deck slab | Scalling | - | 1 | Sq m | 0.86 | 0.85 | - | 0.73 |

**1. Scaling observed on deck slab LHS side, measuring 0.86 m in length and 0.85 m in width, covering an area of 0.73 m<sup>2</sup>.**
