# **LIDAR Inspection Report of VUP ch.1002+060**

**Bridge Chainage:** 1002+060(CKRP)

- **CKRP:** Chittorgarh to kota
- **State:** Rajasthan NH 27
- **Zone:** RJ-06

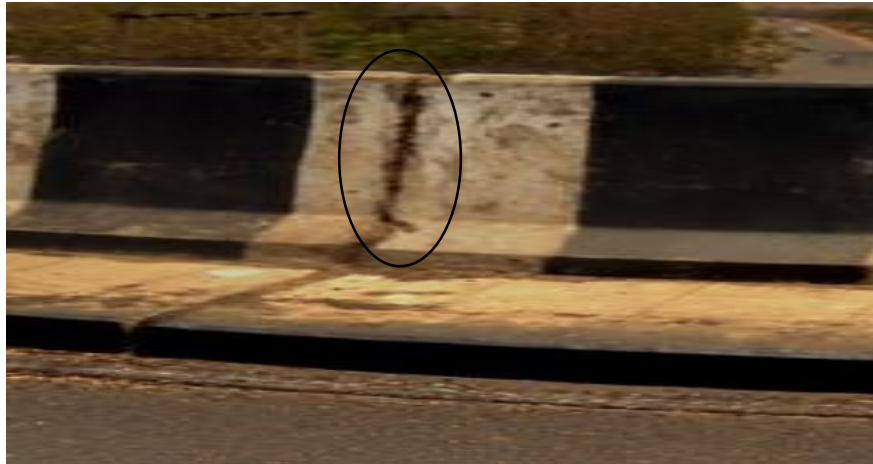
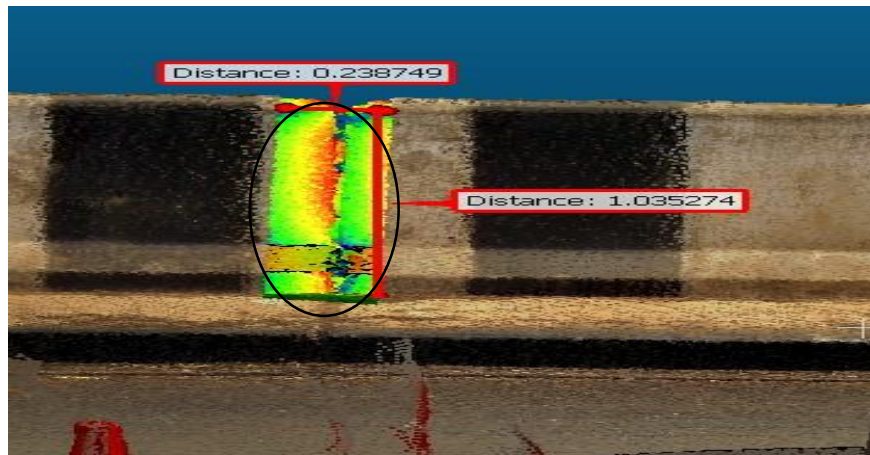
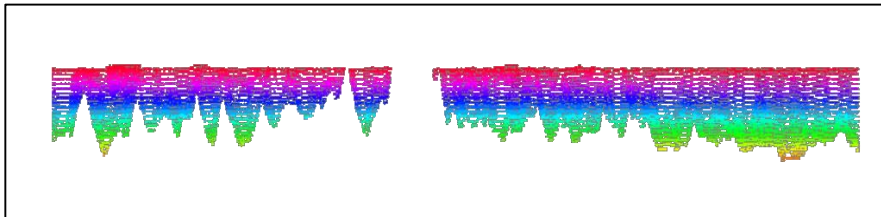
| Element Name | Observation | Location of Distress | Photo No. | Units | Distress Details | | | Area of Repair (Sq.m/ RMT/ m3) |
|---|---|---|---|---|---|---|---|---|
| Abutment 2 | Crack | - | 1 | M | 0.23 | 1.03 | | 0.2369 |

**1. Crack observed on A2 side barrier, measuring 0.23 m in length and 1.03 m in width, covering an area of 0.2369 m<sup>2</sup>**

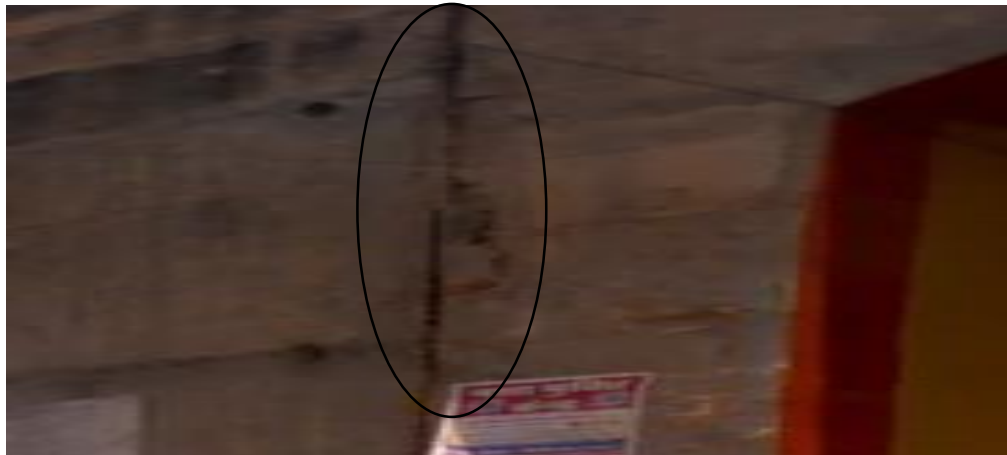
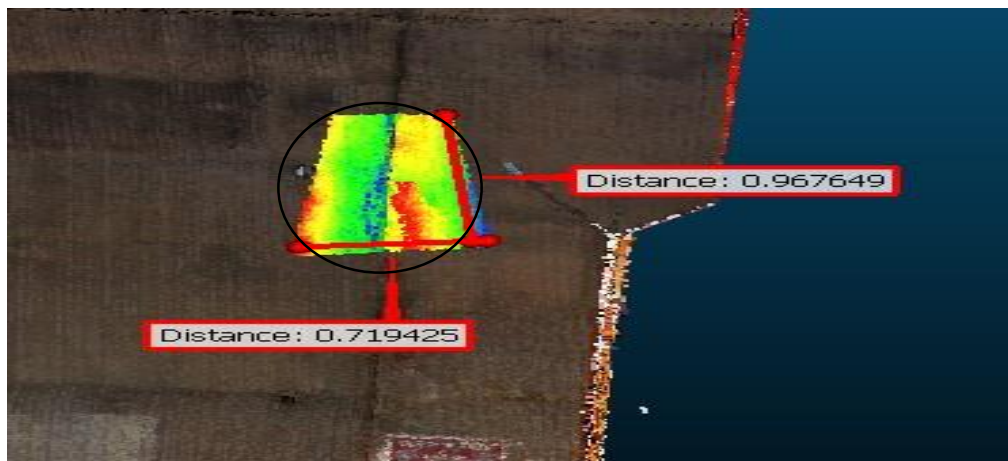
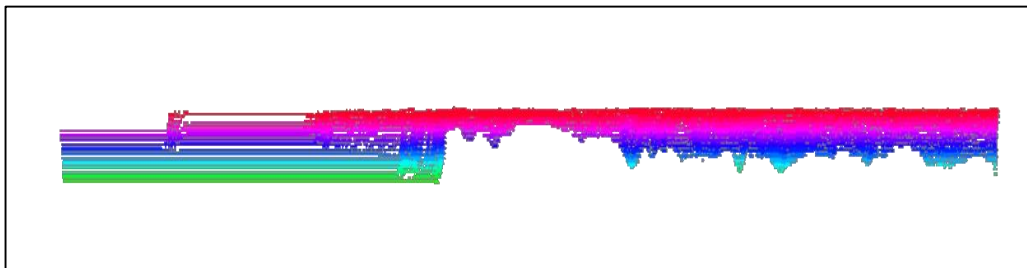
| Element Name | Observation | Location of Distress | Photo No. | Units | Distress Details | | | Area of Repair (Sq.m/ RMT/ m3) |
|---|---|---|---|---|---|---|---|---|
| Abutment | Crack | - | 2 | M | 0.71 | 0.96 | | 0.6816 |

**2. Crack observed on A2 wall, measuring 0.71 m in length and 0.96 m in width, covering an area of 0.6816 m<sup>2</sup>.**
