# **LIDAR Inspection Report of VUP ch.1002+200**

**Bridge Chainage:** 1002+200(CKRP)

- **Bridge No:** -
- **Chainage:** 1002+200
- **Structure type:** VUP

- **CKRP:** Chittorgarh to kota
- **State:** Rajasthan NH 27
- **Zone:** RJ-06

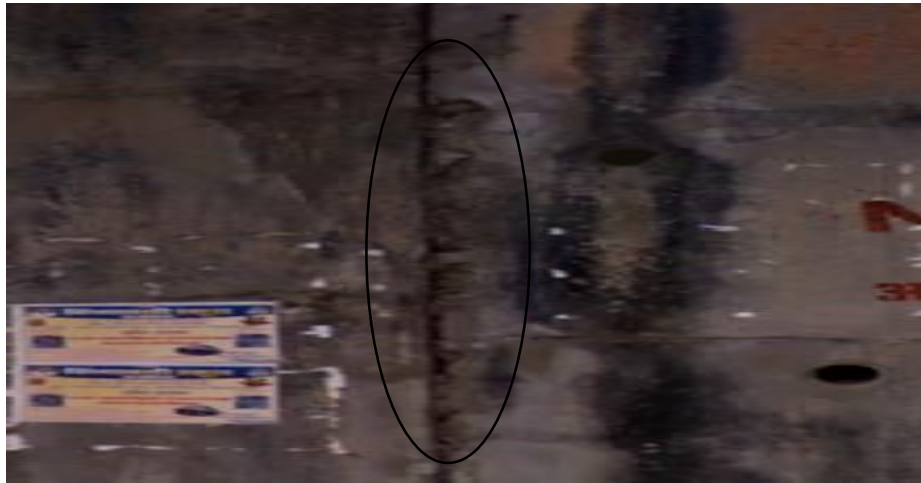
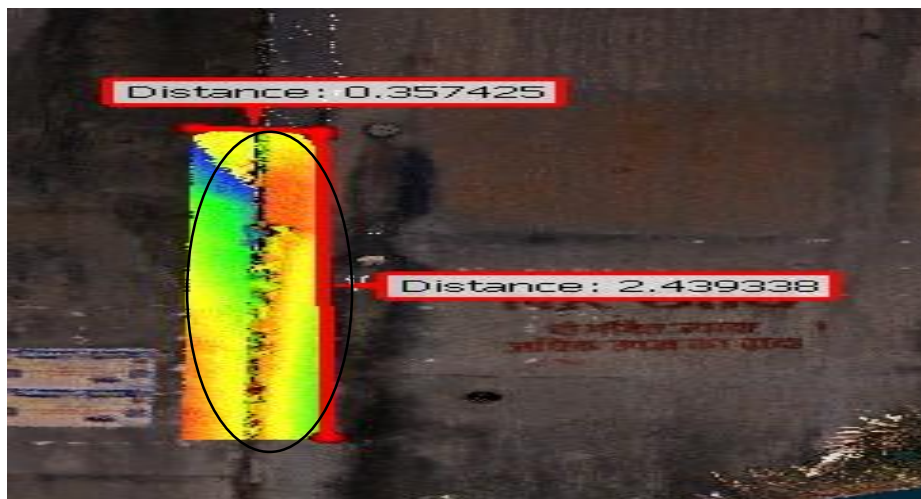
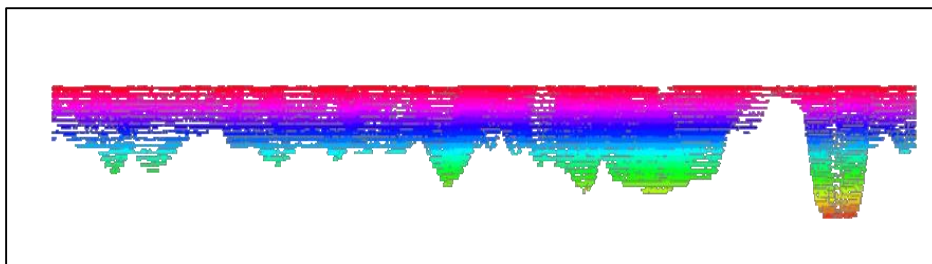
| Element Name | Observation | Location of Distress | Photo No. | Units | Distress Details | | | Area of Repair (Sq.m/ RMT/ m3) |
|---|---|---|---|---|---|---|---|---|
| Abutment 1 | Damage | - | 1 | M | 0.35 | 2.49 | | 0.8715 |

**1. Wall damage observed on LHS A1, measuring 0.35 m in length and 2.49 m in width, covering an area of 0.8715 m<sup>2</sup>.**

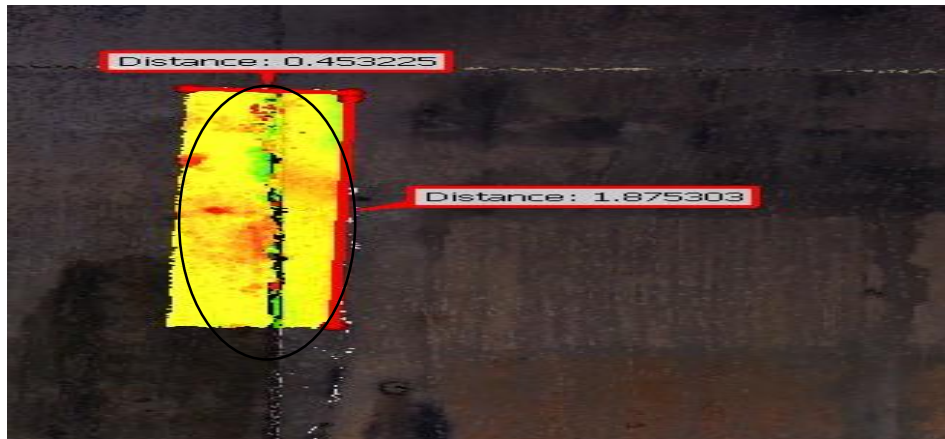
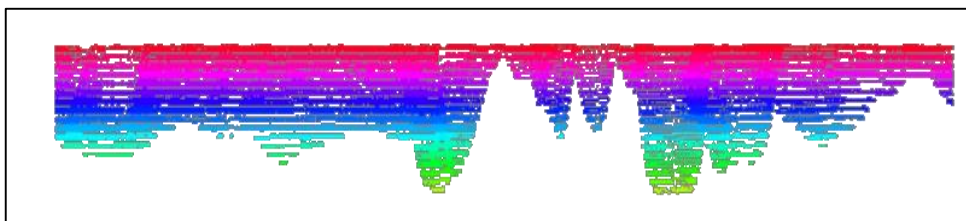
| Element Name | Observation | Location of Distress | Photo No. | Units | Distress Details | | | Area of Repair (Sq.m/ RMT/ m3) |
|---|---|---|---|---|---|---|---|---|
| Abutment 1 | Crack | - | 2 | M | 0.45 | 1.87 | | 0.8415 |

**2. Crack observed on LHS A1 wall, measuring 0.45 m in length and 1.87 m in width, covering an area of 0.8415 m<sup>2</sup>.**

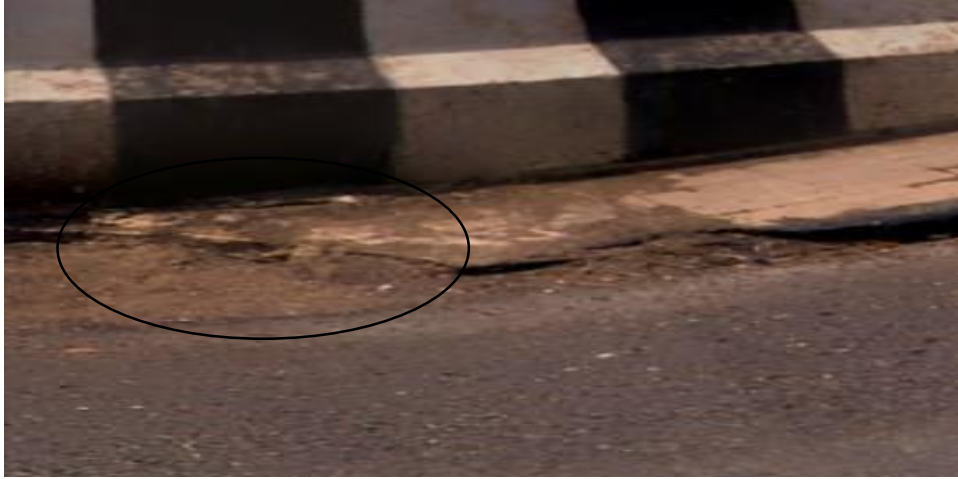
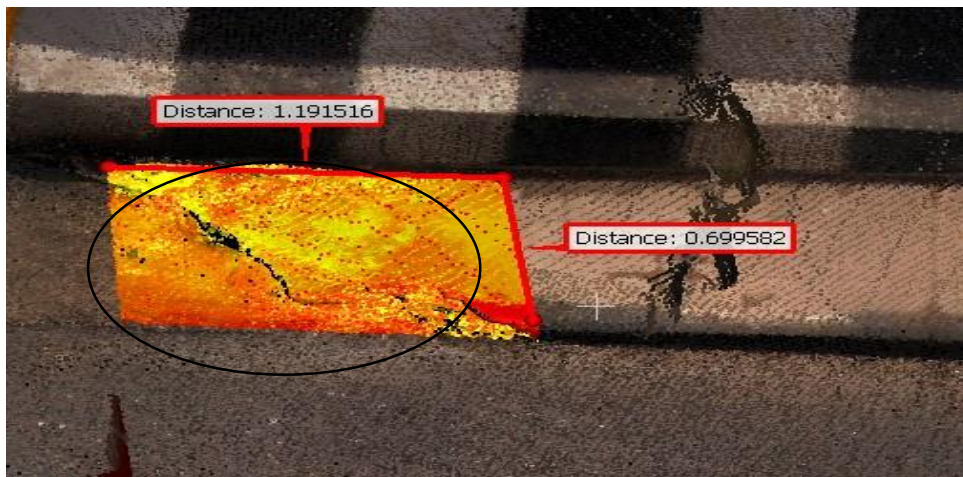
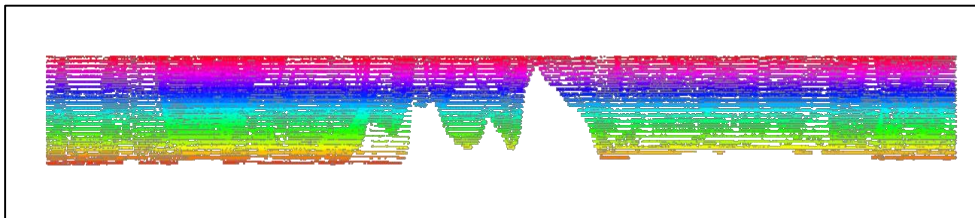
| Element Name | Observation | Location of Distress | Photo No. | Units | Distress Details | | | Area of Repair (Sq.m/ RMT/ m3) |
|---|---|---|---|---|---|---|---|---|
| Footpath | Damage | - | 3 | M | 1.19 | 0.69 | | 0.8211 |

**3. Damage observed on RHS A2 footpath, measuring 1.19 m in length and 0.69 m in width, covering an area of 0.8211 m<sup>2</sup>.**
