# **LIDAR Inspection Report of MNB ch.1002+580**

**Bridge No:** 1003/2

**Bridge Chainage:** 1002+580

- **CKRP:** Chittorgarh to kota
- **State:** Rajasthan NH 27
- **Zone:** RJ-20

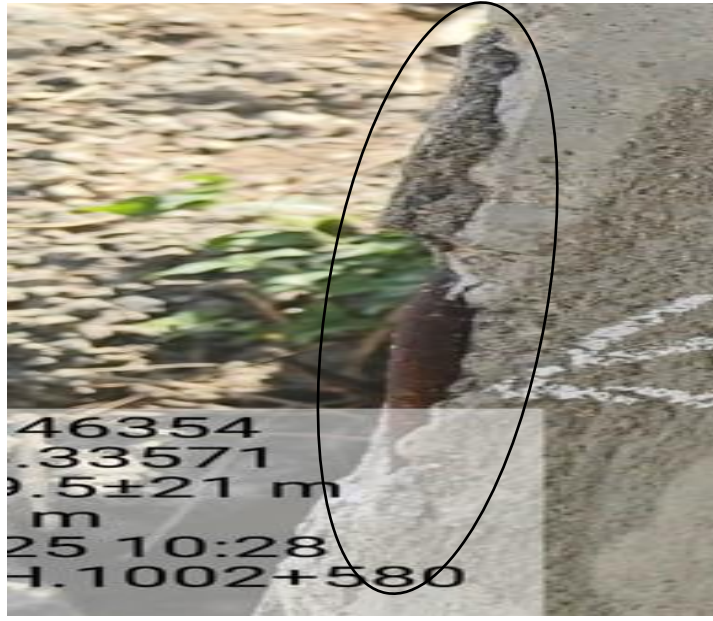
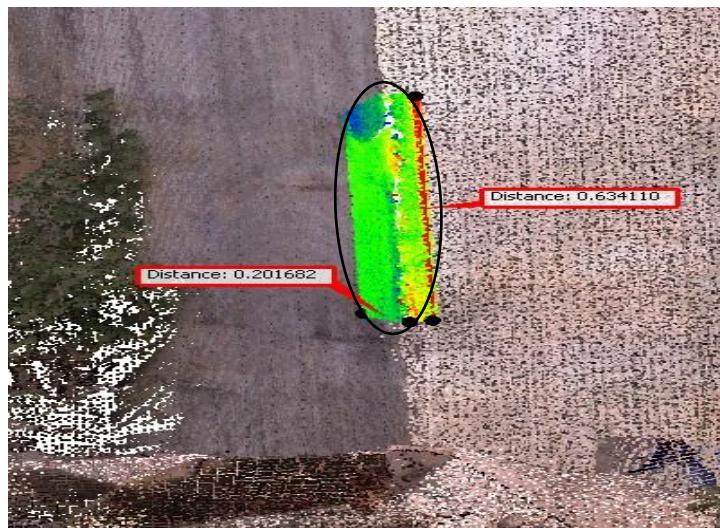
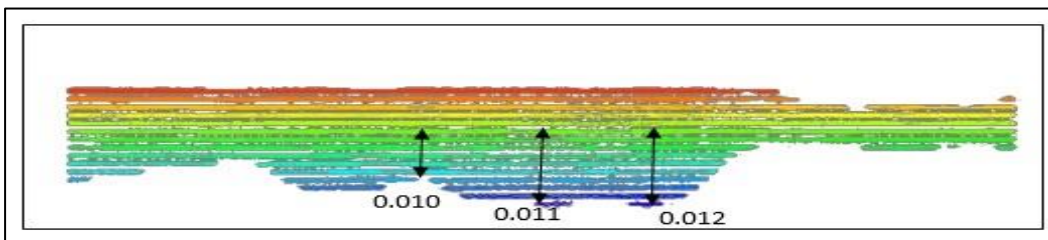
| Element Name | Observation | Location of Distress | Photo No. | Units | Distress Details | | | Area of Repair (Sq./RM T) |
|---|---|---|---|---|---|---|---|---|
| Abutment 2 | Scalling | - | 1 | Cu m | 0.634 | 0.201 | 0.011 | 0.0014 |

1. Steel Exposed (SE) observed on A2 (LHS), measuring 0.634 m in length and 0.201 m in width, covering an area of 0.0014 m<sup>2</sup>, with an average depth of 0.011 m.

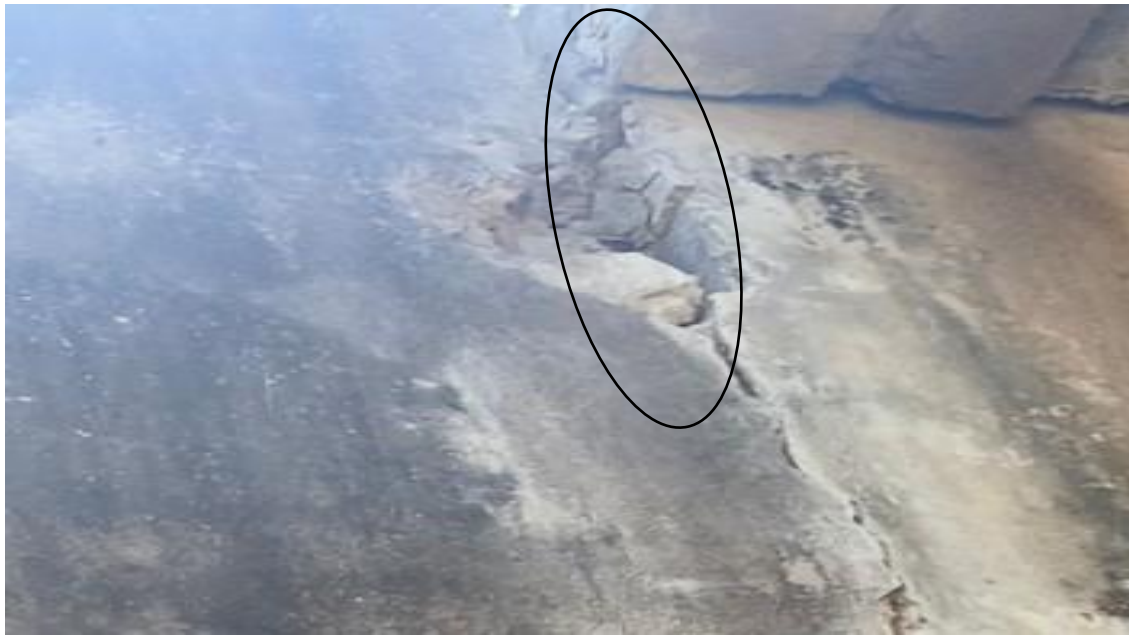
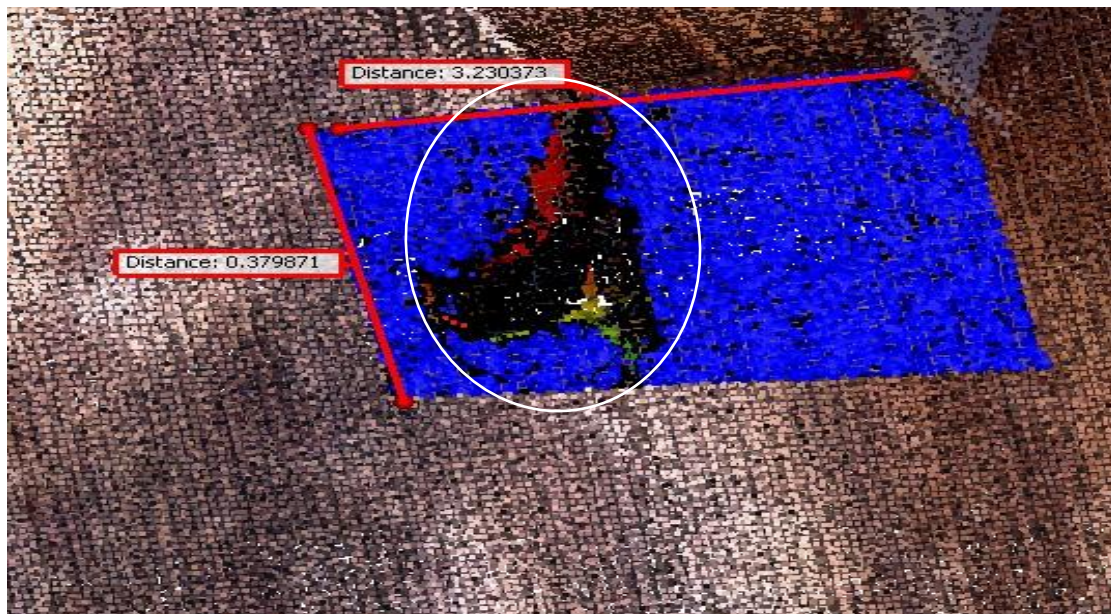
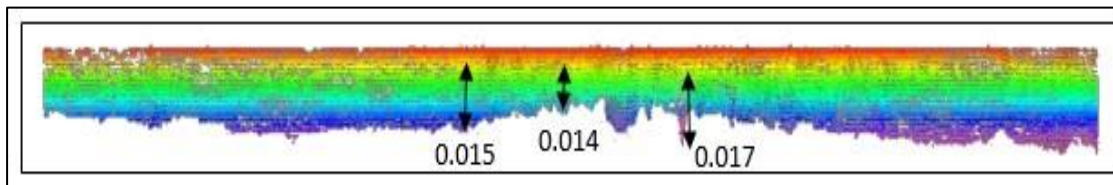
| Element Name | Observation | Location of Distress | Photo No. | Units | Distress Details | | | Area of Repair (Sq./RM T) |
|---|---|---|---|---|---|---|---|---|
| Median | Damaged | - | 2 | Cu m | 3.230 | 0.379 | 0.015 | 0.0183 |

2. Median Damage observed on A1–A2 span, measuring 3.230 m in length and 0.379 m in width, covering an area of 0.0183 m<sup>2</sup>.

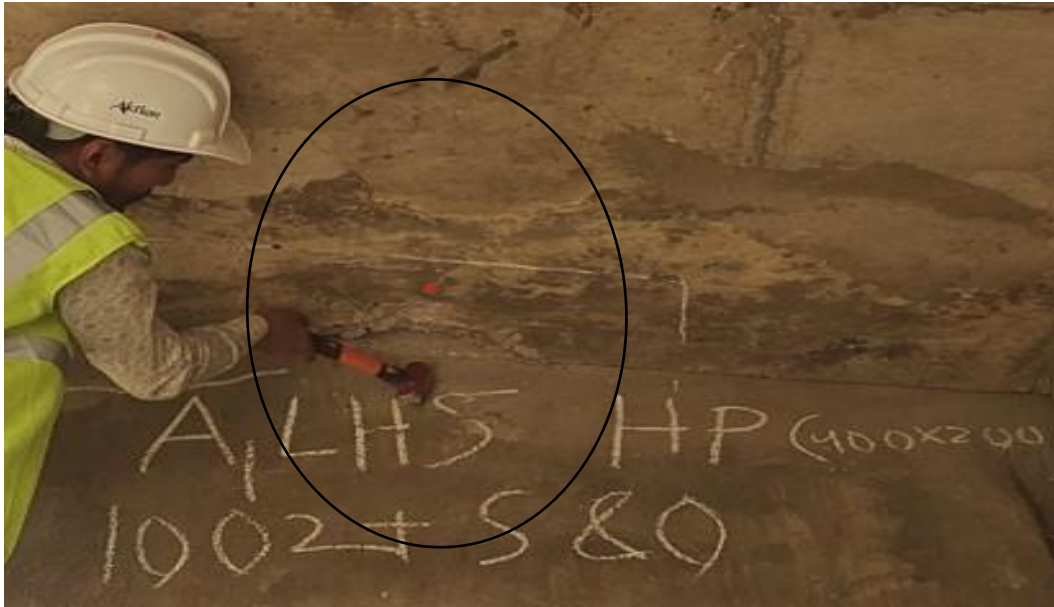
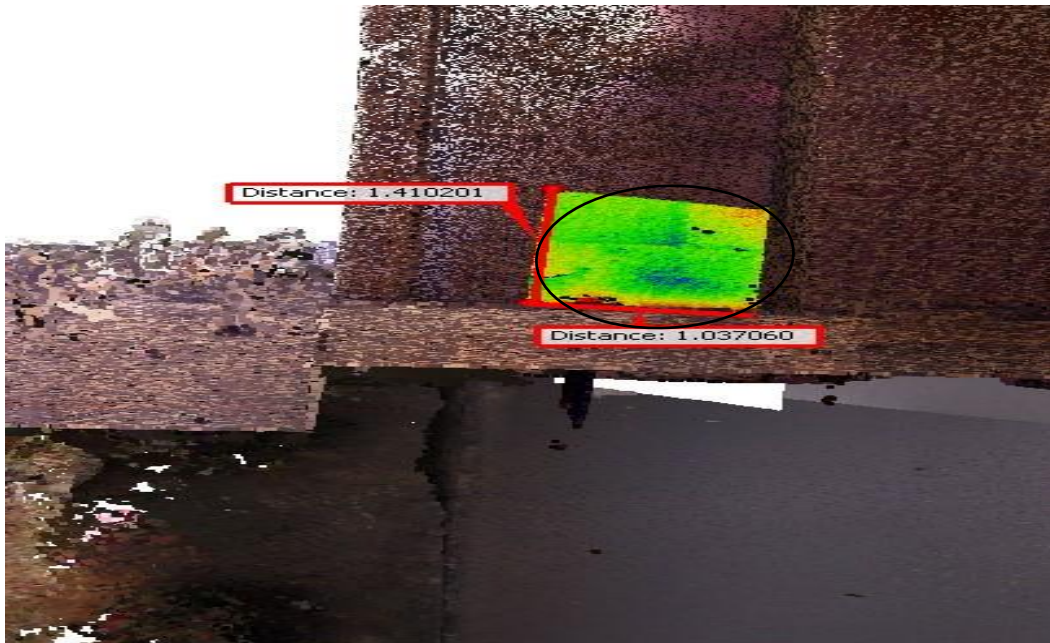
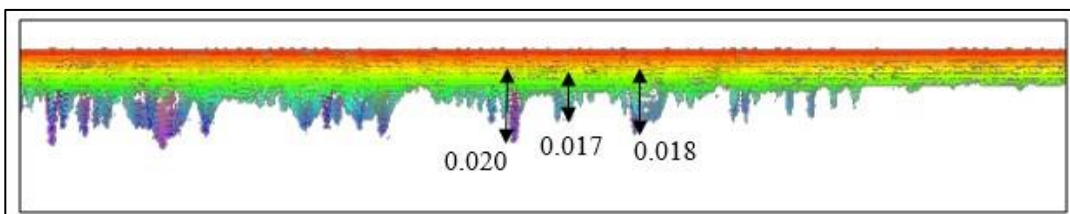
| Element Name | Observation | Location of Distress | Photo No. | Units | Distress Details | | | Area of Repair (Sq./RM T) |
|---|---|---|---|---|---|---|---|---|
| Abutment 1 | Hollow pocket Damage | - | 3 | Cu m | 1.410 | 1.037 | 0.018 | 0.0263 |

3. Hollow Pocket (HP)-Damage observed on A1 (LHS), measuring 1.410 m in length and 1.037 m in width, covering an area of 0.0263 m<sup>2</sup>, with an average depth of 0.018 m.

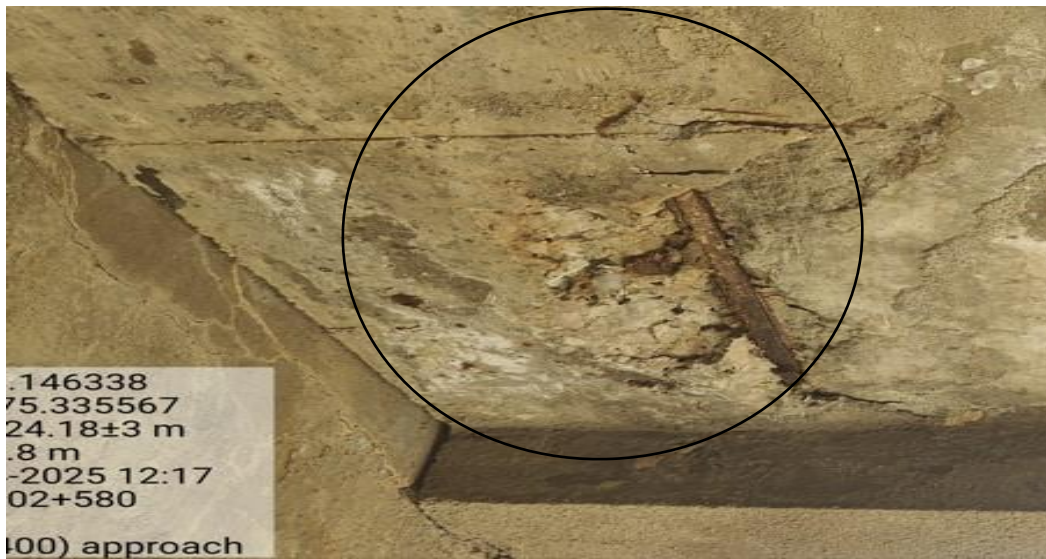
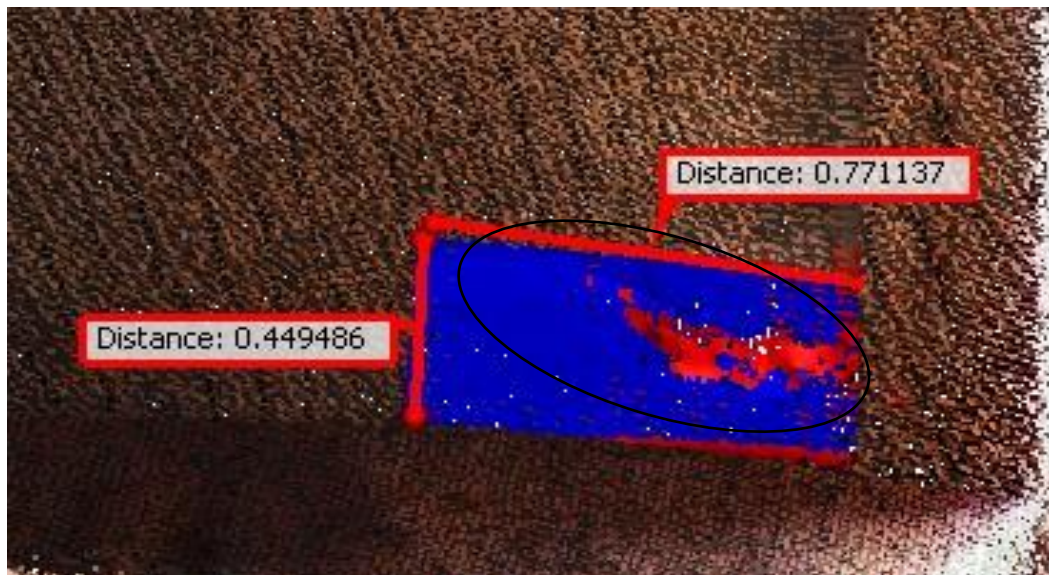
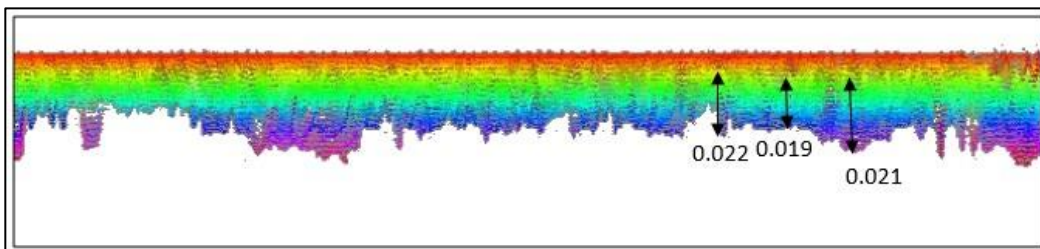
| Element Name | Observation | Location of Distress | Photo No. | Units | Distress Details | | | Area of Repair (Sq./RM T) |
|---|---|---|---|---|---|---|---|---|
| Slab bottom | Steel Exposed | - | 4 | Cu m | 0.771 | 0.449 | 0.021 | 0.0072 |

4. Steel Exposed (SE) observed on A2 (LHS) slab bottom, measuring 0.771 m in length and 0.449 m in width, covering an area of 0.0072 m<sup>2</sup>, with an average depth of 0.021 m.

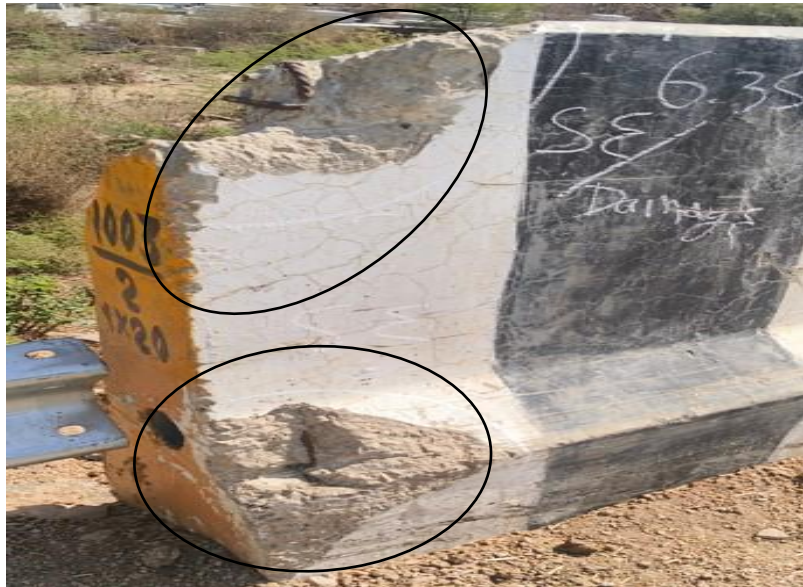
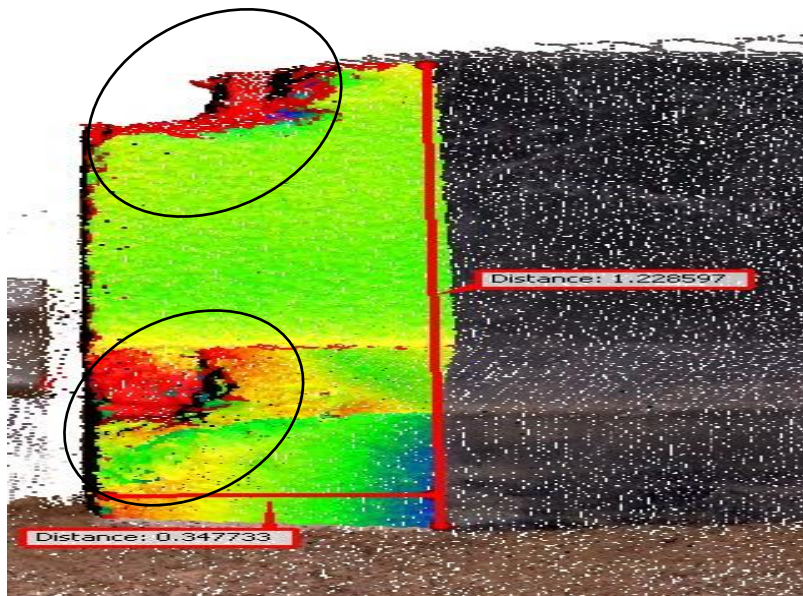
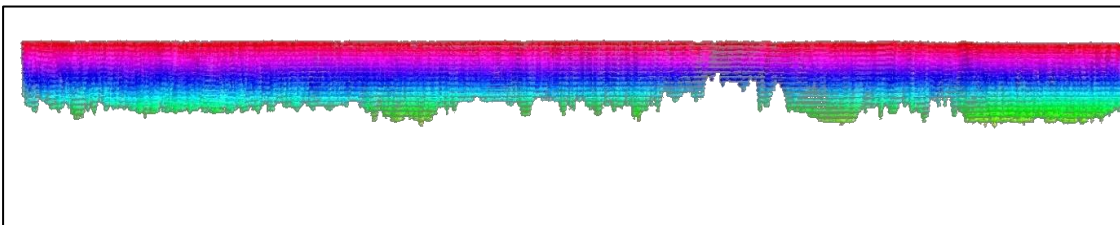
| Element Name | Observation | Location of Distress | Photo No. | Units | Distress Details | | | Area of Repair (Sq./RM T) |
|---|---|---|---|---|---|---|---|---|
| Crash Barrier | damage & Steel Exposed | - | 5 | Sq m | 1.228 | 0.347 | - | 0.4261 |

5. Steel Exposed (SE) observed on A1 (RHS) crash barrier damage, measuring 1.228 m in length and 0.347 m in width, covering an area of 0.4261 m<sup>2</sup>.

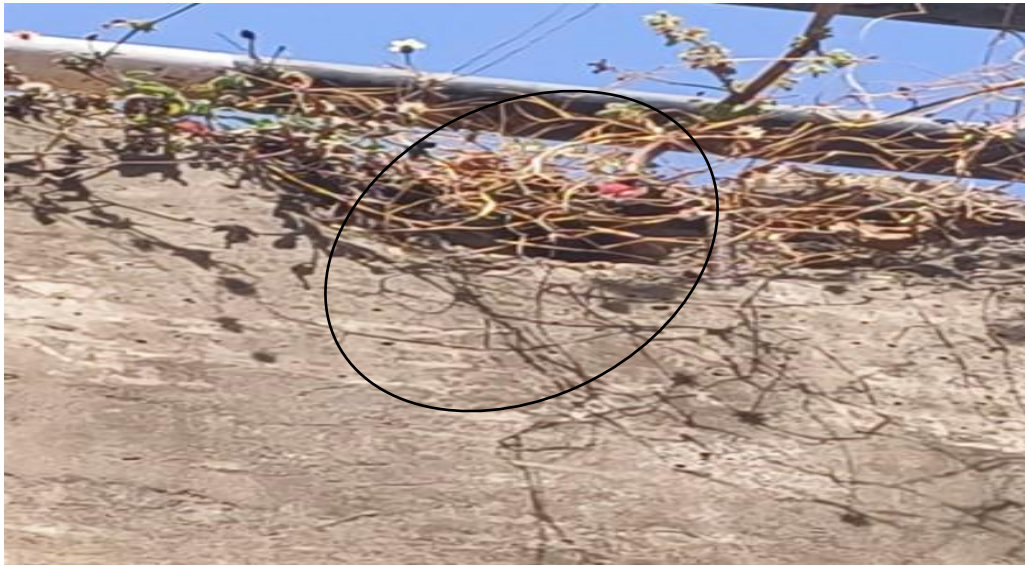
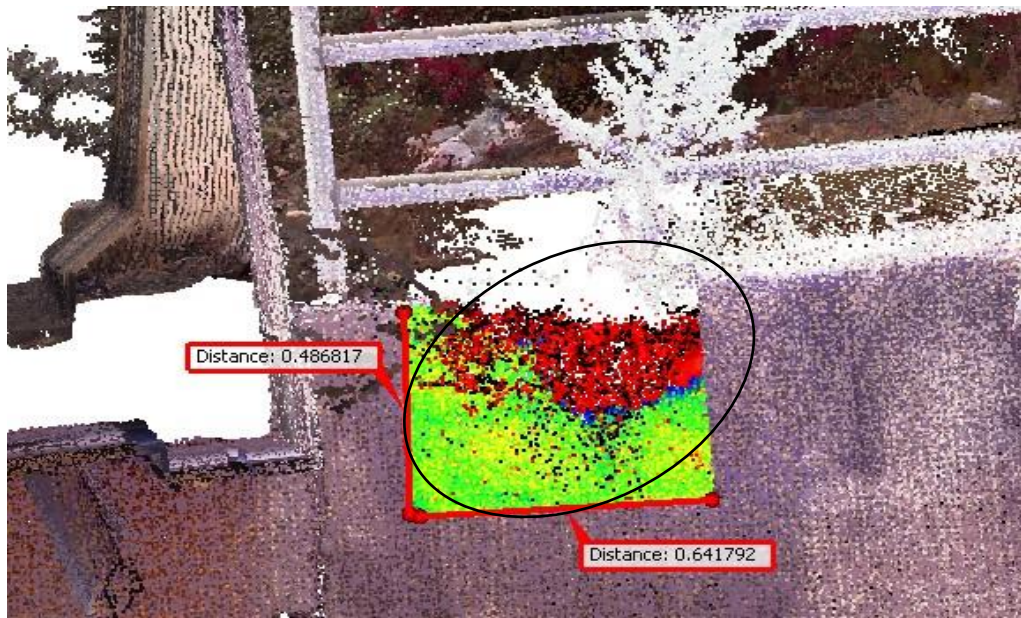
| Element Name | Observation | Location of Distress | Photo No. | Units | Distress Details | | | Area of Repair (Sq./RM T) |
|---|---|---|---|---|---|---|---|---|
| Abutment 1 | Steel Exposed | - | 6 | Sq m | 0.641 | 0.486 | - | 0.3115 |

6. Steel Exposed (SE) observed on A1 (RHS) median, measuring 0.641 m in length and 0.486 m in width, covering an area of 0.3115 m<sup>2</sup>.
