# **LIDAR Inspection Report of Slab Culvert ch.1004+242**

**Bridge Chainage:** 1004+ 242 (CKRP)

# **CH: 1004+242 – SLAB CULVERT**

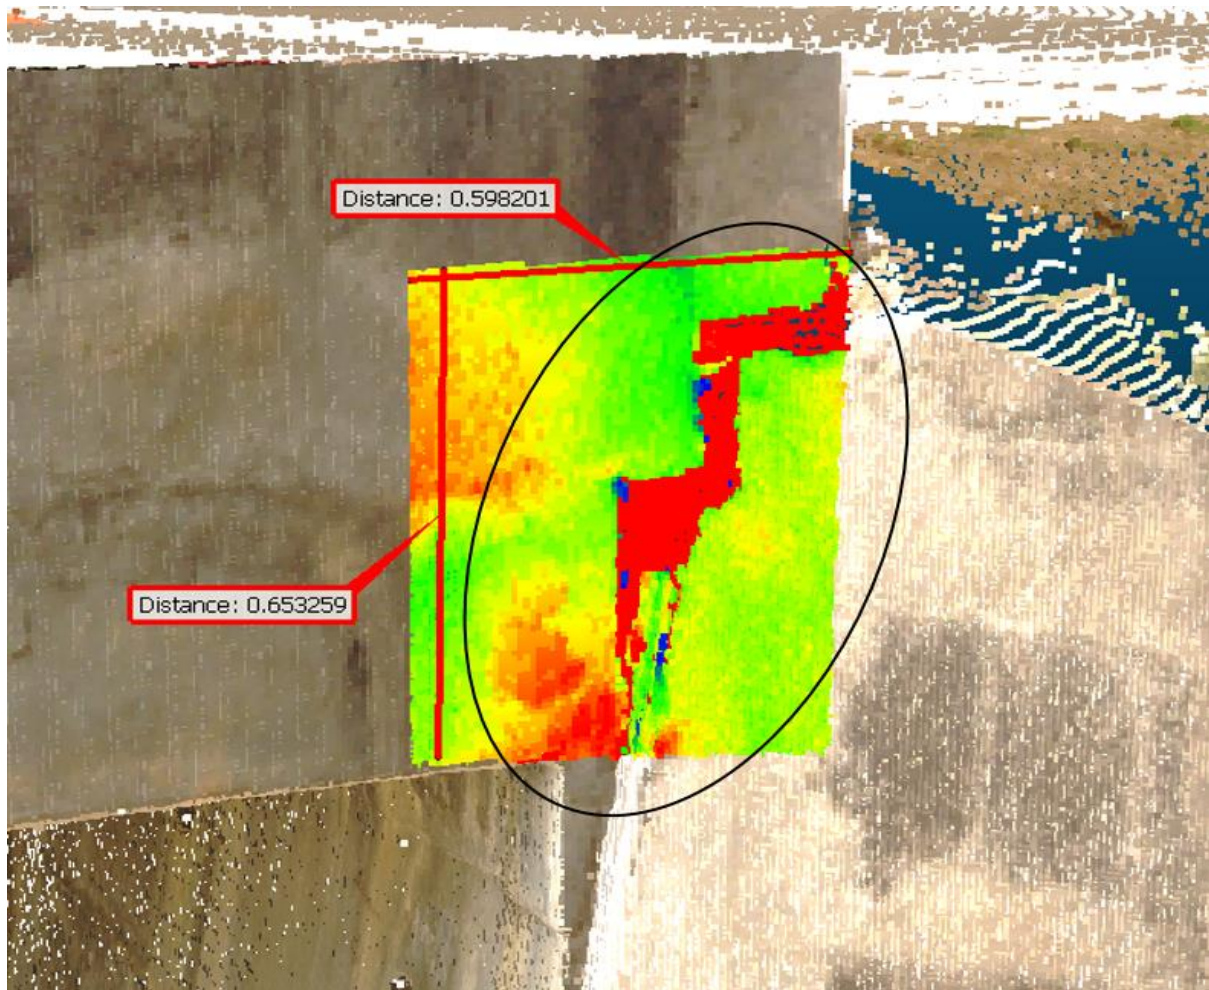
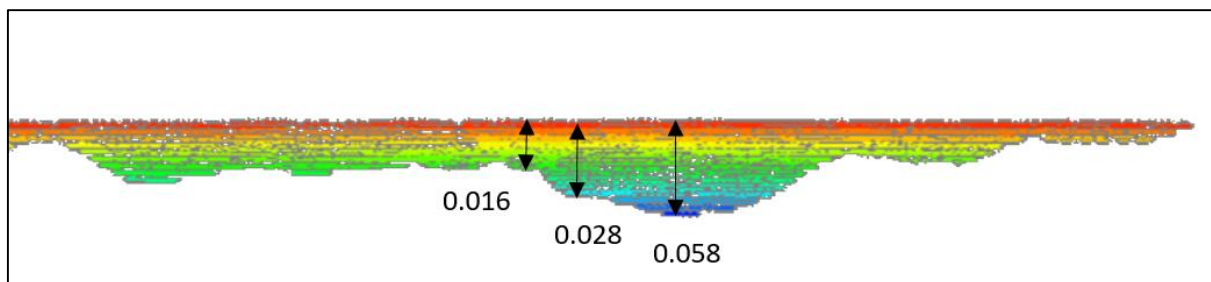
1. Parapet wall damage observed on LHS, measuring 0.6532 m in length and 0.5982 m in width, Depth ranges from 0.016 m (min) to 0.058 m (max), with an average depth of 0.028 m. The calculated volume of the distress is 0.0109 m<sup>3</sup>.

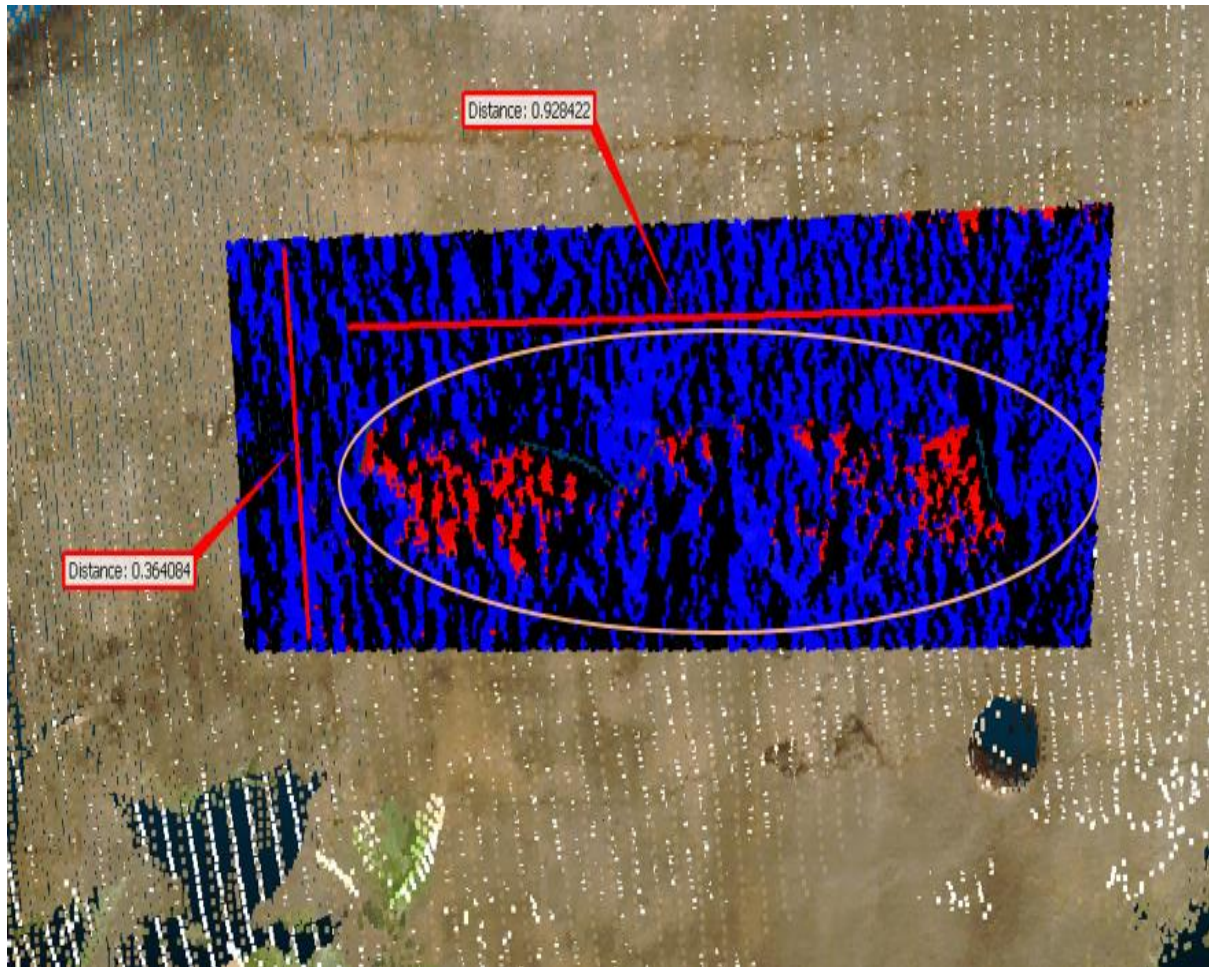
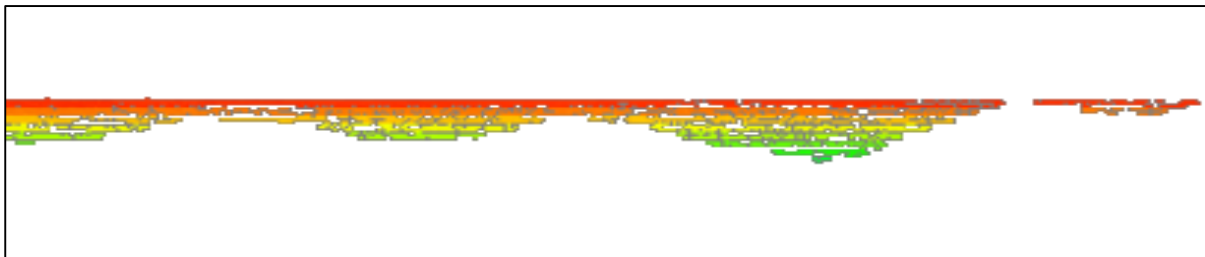
2. Return wall scaling observed on RHS, measuring 0.9284 m in length and 0.3640 m in width, covering an area of 0.34 m<sup>2</sup>.

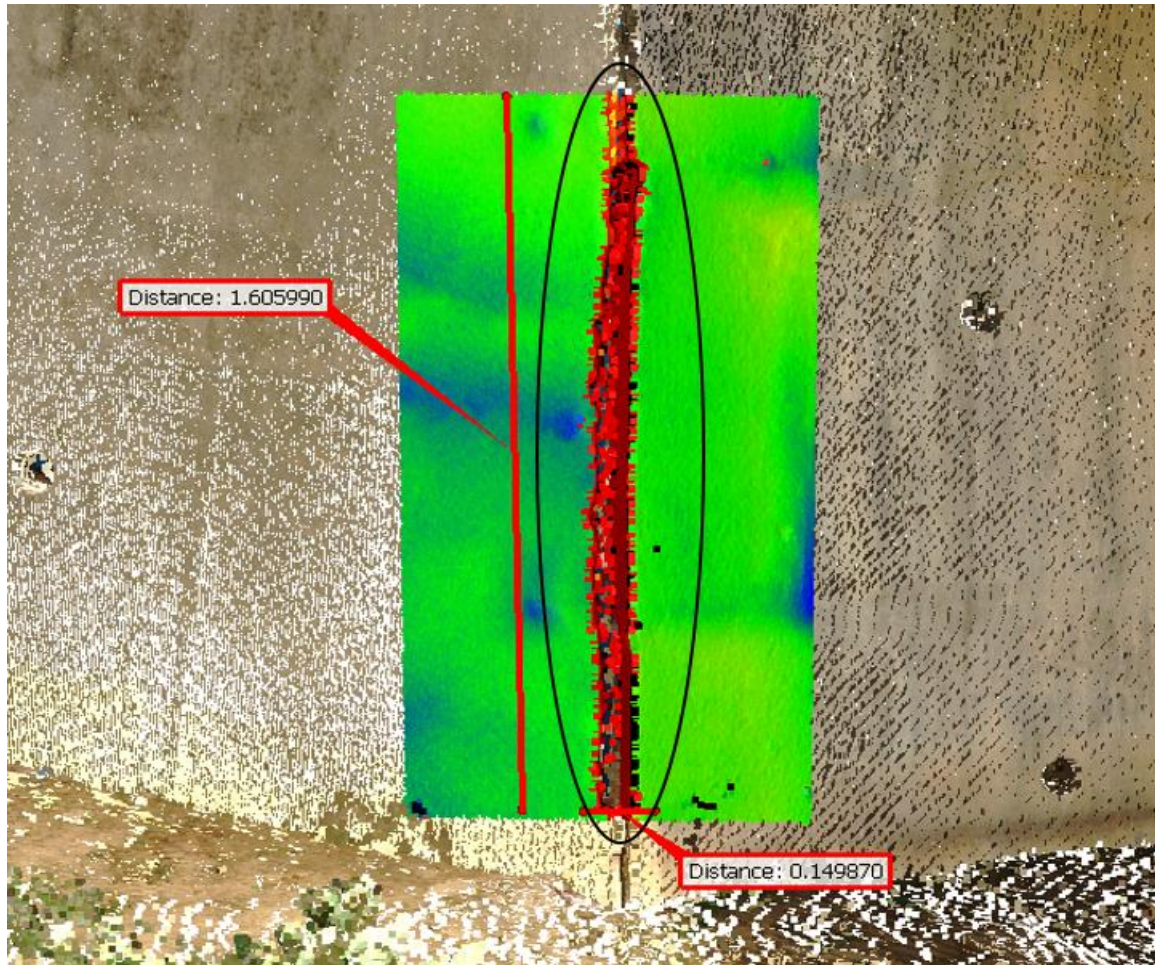
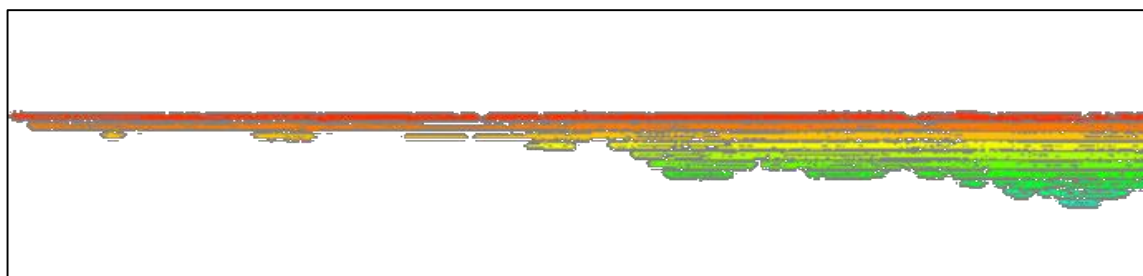
- 3. Return wall damage observed on RHS, measuring 1.6059 m in length and 0.1498 m in width, covering an area of 0.24 m<sup>2</sup>.**
