# **LIDAR Inspection Report of Box Culvert ch.1004+617**

**Bridge Chainage:** 1004+617

- **Bridge No:** -
- **Chainage:** 1004+617
- **Structure type:** Box Culvert

- **CKRP:** Chittorgarh to kota
- **State:** Rajasthan NH 27
- **Zone:** RJ-20

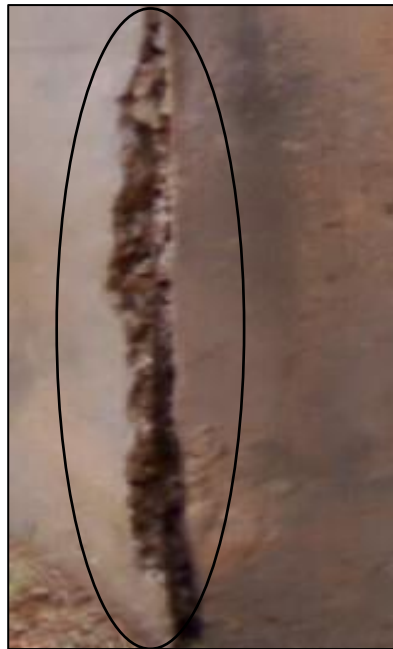
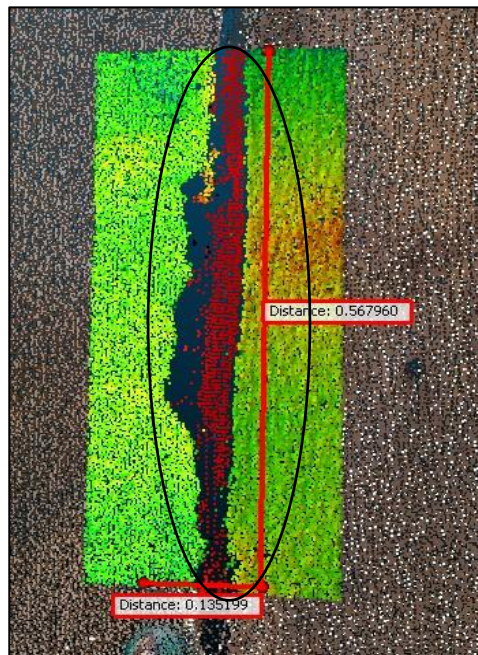
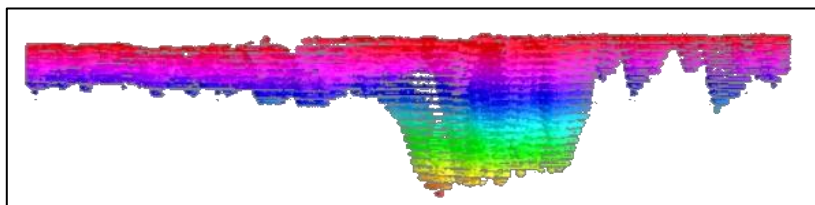
| Element Name | Observation | Location of Distress | Photo No. | Units | Distress Details | | | Area of Repair (Sq.m/R MT/m3) |
|---|---|---|---|---|---|---|---|---|
| Wing Wall | Damage | - | 1 | Sq m | 0.5679 | 0.1351 | - | 0.0767 |

| Sl. No. | Description | Distress Notation | Observation | Location | | Distress Details | | | Area of Repair |
|---|---|---|---|---|---|---|---|---|---|
| 3 | Wing wall | | Damage | | | | | | |

1. Damage observed on the abutment 2 wing wall, corner LHS, measuring 0.5679 m in length and 0.1351 m in width, covering an area of 0.0767 m<sup>2</sup>.
