# **LIDAR Inspection Report of MNB ch.1006+100**

**Bridge No:** MNB -

**Bridge Chainage:** 1006+100 (CKRP)

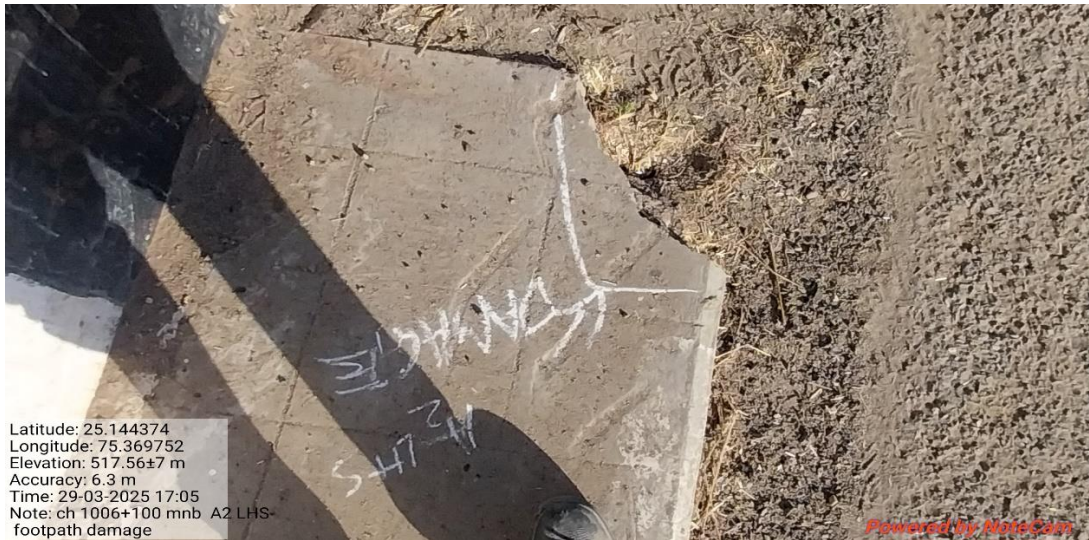
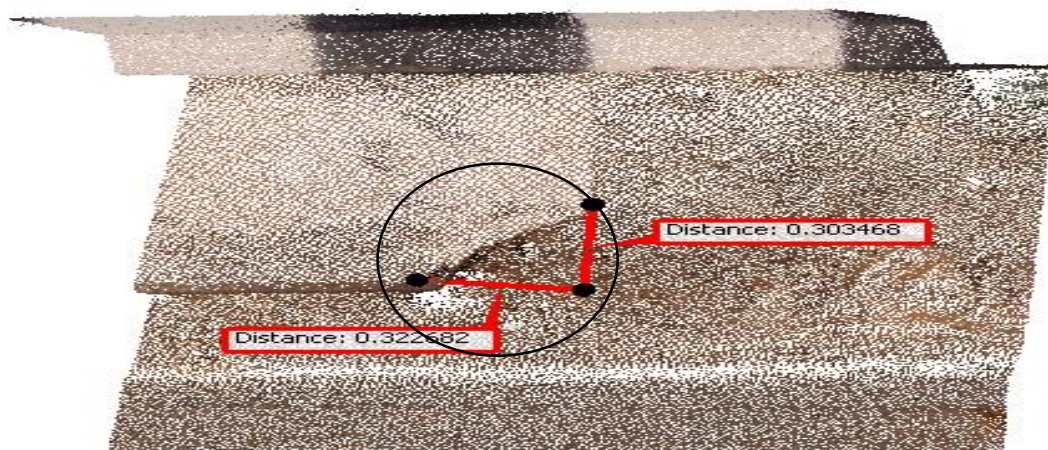
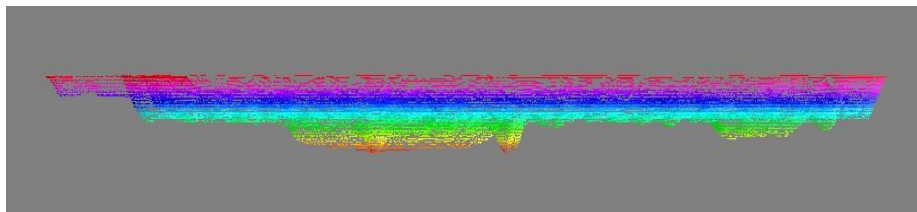
| Element Name | Observation | Location of Distress | Photo No. | Units | Distress Details | | | Area of Repair (Sq.m/R MT) |
|---|---|---|---|---|---|---|---|---|
| Footpath | Damage | | 1 | M | 0.32 | 0.30 | | 0.067 |

**1. A2 LHS Footpath damage, measuring 0.32 m in length and 0.30 m in width, covering an area of 0.067 m<sup>2</sup>.**

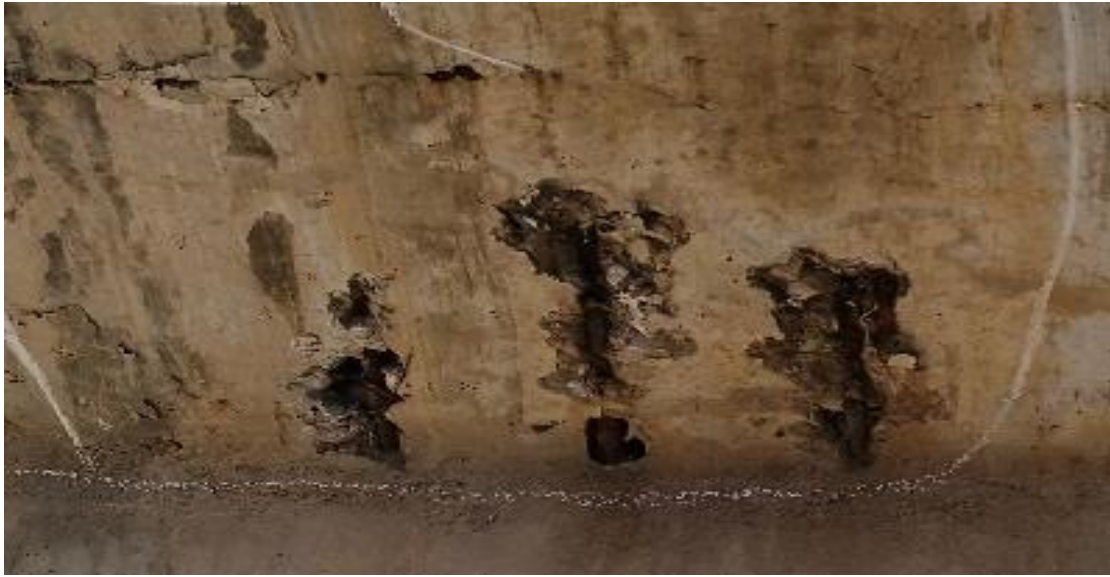
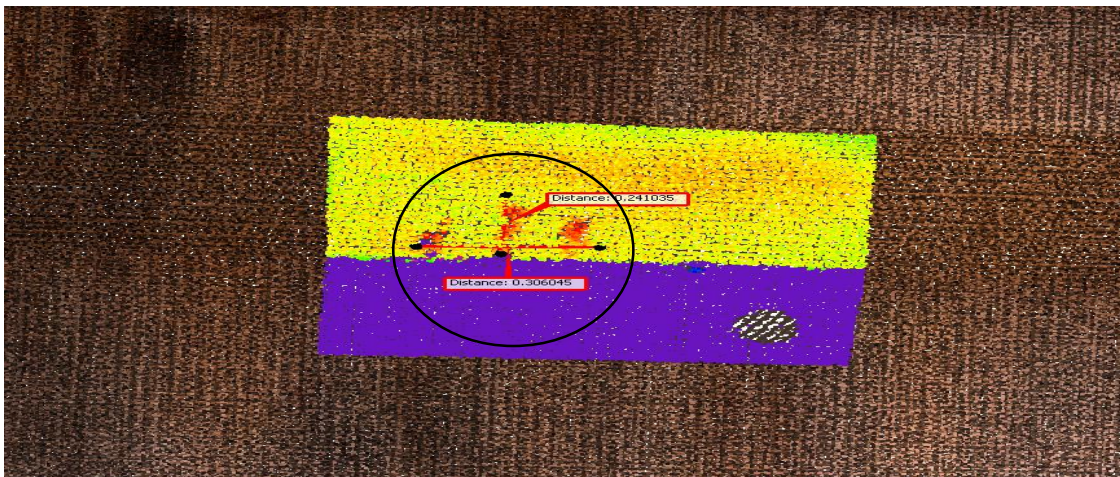
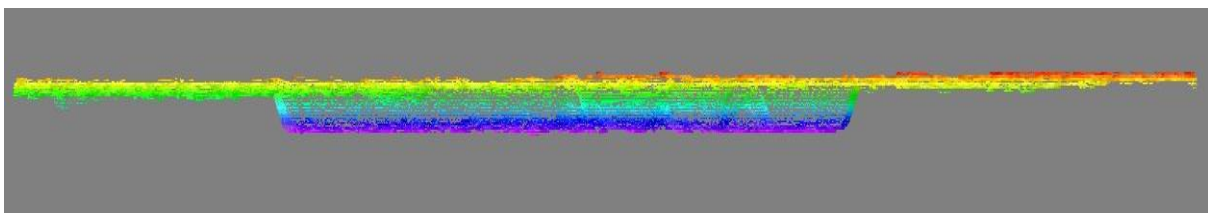
| Element Name | Observation | Location of Distress | Photo No. | Units | Distress Details | | | Area of Repair (Sq.m/R MT) |
|---|---|---|---|---|---|---|---|---|
| Abutment 2 | Steel Exposed | | 2 | M | 0.30 | 0.24 | | 0.072 |

**2. A2 LHS steel exposed on abutment wall, measuring 0.30 m in length and 0.24 m in width, covering an area of 0.072 m<sup>2</sup>.**

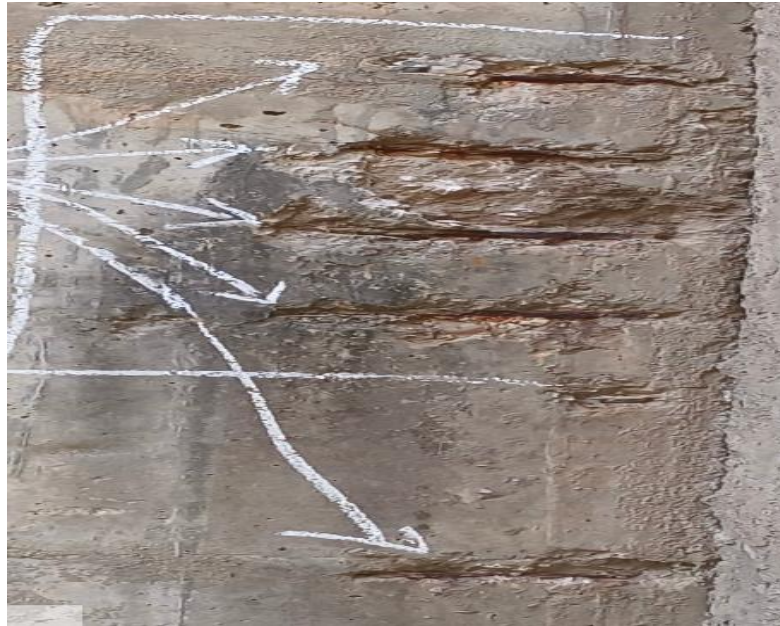
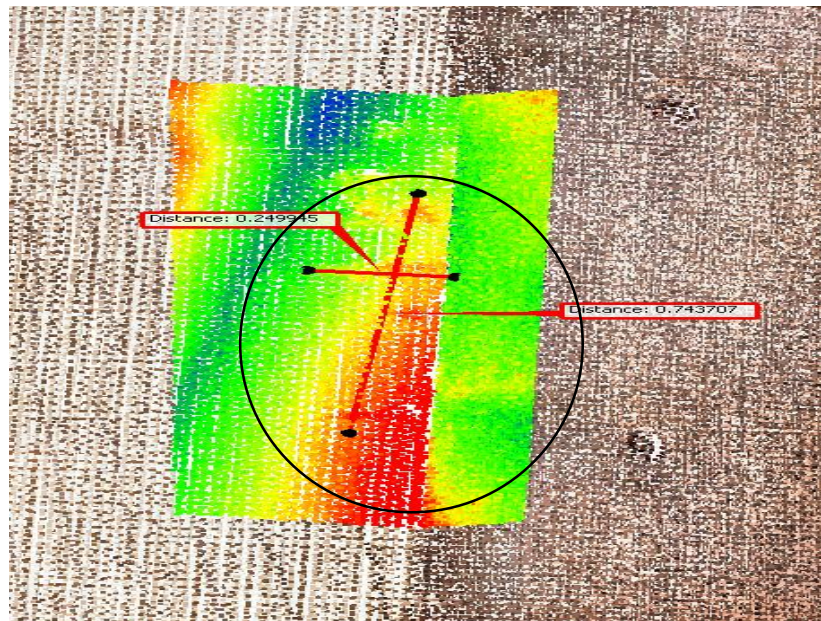
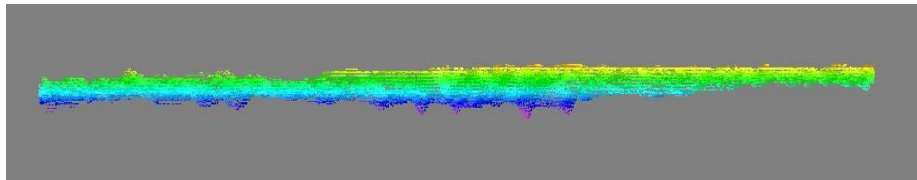
| Element Name | Observation | Location of Distress | Photo No. | Units | Distress Details | | | Area of Repair (Sq.m/R MT) |
|---|---|---|---|---|---|---|---|---|
| Abutment 2 | Steel Exposed | | 3 | M | 0.74 | 0.25 | | 0.185 |

**3. Steel exposed on abutment wall, measuring 0.74 m in length and 0.25 m in width, covering an area of 0.185 m<sup>2</sup>.**

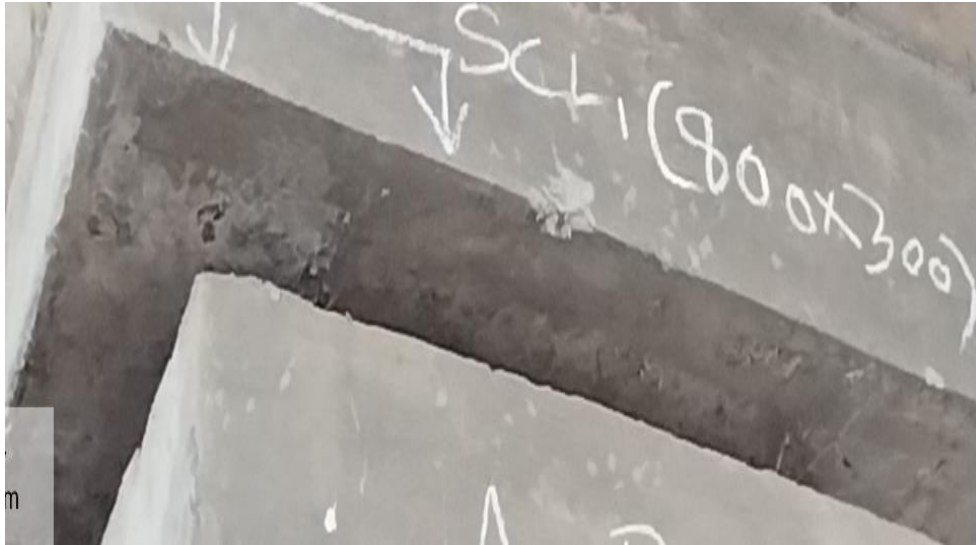
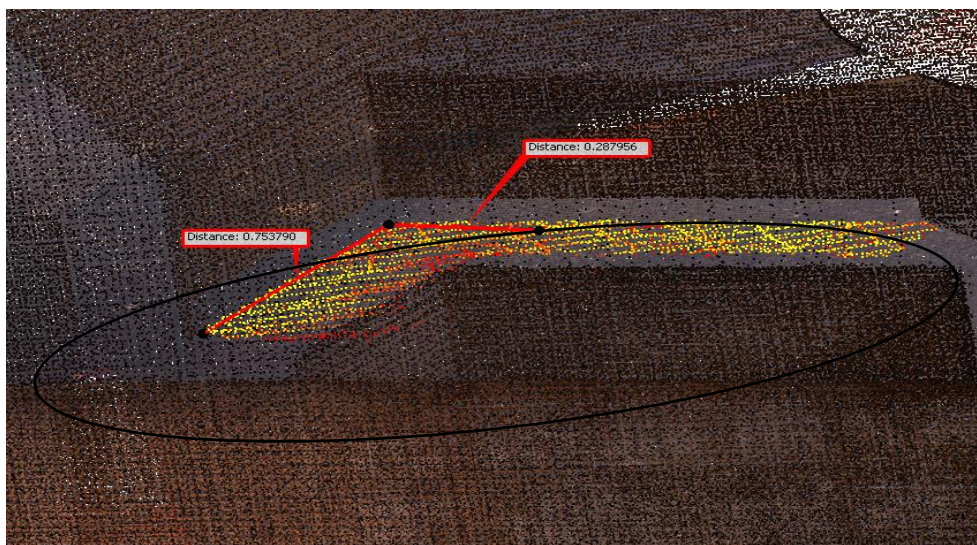
| Element Name | Observation | Location of Distress | Photo No. | Units | Distress Details | | | Area of Repair (Sq.m/R MT) |
|---|---|---|---|---|---|---|---|---|
| Abutment 2 | Scaling | | 5 | M | 0.75 | 0.28 | | 0.21 |

**5. Scaling observed on RHS A2, measuring 0.75 m in length and 0.28 m in width, covering an area of 0.21 m<sup>2</sup>.**
