# **LIDAR Inspection Report of VUP ch.1006+950**

**Bridge Chainage:** 1006+950(CKRP)

- **CKRP:** Chittorgarh to kota
- **State:** Rajasthan NH 27
- **Zone:** RJ-06

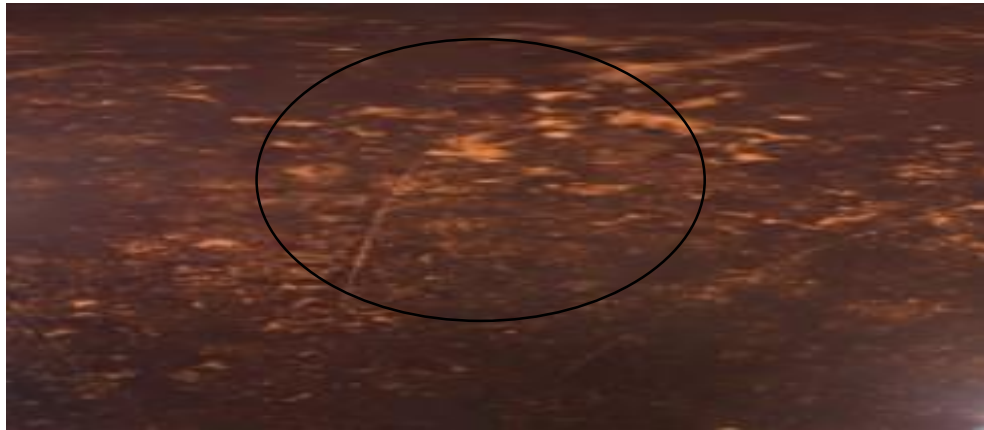
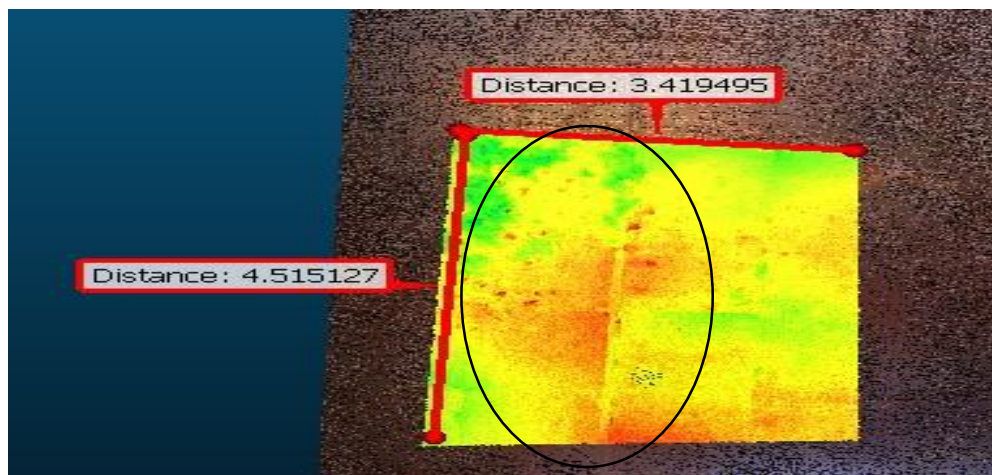
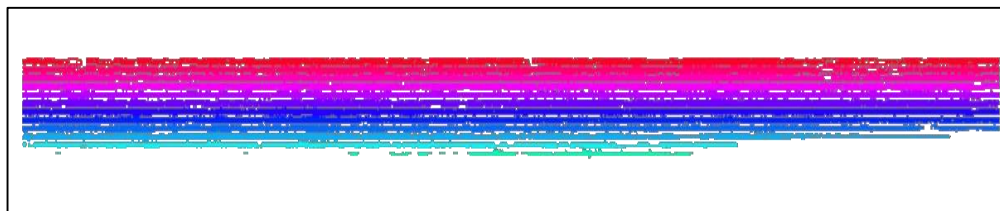
| Element Name | Observation | Location of Distress | Photo No. | Units | Distress Details | | | Area of Repair (Sq.m/ RMT/ m3) |
|---|---|---|---|---|---|---|---|---|
| Deck Slab | Scaling | - | 1 | M | 3.41 | 4.51 | | 15.37 |

**1. Scaling observed on LHS deck slab, measuring 3.41 m in length and 4.51 m in width, covering an area of 15.37 m<sup>2</sup>.**

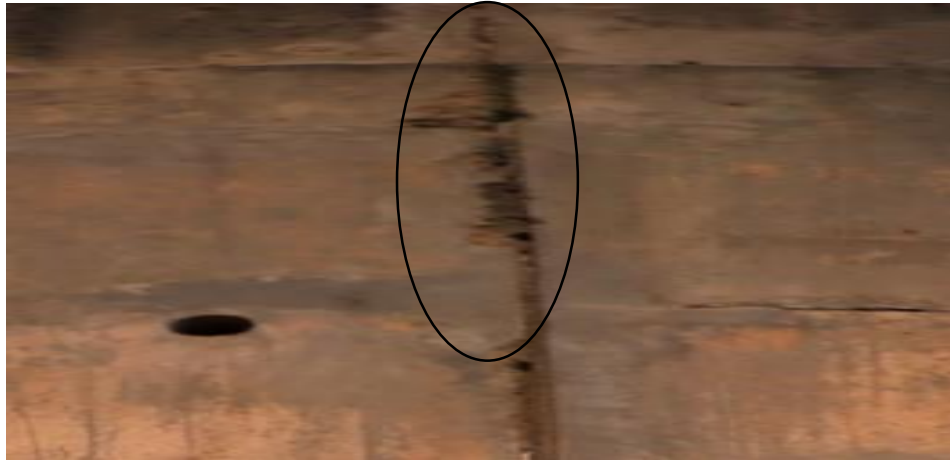
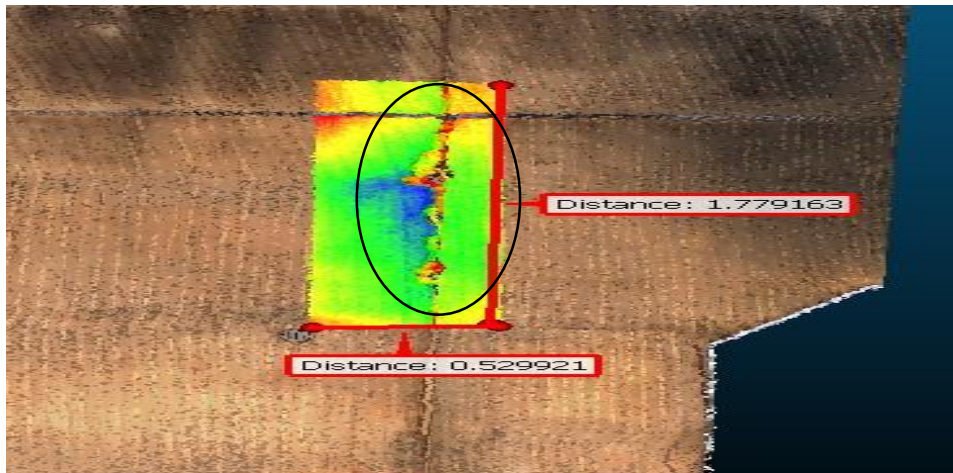
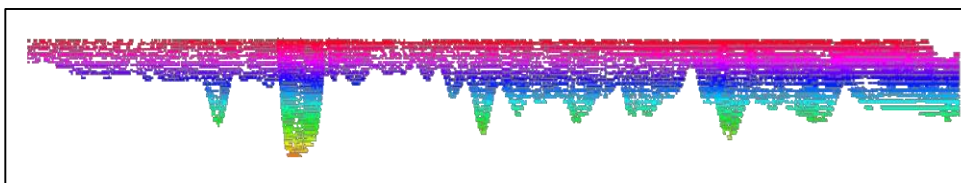
| Element Name | Observation | Location of Distress | Photo No. | Units | Distress Details | | | Area of Repair (Sq.m/ RMT/ m3) |
|---|---|---|---|---|---|---|---|---|
| Abutment 1 | Damage | - | 2 | M | 0.52 | 1.77 | | 0.9204 |

**2. Damage observed on RHS A1, measuring 0.52 m in length and 1.77 m in width, covering an area of 0.9204 m<sup>2</sup>.**
