# **Satellite Structural Inspection Interferometric Synthetic Aperture Radar (InSAR) Based**

State – Rajasthan  
Bridge No. – 899/1  
Bridge Chainage – 1006+950

Project - Chittorgarh to Kota

Structure Type – VUP

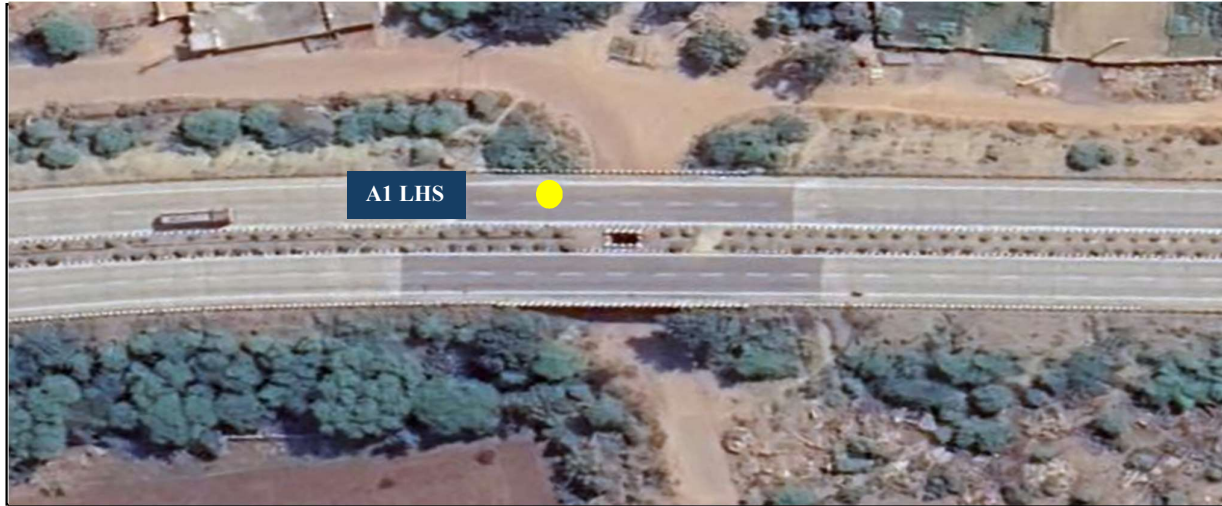
A1 LHS (25.13754245790208, 75.37288336431013)

- **Vertical Displacement (VV)** remains predominantly negative throughout the monitoring period, varying from about -7 mm to -24 mm.
- **Horizontal Displacement (VH)** at A1 LHS shows clear oscillatory behaviour, ranging approximately from -15 mm to +8 mm.

- **January 2025:** VH begins at around -15 mm, while VV is approximately -18 mm, indicating initial lateral displacement accompanied by significant vertical settlement, suggesting early-stage support or foundation response.
- **June 2025:** Both VH and VV decline again, with VH reaching -11 mm and VV approaching -24 mm, indicating continued settlement and renewed lateral movement, pointing to progressive deformation rather than recovery.

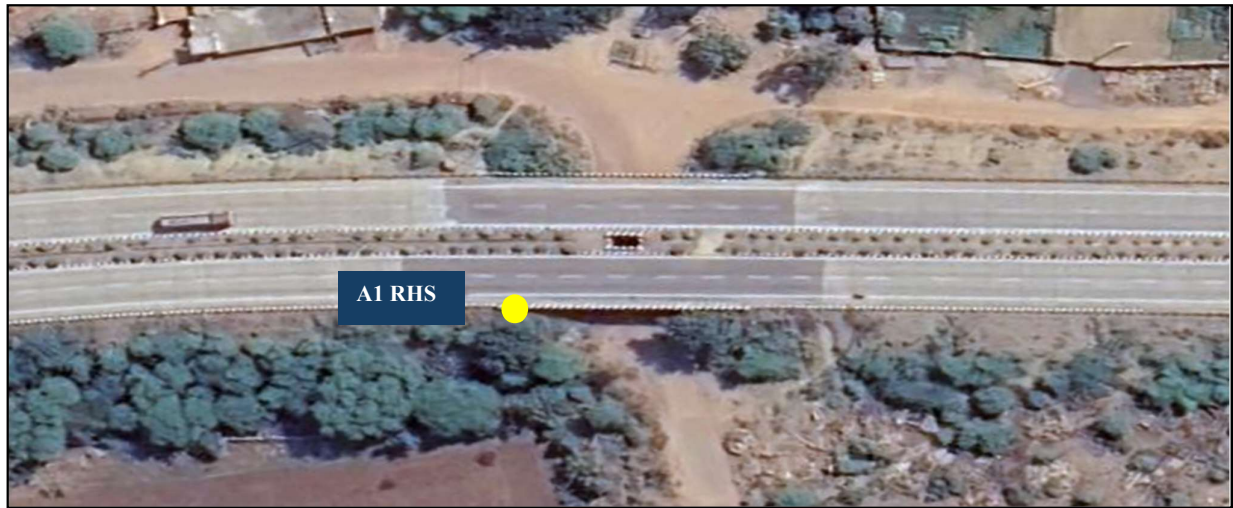
A1 RHS (25.13754245790208, 75.37273964840156)

- **Horizontal displacement (VH)** at A1 RHS shows moderate to high variability, ranging approximately from –4 mm to +24 mm.
- **Vertical displacement (VV)** varies between approximately –5 mm and +21 mm, showing alternating settlement and uplift behaviour.

- **January 2025:** VH and VV both start near +5 mm to +6 mm, indicating initially stable lateral and vertical conditions with minor uplift.
- **June 2025:** VH reaches its maximum of approximately +24 mm, and VV recovers to around +12 mm, indicating continued lateral progression with partial vertical recovery.

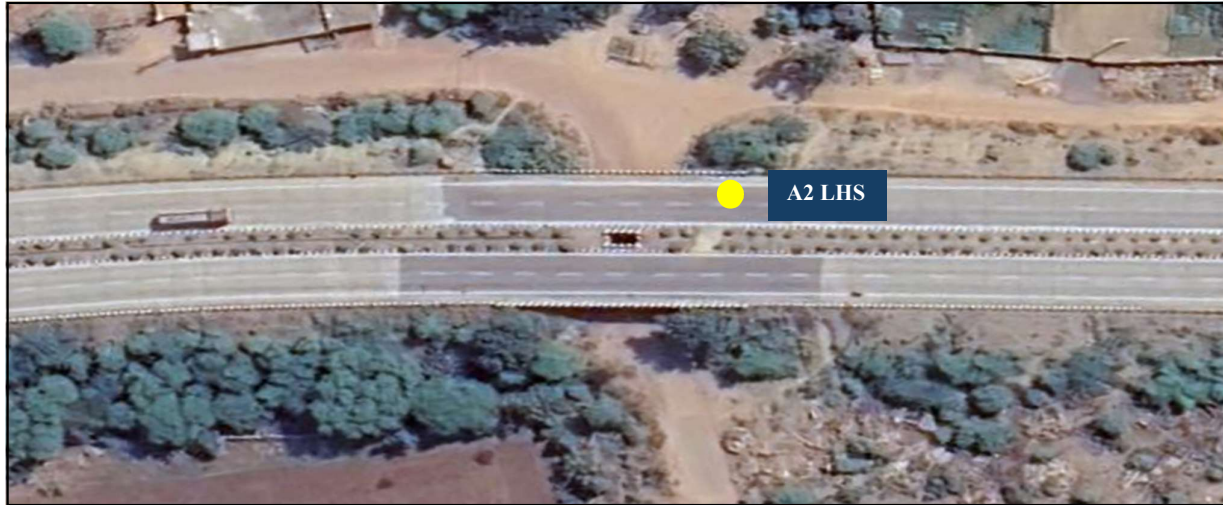
A2 LHS (25.13737102575443, 75.37285800267921)

- Horizontal displacement (VH)** at A2 LHS shows a clear increasing trend over time, ranging approximately from +4 mm to +19 mm.
- Vertical Displacement (VV)** varies between approximately –2 mm and +11 mm, showing alternating settlement and uplift behaviour.

- January 2025:** Both VH and VV begin around +4 mm, indicating initially stable lateral and vertical conditions at A2 LHS.
- June 2025:** VH stabilizes at a high level (16–17 mm), while VV peaks again near +10 mm before dropping to +4 mm by late June, indicating continued lateral dominance with vertical oscillation.

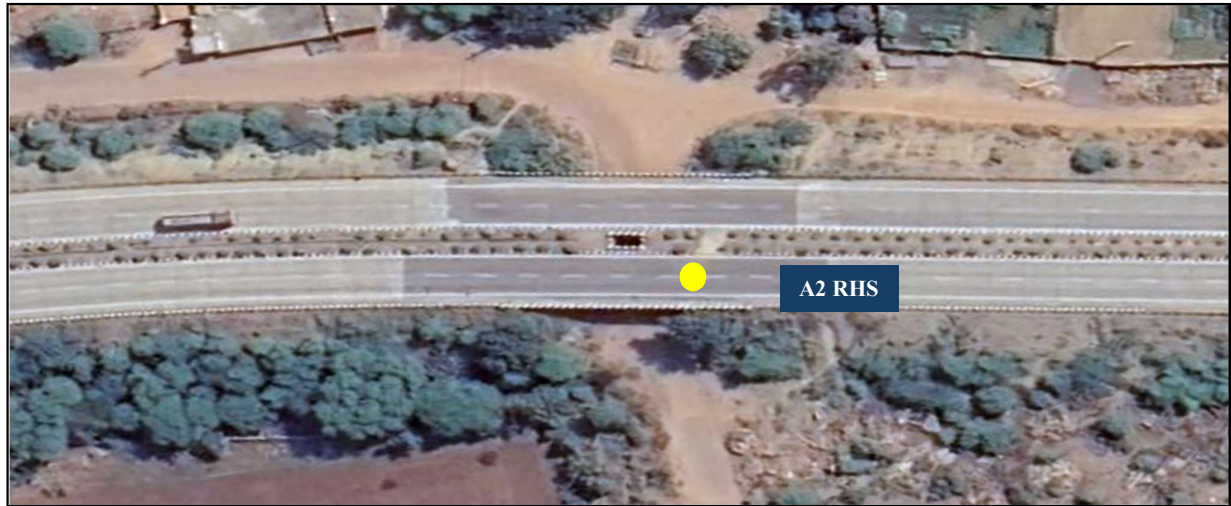
A2 RHS (25.13741388381392, 75.37271259599524)

- **Vertical (VV) displacement** Vertical displacement is predominantly negative, ranging roughly between -5 mm and -22 mm, indicating continuous settlement at A2 RHS.
- **Horizontal (VH) displacement** at A2 RHS shows a clear progressive increasing trend, ranging approximately from -2 mm to +18 mm.

- **January 2025:** VH starts near -2 mm, while VV is around -6 mm, suggesting initial minor lateral displacement accompanied by vertical settlement.
- **April 2025:** VH increases to approximately +11 mm, while VV recovers slightly to around -5 mm, suggesting partial vertical rebound with continued horizontal drift.
- **June 2025:** VH remains elevated (14-15 mm), while VV continues to decline toward -20 mm, confirming persistent settlement dominance in the vertical direction.
