# **LIDAR Inspection Report of VUP ch.1008+050**

**Bridge Chainage:** 1008+050 (CKRP)

## **CH: 1008+050– VUP**

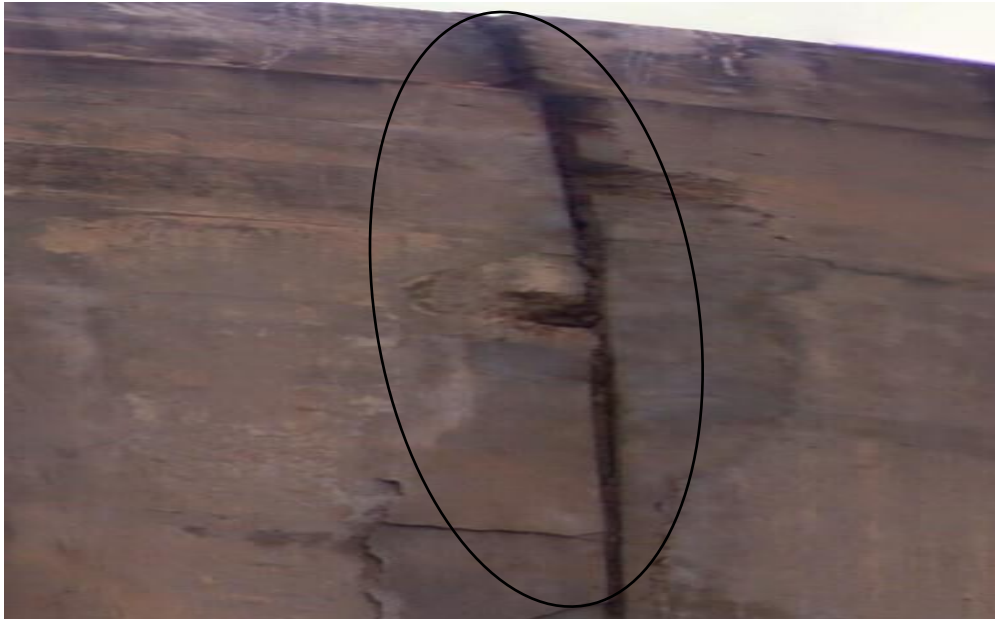
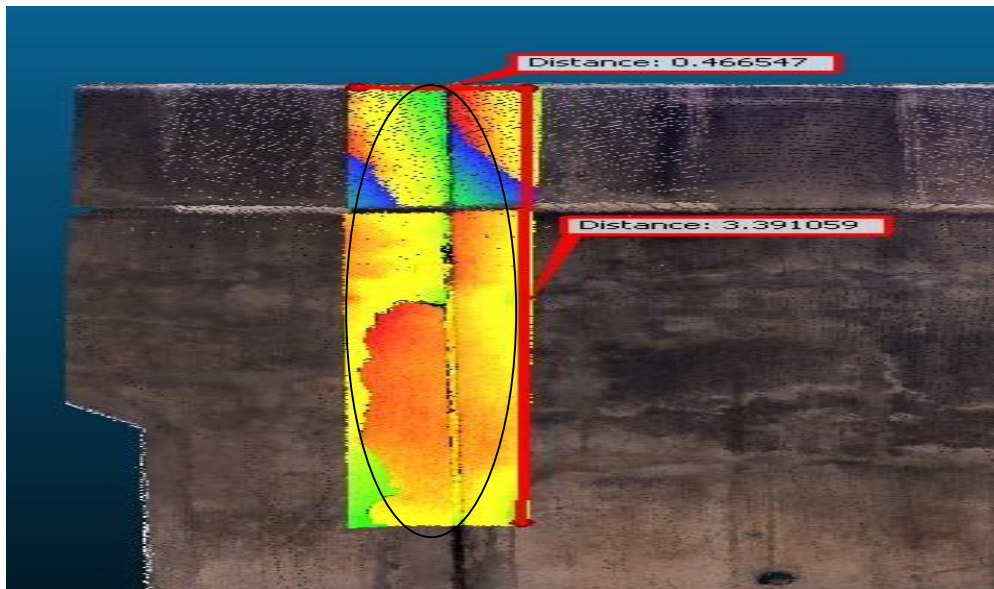
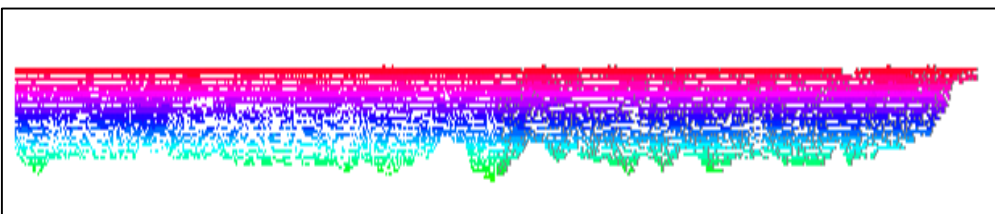
| Element Name | Observation | Location of Distress | Photo No. | Units | Distress Details | | | Area of Repair (Sq.m/R MT/m3) |
|---|---|---|---|---|---|---|---|---|
| Abutment 1 | Damage | - | 1 | M | 3.39 | 0.46 | - | 1.559 |

**1. Damage observed on LHS Abutment 1 wing wall, measuring 3.39 m in length and 0.46 m in width, covering an area of 1.559 m<sup>2</sup>.**
