# **Satellite Structural Inspection Interferometric Synthetic Aperture Radar (InSAR) Based**

State – Rajasthan  
Bridge No. – 899/1  
Bridge Chainage – 1008+050

Project - Chittorgarh to Kota

Structure Type – VUP

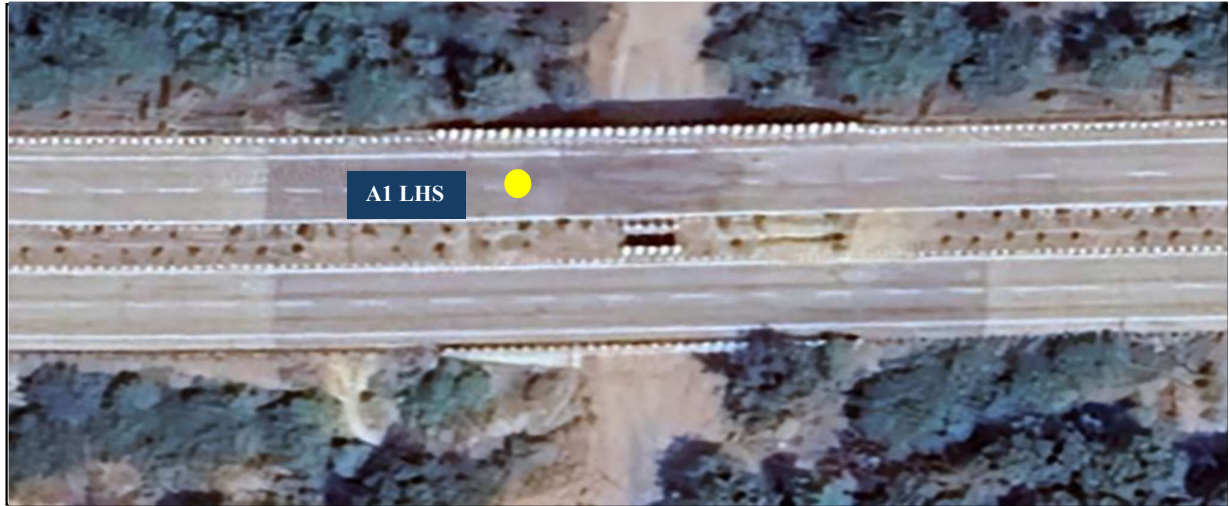
A1 LHS (25.129171889057723, 75.37611891813707)

- **Vertical Displacement (VV)** exhibits dominant settlement behaviour, with values ranging roughly between -3 mm and -20 mm.
- **Horizontal Displacement (VH)** at A1 LHS shows a consistent increasing trend, ranging approximately from 0 mm to +27 mm.

- **January 2025:** VH begins around +7 mm, while VV is near -9 mm, suggesting initial lateral displacement accompanied by vertical settlement.
- **June 2025:** VH peaks at approximately +27 mm, while VV simultaneously drops back to around -14 mm, highlighting strong lateral displacement dominance with renewed settlement.

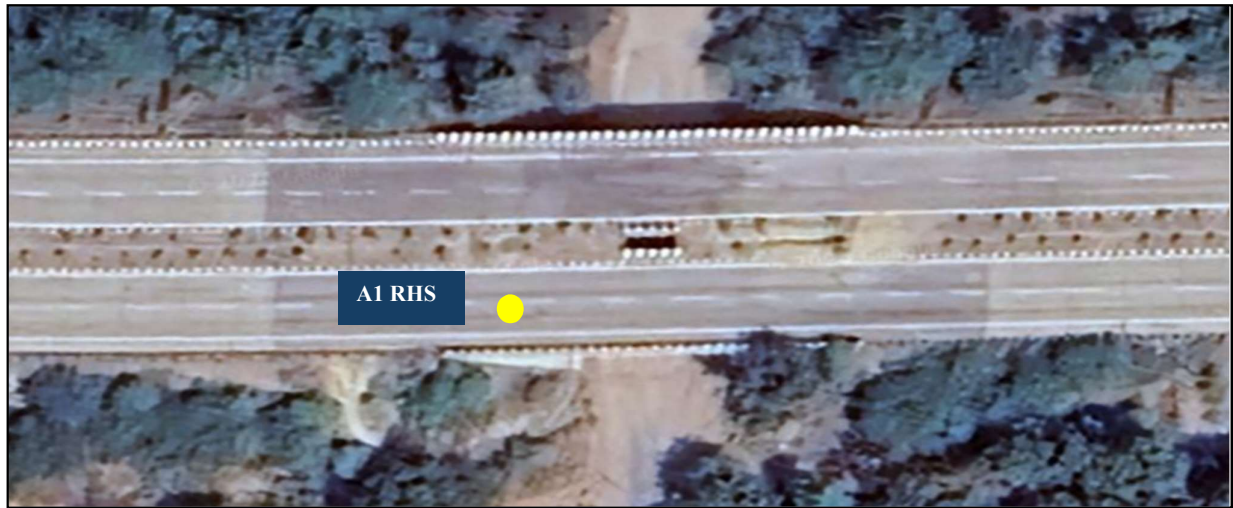
A1 RHS (25.12905204510086, 75.37609898250261)

- **Horizontal displacement (VH)** at A1 RHS shows high variability with an overall negative trend, ranging approximately from +3 mm to -22 mm.
- **Vertical displacement (VV)** exhibits predominant settlement behaviour, with values ranging roughly between +5 mm uplift and -28 mm settlement.

- **January 2025:** VH starts near +3 mm, while VV is around -6 mm, indicating initial mild lateral displacement accompanied by vertical settlement.
- **June 2025:** VV experiences a sharp settlement event, reaching approximately -28 mm, while VH remains between -12 mm and -17 mm, highlighting severe vertical settlement with sustained lateral displacement.

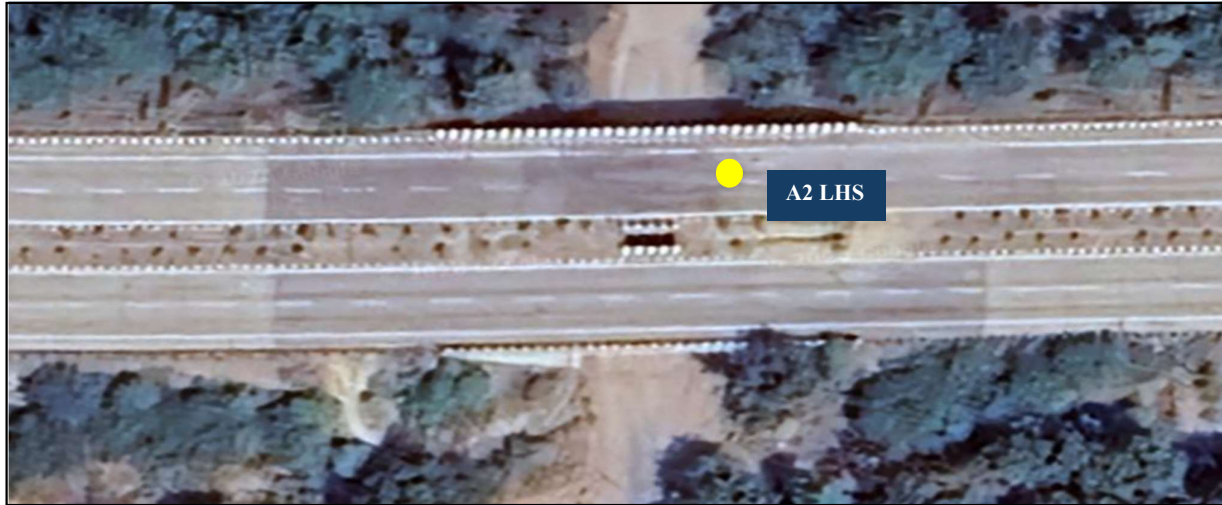
**A2 LHS (25.12915239637395, 75.37631508478013)**

- **Horizontal displacement (VH)** at A2 LHS shows moderate to high variability with an overall increasing positive trend, ranging approximately from –2 mm to +19 mm.
- **Vertical Displacement (VV)** exhibits predominantly settlement behaviour, with values ranging roughly from +1 mm uplift to –22 mm settlement.

- **January 2025:** VH begins around +7 mm, while VV is approximately –12 mm, indicating initial lateral displacement accompanied by noticeable vertical settlement.
- **June 2025:** VV declines rapidly from –8 mm to –22 mm, while VH remains elevated between +15 mm and +18 mm, highlighting severe vertical settlement occurring alongside sustained lateral displacement.

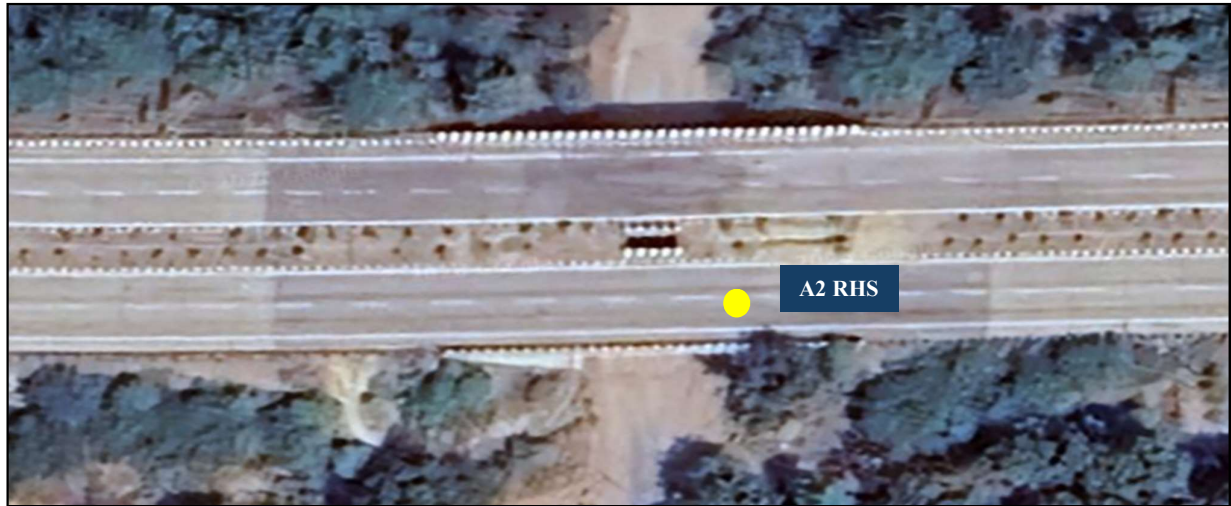
**A2 RHS** (25.129044103629695, 75.376283187765)

- **Vertical (VV) displacement** exhibits alternating uplift and settlement behaviour, with values ranging from approximately -10 mm to +14 mm.
- **Horizontal (VH) displacement** at A2 RHS shows moderate variability with an overall positive tendency, ranging approximately from -6 mm to +11 mm.

- **January 2025:** VH starts near -6 mm, while VV is around -7 mm, indicating initial combined lateral and vertical settlement.
- **April 2025:** VV spikes to approximately +14 mm while VH remains positive (+8 mm), marking the maximum vertical uplift event in the dataset.
- **June 2025:** VH rises again, ending near +10 mm, while VV fluctuates between -2 mm and +8 mm, suggesting renewed lateral displacement with unstable vertical response.
