# **LIDAR Inspection Report of Box Culvert ch.1009+014**

**Bridge Chainage:** 1009+014

- **Bridge No:** -
- **Chainage:** 1009+014
- **Structure type:** Box Culvert

# **CH: 1009+014 BOX CULVERT**

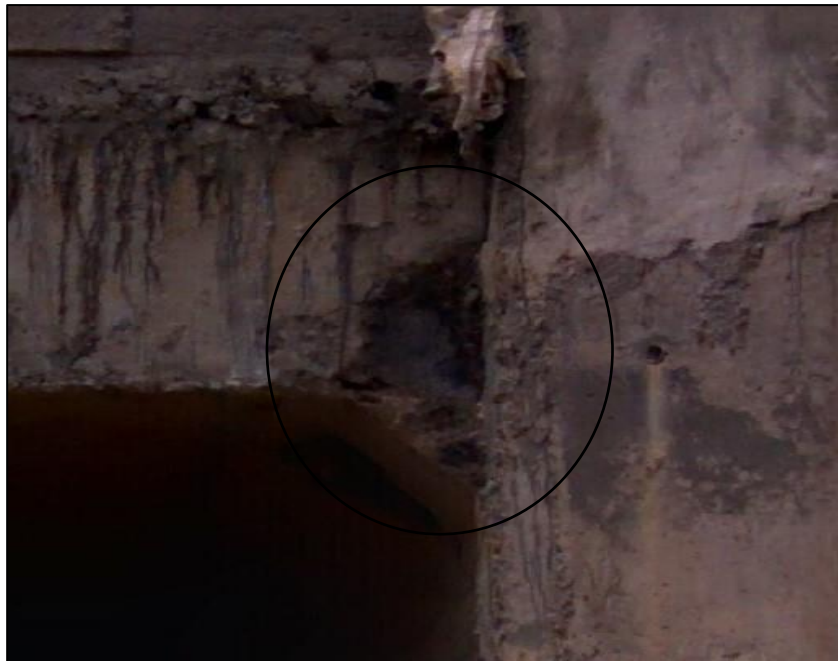
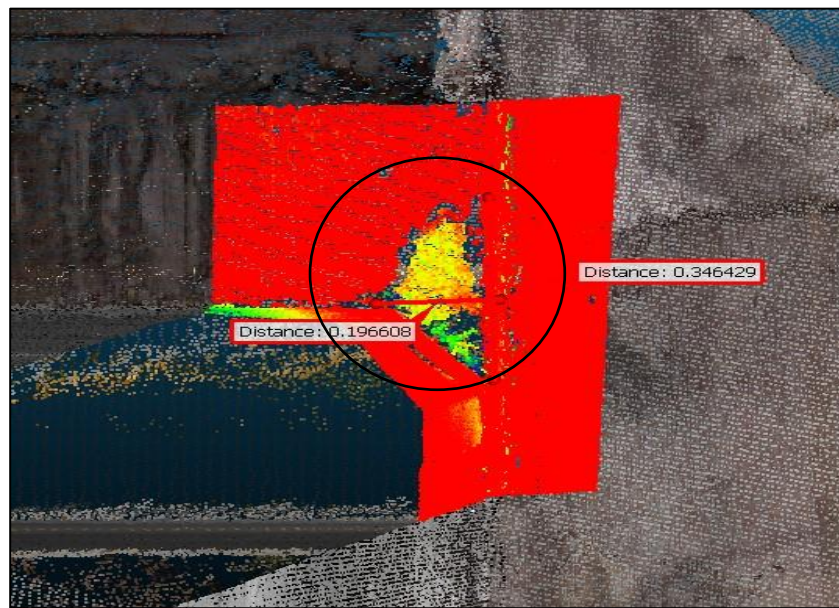
| Element Name | Observation | Location of Distress | Photo No. | Units | Distress Details | | | Area of Repair (Sq.m/R MT/m3) |
|---|---|---|---|---|---|---|---|---|
| Wing Wall | Damage | - | 1 | Sq m | 0.34 | 0.19 | - | 0.06 |

**1.Damage observed on abutment 1 wing wall corner on RHS side, measuring 0.34 m in length and 0.19 m in width, covering an area of 0.06 m<sup>2</sup>.**
