# **LIDAR Inspection Report of MNB ch.1010 + 420**

**Bridge No:** MNB - 1011/4

**Bridge Chainage:** 1010+420 (CKRP)

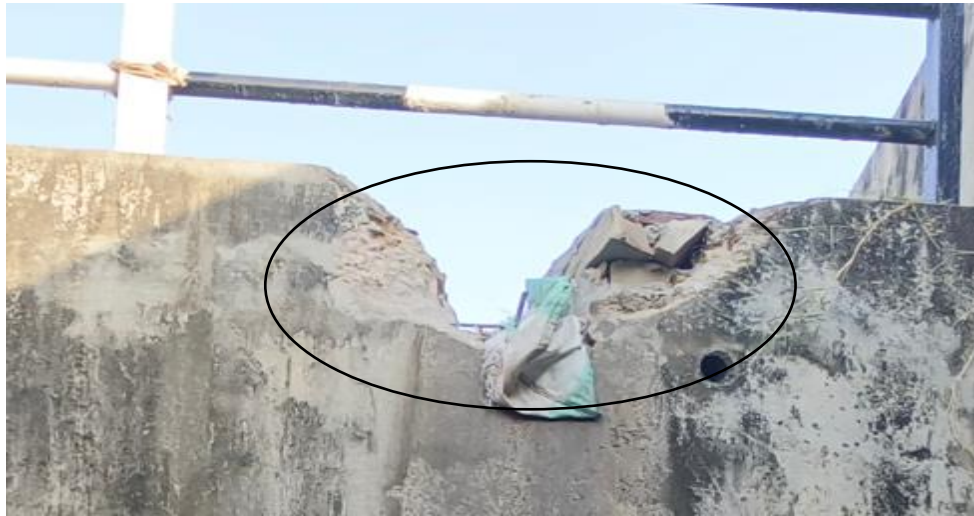
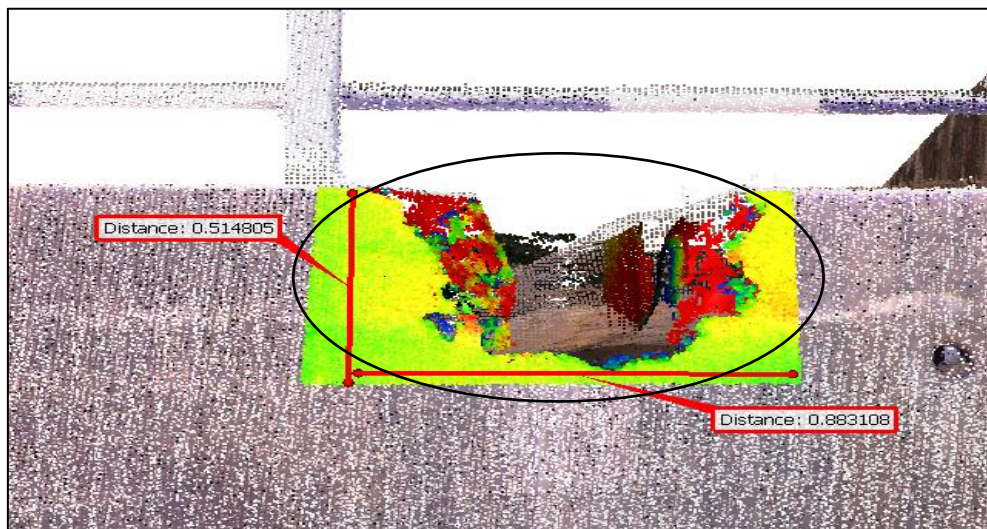
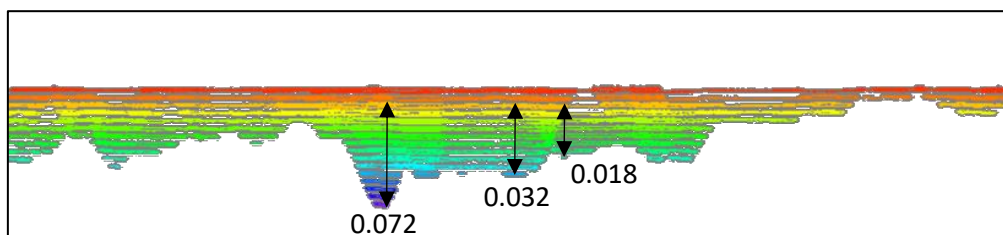
| Element Name | Observation | Location of Distress | Photo No. | Units | Distress Details | | | Area of Repair (Sq.m/R MT) |
|---|---|---|---|---|---|---|---|---|
| Median | Damage | - | 1 | M | 0.88 | 0.51 | 0.032 | 0.0143 |

| Sl. No. | Description | Distress Notation | Observation | Location | | Distress Details | | | Area of Repair |
|---|---|---|---|---|---|---|---|---|---|
| 10 | Median wall | | DAMAGE (RHS) | | | | | | |

1. Damage observed on Median RHS Abutment 2 , measuring 0.88 m in length and 0.51 m in width, Depth ranges from 0.018 m (min) to 0.072 m (max), with an average depth of 0.032 m. The calculated volume of the distress is 0.0143 m<sup>3</sup>.
