# **Satellite Structural Inspection Interferometric Synthetic Aperture Radar (InSAR) Based**

State – Rajasthan  
Bridge No. – 903/2  
Bridge Chainage – 1010+420

Project - Chittorgarh to Kota  
Zone – RJ 06  
Structure Type – MJB

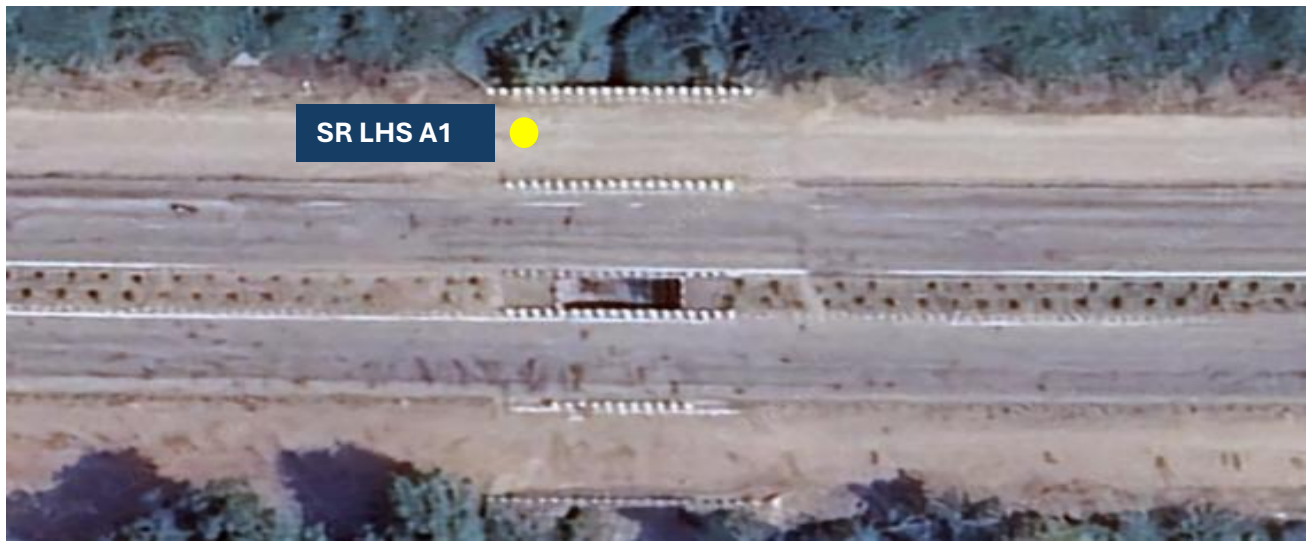
**SR LHS A1** (25.125636471229086, 75.39829774966383)

- **Vertical Displacement (VV)** Vertical displacement shows moderate to high variability with an overall positive trend over the monitoring period.
- **Horizontal displacement (VH)** Horizontal displacement exhibits moderate oscillatory behaviour, varying roughly between -3 mm and +15 mm.

- **March 2025:** VV reaches a distinct negative minimum while VH also decreases to 0–1 mm, marking a short-term coupled downward adjustment affecting both displacement components.
- **April–May 2025:** VV peaks near +18 mm, while VH stabilizes around +11–12 mm, highlighting a strong vertical uplift dominance during this interval.
- **June 2025:** VH and VV representing the largest combined vertical uplift and lateral displacement of the monitoring period, indicating continued deformation activity at this abutment location.

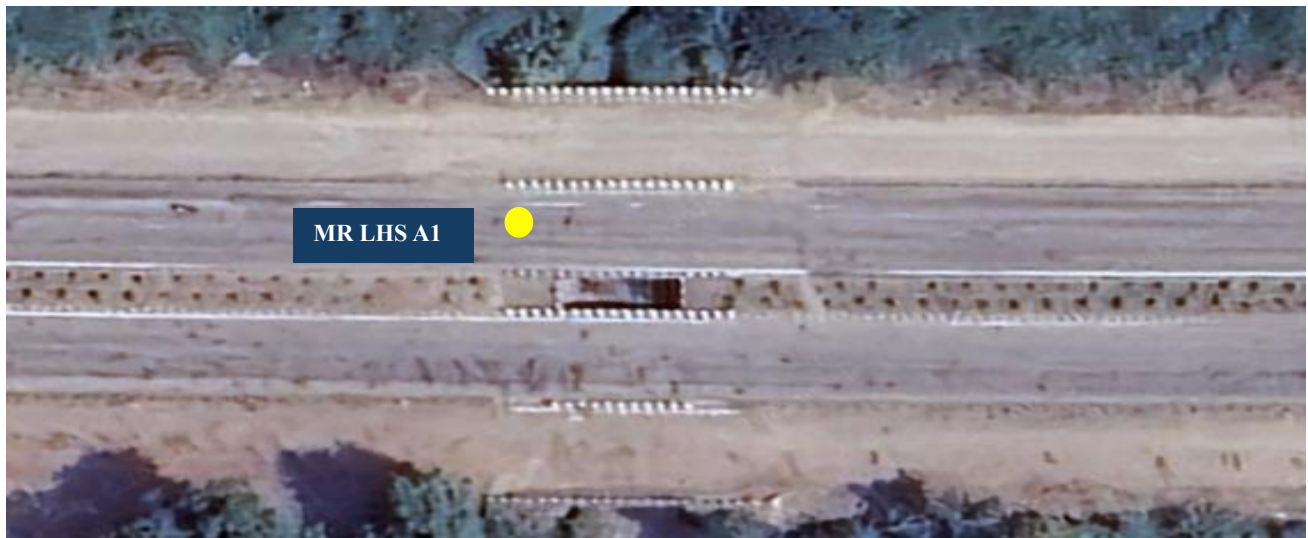
MR LHS A1 (25.12555490633915, 75.39825033437127)

- **Horizontal displacement (VH)** Horizontal displacement shows high variability with frequent oscillations, ranging roughly between  $-7$  mm and  $+10$  mm.
- **Vertical displacement (VV)** Vertical displacement exhibits moderate variability with a generally positive trend over the monitoring period (Jan–Jun 2025).

- **February 2025:** VH drops to around  $-6$  mm, while VV also becomes slightly negative ( $-2$  mm), marking a short-term coupled settlement event affecting both horizontal and vertical components.
- **April–May 2025:** VH reaches a pronounced negative minimum ( $-7$  mm), while VV peaks near  $+11$  mm, representing a strongly asymmetric deformation phase.
- **June 2025:** Both VH and VV end at moderate positive values (VH  $+5$  mm, VV  $+10$  mm), suggesting partial stabilization but ongoing deformation activity at this location.

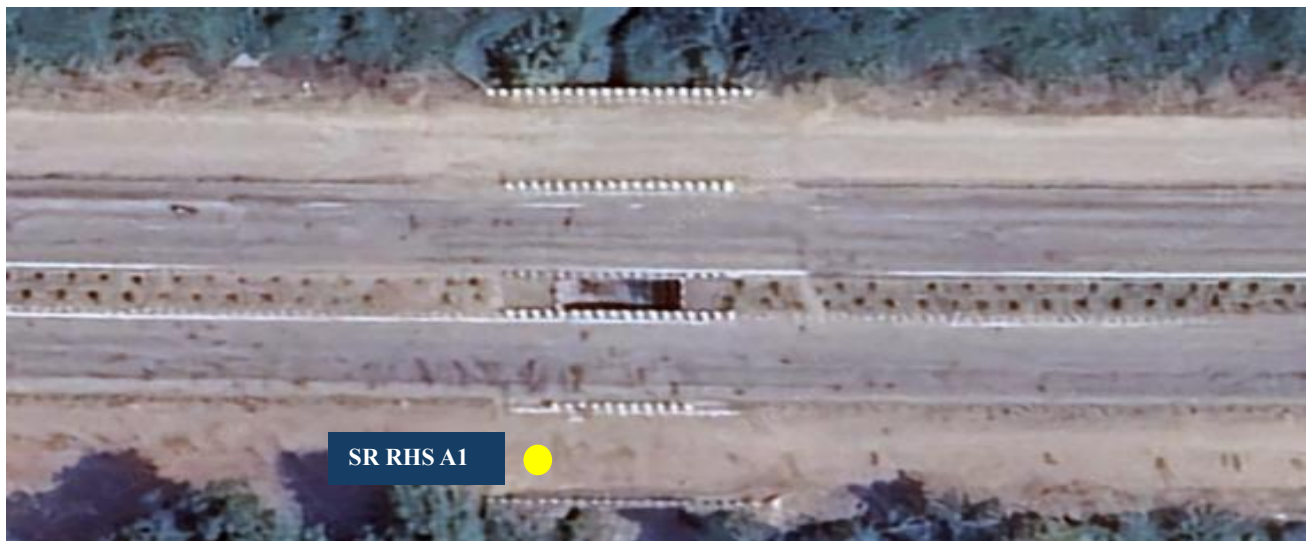
SR RHS A1 (25.125378022898754, 75.39811237975516)

- **Vertical Displacement (VV)** Vertical displacement shows consistently negative values throughout the monitoring period (Jan–Jun 2025), indicating persistent downward settlement at the SR A1 RHS location.
- **Horizontal Displacement (VH)** Horizontal displacement exhibits moderate to high variability, ranging roughly between –5 mm and +18 mm.

- **February 2025:** VV drops sharply to around –18 mm, while VH remains near 0 mm, indicating a strong vertical settlement event without corresponding lateral movement.
- **April 2025:** VH rebounds sharply to +8 mm, while VV improves slightly but remains strongly negative, indicating lateral recovery without vertical stabilization.
- **June 2025:** VH ends at a high positive value (+15 mm), while VV remains negative (-14 mm), confirming ongoing deformation activity with no vertical recovery at this abutment location.

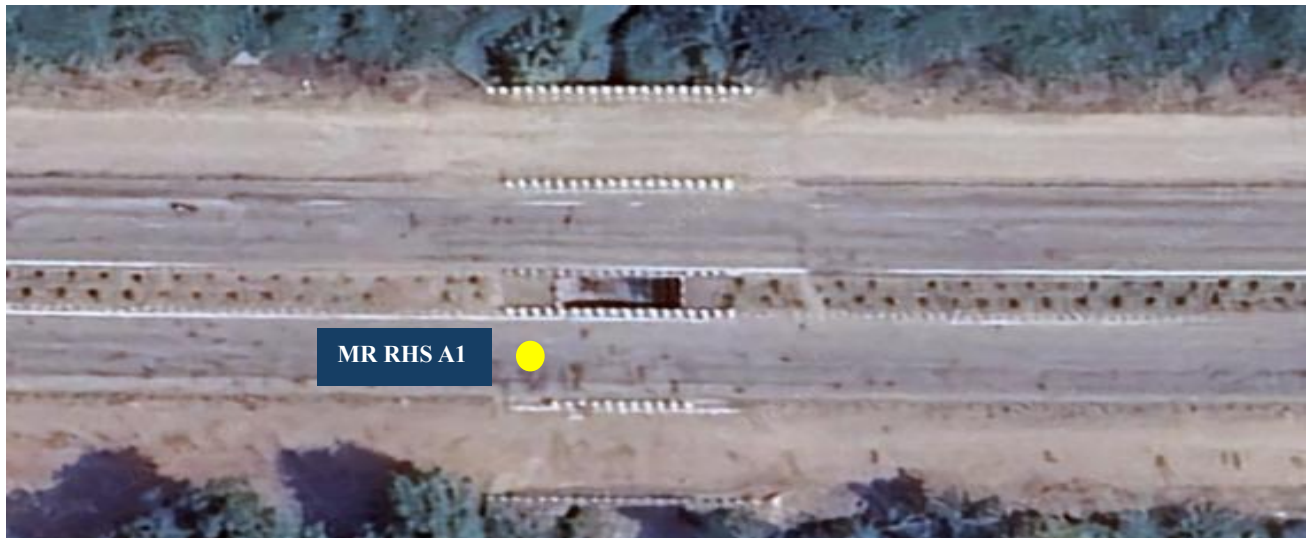
MR RHS A1 (25.125450942225623, 75.39816261756334)

- **Vertical Displacement (VV)** Vertical displacement shows a clear transition from early-period settlement to strong uplift toward the end of the monitoring period.
- **Horizontal Displacement (VH)** Horizontal displacement exhibits consistently positive values with moderate variability, ranging roughly between +8 mm and +21 mm.

- **February 2025:** VH remains elevated (+15–18 mm), while VV decreases to –5 mm, indicating a temporary vertical settlement phase occurring under continued lateral displacement.
- **May 2025:** VH remains consistently high (+19–21 mm), while VV fluctuates between +7 mm and +10 mm, reflecting a stable lateral displacement regime with moderate vertical uplift.
- **June 2025:** VH shows minimal variation (+19 mm), while VV increases again to +14 mm, suggesting continued vertical accumulation under steady lateral movement.

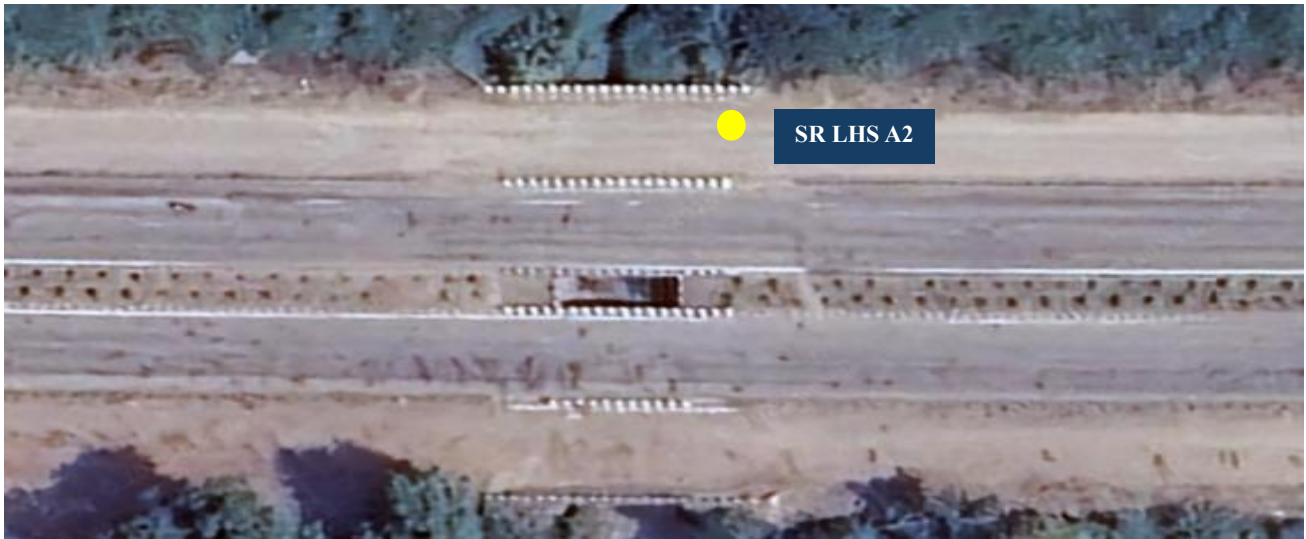
SR LHS A2(25.125561404093308, 75.39842497056159)

- **Horizontal Displacement (VH)** Horizontal displacement exhibits high variability with frequent oscillations, ranging roughly between  $-2$  mm and  $+15$  mm.
- **Vertical Displacement (VV)** Vertical displacement shows a predominantly positive trend throughout the monitoring period (Jan–Jun 2025), indicating overall vertical uplift at the SR A2 LHS location.

- **February 2025:** VH reaches a local positive peak ( $+15$  mm), while VV remains low but positive ( $+3$  mm), indicating a strong lateral displacement event with limited vertical participation
- **May 2025:** VH drops again to  $+2$  mm, while VV remains elevated ( $+13$  mm), suggesting temporary lateral relaxation without vertical loss.
- **June 2025:** VH recovers to  $+4$ – $5$  mm, while VV peaks again near  $+14$  mm, marking renewed uplift toward the end of the monitoring period.

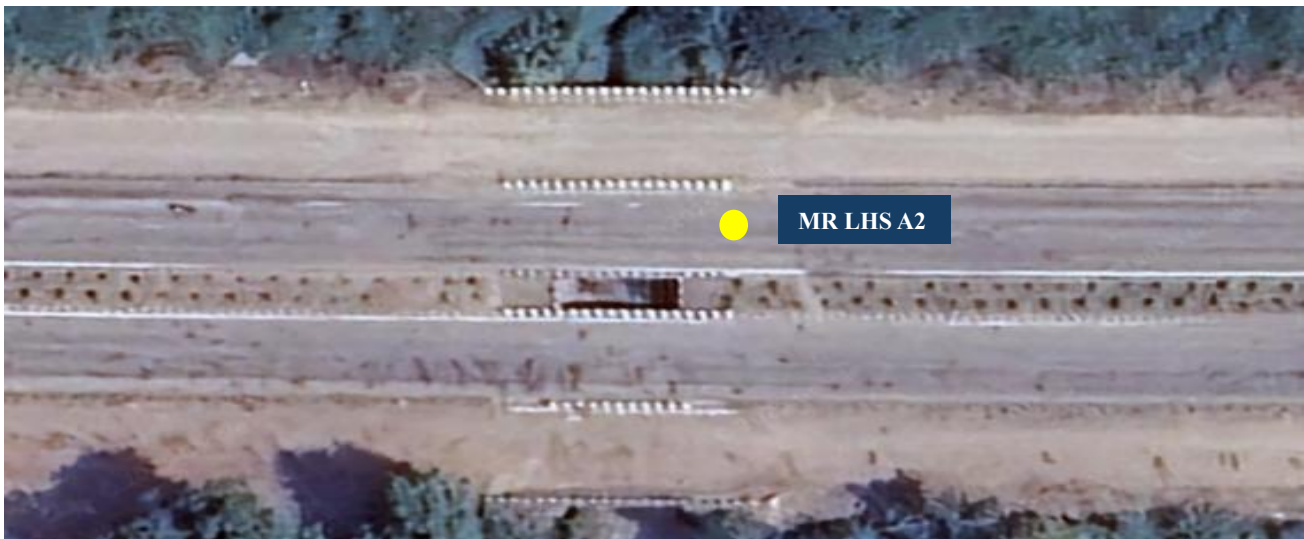
MR LHS A2(25.12548270904748, 75.39836755592368)

- **Vertical Displacement (VV)** Vertical displacement is predominantly negative throughout the monitoring period (Jan–Jun 2025), indicating persistent vertical settlement at the MR A2 LHS location.
- **Horizontal Displacement (VH)** Horizontal displacement exhibits high variability with strong negative dominance, ranging roughly between –8 mm and –27 mm.

- **March 2025:** VH recovers to –6 mm, while VV remains negative (–9 mm), suggesting temporary lateral relaxation without vertical stabilization.
- **June 2025:** Both VH and VV converge near –20 to –22 mm, indicating persistent combined settlement with no recovery trend toward the end of the monitoring period.

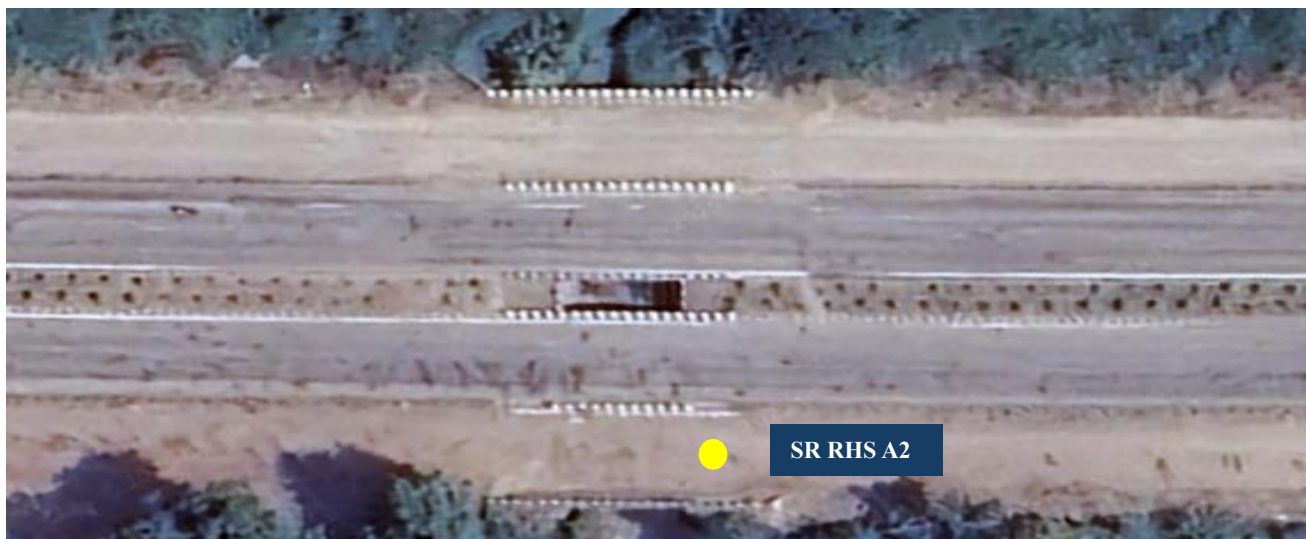
SR RHS A2 (25.125294273911795, 75.3982383729883)

- **Vertical Displacement (VV)** Vertical displacement shows a consistently positive and increasing trend throughout the monitoring period (Jan–Jun 2025), indicating dominant vertical uplift at the SR A2 RHS location.
- **Horizontal Displacement (VH)** Horizontal displacement exhibits moderate to high variability, ranging roughly between  $-7$  mm and  $+19$  mm.

- **February 2025:** VH crosses into positive values ( $+8$  mm), while VV increases to  $+7$  mm, marking the onset of coupled vertical uplift and lateral displacement.
- **June 2025:** VH decreases slightly to  $+8$ – $12$  mm, while VV remains high ( $+13$ – $14$  mm), indicating post-peak adjustment under sustained uplift conditions

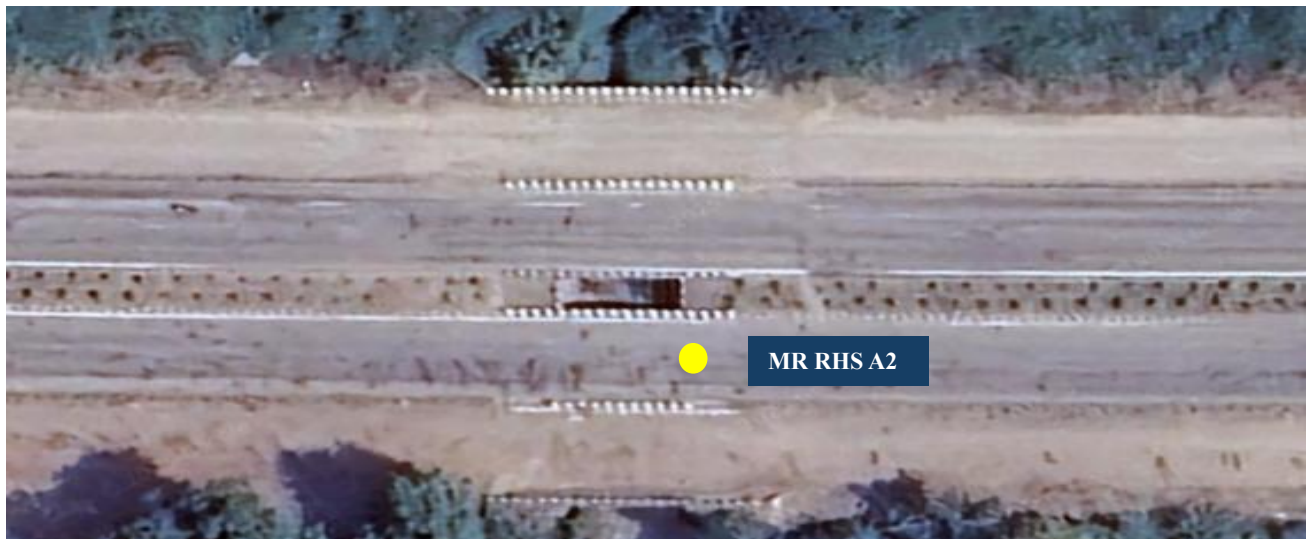
**MR RHS A2** (25.125376578951254, 75.39829180049865)

- **Vertical Displacement (VV)** Vertical displacement is consistently negative throughout the monitoring period (Jan–Jun 2025), indicating persistent vertical settlement at the MR A2 RHS location.
- **Horizontal Displacement (VH)** Horizontal displacement exhibits consistently positive values with moderate variability, ranging roughly between +5 mm and +28 mm.

- **Feb 2025:** VH rises sharply to +25 mm, while VV drops to –5 mm, indicating a strong lateral displacement event occurring alongside moderate vertical settlement.
- **May 2025:** VV drops sharply to –20 to –25 mm, while VH remains high (+20–28 mm), representing the most severe vertical settlement phase coupled with dominant lateral movement.
- **June 2025:** VH remains consistently elevated (+22–25 mm), while VV stays strongly negative (–15 to –20 mm), indicating persistent deformation with no vertical stabilization toward the end of the monitoring period.
