# LIDAR Inspection Report of **Box Culvert** ch.1010+820

**Bridge Chainage:** 1010+820(CKRP)

# **CH: 1010+820 – Box CULVERT**

**DISTRESS PHOTOS**

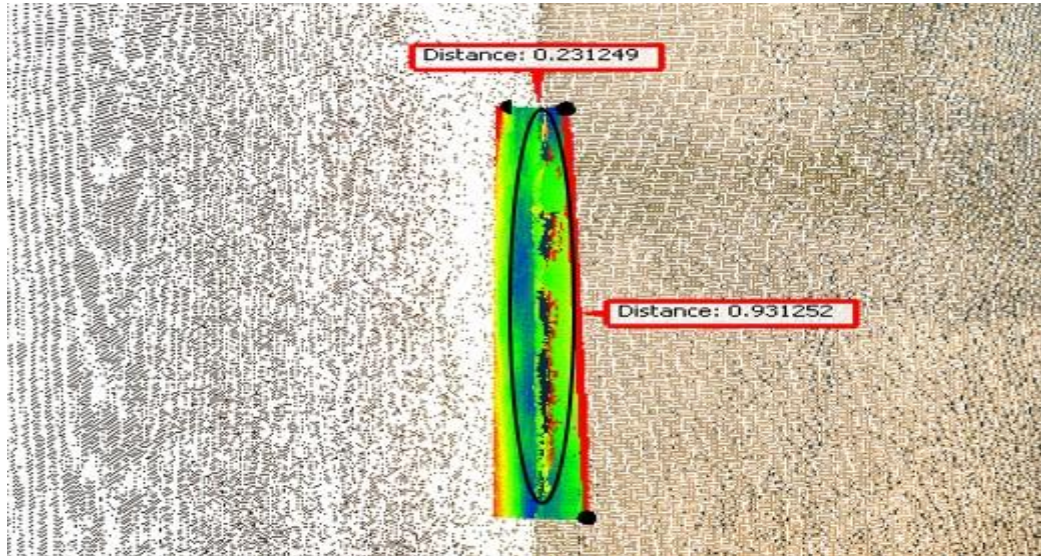
1. "Wing wall damage observed, measuring 0.23 m in length and 0.93 m in width, covering an area of 0.2139 m<sup>2</sup>."

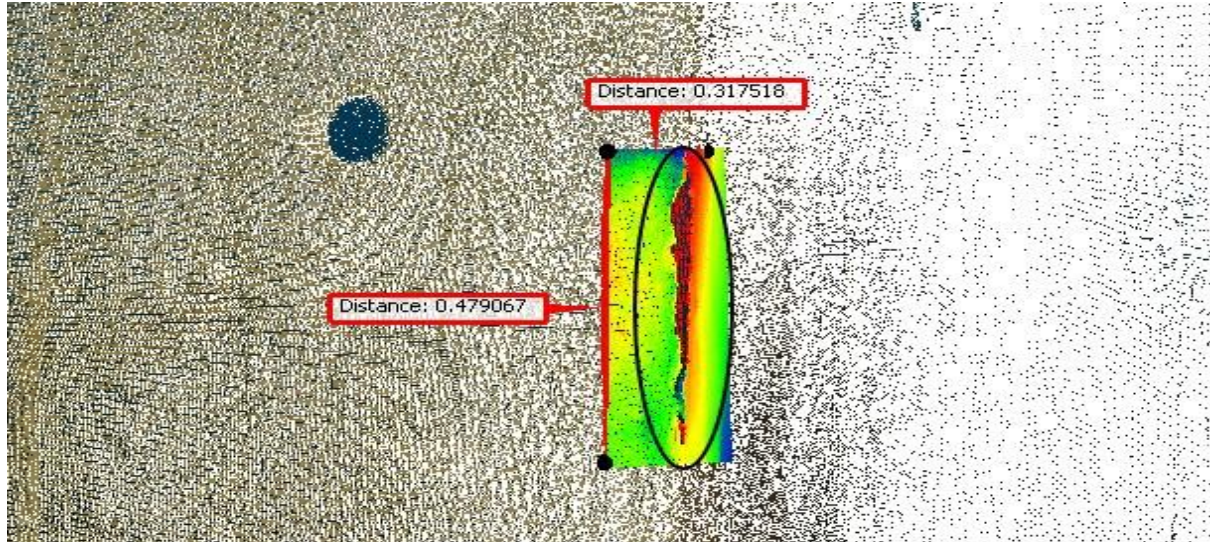
**2. "Wing wall damage observed, measuring 0.31 m in length and 0.47 m in width, covering an area of 0.1457 m<sup>2</sup>."**

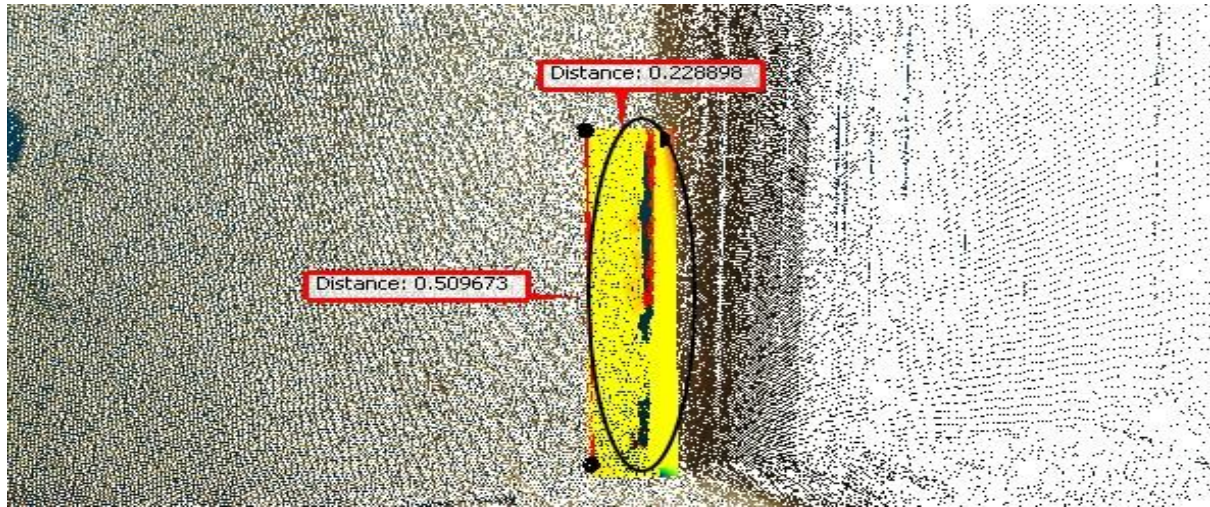
**3. "Wing wall damage observed, measuring 0.22 m in length and 0.50 m in width, covering an area of 0.11 m<sup>2</sup>."**

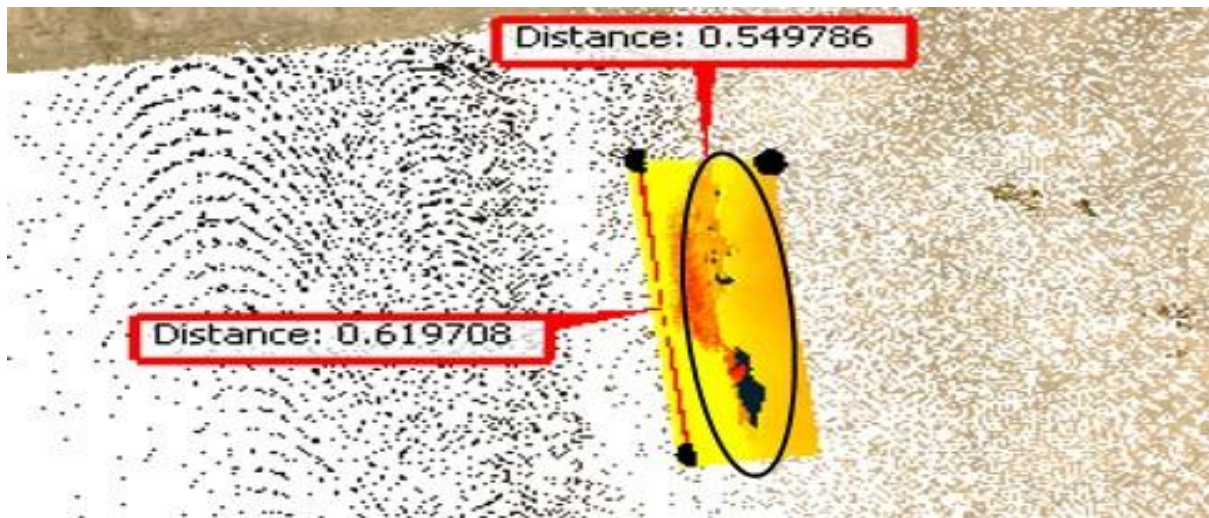
**4. "Wing wall damage observed, measuring 0.54 m in length and 0.61 m in width, covering an area of 0.3294 m<sup>2</sup>."**

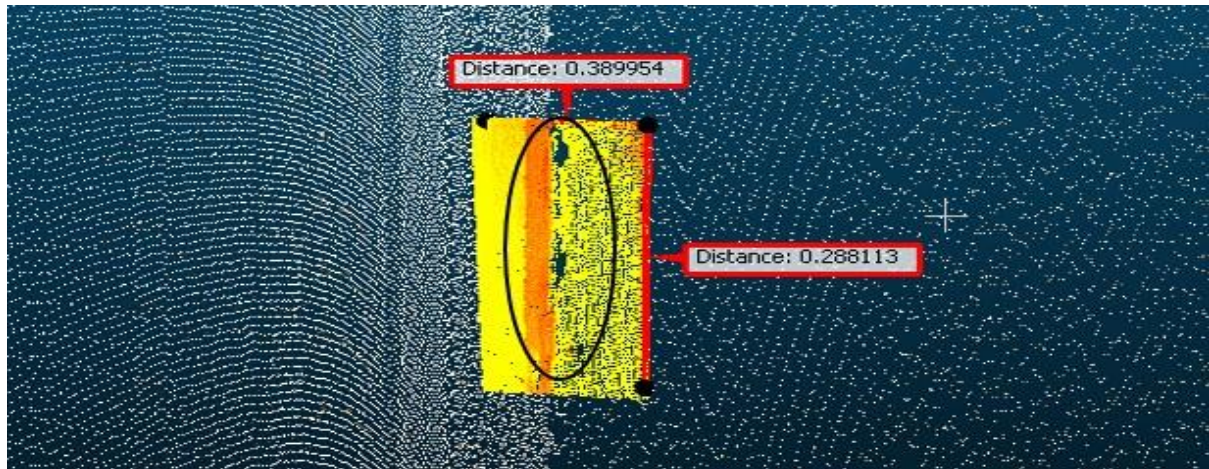
5. "Wing wall damage observed, measuring 0.38 m in length and 0.28 m in width, covering an area of 0.1064 m<sup>2</sup>."
