# LIDAR Inspection Report of **Box Culvert** ch.1014+450

**Bridge Chainage:** 1014+450(CKRP)

- **CKRP:** Chittorgarh to kota
- **State:** Rajasthan NH 27
- **Zone:** RJ-06

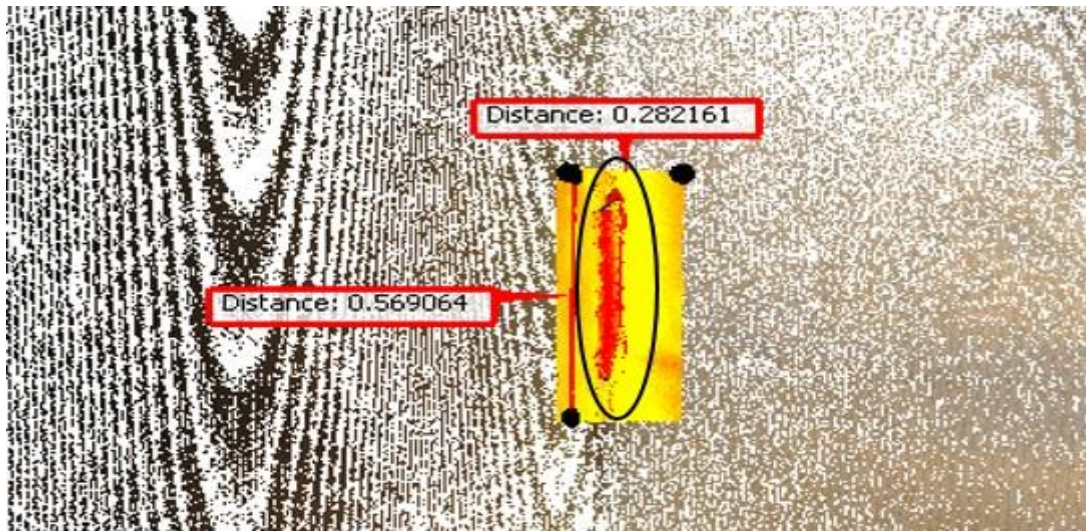
1. "Wing wall damage observed, measuring 0.28 m in length and 0.56 m in width, covering an area of 0.1568 m<sup>2</sup>."

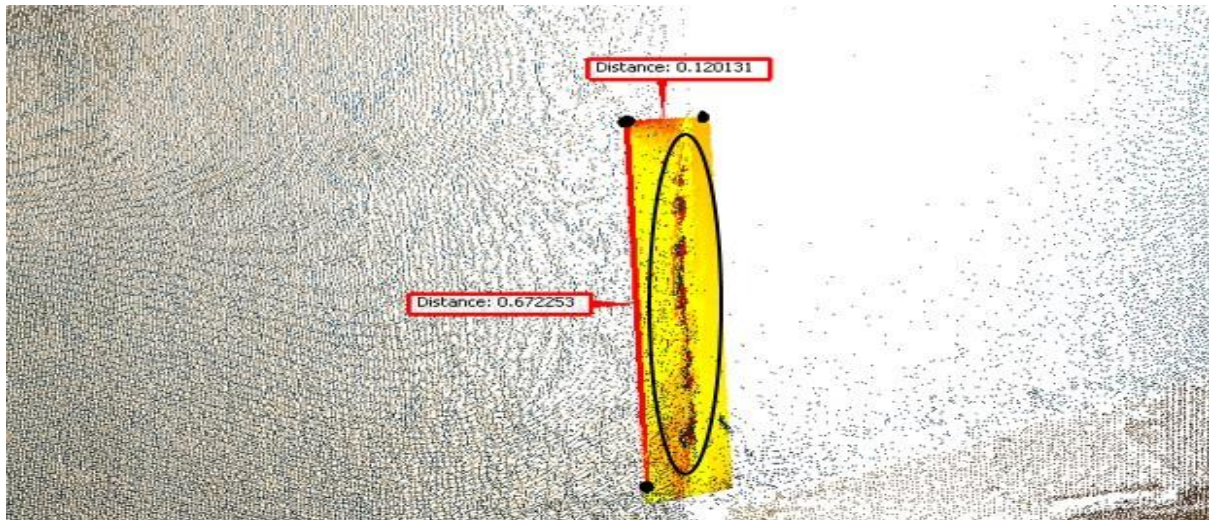
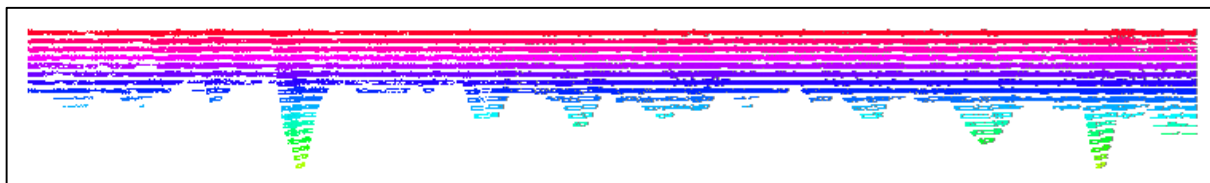
**2. "Wing wall damage observed, measuring 0.12 m in length and 0.67 m in width, covering an area of 0.0804 m<sup>2</sup>."**

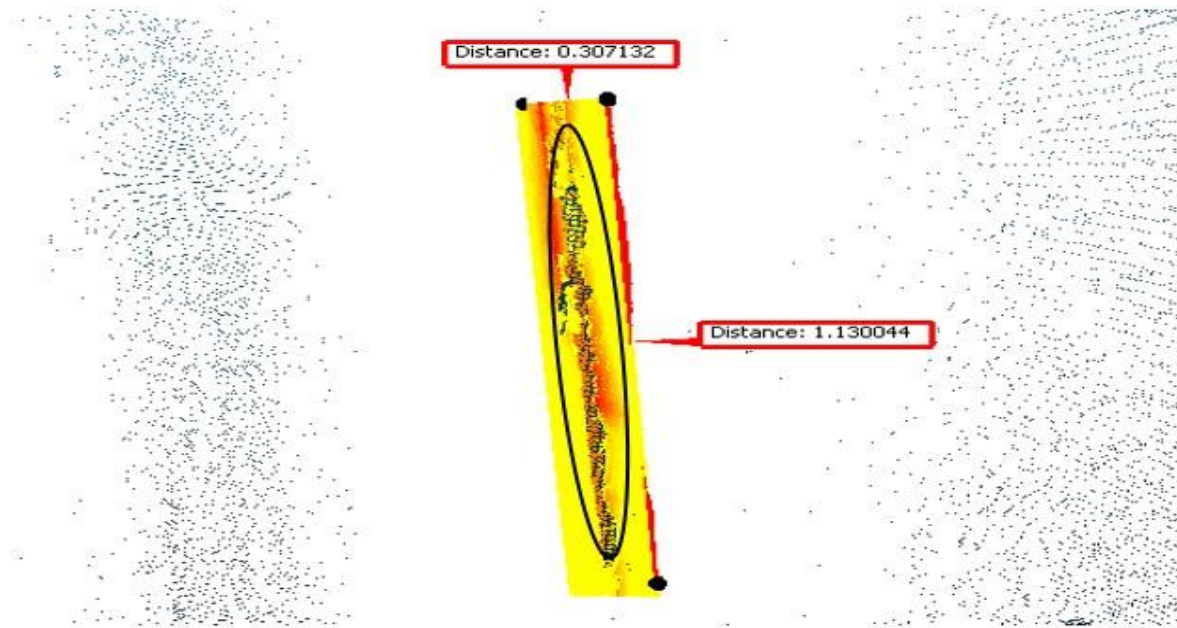
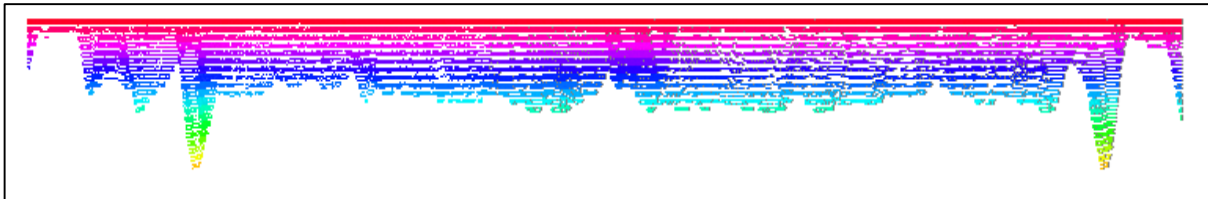
**3. Wing wall damage observed, measuring 0.30 m in length and 1.12 m in width, covering an area of 0.0336 m<sup>2</sup>."**

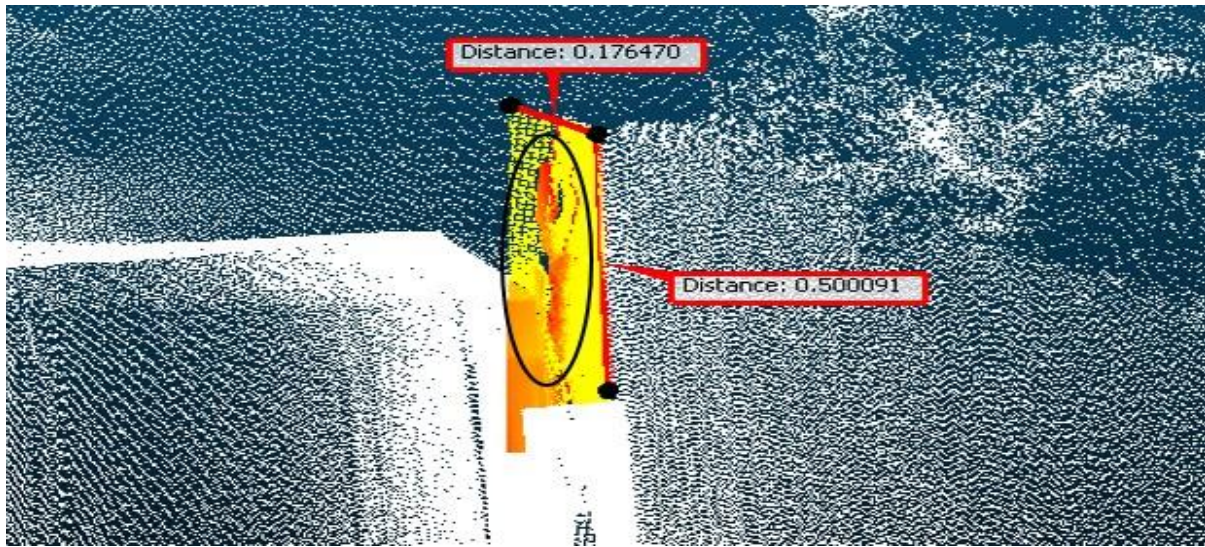
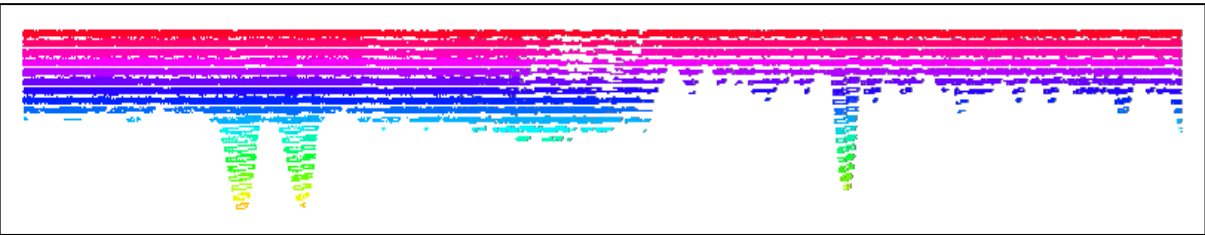
**4. "Wing wall damage observed, measuring 0.17 m in length and 0.50 m in width, covering an area of 0.085 m<sup>2</sup>."**

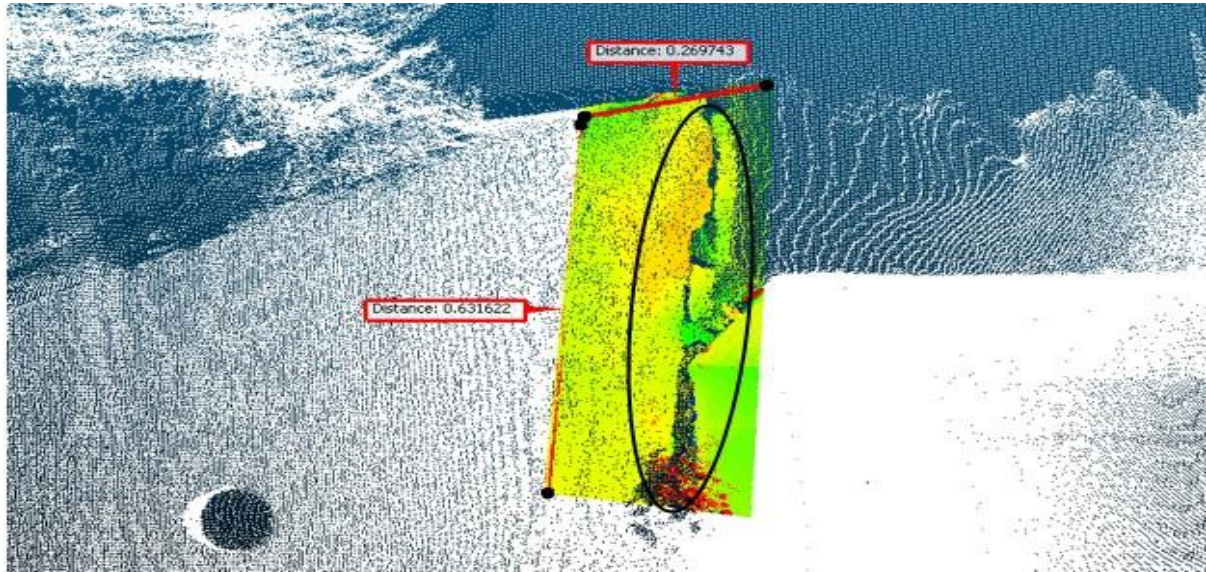
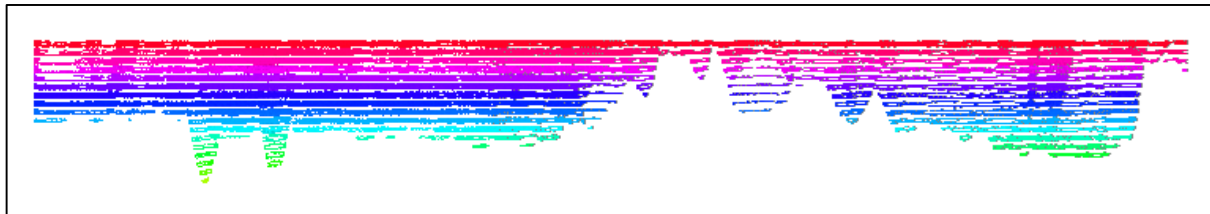
**5. "Wing wall damage observed, measuring 0.26 m in length and 0.63 m in width, covering an area of 0.1638 m<sup>2</sup>."**
