# **LIDAR Inspection Report of MNB ch.1015+300**

**Bridge No:** MNB - 1016/1

**Bridge Chainage:** 1015+300 (CKRP)

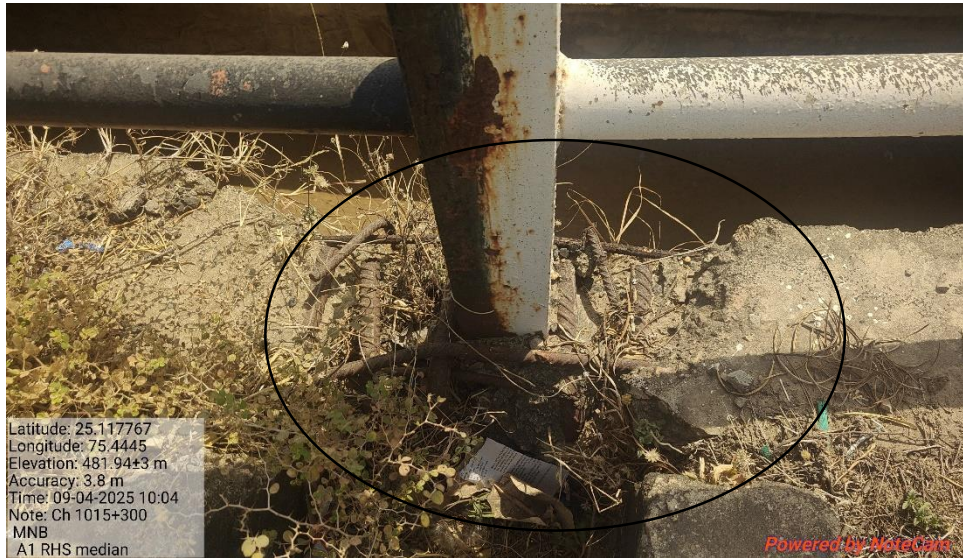
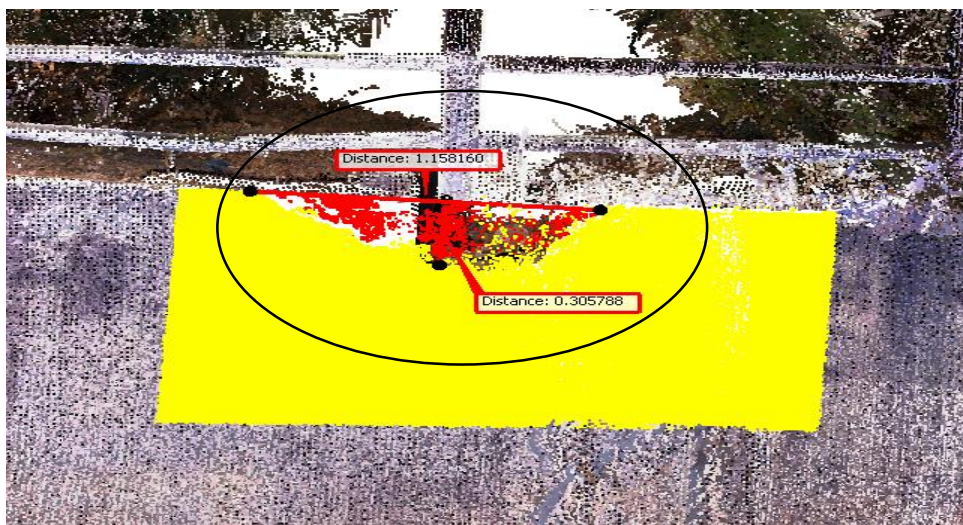
| Element Name | Observation | Location of Distress | Photo No. | Units | Distress Details | | | Area of Repair (Sq./RM T) |
|---|---|---|---|---|---|---|---|---|
| Median wall | Damage | - | 1 | M | 1.16 | 0.30 | | 0.348 |

1. Median damage observed on A1, measuring 1.16 m in length and 0.30 m in width, covering an area of 0.348 m<sup>2</sup>.
