# **Satellite Structural Inspection Interferometric Synthetic Aperture Radar (InSAR) Based**

State – Rajasthan  
Bridge No. – 903/2  
Bridge Chainage – 1016+930

Project - Chittorgarh to Kota  
Zone – RJ 06  
Structure Type – MNB

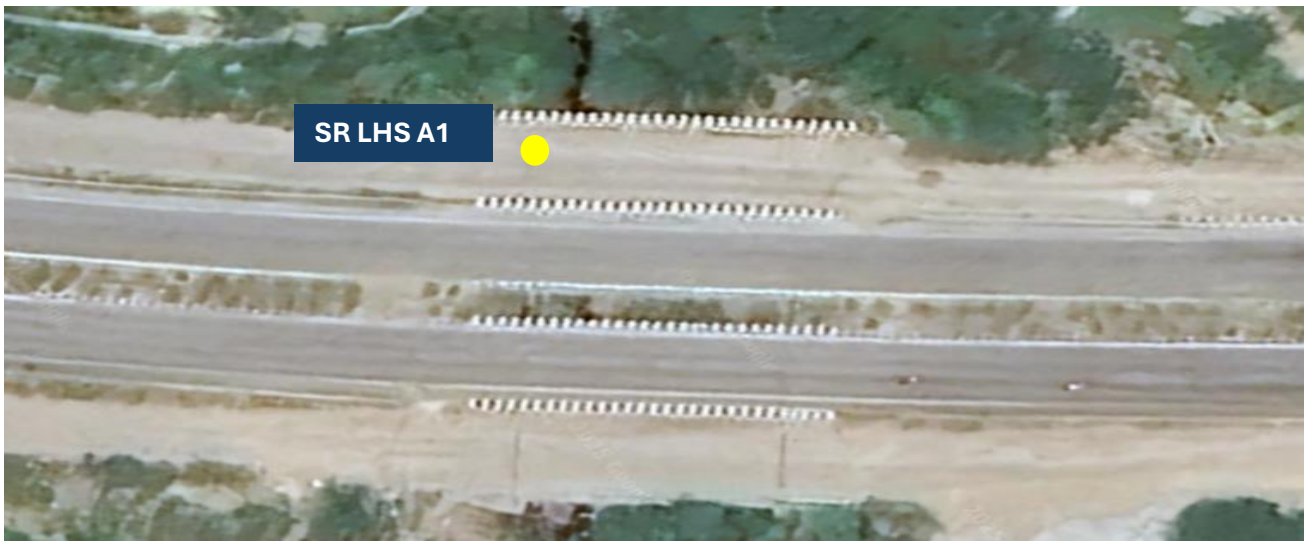
SR LHS A1 (25.119613597341285, 75.45946884283508)

- **Vertical Displacement (VV)** Vertical displacement is predominantly positive throughout the monitoring period (Jan–Jun 2025), showing moderate to high variability.
- **Horizontal displacement (VH)** Horizontal displacement shows greater fluctuation and frequent negative values, ranging approximately from –12 mm to +5 mm.

- **January–February 2025:** VH transitions from slightly positive to negative values (down to ~–5 mm), while VV remains mildly positive.
- **April 2025:** Both VH and VV increase together (VH approaching 0 to +2 mm, VV around +10–12 mm), indicating a combined lateral–vertical displacement phase, possibly linked to external forcing (e.g., loading or hydrological effects).
- **June 2025:** VV reaches one of its highest values (+18 mm) while VH partially recovers but remains negative (–3 mm).

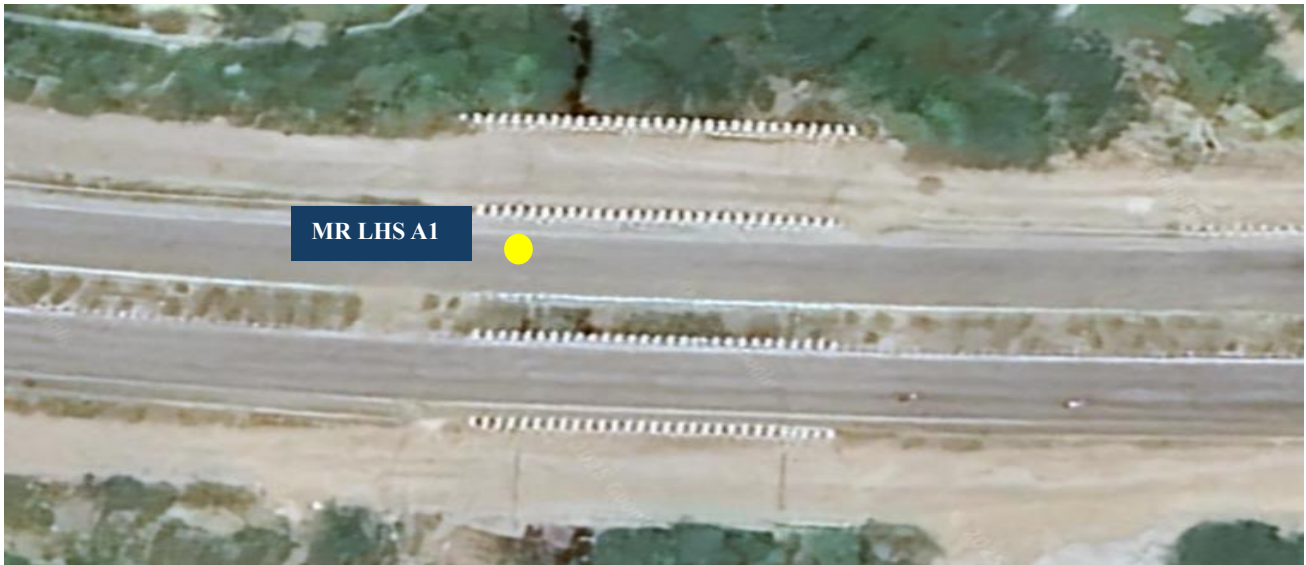
MR LHS A1 (25.119613597341285, 75.45946884283508)

- **Horizontal displacement (VH)** Horizontal displacement exhibits higher variability and frequent sign changes, ranging approximately from -12 mm to +6 mm.
- **Vertical displacement (VV)** Vertical displacement remains mostly positive from mid-February onward, with values generally ranging between -3 mm and +5 mm.

- **February 2025:** Both VH and VV converge near zero displacement, indicating a short stabilization phase with minimal deformation in both directions.
- **April 2025:** VH drops back toward zero, and VV begins transitioning into positive values. This marks the onset of gradual vertical displacement dominance.
- **June 2025:** VH partially recovers (to -4 mm), and VV remains stable (+4 mm), suggesting lateral rebound with continued vertical consistency.

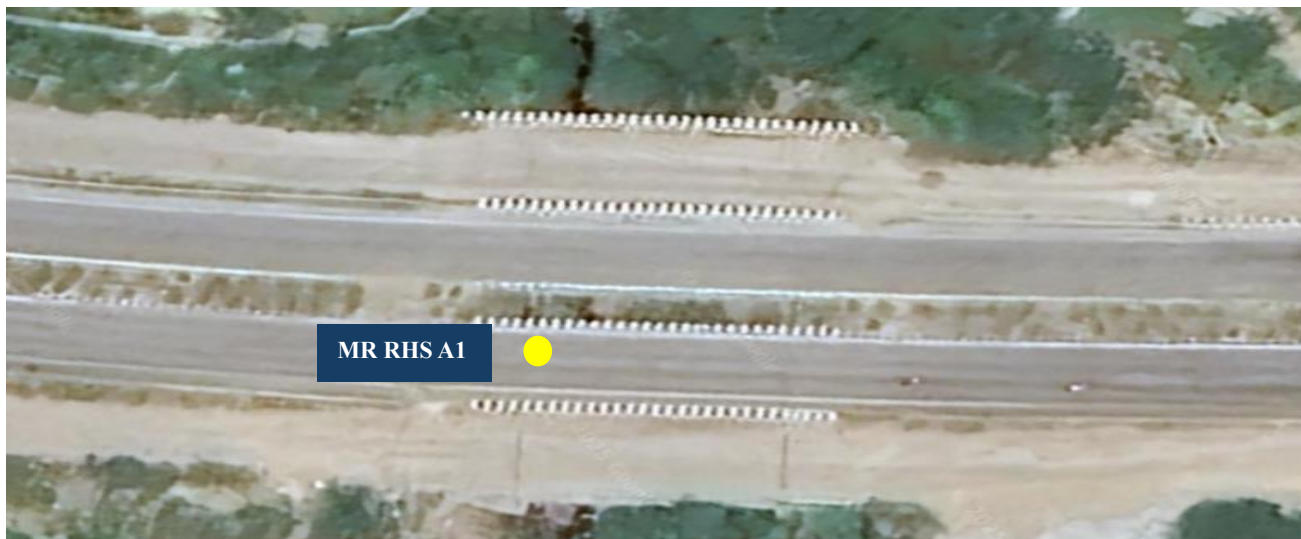
MR RHS A1 (25.119613597341285, 75.45946884283508)

- **Vertical Displacement (VV)** Vertical displacement shows a predominantly positive and strengthening trend from February through June 2025.
- **Horizontal Displacement (VH)** Horizontal displacement exhibits moderate to high variability, ranging roughly between -2 mm and +15 mm.

- **January-February 2025:** VH remains slightly positive (+2–4 mm), while VV decreases into negative values (down to -4 mm). This indicates minor lateral movement concurrent with short-term vertical settlement.
- **April 2025:** VH reaches a local peak (+15 mm) while VV slightly decreases (+8 mm), implying lateral displacement dominance during this interval.
- **June 2025:** VV again approaches +16–17 mm, while VH remains elevated (+10–11 mm), indicating continued vertical accumulation with stable lateral movement.

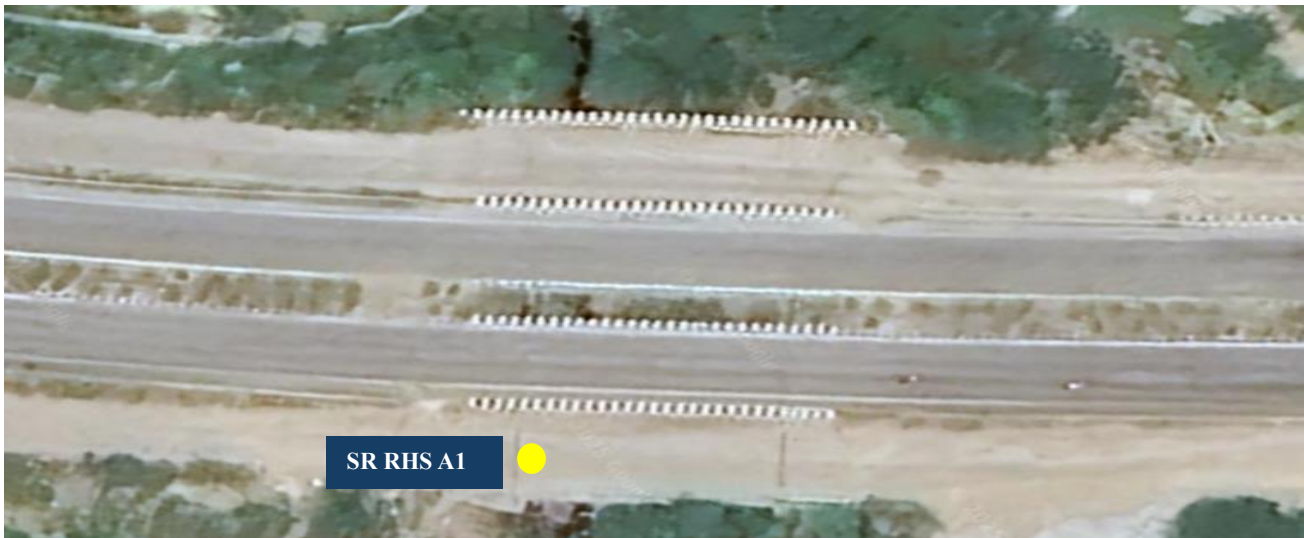
SR RHS A1 (25.119613597341285, 75.45946884283508)

- **Vertical Displacement (VV)** Vertical displacement remains consistently negative throughout the monitoring period (Jan–Jun 2025), indicating sustained downward movement.
- **Horizontal Displacement (VH)** Horizontal displacement remains consistently positive, ranging approximately from +5 mm to +20 mm, indicating continuous lateral movement in a dominant direction.

- **February 2025:** VV shows a noticeable downward shift (–10 to –12 mm), while VH remains moderately positive (+8 to +10 mm), indicating increasing vertical settlement without corresponding lateral acceleration.
- **May 2025:** VV deepens further (–15 to –18 mm), while VH slightly dips before recovering, indicating short-term lateral relaxation under continued vertical settlement.
- **June 2025:** VV reaches its maximum downward displacement (–22 to –25 mm), while VH peaks around +20 mm.

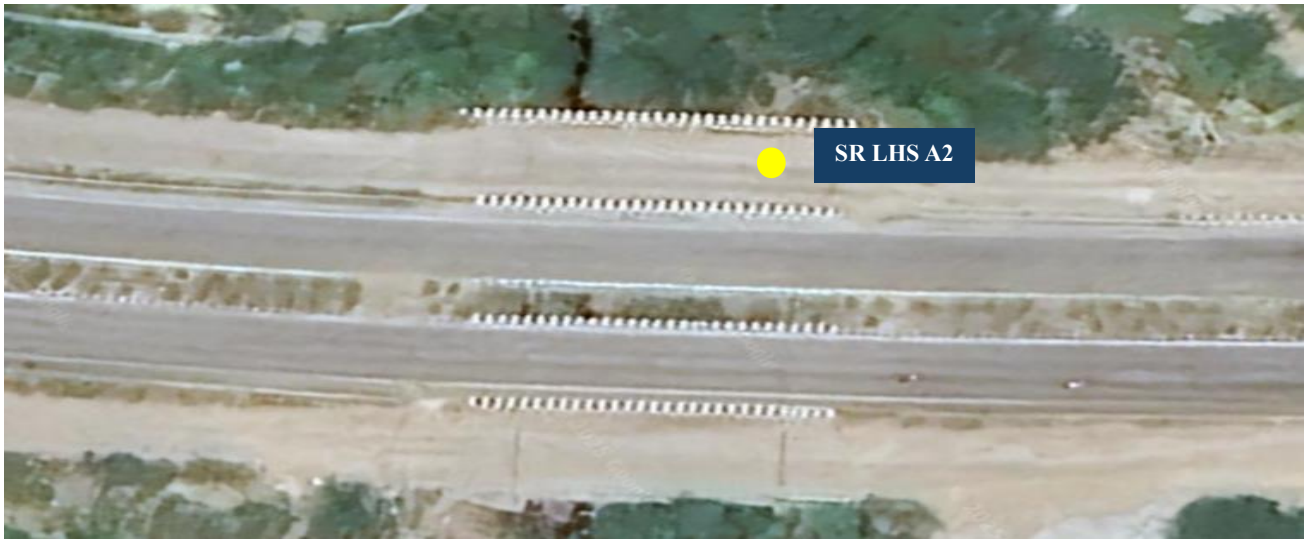
SR LHS A2(25.119613597341285, 75.45946884283508)

- **Horizontal Displacement (VH)** Horizontal displacement exhibits bidirectional variability, ranging approximately from –6 mm to +16 mm. While generally positive, intermittent negative excursions indicate short-lived reversals in lateral movement, suggesting sensitivity to transient loading or environmental effects.
- **Vertical Displacement (VV)** Vertical displacement remains consistently positive throughout the monitoring period (Jan–Jun 2025), indicating sustained uplift behaviour.

- **February 2025:** VV rises sharply to around +16 mm, while VH oscillates near neutral (–1 to +2 mm), reflecting strong vertical response with minimal lateral contribution.
- **June 2025:** VH peaks near +17 mm, while VV stabilizes around +13–15 mm, indicating sustained lateral movement under continued vertical uplift.

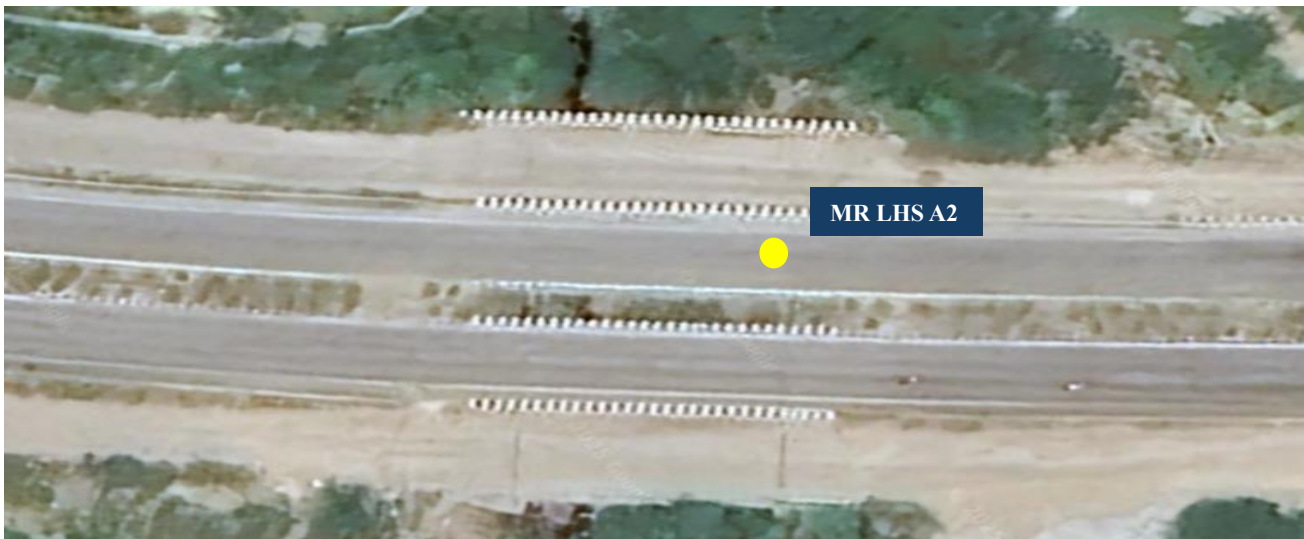
MR LHS A2(25.119613597341285, 75.45946884283508)

- Vertical Displacement (VV)** Vertical displacement remains predominantly negative throughout the monitoring period (Jan–Jun 2025), indicating sustained downward movement.
- Horizontal Displacement (VH)** Horizontal displacement shows high variability, fluctuating between approximately +8 mm and –17 mm.

- February 2025:** Both VH and VV fluctuate sharply. VV briefly rises toward –2 mm before dropping again, while VH oscillates between positive and negative values, reflecting unstable transitional behaviour.
- June 2025:** VH reaches its most negative level (–17 mm), while VV stabilizes near –10 to –12 mm, reflecting continued lateral progression under stabilized vertical settlement.

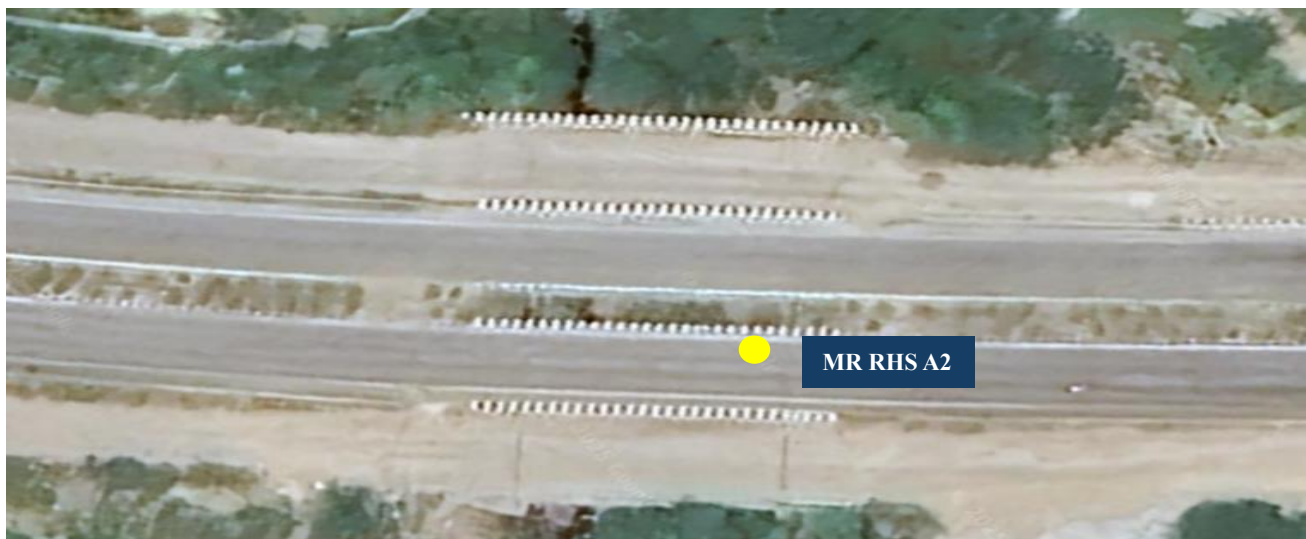
MR RHS A2 (25.119670350946787, 75.45979502060804)

- **Vertical Displacement (VV)** Vertical displacement remains consistently negative throughout the monitoring period (Jan–Jun 2025), indicating continuous downward movement.
- **Horizontal Displacement (VH)** Horizontal displacement shows significant variability, ranging approximately from +5 mm to –25 mm. The overall trend transitions from mild positive movement early in the monitoring period to pronounced negative displacement toward the end, indicating a directional shift in lateral response.

- **February 2025:** VH fluctuates around neutral (–2 to +4 mm), while VV remains moderately negative (–5 to –8 mm), reflecting transitional behaviour with limited directional dominance.
- **June 2025:** VH reaches its lowest value (–25 mm), while VV also declines further (–22 mm), marking the most critical deformation phase observed in the monitoring period.

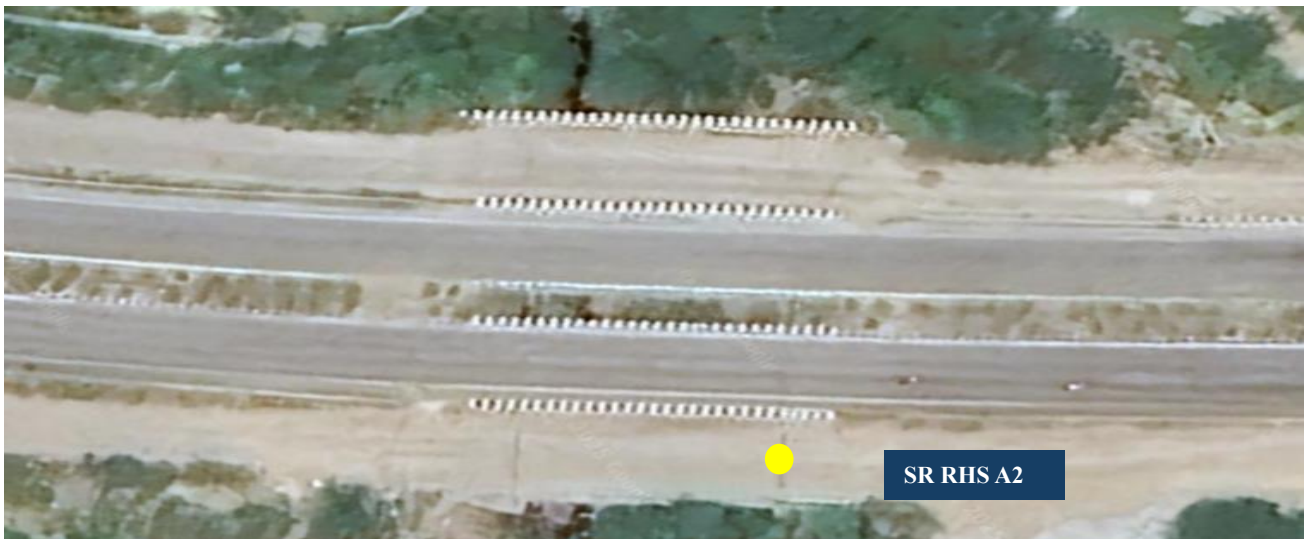
SR RHS A2 (25.119670350946787, 75.45979502060804)

- **Vertical Displacement (VV)** Vertical displacement shows a predominantly positive trend throughout the monitoring period (Jan–Jun 2025), indicating sustained uplift.
- **Horizontal Displacement (VH)** Horizontal displacement remains consistently negative, ranging approximately from –5 mm to –28 mm. The magnitude increases steadily over time, indicating continuous lateral movement in a dominant direction with limited recovery.

- **Feb 2025:** VH gradually deepens to around –10 mm, while VV fluctuates mildly between –2 mm and +4 mm, suggesting early-stage lateral progression under relatively stable vertical conditions.
- **May 2025:** VH continues trending negatively (–15 to –18 mm), while VV increases steadily toward +8 mm, indicating renewed vertical uplift alongside sustained lateral movement.
- **June 2025:** VH reaches its most negative value (–28 mm), while VV peaks near +14 mm, marking a phase of simultaneous high lateral displacement and vertical uplift
