# **LIDAR Inspection Report of MNB ch.1022+850**

**Bridge No:** 1023/2

**Bridge Chainage:** 1022+850

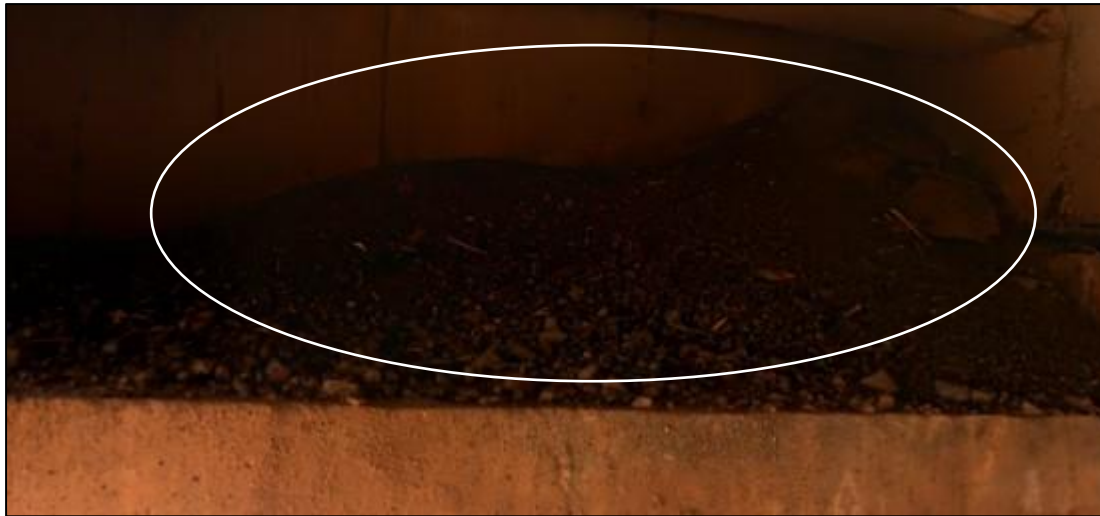
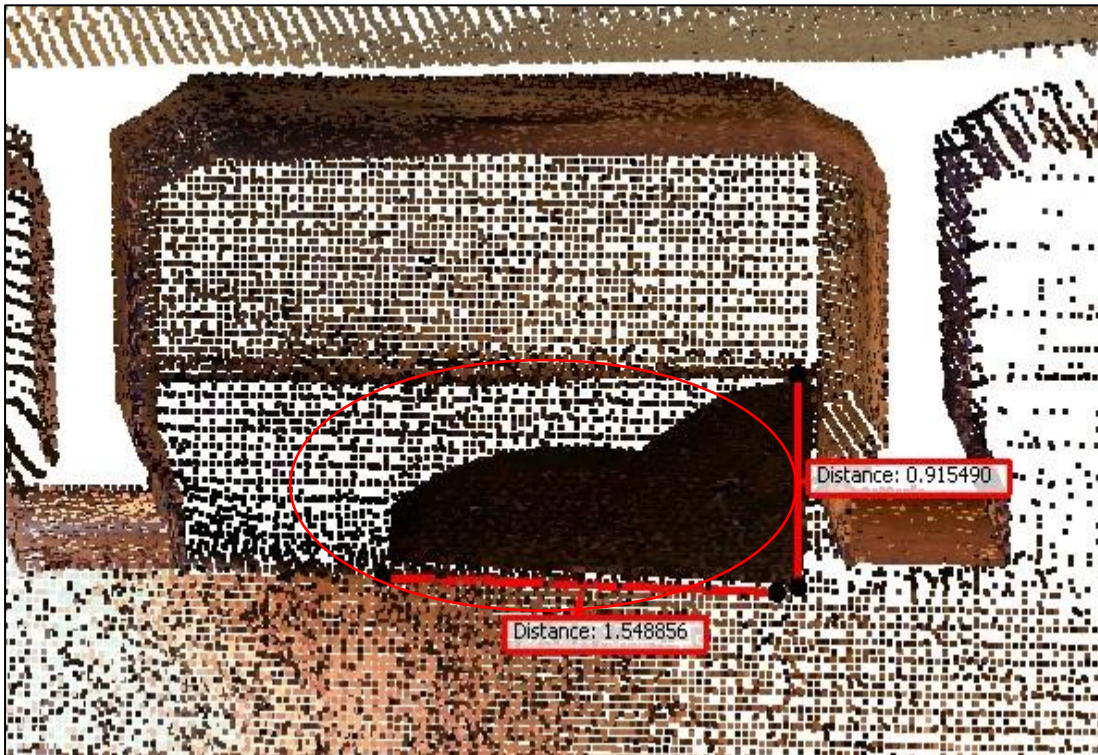
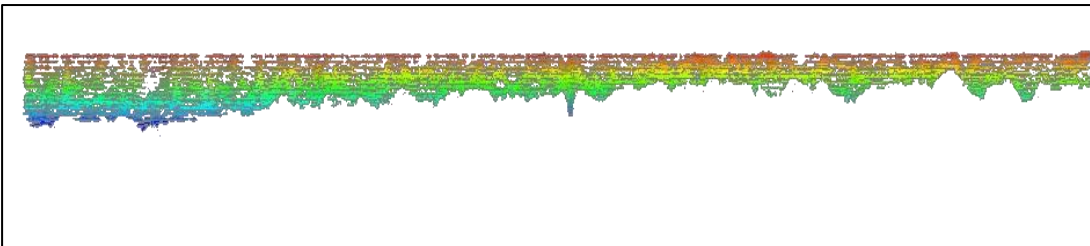
| Element Name | Observation | Location of Distress | Photo No. | Units | Distress Details | | | Area of Repair (Sq./RM T/m3) |
|---|---|---|---|---|---|---|---|---|
| Abutment 2 | Silt And Dibrit | - | 1 | Sq m | 1.548 | 0.915 | - | 1.416 |

1. Silt & Debris observed on A2 (LHS) B2, measuring 1.548 m in length and 0.915 m in width, covering an area of 1.416 m<sup>2</sup>.

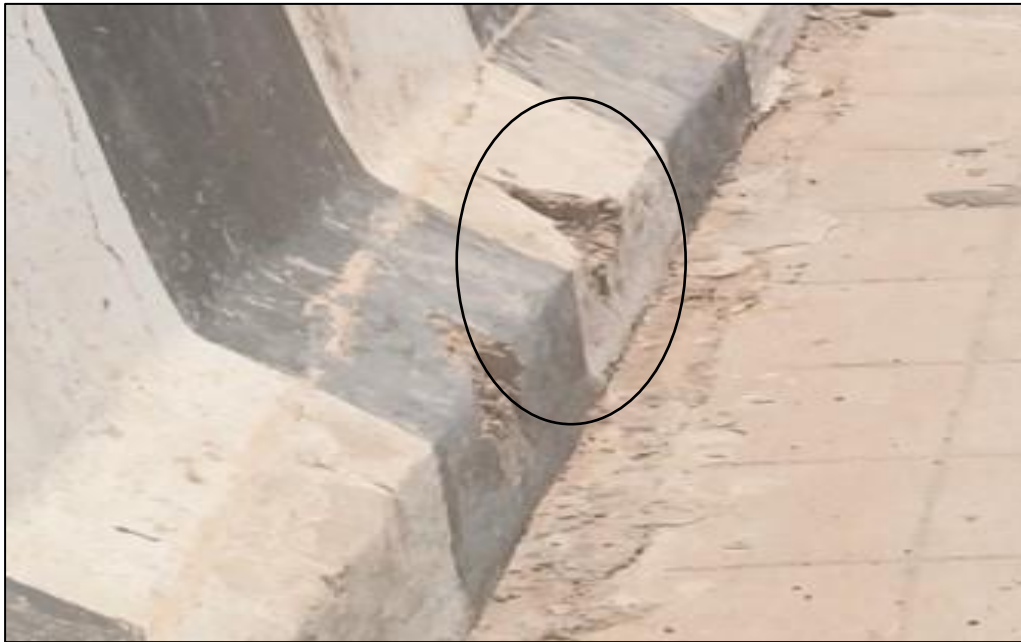
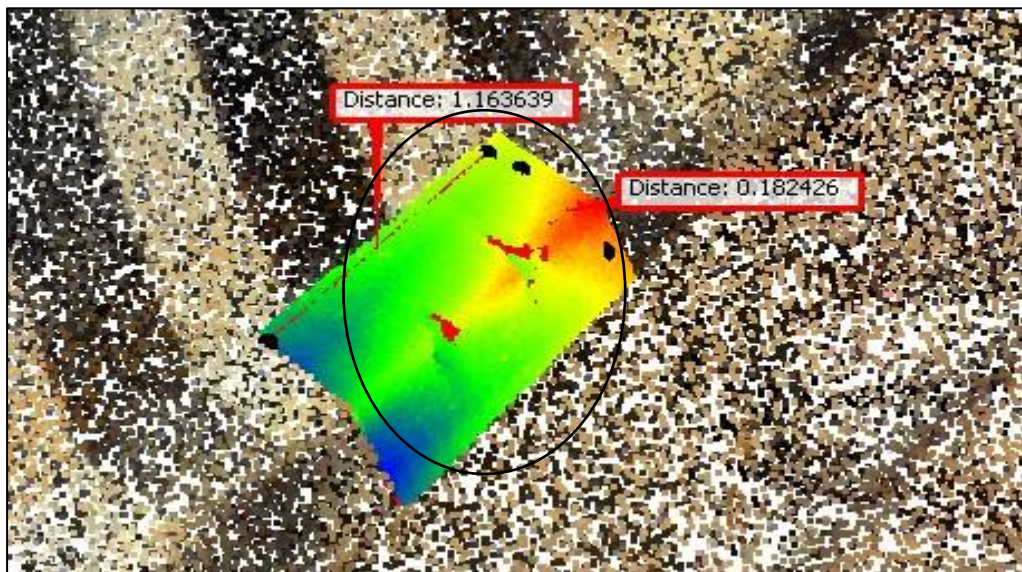
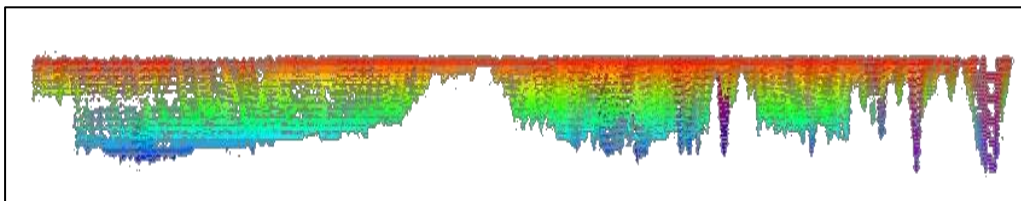
| Element Name | Observation | Location of Distress | Photo No. | Units | Distress Details | | | Area of Repair (Sq./RM T/m3) |
|---|---|---|---|---|---|---|---|---|
| Crash Barrier | Damage | - | 2 | Sq m | 1.163 | 0.182 | - | 0.211 |

2. Crash Barrier Damage observed on A1 (LHS), measuring 1.163 m in length and 0.182 m in width, covering an area of 0.211 m<sup>2</sup>.

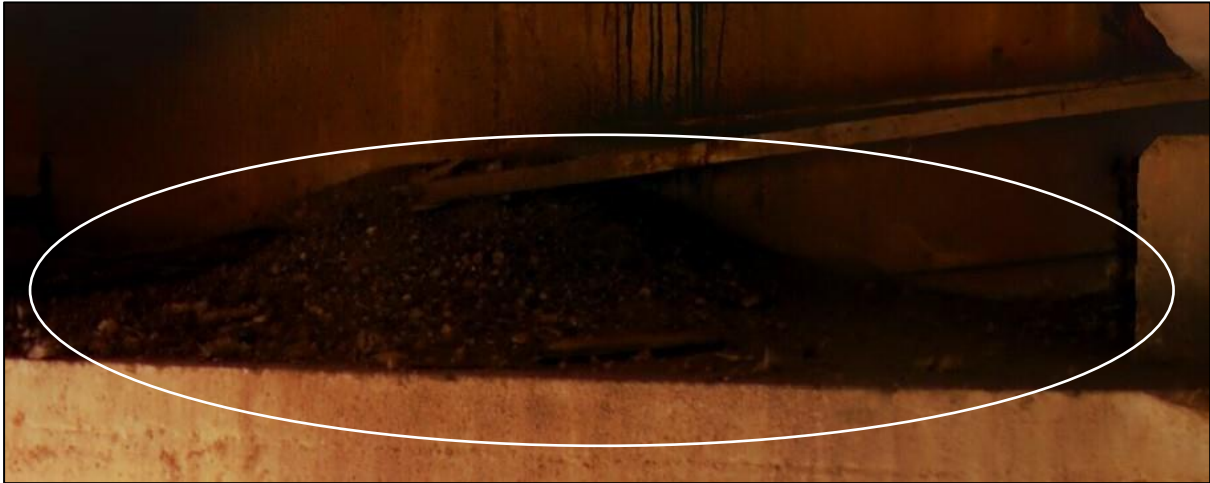
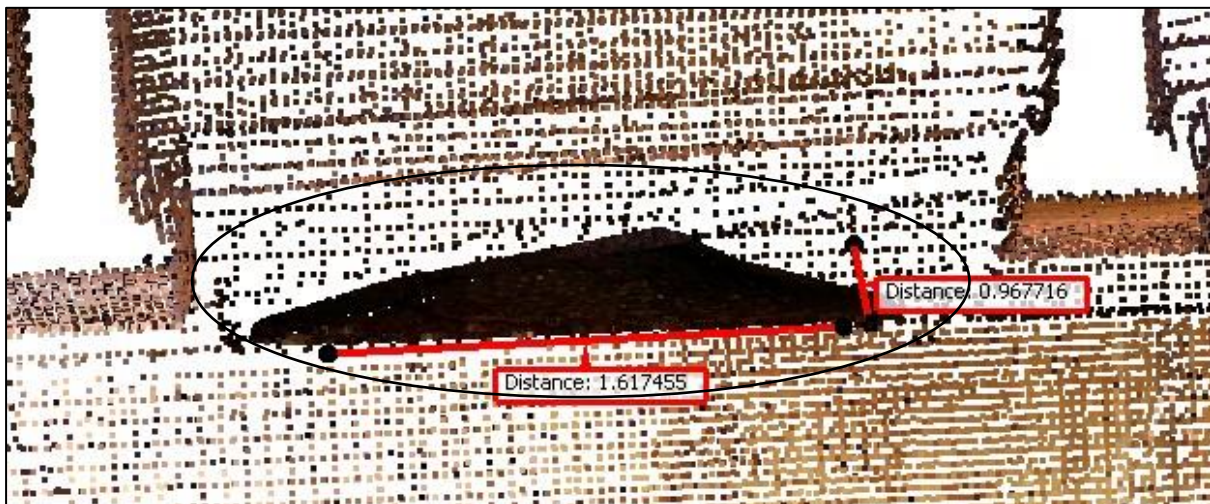
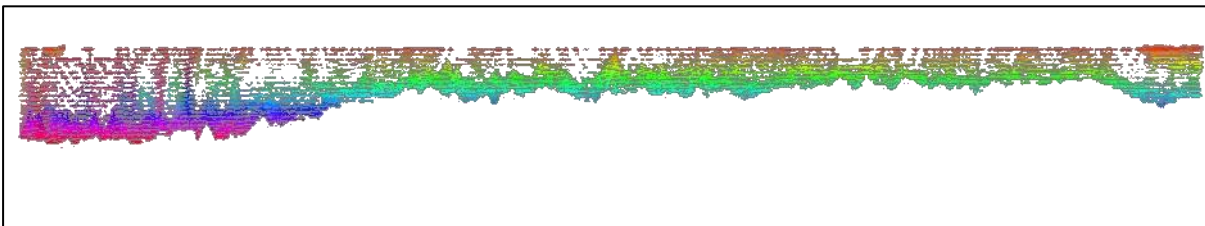
| Element Name | Observation | Location of Distress | Photo No. | Units | Distress Details | | | Area of Repair (Sq./RM T/m3) |
|---|---|---|---|---|---|---|---|---|
| Abutment 2 | Silt And Dibrit | - | 3 | Sq m | 1.617 | 0.967 | - | 1.563 |

3. Silt & Debris observed at B2 (A2 RHS), measuring 1.617 m in length and 0.967 m in width, covering an area of 1.563 m<sup>2</sup>.

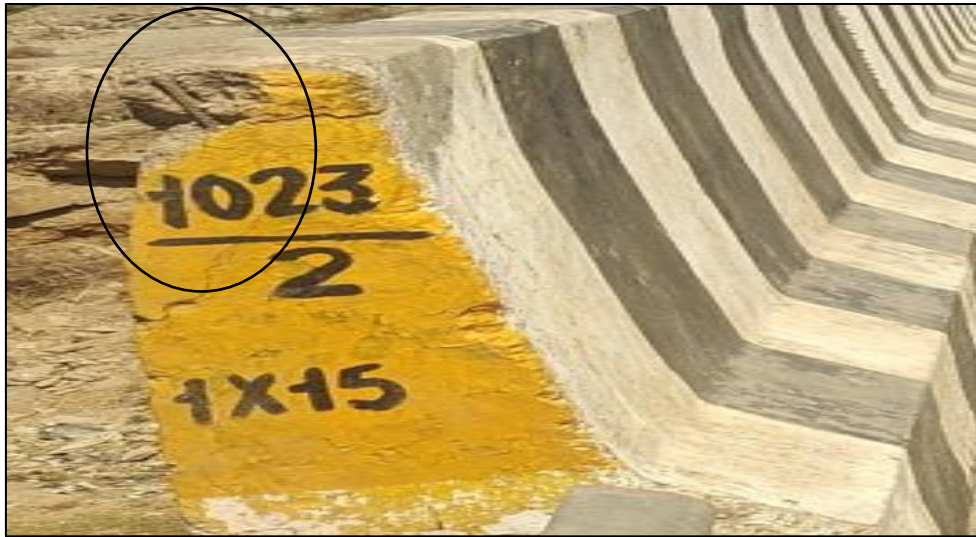
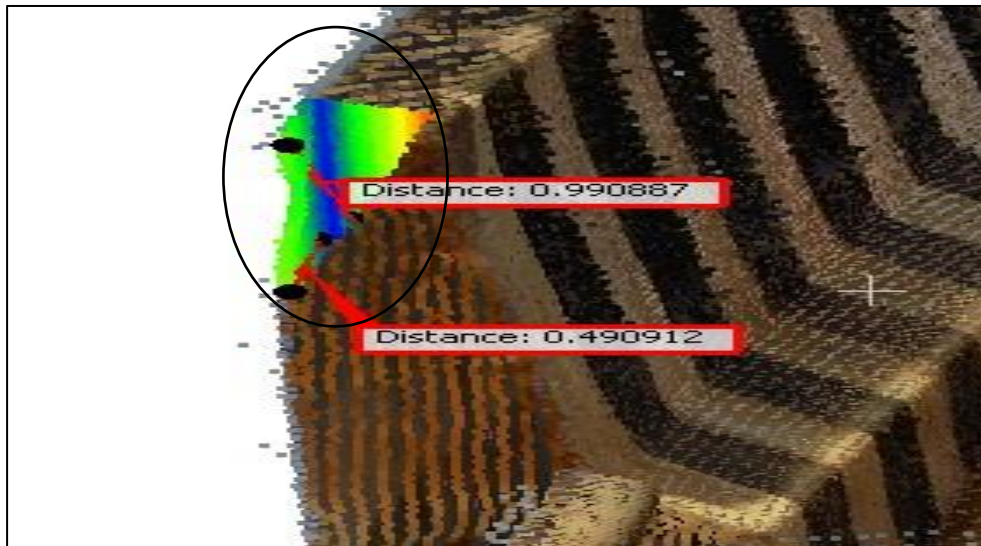
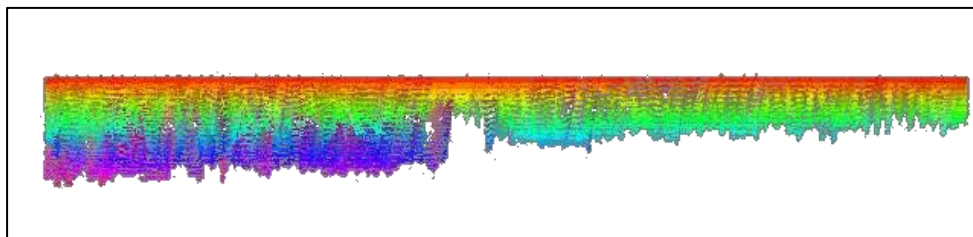
| Element Name | Observation | Location of Distress | Photo No. | Units | Distress Details | | | Area of Repair (Sq./RM T/m3) |
|---|---|---|---|---|---|---|---|---|
| Abutment 2 & Crash Barrier | SE & Damage | - | 4 | Sq m | 0.990 | 0.490 | - | 0.485 |

**4. Steel Exposed (SE) and Crash Barrier Damage observed on A2 (RHS), measuring 0.990 m in length and 0.490 m in width, covering an area of 0.485 m<sup>2</sup>.**
