# **LIDAR Inspection Report of VUP ch.1024+000**

**Bridge Chainage:** 1024+000(CKRP)

- **Bridge No:** -
- **Chainage:** 1024+000
- **Structure type:** VUP

- **CKRP:** Chittorgarh to kota
- **State:** Rajasthan NH 27
- **Zone:** RJ-06

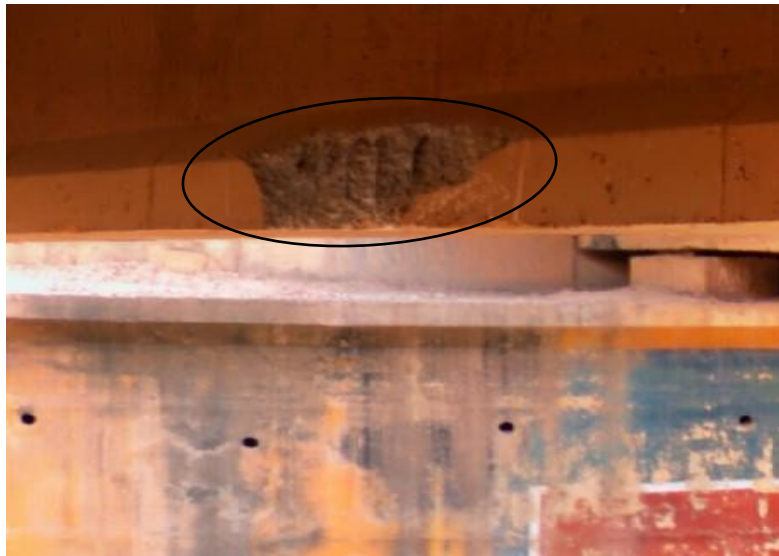
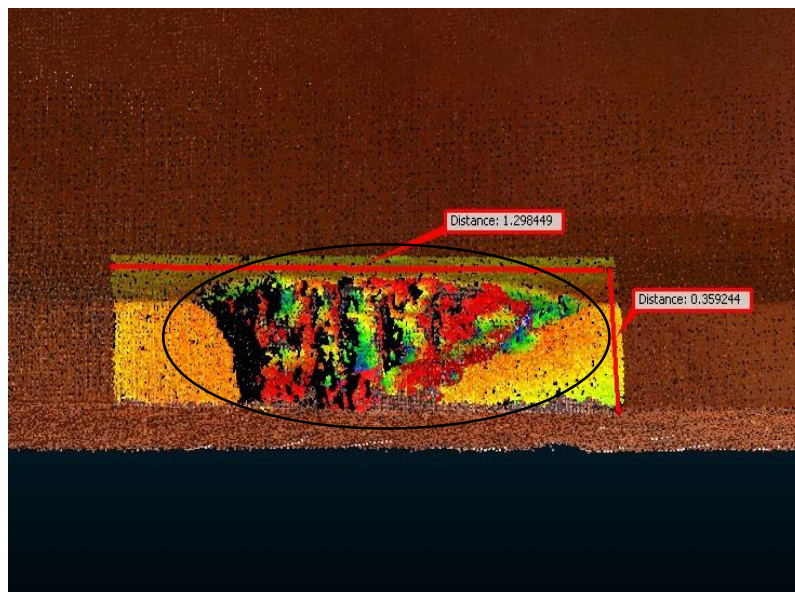
| Element Name | Observation | Location of Distress | Photo No. | Units | Distress Details | | | Area of Repair (Sq.m/R MT/m3) |
|---|---|---|---|---|---|---|---|---|
| Abutment 1 | Damage | - | 1 | M | 1.29 | 0.35 | 0.040 | 0.018 |

**1. Damage observed on LHS A1 G1, measuring 1.29 m in length and 0.35 m in width. Depth ranges from 0.022(min) to 0.062 m (max), with an average depth of 0.040m. The calculated volume of the distress is 0.018m<sup>3</sup>.**

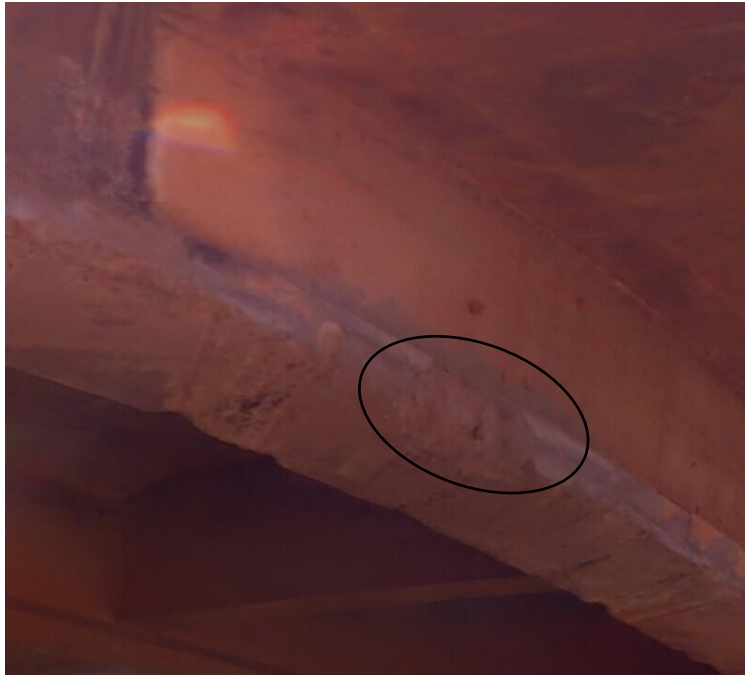
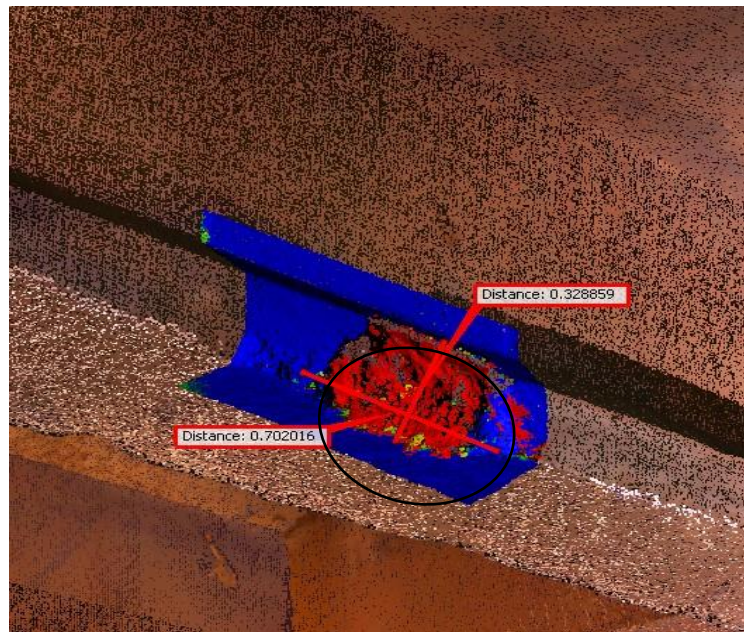
| Element Name | Observation | Location of Distress | Photo No. | Units | Distress Details | | | Area of Repair (Sq.m/RM T/m3) |
|---|---|---|---|---|---|---|---|---|
| Girder 2 | Damage | - | 1 | M | 0.70 | 0.32 | 0.08 | 0.017 |

**2. Damage observed on RHS G2, measuring 0.70 m in length and 0.32 m in width. Depth ranges from 0.03(min) to 0.13 m (max), with an average depth of 0.08m. The calculated volume of the distress is 0.017m<sup>3</sup>.**
