# **LIDAR Inspection Report of VUP ch.1026 + 950**

**Bridge Chainage:** 1026 + 950 (CKRP)

# **CH: 1026+950 – VUP**

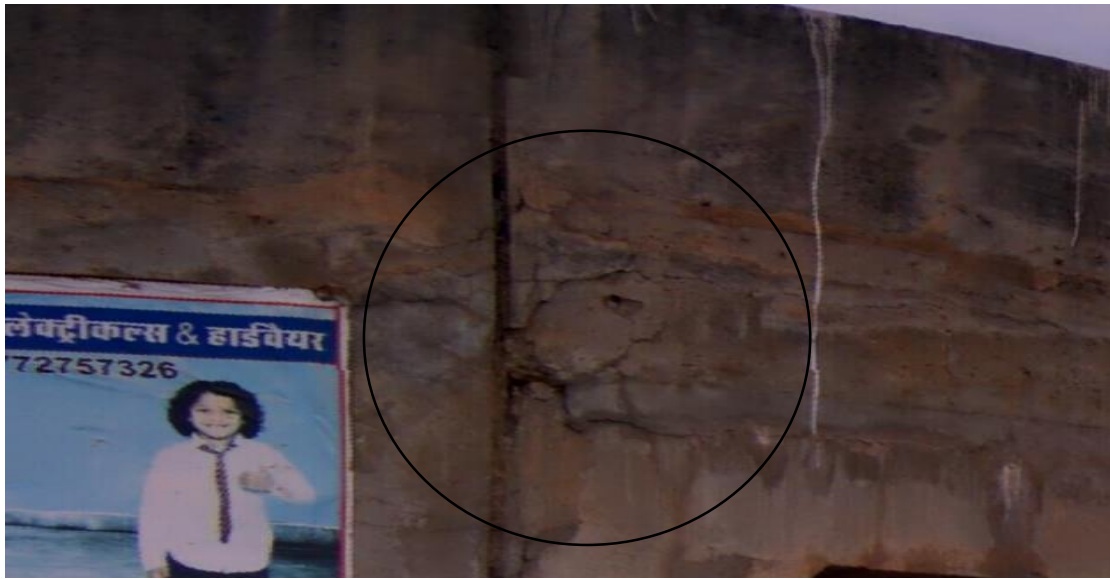
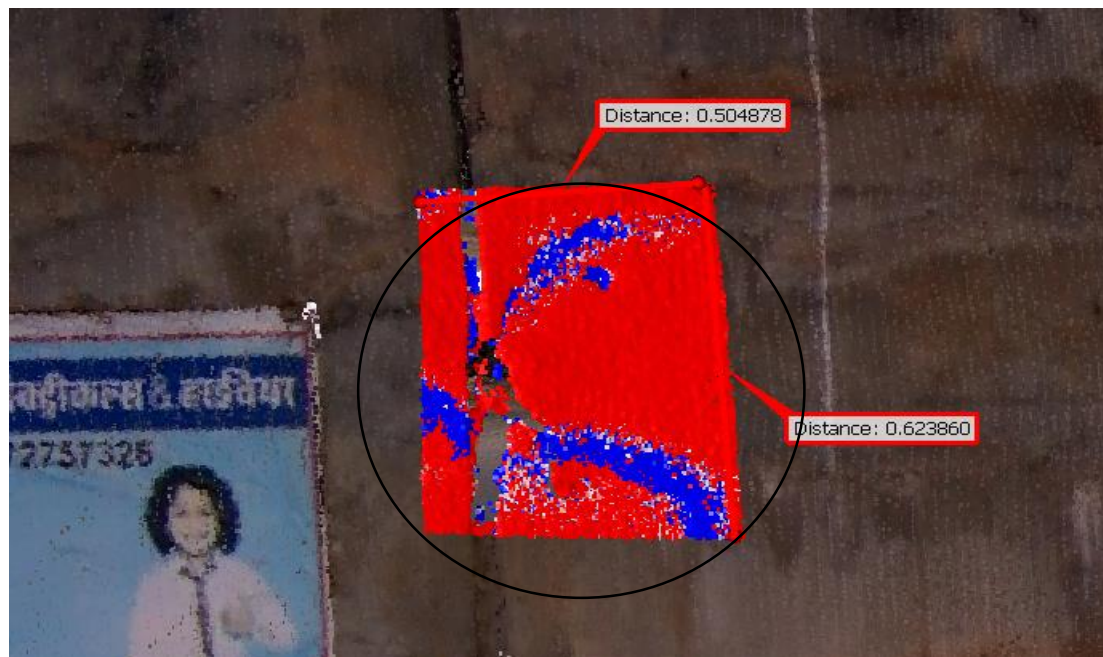
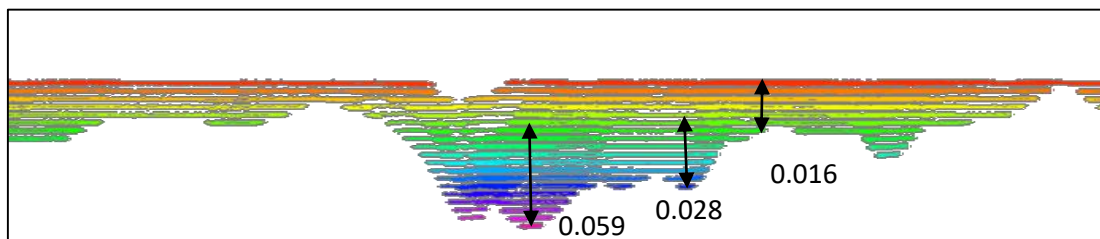
| Element Name | Observation | Location of Distress | Photo No. | Units | Distress Details | | | Area of Repair (Sq.m/ RMT/m 3) |
|---|---|---|---|---|---|---|---|---|
| Parapet Wall | Damage | | 1 | M | 0.62s | 0.50 | 0.028 | 0.0086 |

**1. Damage observed on Abutment 2 LHS Parapet Wall 1, measuring 0.62 m in length and 0.50 m in width, Depth ranges from 0.016 m (min) to 0.059 m (max), with an average depth of 0.028 m. The calculated volume of the distress is 0.0086 m<sup>3</sup>.**

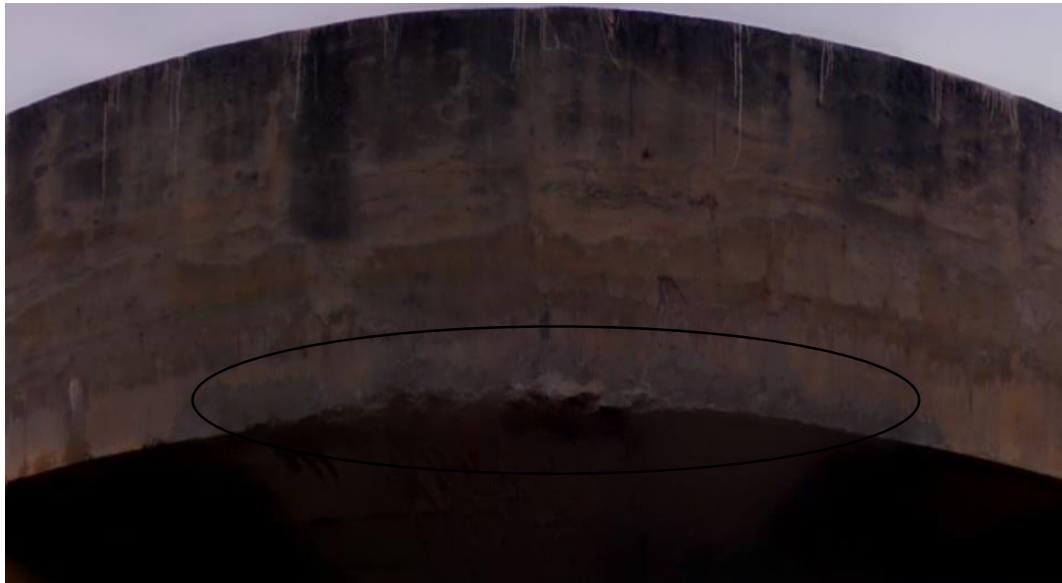
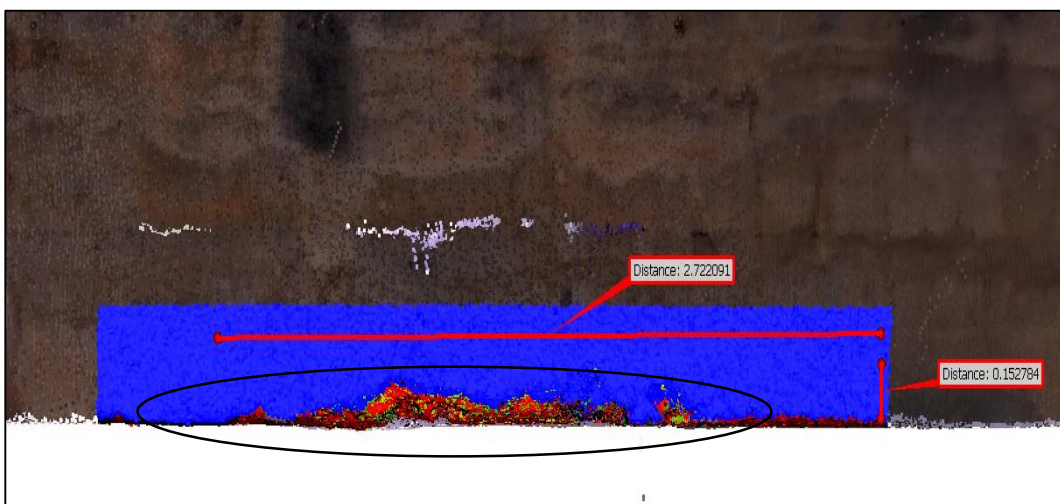
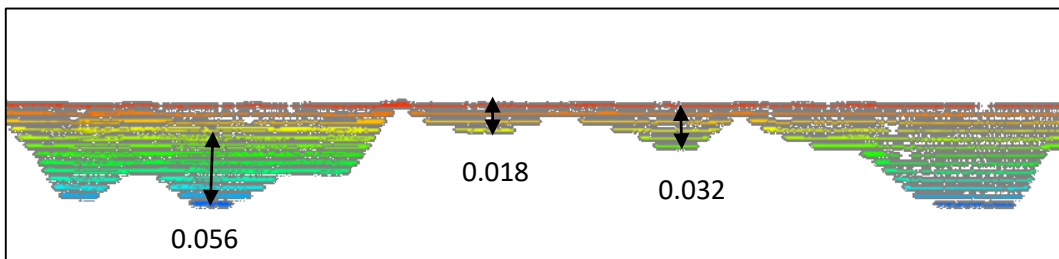
| Element Name | Observation | Location of Distress | Photo No. | Units | Distress Details | | | Area of Repair (Sq.m/ RMT/m 3) |
|---|---|---|---|---|---|---|---|---|
| Parapet Wall | Damage | | 2 | M | 2.72 | 0.15 | 0.032 | 0.0130 |

**2.Damage observed on LHS Parapet Wall, measuring 2.72 m in length and 0.15 m in width, Depth ranges from 0.018 m (min) to 0.056 m (max), with an average depth of 0.032 m. The calculated volume of the distress is 0.0132 m<sup>3</sup>.**

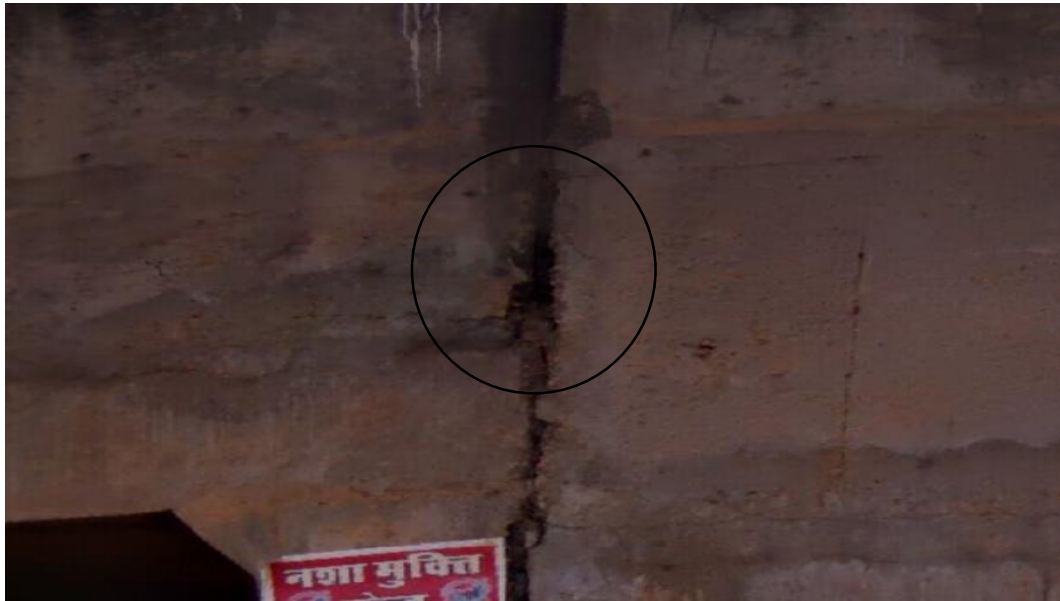
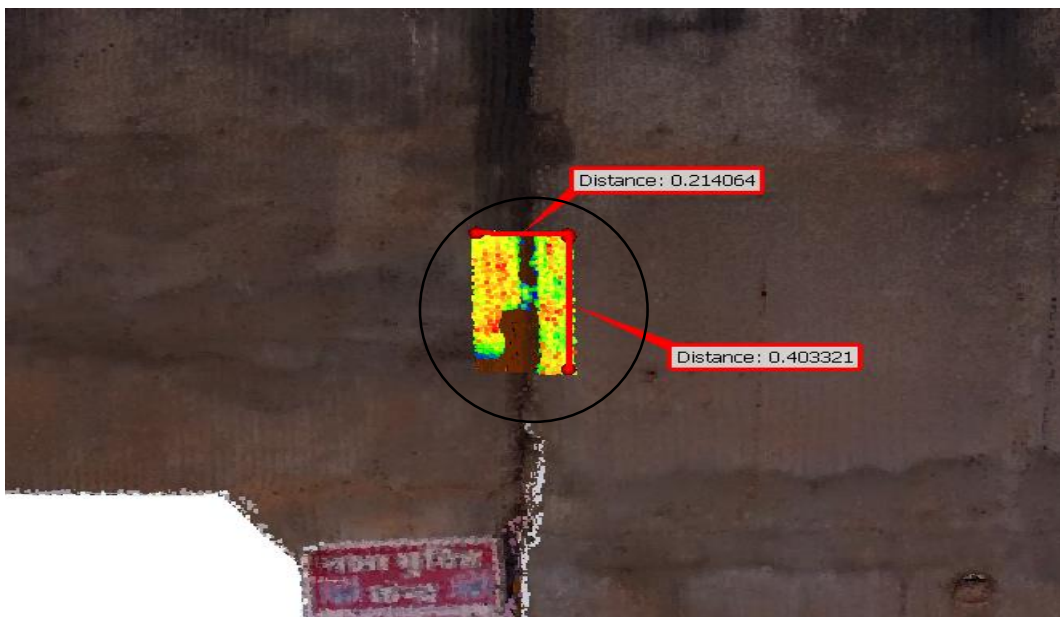
| Element Name | Observation | Location of Distress | Photo No. | Units | Distress Details | | | Area of Repair (Sq.m/ RMT/m 3) |
|---|---|---|---|---|---|---|---|---|
| Parapet Wall | Damage | | 3 | M | 0.40 | 0.21 | 0.033 | 0.0027 |

**3. Damage observed on Abutment 1 LHS Parapet Wall 2, measuring 0.40 m in length and 0.21 m in width, Depth ranges from 0.022 m (min) to 0.060 m (max), with an average depth of 0.033 m. The calculated volume of the distress is 0.0027 m<sup>3</sup>.**

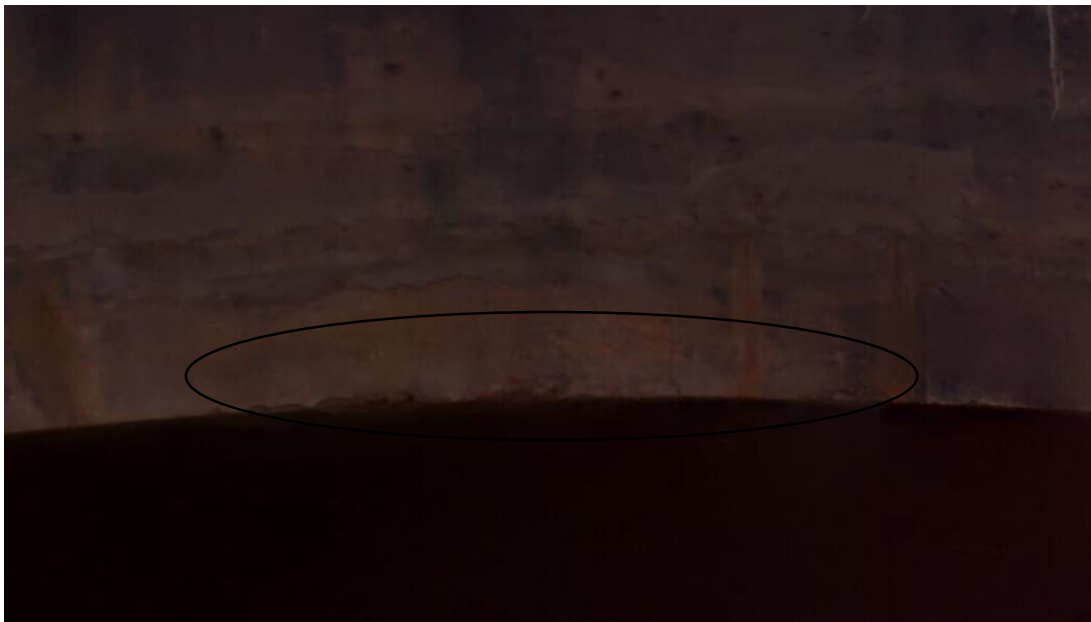
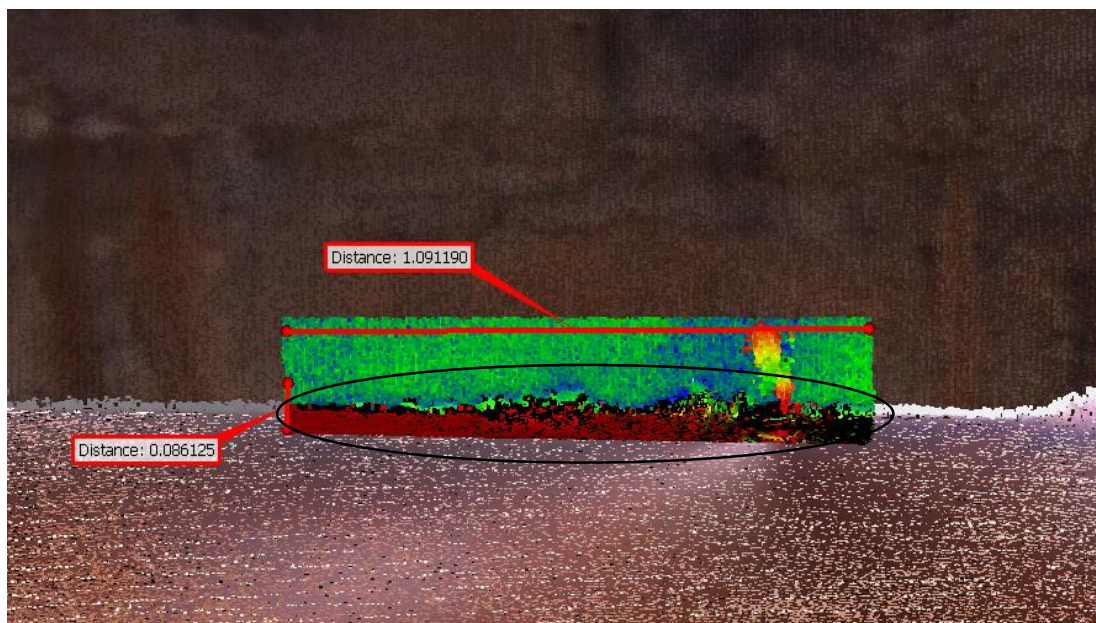
| Element Name | Observation | Location of Distress | Photo No. | Units | Distress Details | | | Area of Repair (Sq.m/ RMT/m 3) |
|---|---|---|---|---|---|---|---|---|
| Parapet Wall | Damage | | 4 | M | 1.09 | 0.08 | 0.031 | 0.0027 |

**4. Damage observed on RHS Parapet Wall 3, measuring 1.09 m in length and 0.08 m in width, Depth ranges from 0.022 m (min) to 0.057 m (max), with an average depth of 0.031 m. The calculated volume of the distress is 0.0027 m<sup>3</sup>.**

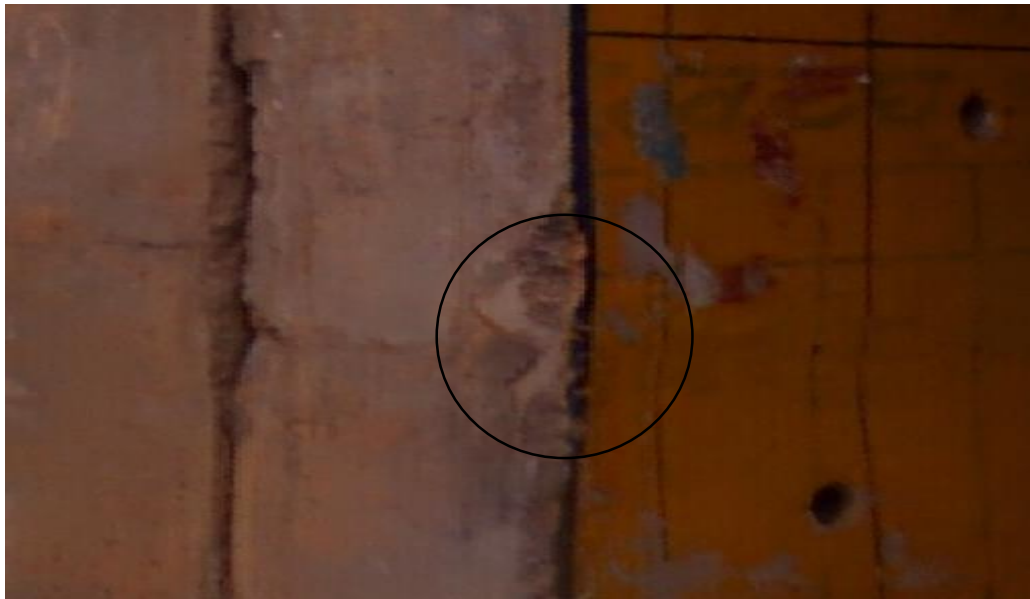
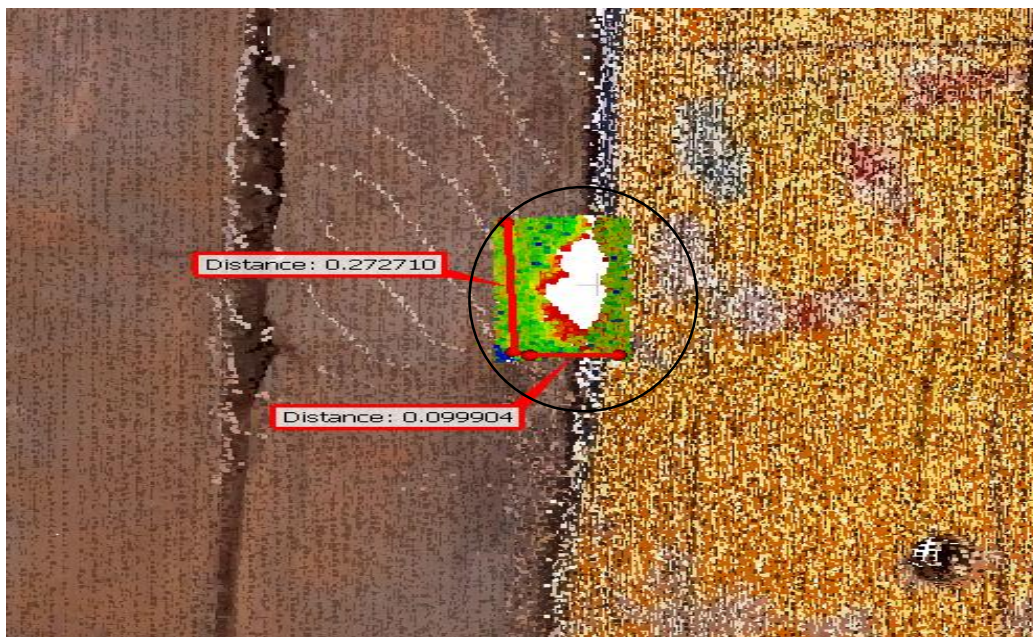
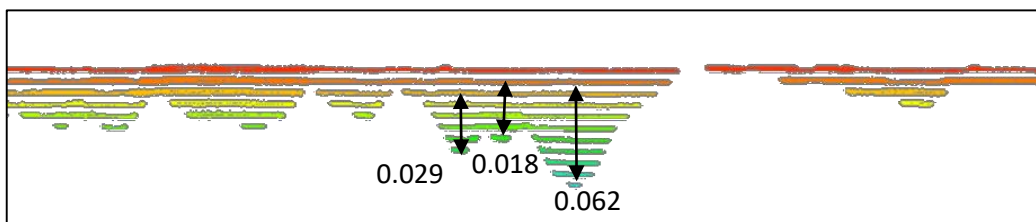
| Element Name | Observation | Location of Distress | Photo No. | Units | Distress Details | | | Area of Repair (Sq.m/ RMT/m 3) |
|---|---|---|---|---|---|---|---|---|
| Wing Wall | Damage | | 5 | M | 0.27 | 0.09 | 0.029 | 0.0007 |

**5. Damage observed on Abutment 1 RHS Wing Wall, measuring 0.27 m in length and 0.09 m in width, Depth ranges from 0.018 m (min) to 0.062 m (max), with an average depth of 0.029 m. The calculated volume of the distress is 0.0007 m<sup>3</sup>.**
