# **LIDAR Inspection Report of MNB ch.1027+400**

**Bridge No:** MNB - 1028/1

**Bridge Chainage:** 1027+400 (CKRP)

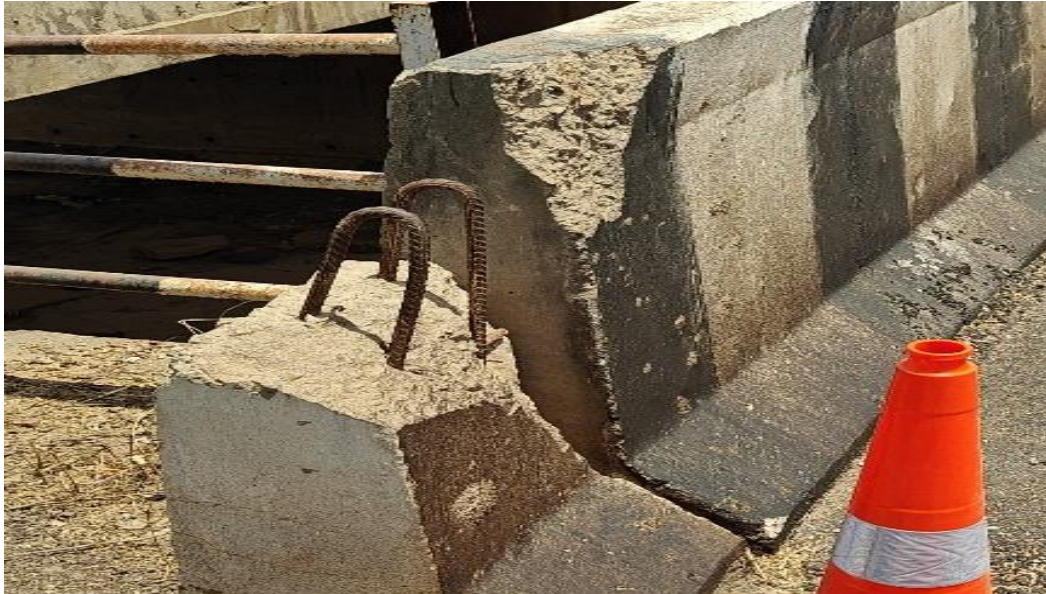
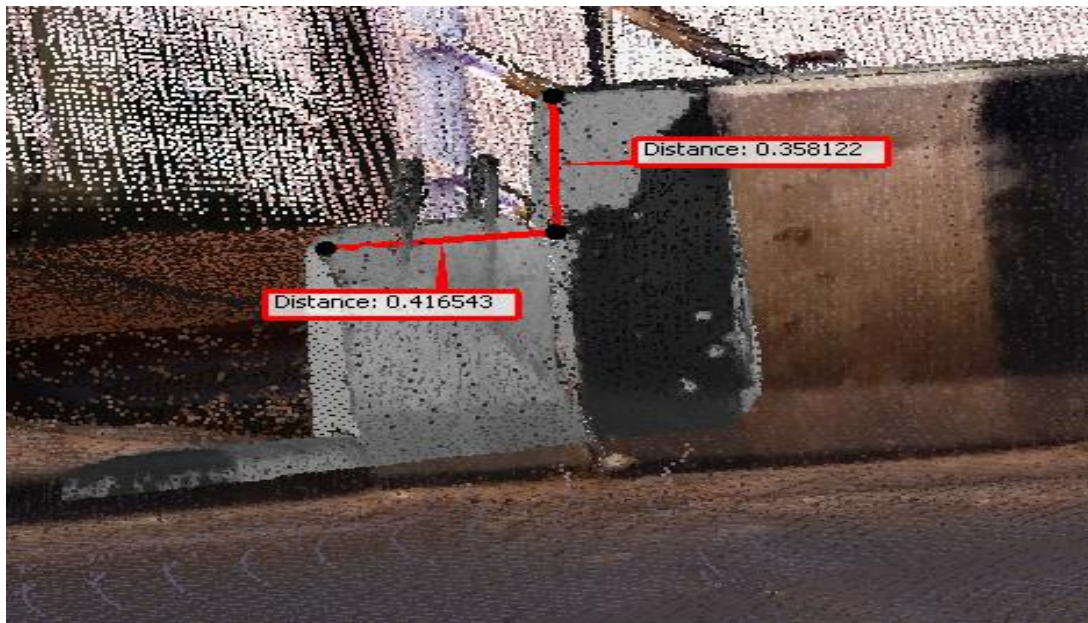
| Element Name | Observation | Location of Distress | Photo No. | Units | Distress Details | | | Area of Repair (Sq./RM T) |
|---|---|---|---|---|---|---|---|---|
| Median Crash Barrier | Damage | | 1 | | 0.41 | 0.36 | | 0.1476 |

1. Median damage observed on A1 RHS, measuring 0.41 m in length and 0.36 m in width, covering an area of 0.1476 m<sup>2</sup>.

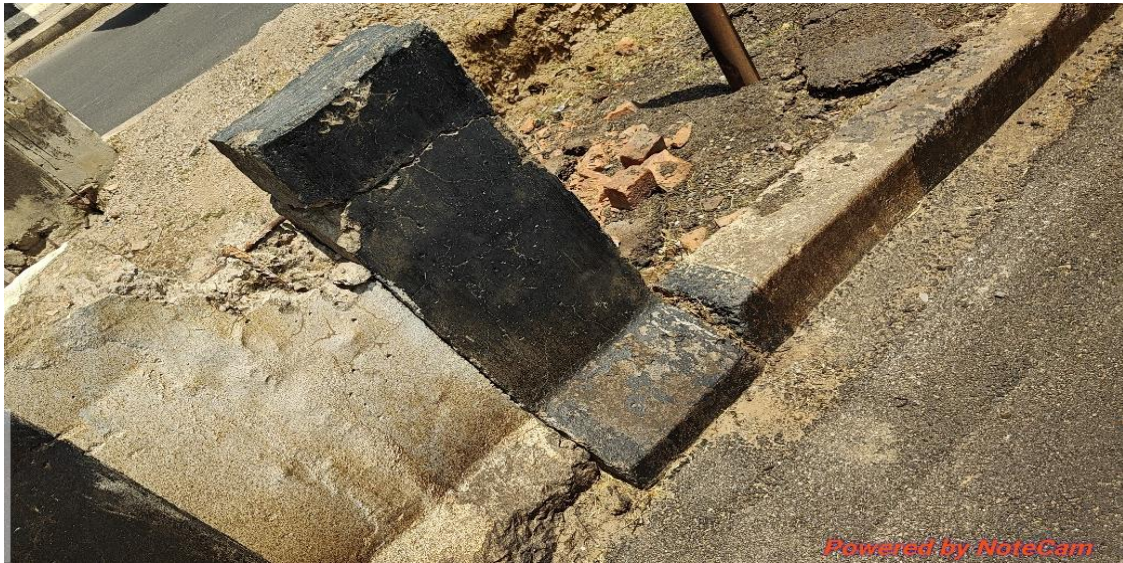
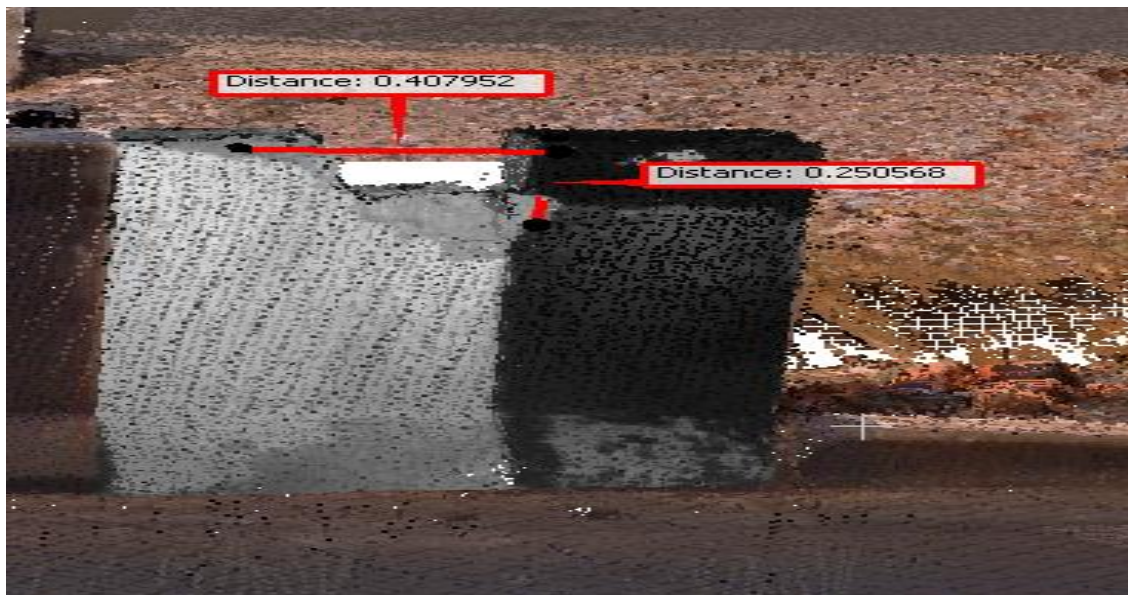
| Element Name | Observation | Location of Distress | Photo No. | Units | Distress Details | | | Area of Repair (Sq./RM T) |
|---|---|---|---|---|---|---|---|---|
| Median Crash Barrier | Damage | | 2 | | 0.40 | 0.25 | | 0.1 |

- 2. Median damage observed on A2 RHS, measuring 0.40 m in length and 0.25 m in width, covering an area of 0.100 m<sup>2</sup>.**

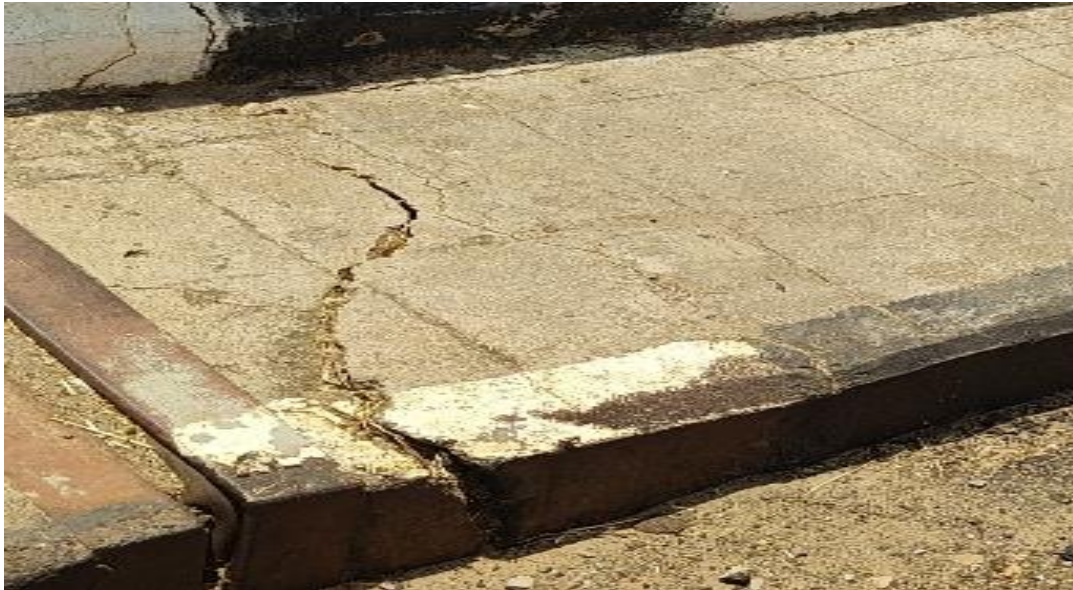
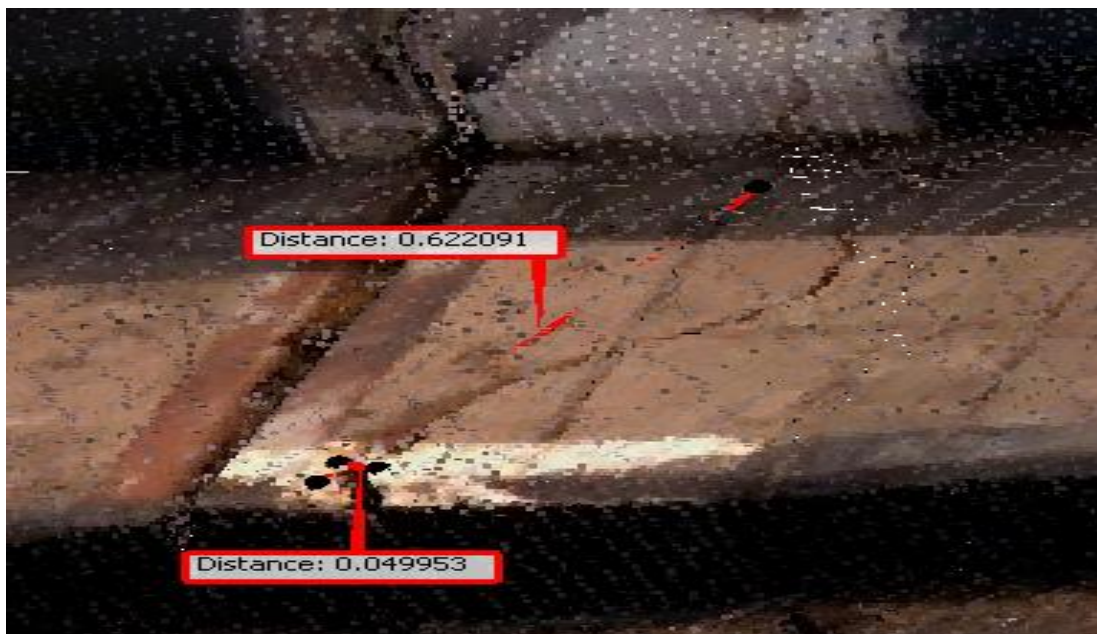
| Element Name | Observation | Location of Distress | Photo No. | Units | Distress Details | | | Area of Repair (Sq./RM T) |
|---|---|---|---|---|---|---|---|---|
| Footpath | Damage | | 3 | | 0.62 | 0.04 | | 0.0248 |

**3. Footpath damage observed on RHS, measuring 0.62 m in length and 0.04 m in width, covering an area of 0.0248 m<sup>2</sup>.**
