# **LIDAR Inspection Report of MNB ch.1027+740**

**Bridge No:** 1028/2

**Bridge Chainage:** 1027+740

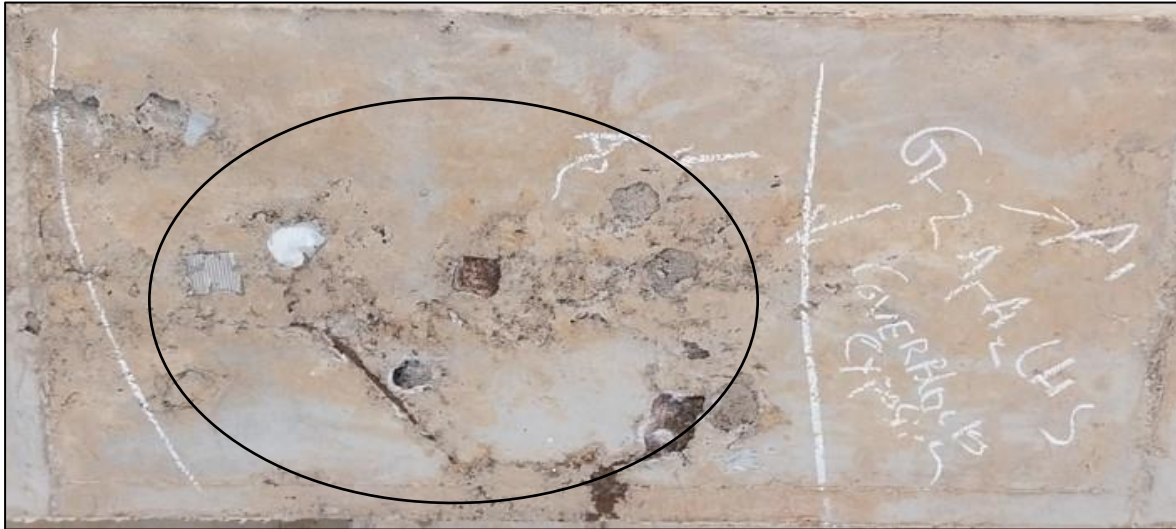
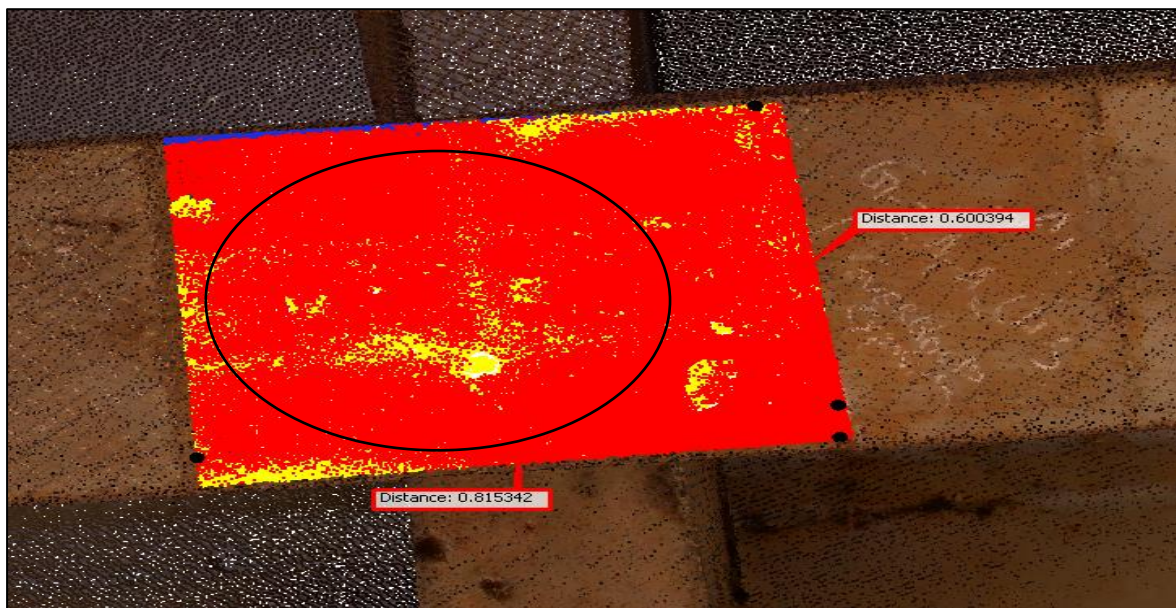
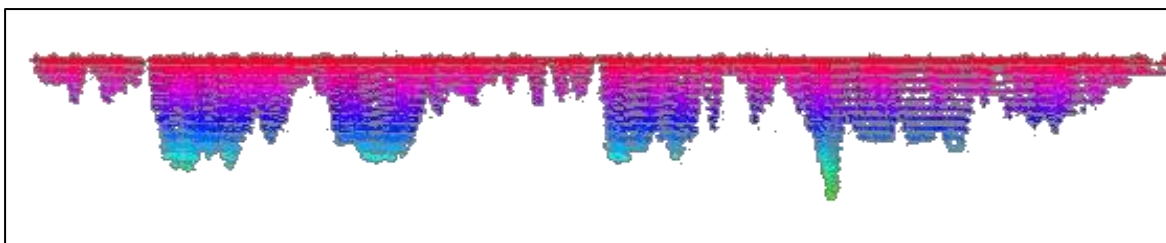
| Element Name | Observation | Location of Distress | Photo No. | Units | Distress Details | | | Area of Repair (Sq./RM T) |
|---|---|---|---|---|---|---|---|---|
| Girder | Cover Block Expose | - | 1 | Sq m | 0.81 | 0.60 | - | 0.486 |

- 1. Cover Block Expose observed on A1-A2 span (LHS), measuring 0.81 m in length and 0.60 m in width, covering an area of 0.486 m<sup>2</sup>.**

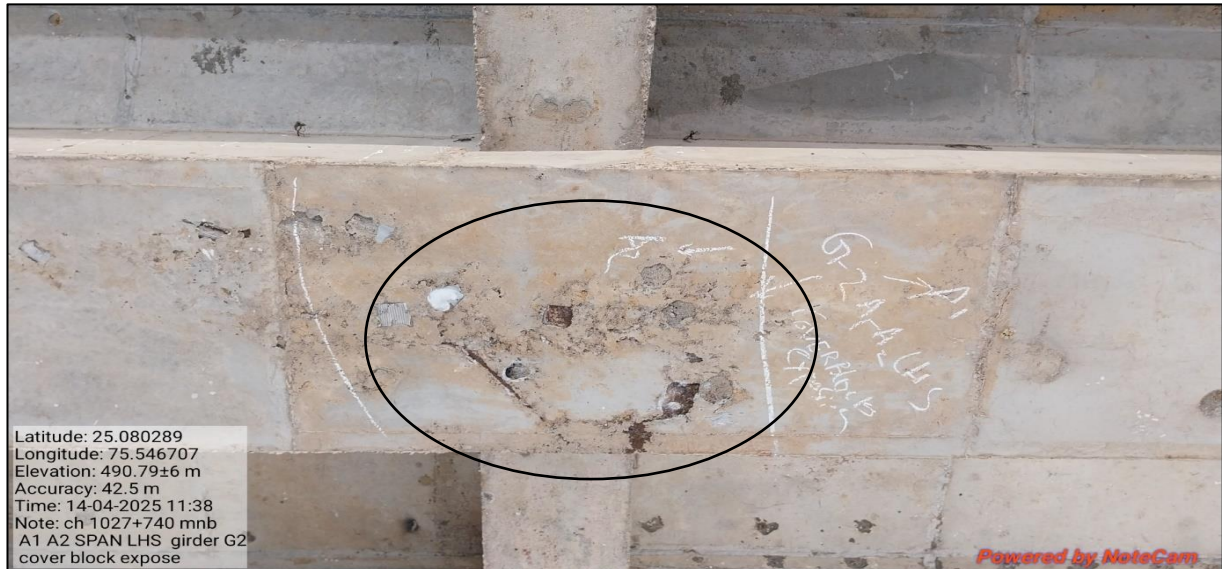
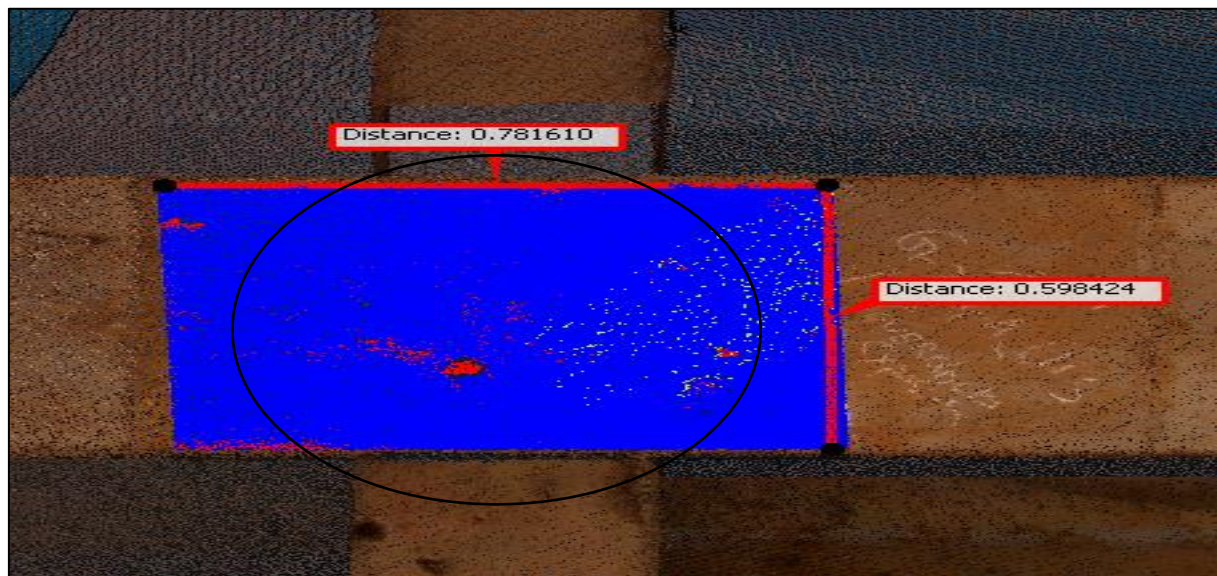
| Element Name | Observation | Location of Distress | Photo No. | Units | Distress Details | | | Area of Repair (Sq./RM T) |
|---|---|---|---|---|---|---|---|---|
| Girder | Cover Block Expose | - | 2 | Sq m | 0.78 | 0.59 | - | 0.4602 |

2. Cover Block Expose observed at G2, measuring 0.78 m in length and 0.59 m in width, covering an area of 0.4602 m<sup>2</sup>.

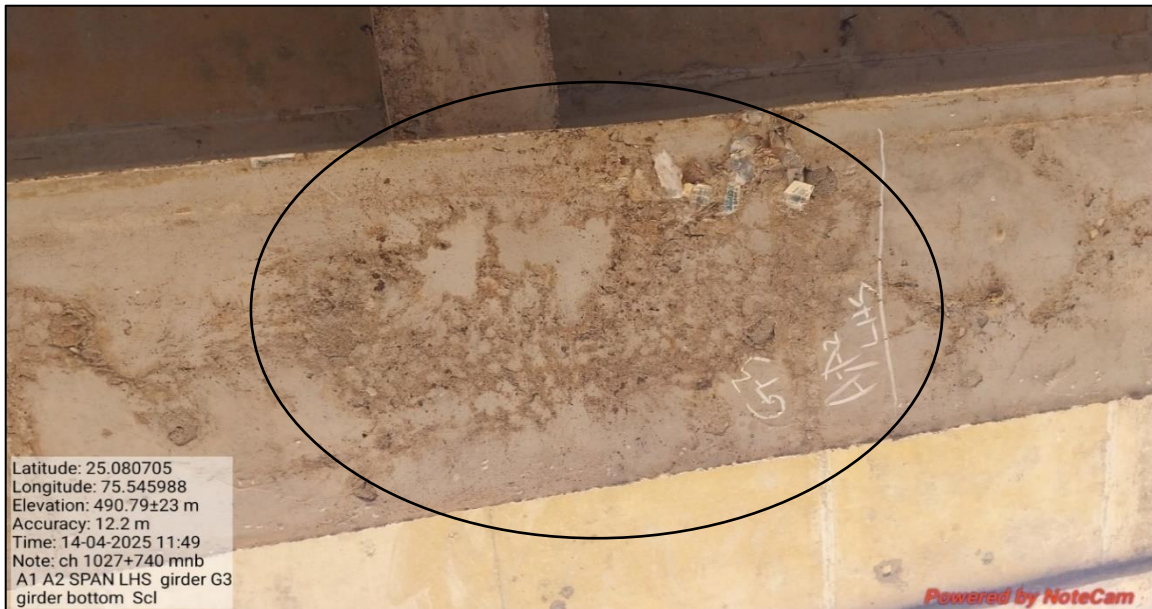
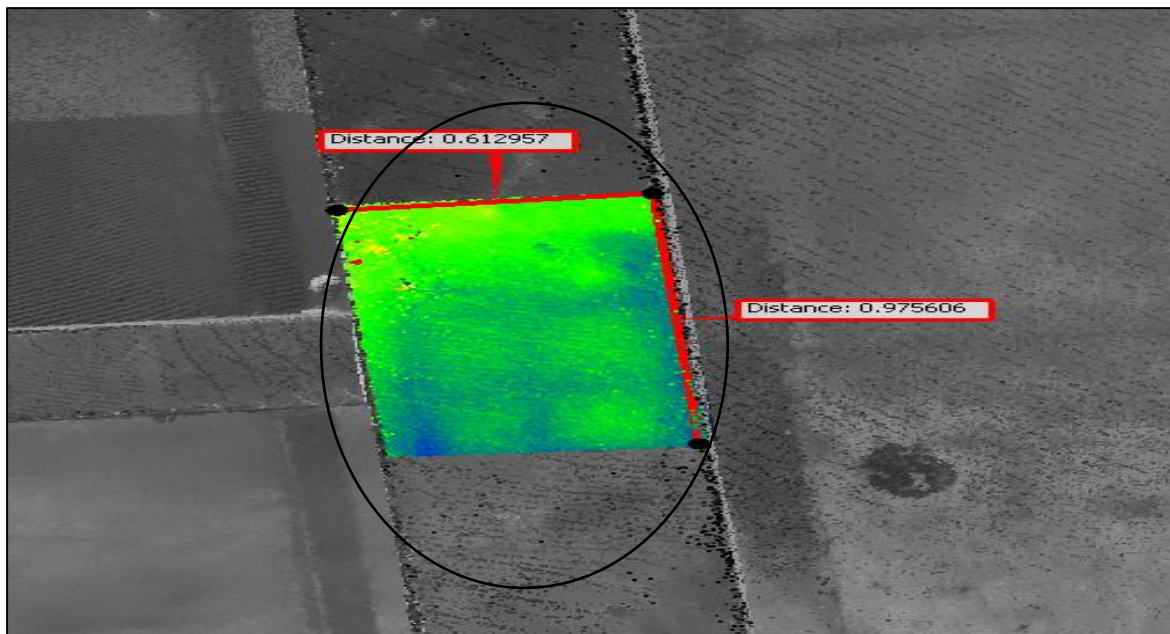
| Element Name | Observation | Location of Distress | Photo No. | Units | Distress Details | | | Area of Repair (Sq./RM T) |
|---|---|---|---|---|---|---|---|---|
| Girder | Scalling | - | 3 | Sq m | 0.97 | 0.61 | - | 0.5917 |

3. Scaling (SCL) observed in G3, measuring 0.97 m in length and 0.61 m in width, covering an area of 0.5917 m<sup>2</sup>.

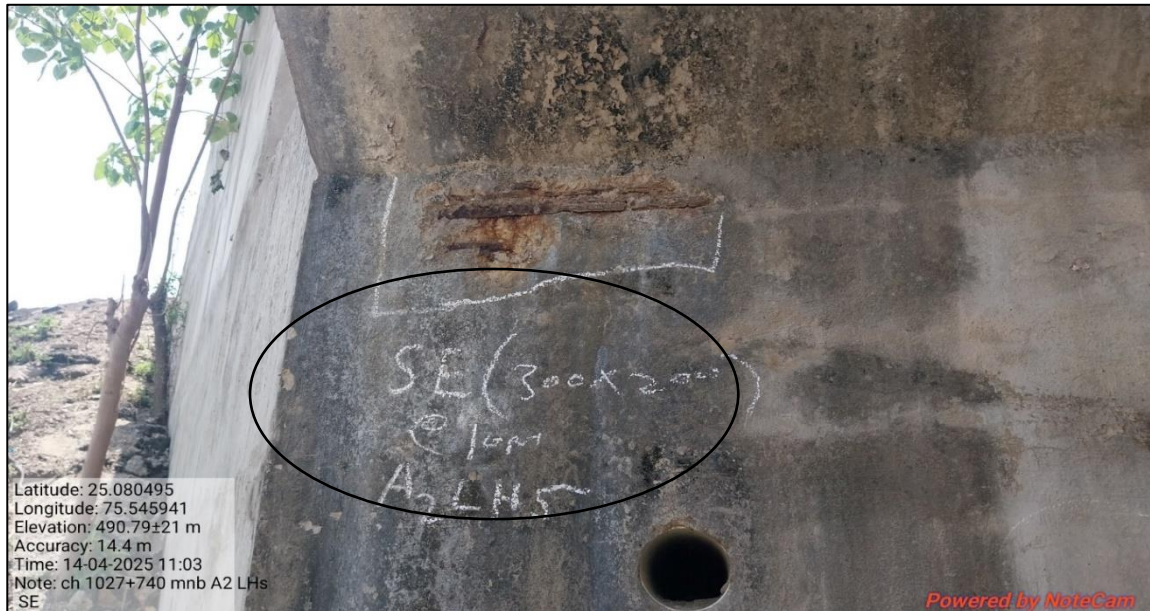
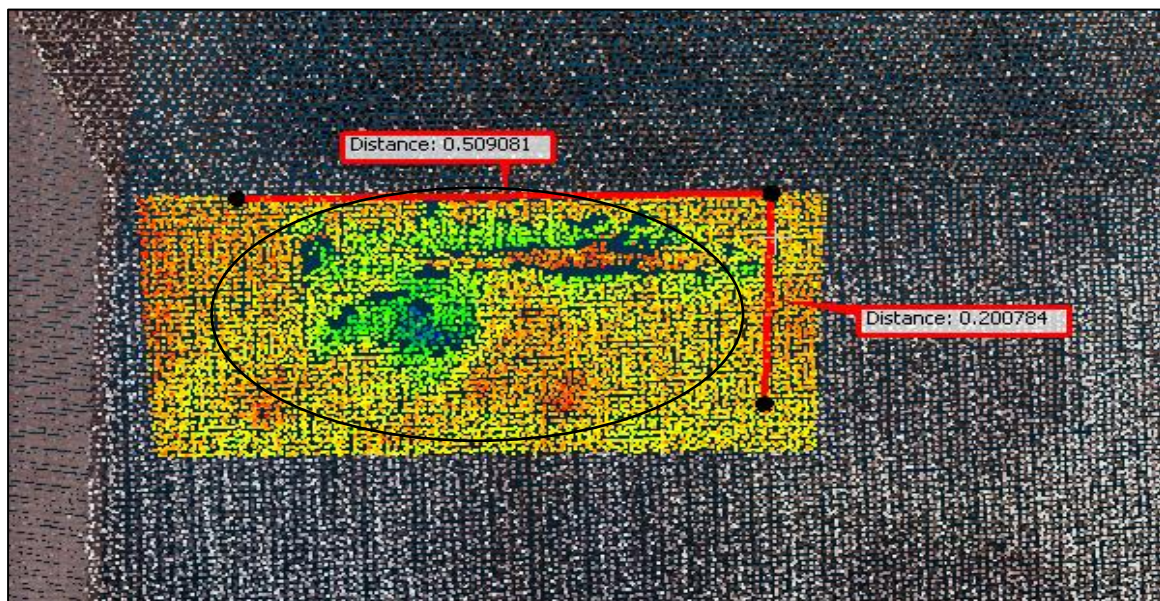
| Element Name | Observation | Location of Distress | Photo No. | Units | Distress Details | | | Area of Repair (Sq./RM T) |
|---|---|---|---|---|---|---|---|---|
| Abutment 2 | Steel Exposed | - | 4 | Sq m | 0.50 | 0.20 | - | 0.1 |

4. Steel Exposed (SE) observed on A2 (LHS), measuring 0.50 m in length and 0.20 m in width, covering an area of 0.10 m<sup>2</sup>.

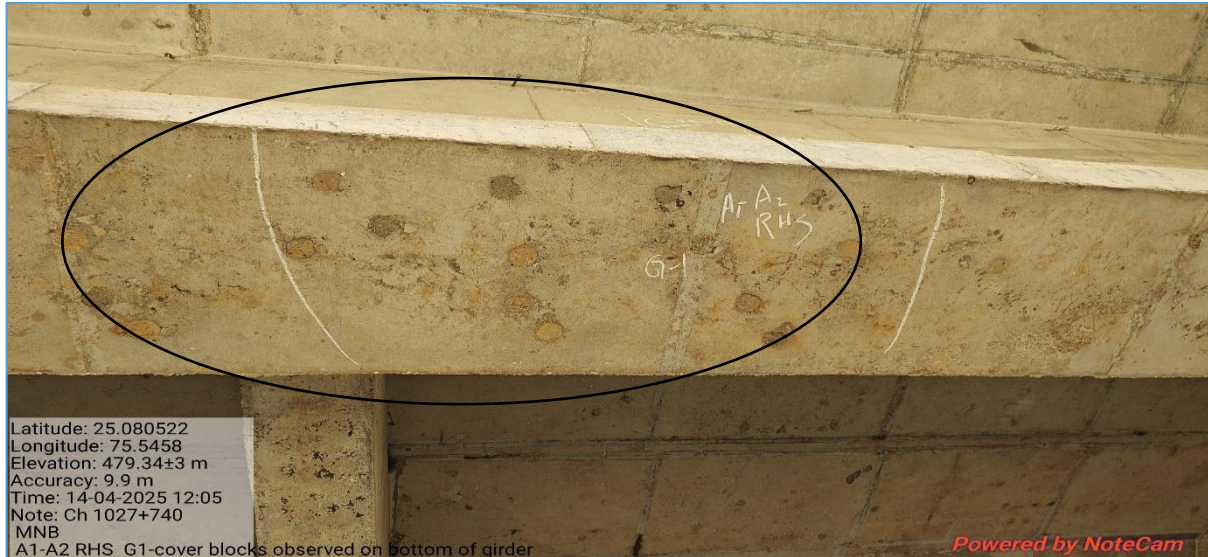
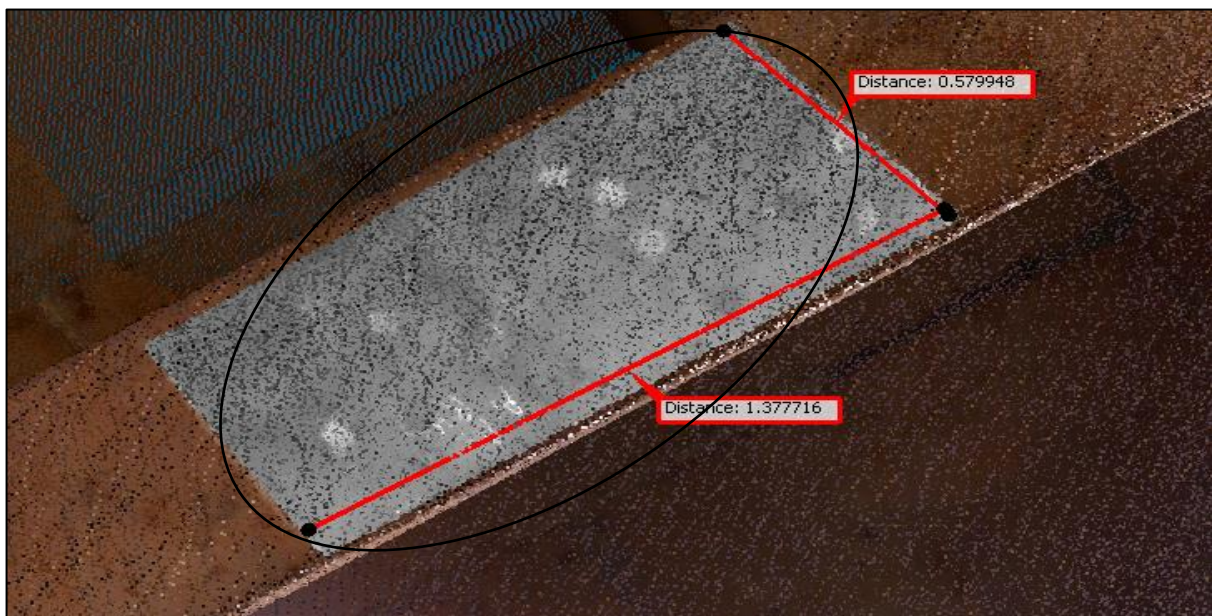
| Element Name | Observation | Location of Distress | Photo No. | Units | Distress Details | | | Area of Repair (Sq./RM T/m3) |
|---|---|---|---|---|---|---|---|---|
| Girder | Cover Block Exposed | - | 1 | Sq m | 1.37 | 0.57 | - | 0.7809 |

5. Cover Block Expose observed on G1 (RHS), measuring 1.37 m in length and 0.57 m in width, covering an area of 0.7809 m<sup>2</sup>.
