# **LIDAR Inspection Report of VUP ch.1029+650**

**Bridge Chainage:** 1029+650(CKRP)

- **Bridge No:** -
- **Chainage:** 1029+650
- **Structure type:** VUP

- **CKRP:** Chittorgarh to kota
- **State:** Rajasthan NH 27
- **Zone:** RJ-06

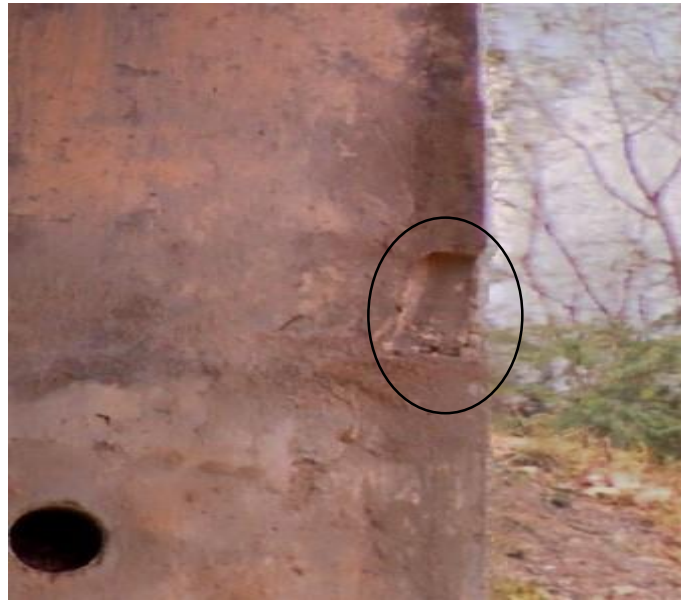
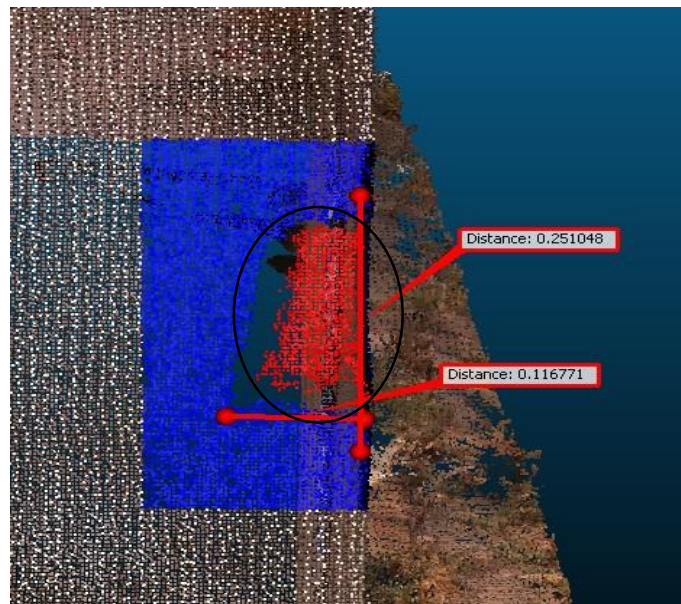
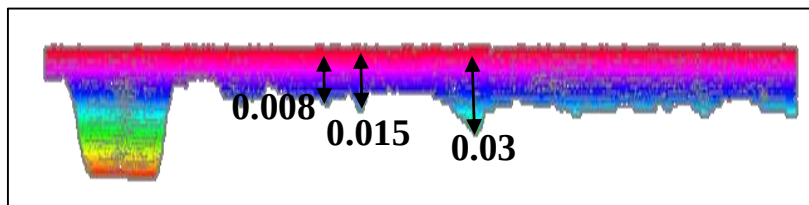
| Element Name | Observation | Location of Distress | Photo No. | Units | Distress Details | | | Area of Repair (Sq.m/ RMT/ m3) |
|---|---|---|---|---|---|---|---|---|
| Abutment 1 Wall | Damage | - | 1 | M | 0.25 | 0.11 | 0.015 | 0.0004 |

**1. Damage observed on LHS A1 wing wall, measuring 0.25 m in length and 0.11 m in width. Depth ranges from 0.03(min) to 0.015 m (max), with an average depth of 0.008m. The calculated volume of the distress is 0.0004m<sup>3</sup>.**
