# **LIDAR Inspection Report of VUP ch.1032+310**

**Bridge Chainage:** 1032+310(CKRP)

- **Bridge No:** -
- **Chainage:** 1032+310
- **Structure type:** VUP

- **CKRP:** Chittorgarh to kota
- **State:** Rajasthan NH 27
- **Zone:** RJ-06

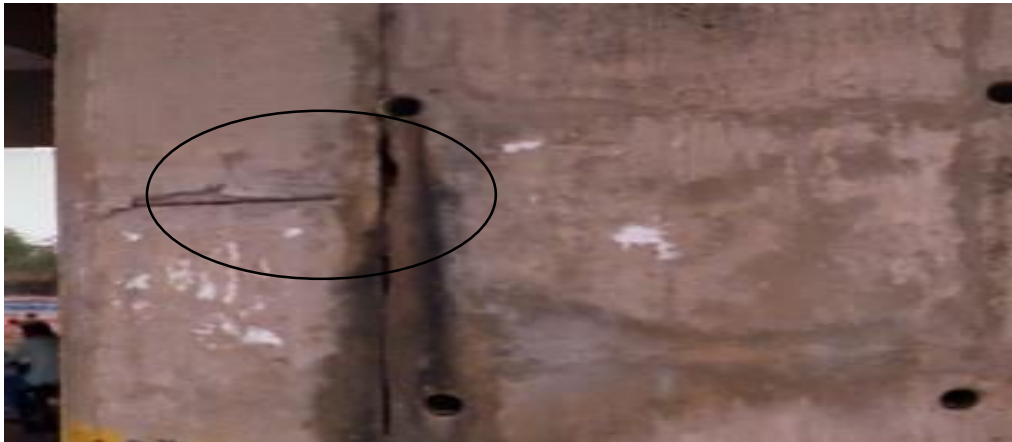
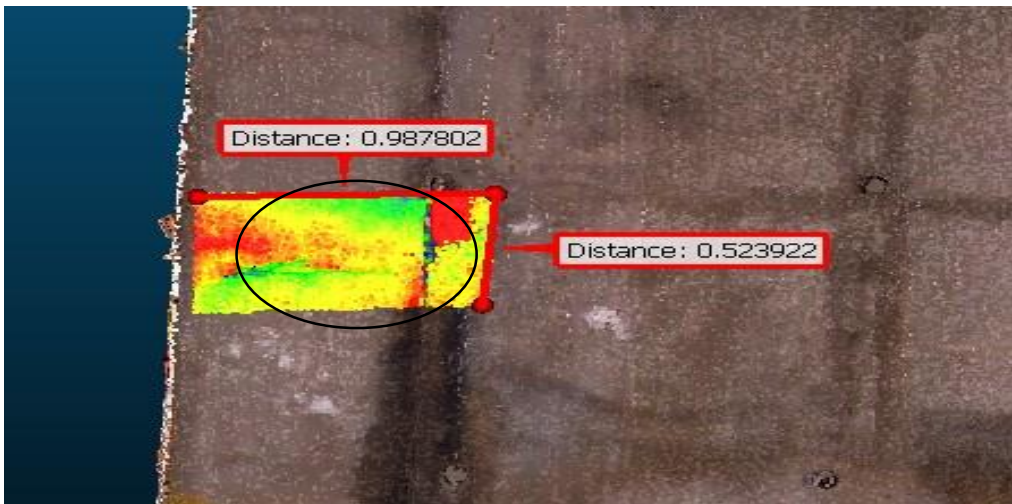
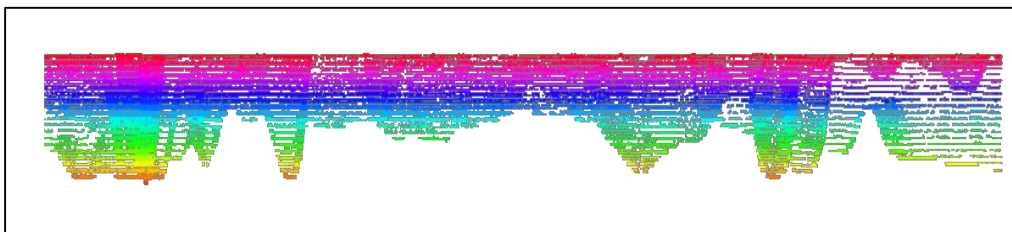
| Element Name | Observation | Location of Distress | Photo No. | Units | Distress Details | | | Area of Repair (Sq.m/ RMT/ m3) |
|---|---|---|---|---|---|---|---|---|
| Abutment 1 | Damage | - | 1 | M | 0.98 | 0.52 | | 0.5096 |

**1. Wall damage observed on LHS A1, measuring 0.98 m in length and 0.52 m in width, covering an area of 0.5096 m<sup>2</sup>.**

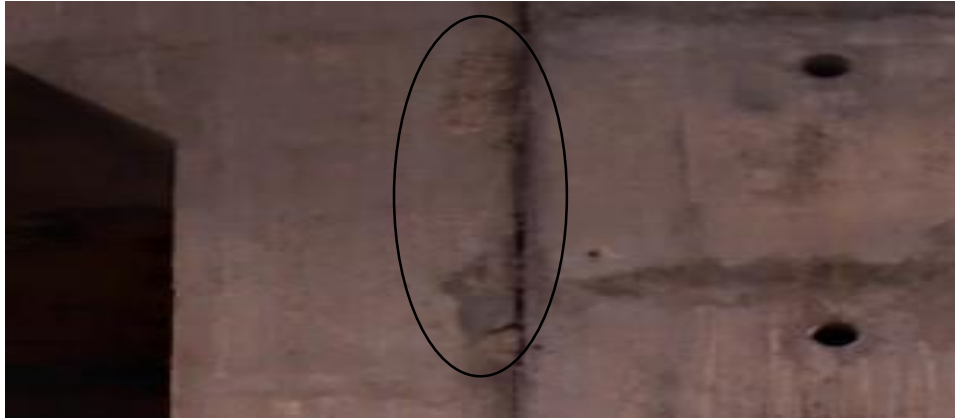
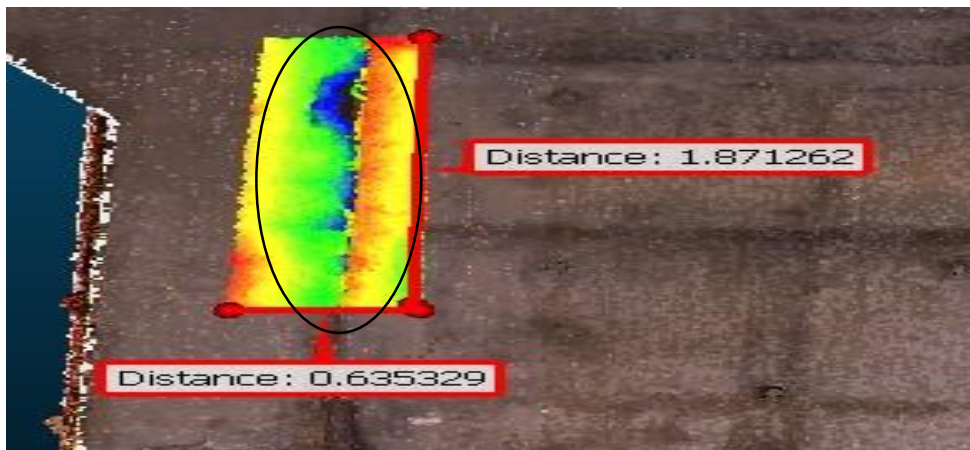
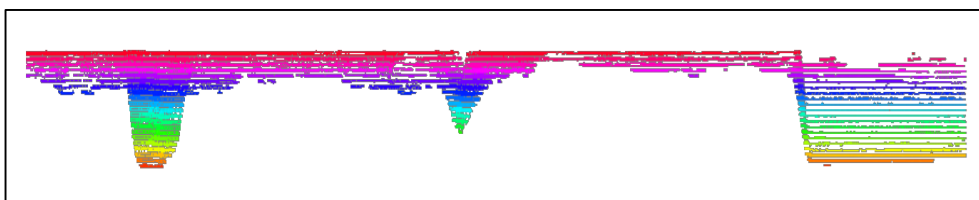
| Element Name | Observation | Location of Distress | Photo No. | Units | Distress Details | | | Area of Repair (Sq.m/ RMT/ m3) |
|---|---|---|---|---|---|---|---|---|
| Abutment 1 | Damage | | 2 | M | 0.63 | 1.87 | | 1.17 |

**2. Wall damage observed on LHS A1, measuring 0.63 m in length and 1.87 m in width, covering an area of 1.17 m<sup>2</sup>.**

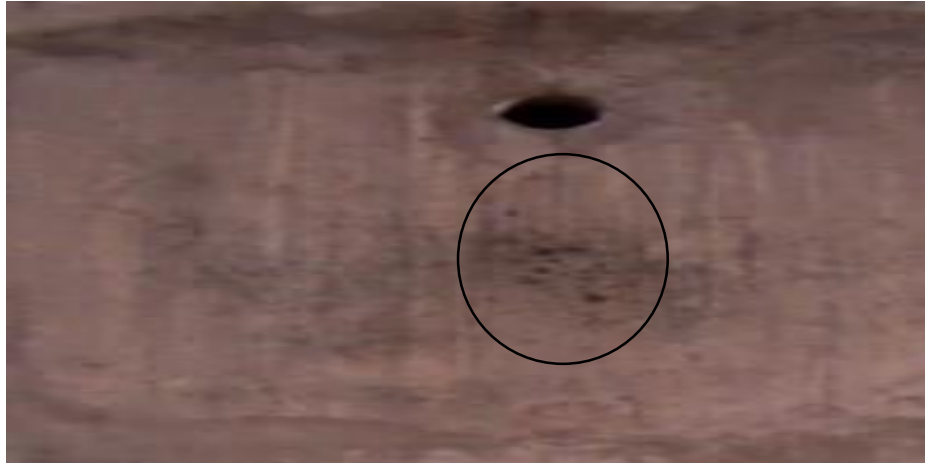
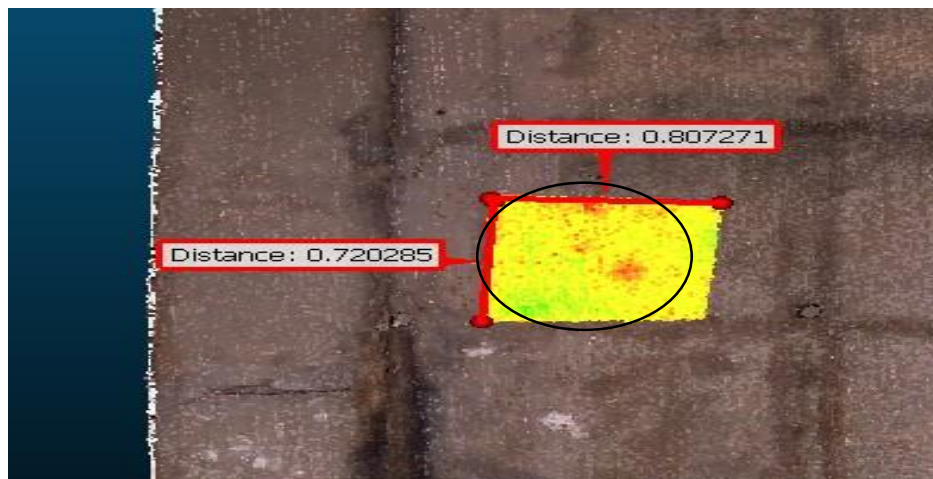
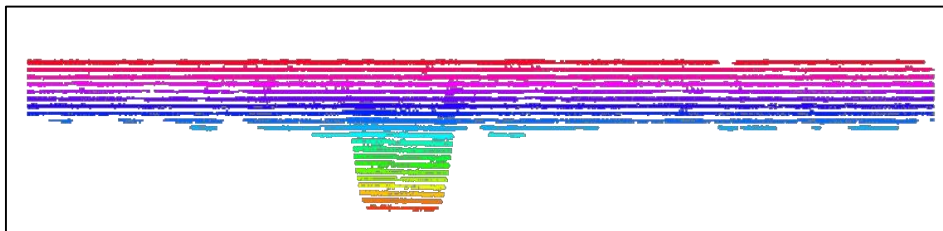
| Element Name | Observation | Location of Distress | Photo No. | Units | Distress Details | | | Area of Repair (Sq.m/ RMT/ m3) |
|---|---|---|---|---|---|---|---|---|
| Abutment 1 | Scaling | | 3 | M | 0.80 | 0.72 | | 0.576 |

**3. Scaling observed on LHS A1 wall, measuring 0.80 m in length and 0.72 m in width, covering an area of 0.576 m<sup>2</sup>.**

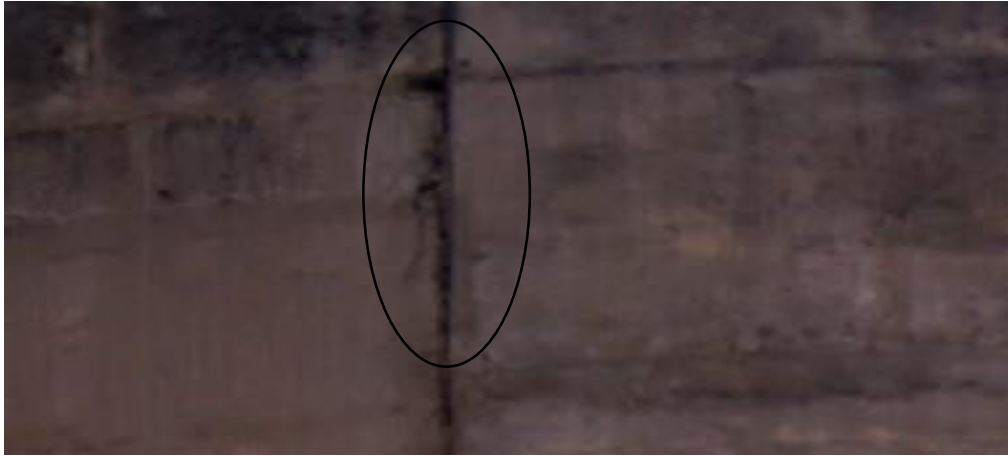
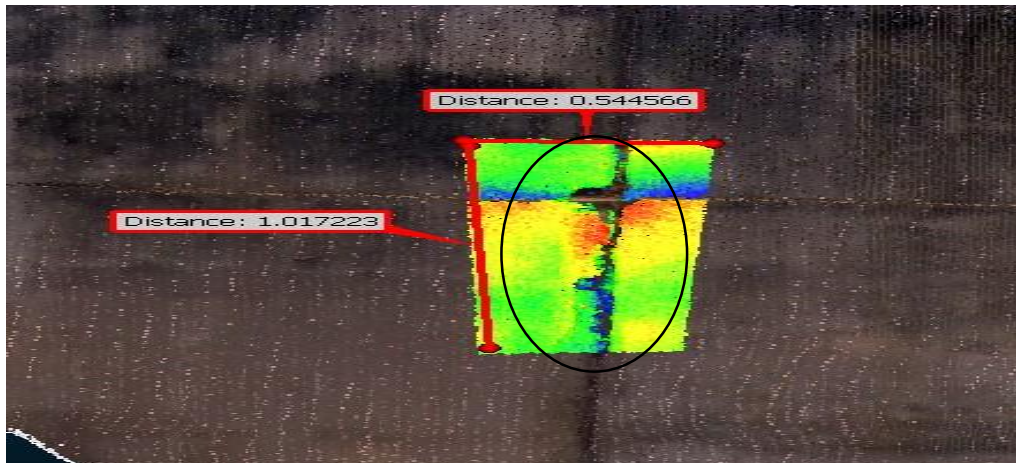
| Element Name | Observation | Location of Distress | Photo No. | Units | Distress Details | | | Area of Repair (Sq.m/ RMT/ m3) |
|---|---|---|---|---|---|---|---|---|
| Abutment 1 | Damage | | 4 | M | 0.54 | 1.01 | | 0.5454 |

**4. Wall damage observed on LHS A1, measuring 0.54 m in length and 1.01 m in width, covering an area of 0.5454 m<sup>2</sup>.**

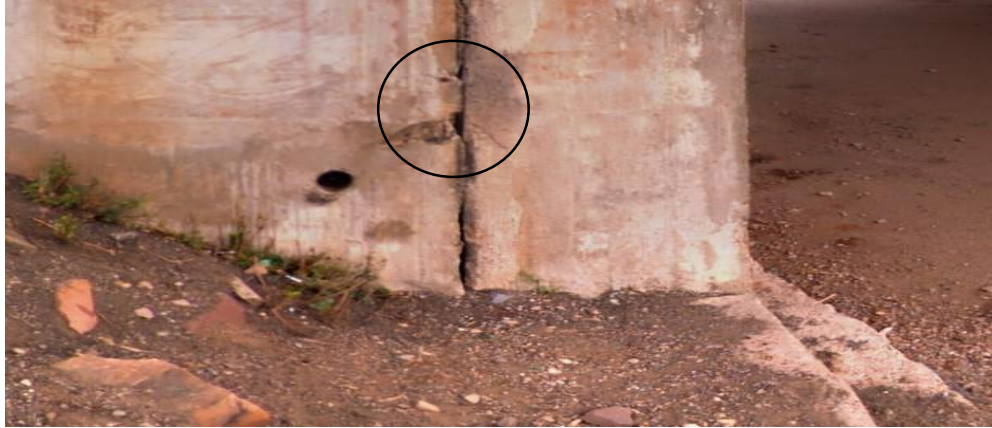
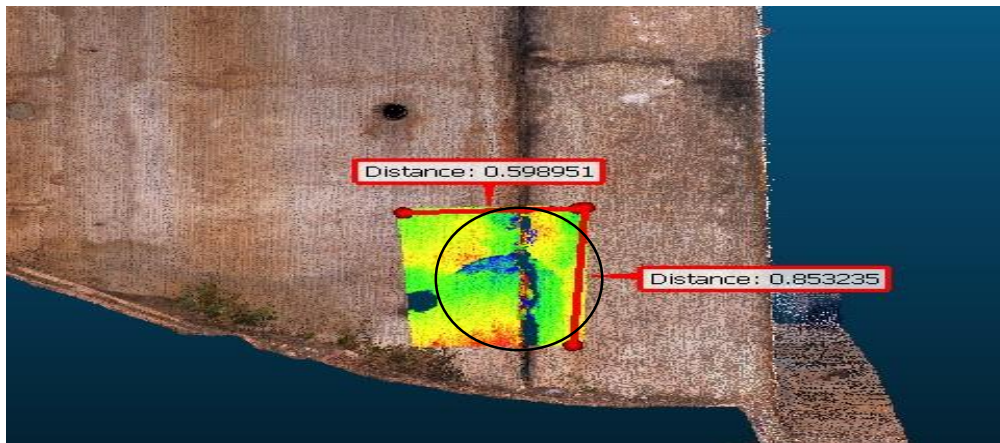
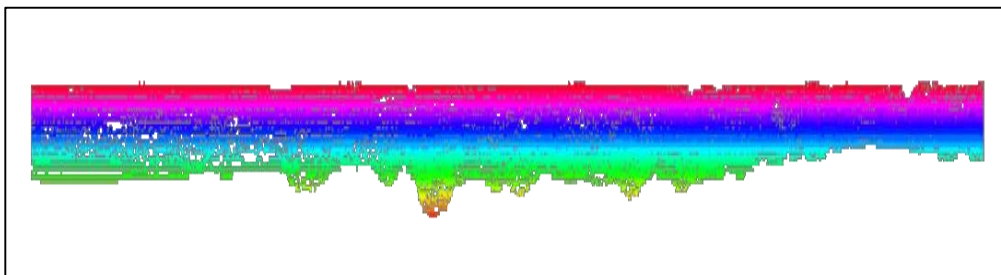
| Element Name | Observation | Location of Distress | Photo No. | Units | Distress Details | | | Area of Repair (Sq.m/ RMT/ m3) |
|---|---|---|---|---|---|---|---|---|
| Abutment 2 | Damage | | 5 | M | 0.59 | 0.85 | | 0.5015 |

**5. Wall damage observed on LHS A2, measuring 0.59 m in length and 0.85 m in width, covering an area of 0.5015 m<sup>2</sup>.**

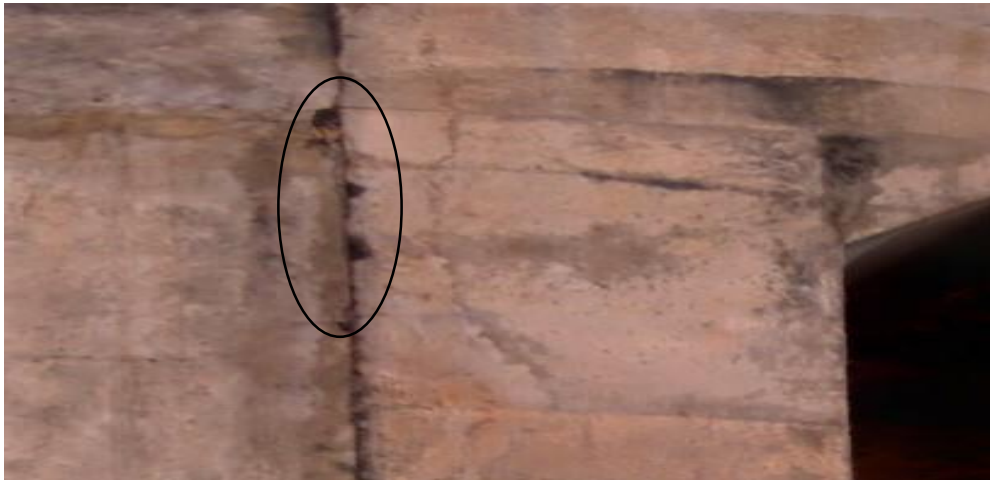
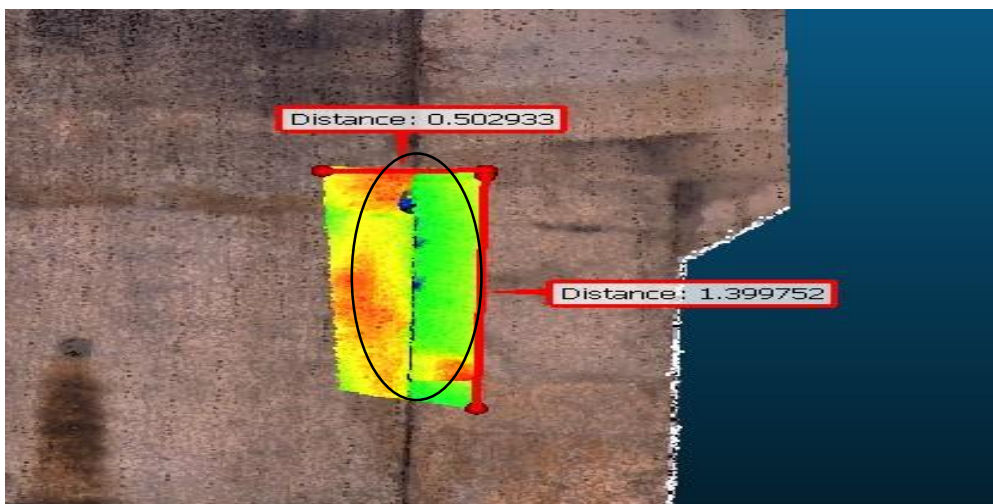
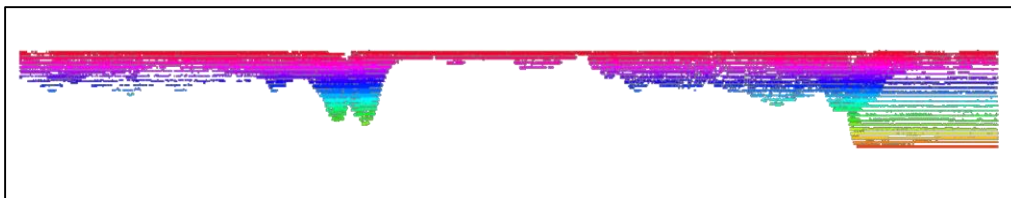
| Element Name | Observation | Location of Distress | Photo No. | Units | Distress Details | | | Area of Repair (Sq.m/ RMT/ m3) |
|---|---|---|---|---|---|---|---|---|
| Abutment 2 | Damage | | 6 | M | 0.50 | 1.39 | | 0.695 |

**6. Wall damage observed on LHS A2, measuring 0.50 m in length and 1.39 m in width, covering an area of 0.695 m<sup>2</sup>.**

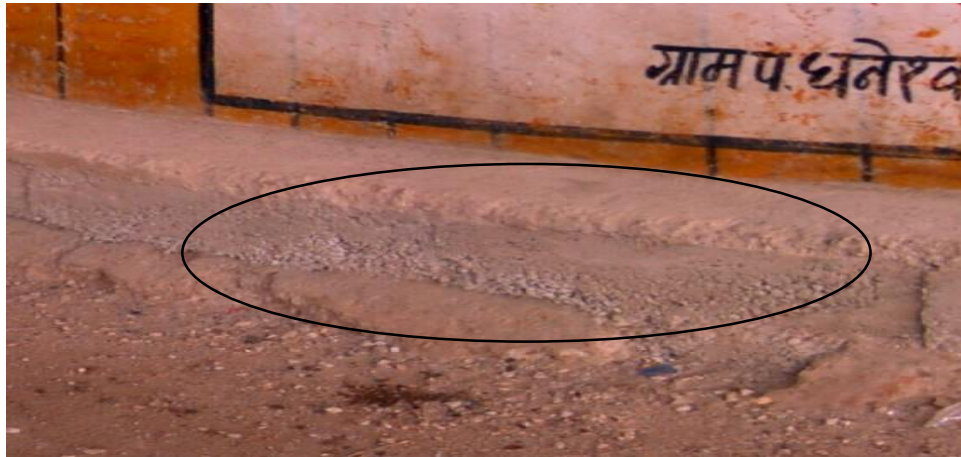
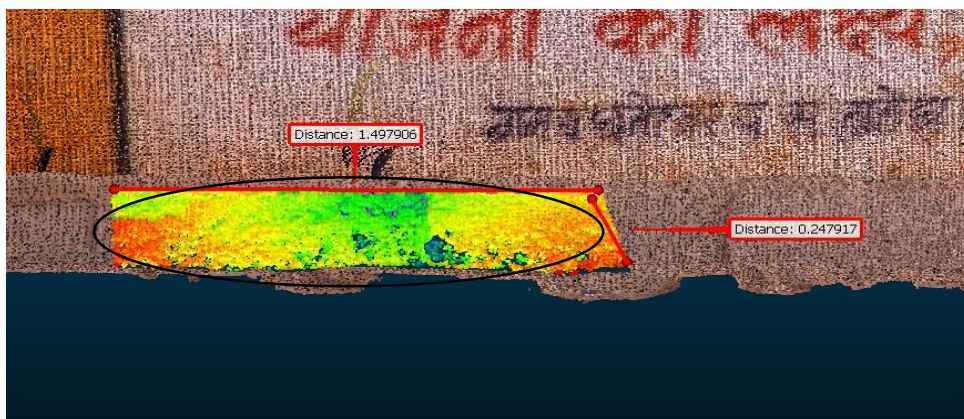
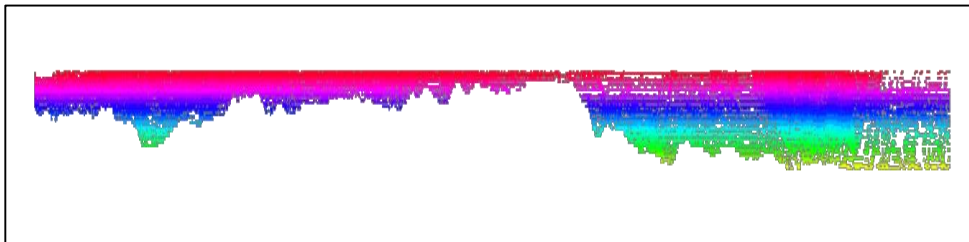
| Element Name | Observation | Location of Distress | Photo No. | Units | Distress Details | | | Area of Repair (Sq.m/ RMT/ m3) |
|---|---|---|---|---|---|---|---|---|
| Abutment 1 | Honeycombing | | 7 | M | 1.49 | 0.25 | | 0.3576 |

**7. Honeycombing observed on LHS A1 wall, measuring 1.49 m in length and 0.24 m in width, covering an area of 0.3576 m<sup>2</sup>.**

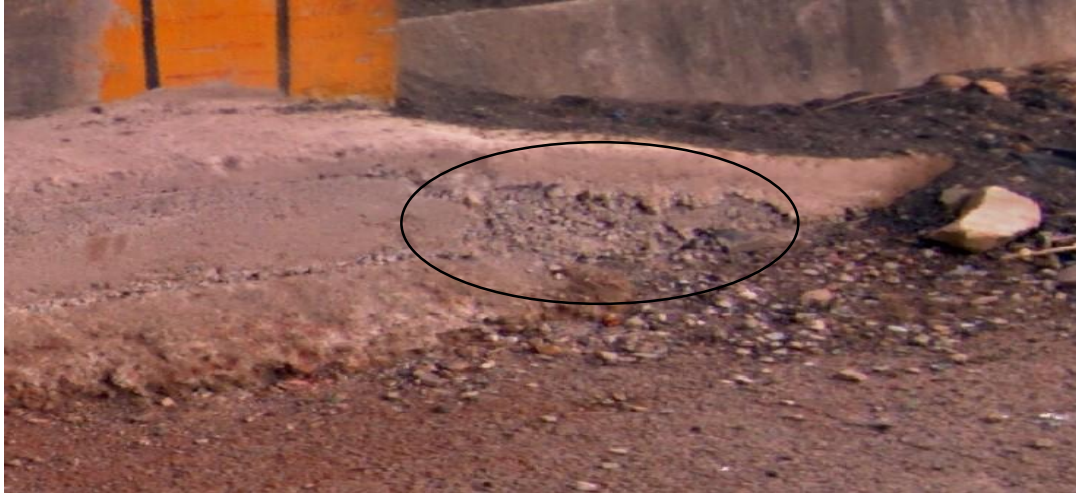
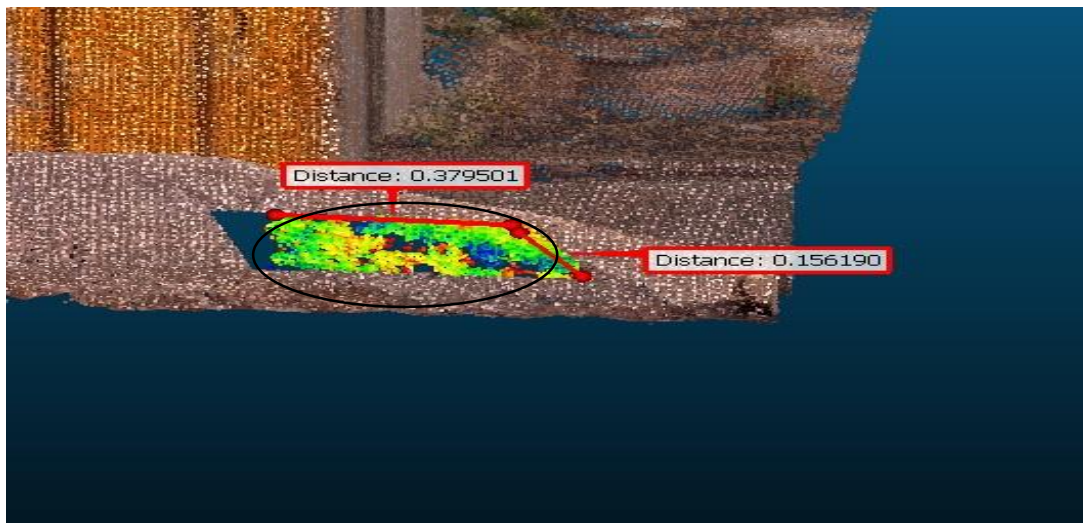
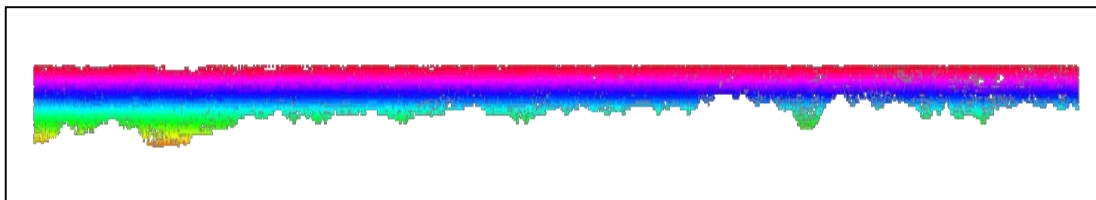
| Element Name | Observation | Location of Distress | Photo No. | Units | Distress Details | | | Area of Repair (Sq.m/ RMT/ m3) |
|---|---|---|---|---|---|---|---|---|
| Abutment 1 | Honeycombing | | 8 | M | 0.37 | 0.15 | | 0.055 |

**8. Honeycombing observed on LHS A1 wall, measuring 0.37 m in length and 0.15 m in width, covering an area of 0.055 m<sup>2</sup>.**

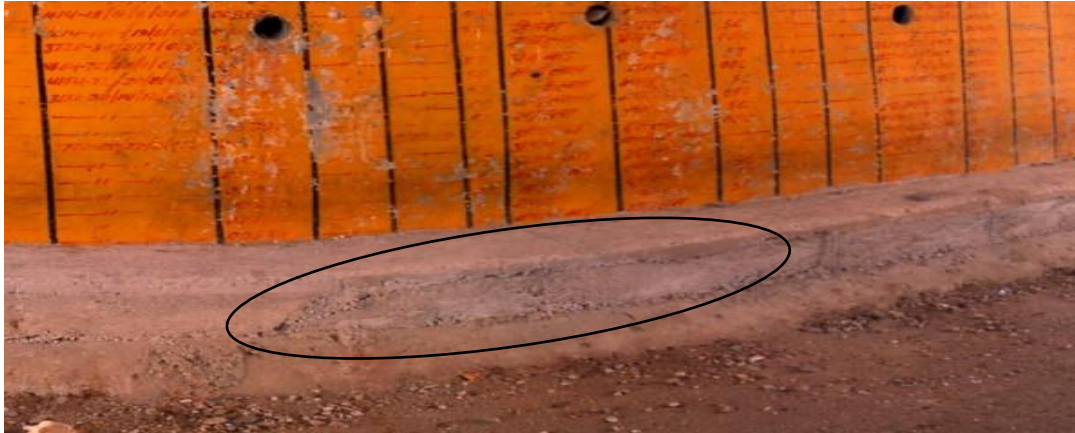
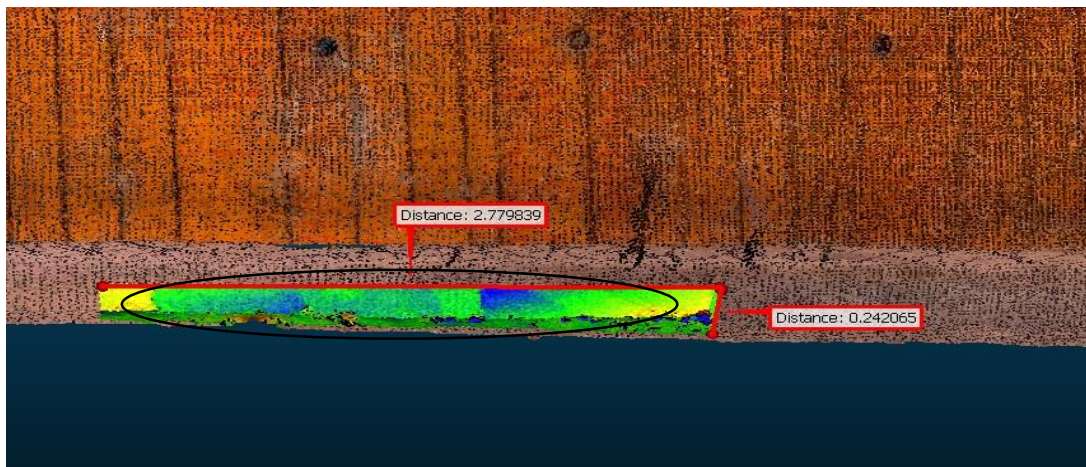
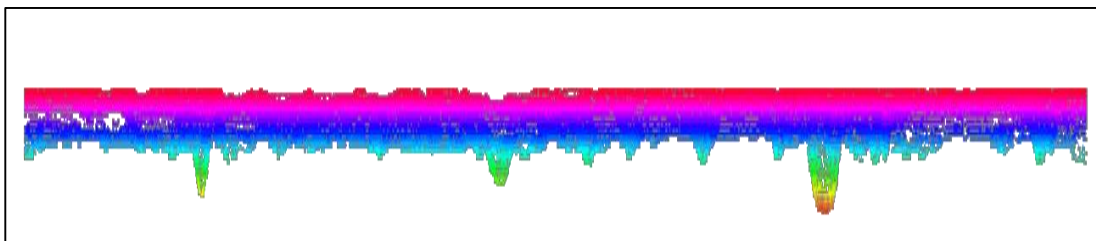
| Element Name | Observation | Location of Distress | Photo No. | Units | Distress Details | | | Area of Repair (Sq.m/ RMT/ m3) |
|---|---|---|---|---|---|---|---|---|
| Abutment 1 | Honeycombing | | 9. | M | 2.77 | 0.24 | | 0.6648 |

**9. Honeycombing observed on A1 wall, measuring 2.77 m in length and 0.24 m in width, covering an area of 0.6648 m<sup>2</sup>.**

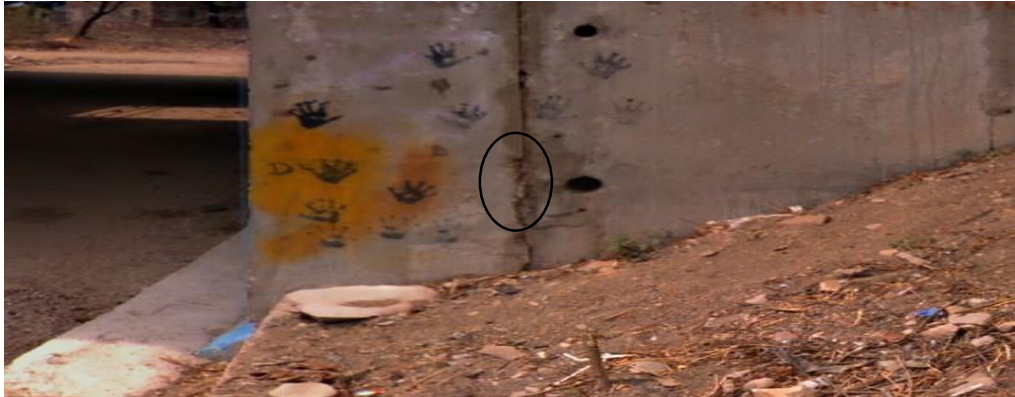
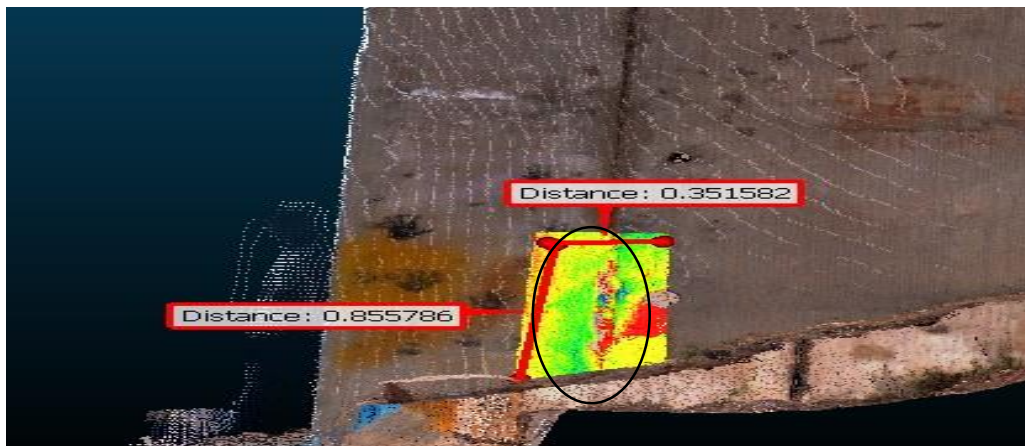
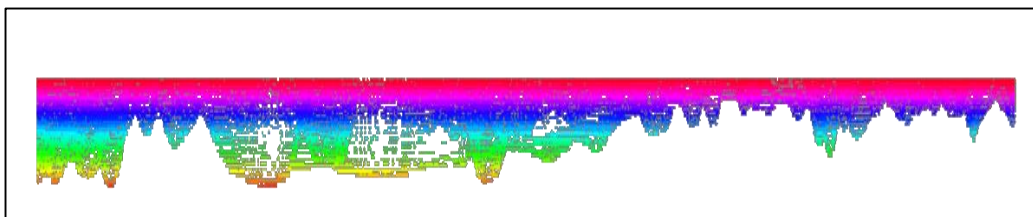
| Element Name | Observation | Location of Distress | Photo No. | Units | Distress Details | | | Area of Repair (Sq.m/ RMT/ m3) |
|---|---|---|---|---|---|---|---|---|
| Abutment 2 | Damage | - | 10 | M | 0.35 | 0.85 | | 0.2975 |

**10. Wall damage observed on RHS A2, measuring 0.35 m in length and 0.85 m in width, covering an area of 0.2975 m<sup>2</sup>.**
