# **LIDAR Inspection Report of MNB ch.1032+420**

**Bridge No:** MNB – 1033/4

**Bridge Chainage:** 1032+420 (CKRP)

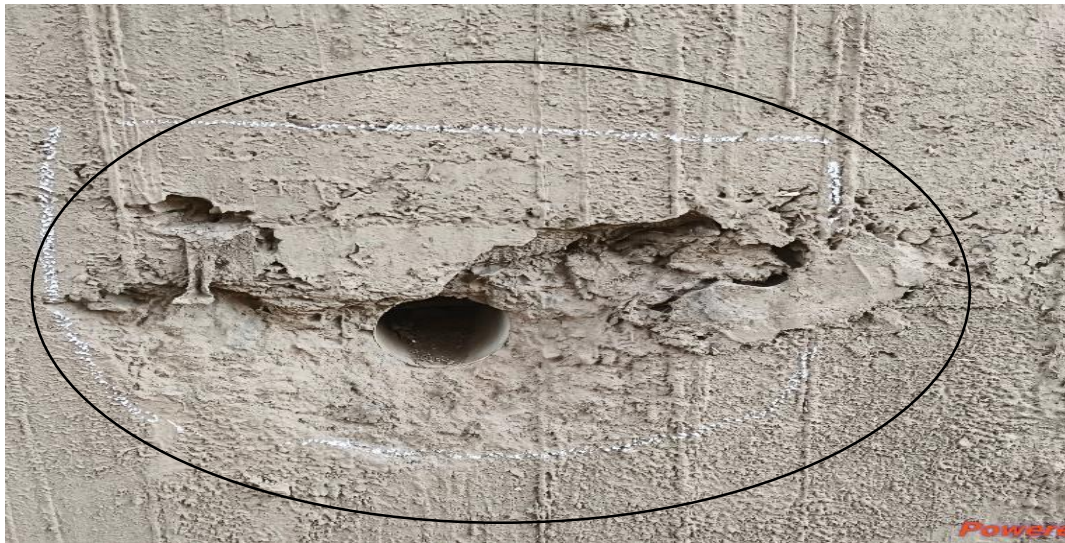
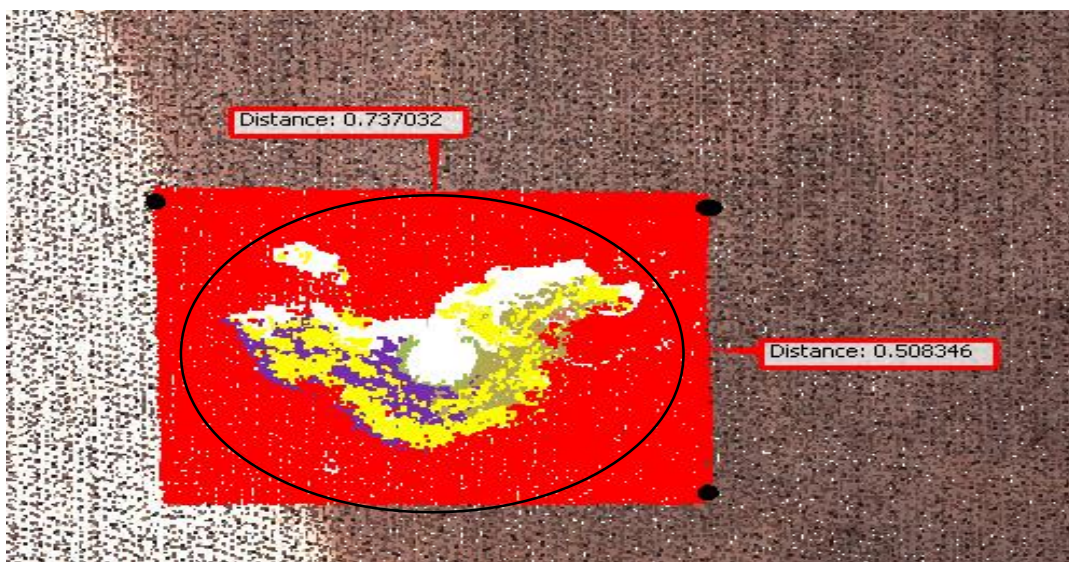
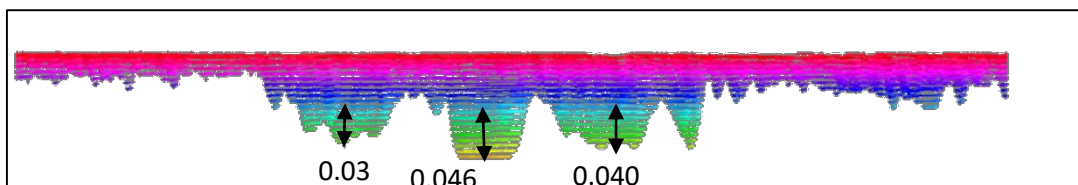
| Element Name | Observation | Location of Distress | Photo No. | Units | Distress Details | | | Area of Repair (Sq.m/R MT) |
|---|---|---|---|---|---|---|---|---|
| Abutment 1 | Damage | | 1 | M | 0.73 | 0.50 | 0.040 | 0.0146 |

**1. Damage observed on the Left Hand Side (LHS) of A1, measuring 0.73 m in length and 0.50 m in width. Depth ranges from 0.03 m (min) to 0.046 m (max), with an average depth of 0.040 m. The calculated volume of the distress is 0.0146 m<sup>3</sup>.**

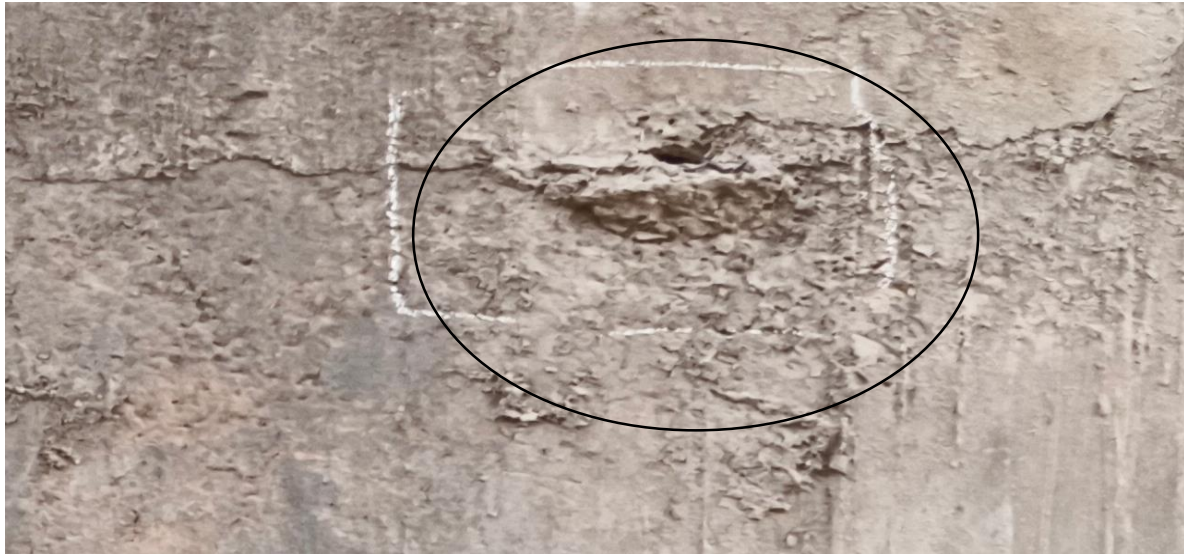
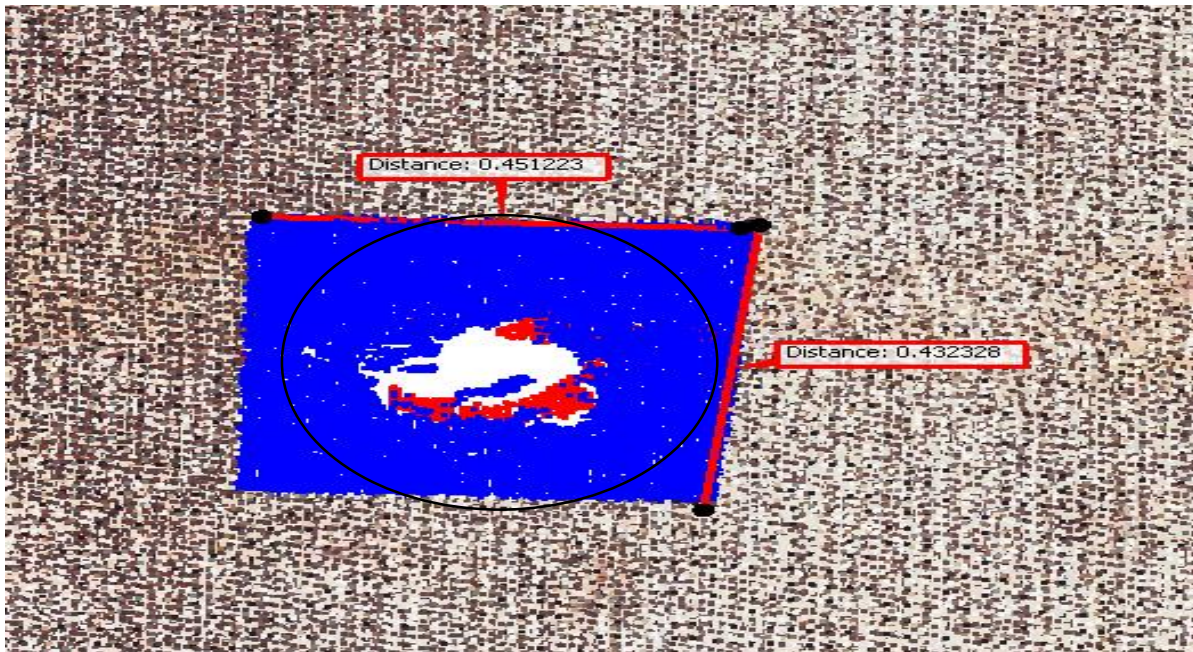
| Element Name | Observation | Location of Distress | Photo No. | Units | Distress Details | | | Area of Repair (Sq.m/R MT) |
|---|---|---|---|---|---|---|---|---|
| Abutment 1 | V Pool damage | | 2 | M | 0.45 | 0.43 | | 0.193 |

**2.V pool damage observed on LHS A1, measuring 0.45 m in length and 0.43 m in width, covering an area of 0.1935 m<sup>2</sup>.**

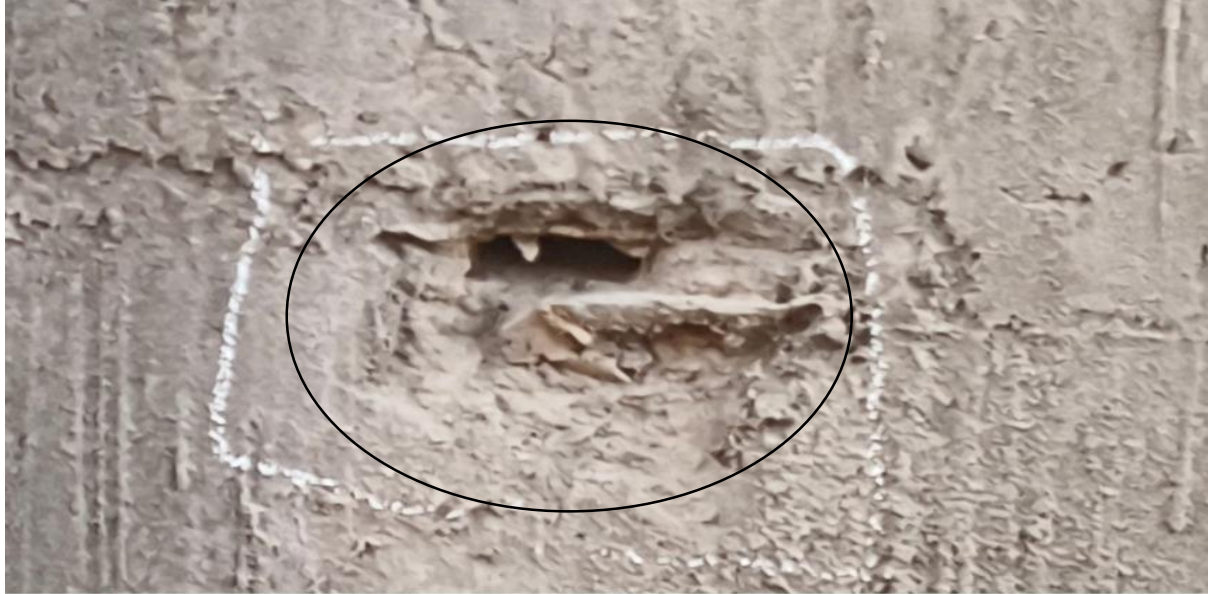
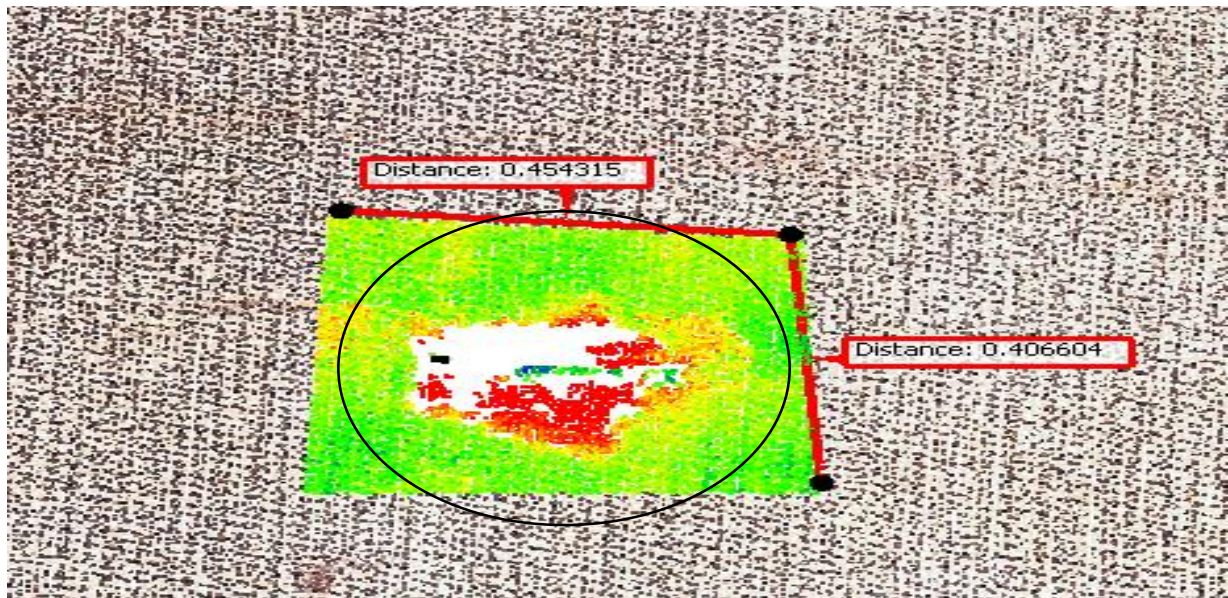
| Element Name | Observation | Location of Distress | Photo No. | Units | Distress Details | | | Area of Repair (Sq.m/R MT) |
|---|---|---|---|---|---|---|---|---|
| Abutment 1 | V Pool block | | 3 | M | 0.45 | 0.45 | | 0.202 |

**3. Weep Hole block observed on LHS A1, measuring 0.45 m in length and 0.45 m in width, covering an area of 0.2025 m<sup>2</sup>.**

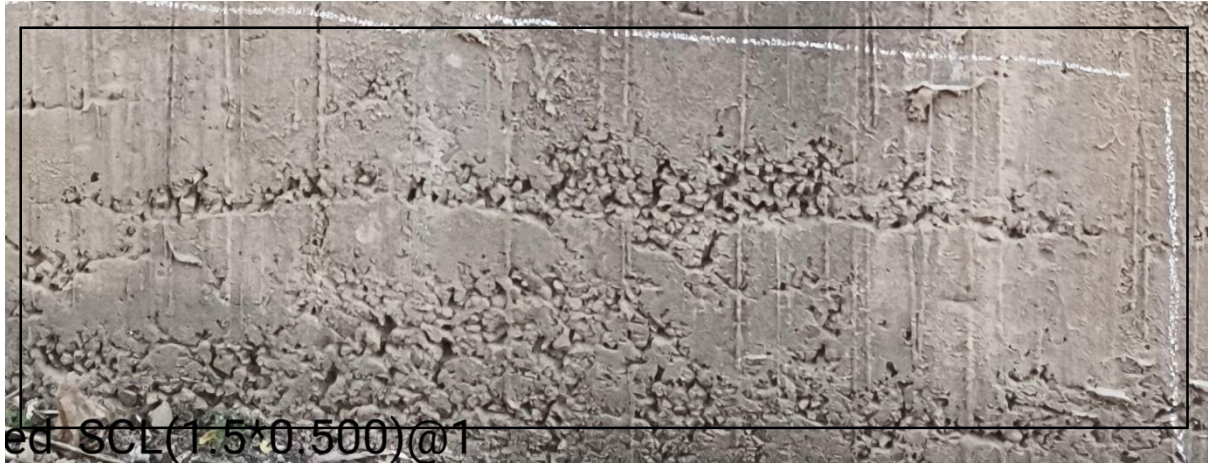
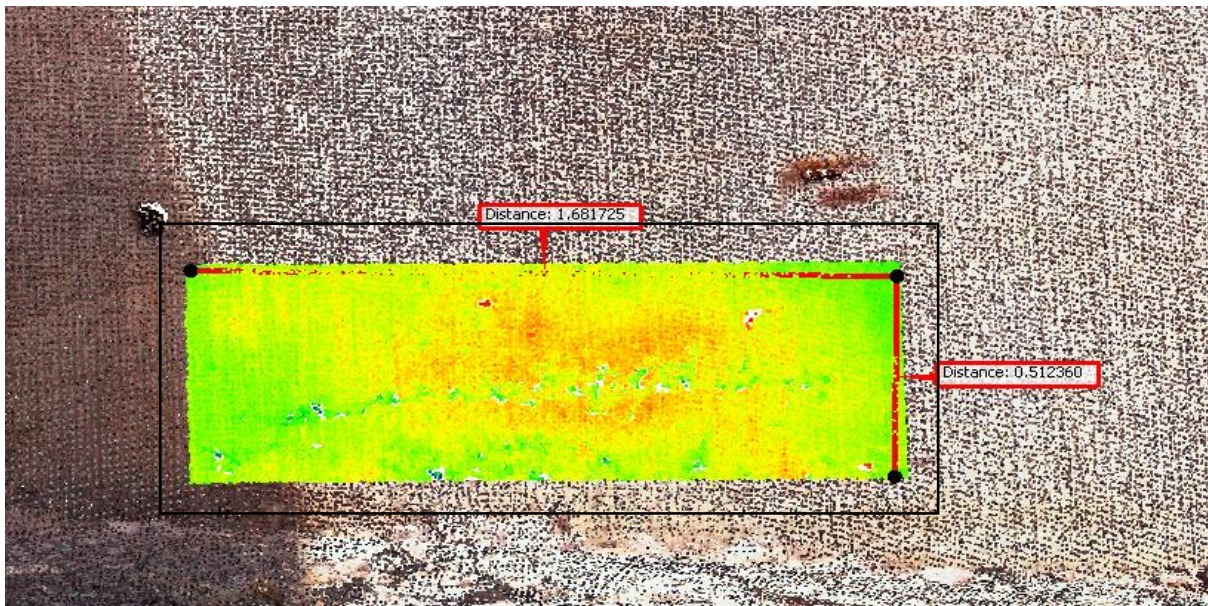
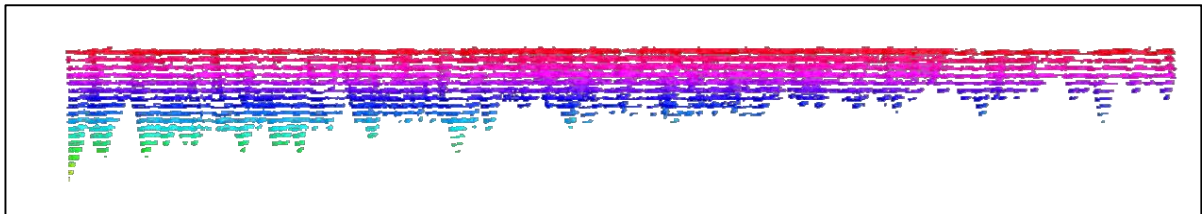
| Element Name | Observation | Location of Distress | Photo No. | Units | Distress Details | | | Area of Repair (Sq.m/R MT) |
|---|---|---|---|---|---|---|---|---|
| Abutment 1 | Scaling | | 4 | M | 1.68 | 0.51 | | 0.856 |

**4. Scaling observed on LHS A1, measuring 1.68 m in length and 0.51 m in width, covering an area of 0.8568 m<sup>2</sup>.**

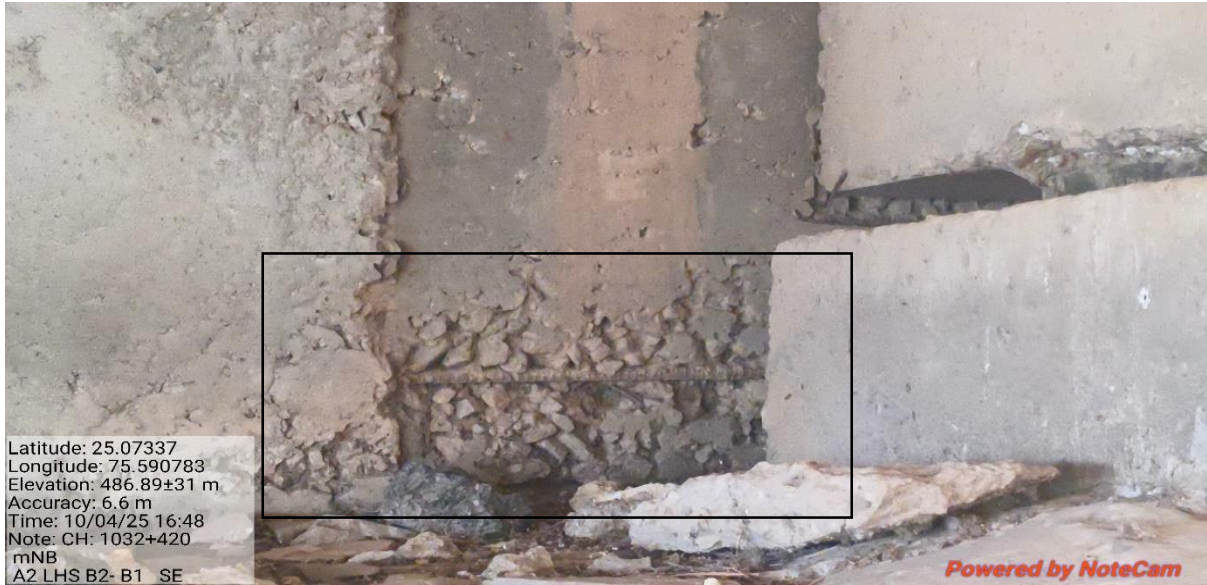
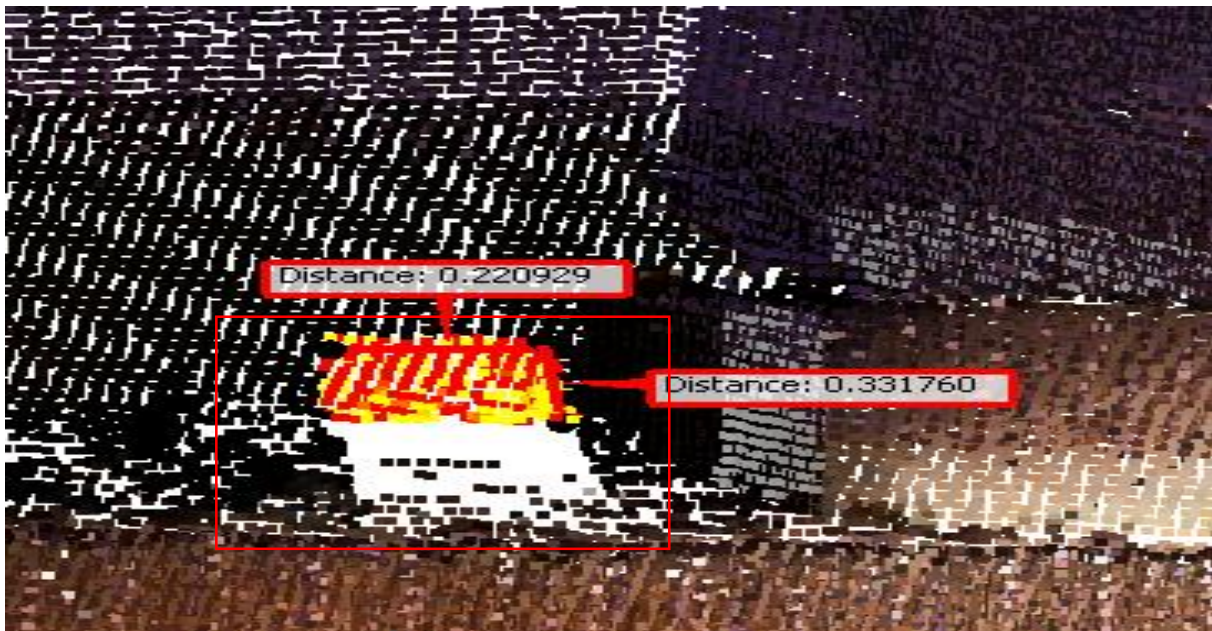
| Element Name | Observation | Location of Distress | Photo No. | Units | Distress Details | | | Area of Repair (Sq.m/R MT) |
|---|---|---|---|---|---|---|---|---|
| Abutment 2 | Steel exposed | | 5 | M | 0.22 | 0.33 | | 0.072 |

**5. Steel exposed observed on LHS A2 B2-B1, measuring 0.22 m in length and 0.33 m in width, covering an area of 0.0726 m<sup>2</sup>.**

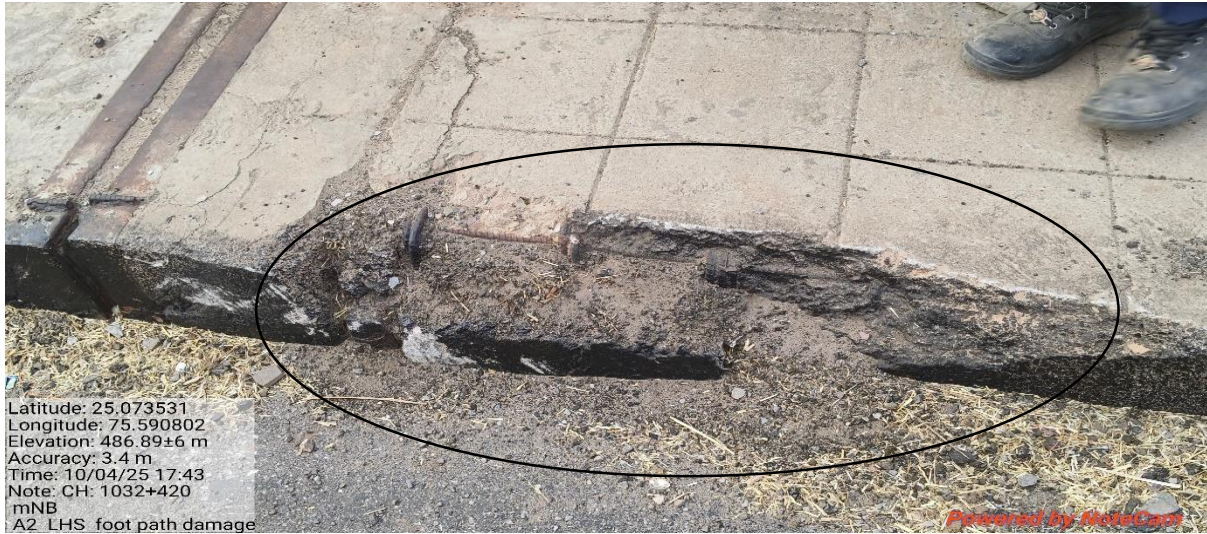
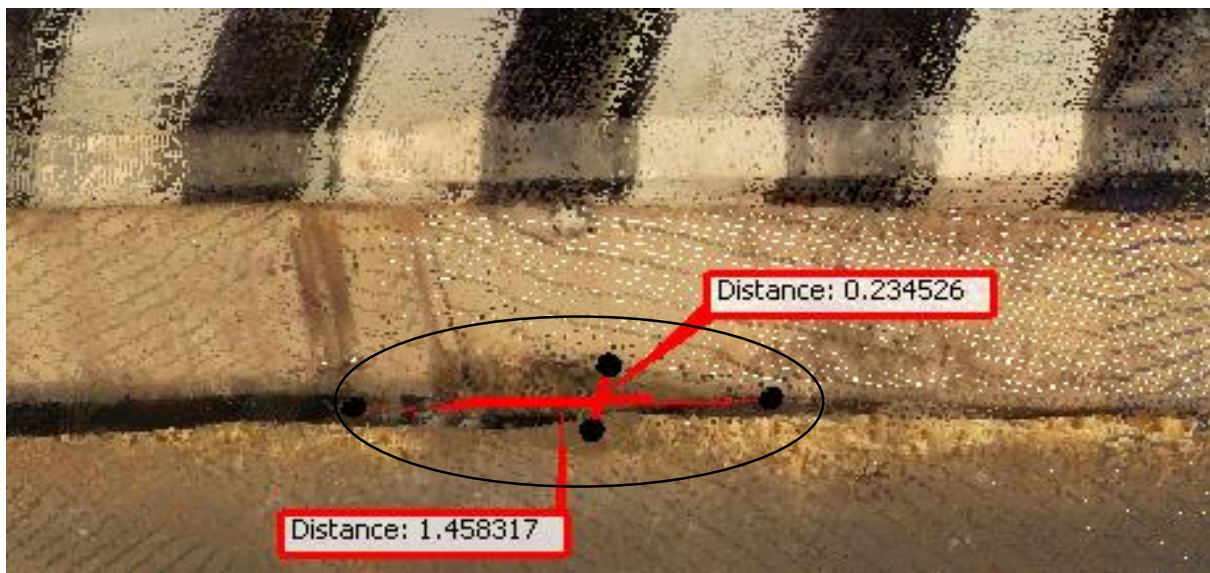
| Element Name | Observation | Location of Distress | Photo No. | Units | Distress Details | | | Area of Repair (Sq.m/R MT) |
|---|---|---|---|---|---|---|---|---|
| Footpath | Damage | | 6 | M | 1.45 | 0.23 | | 0.333 |

**6. Foot path Damage observed on the Left-Hand Side (LHS) of A2, affecting the foot path. The affected area measures  $L = 1.45$  m,  $W = 0.23$  m, with a total computed area of  $A = 0.3335$  m<sup>2</sup>.**

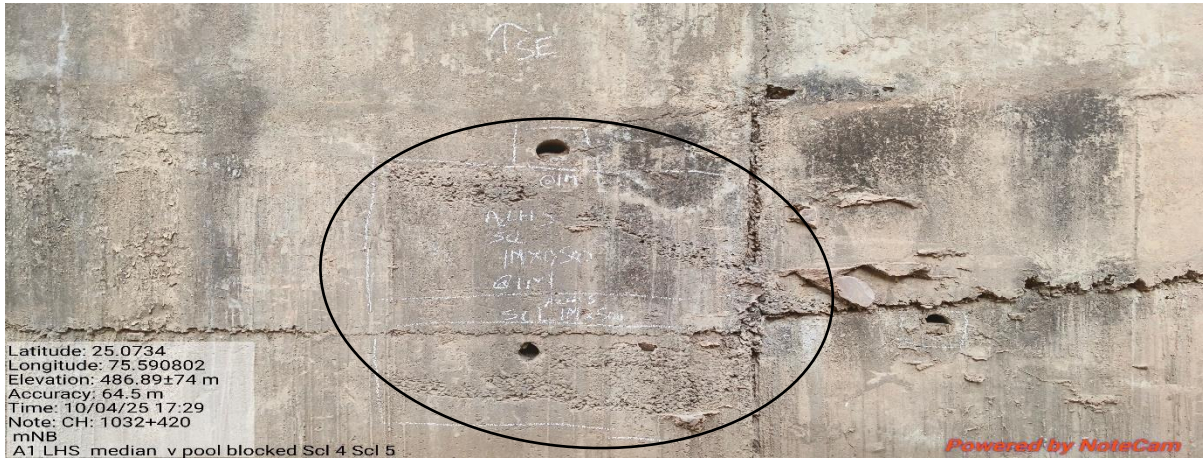
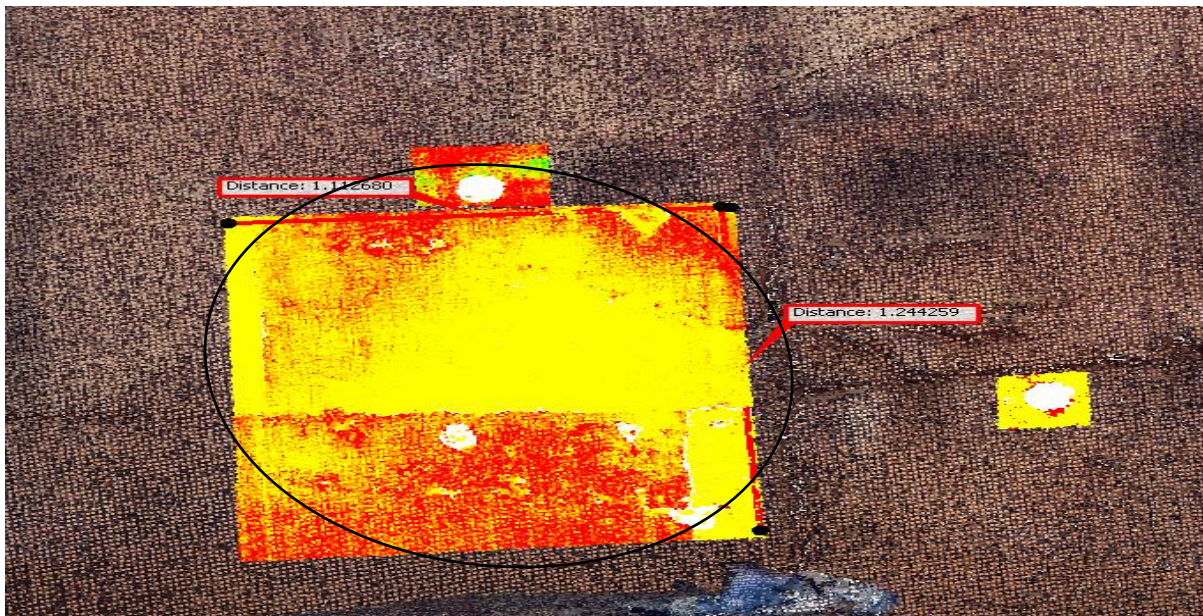
| Element Name | Observation | Location of Distress | Photo No. | Units | Distress Details | | | Area of Repair (Sq.m/R MT) |
|---|---|---|---|---|---|---|---|---|
| Abutment 2 | Scaling | | 7 | M | 1.24 | 1.11 | | 1.376 |

**7. Scaling observed on LHS A2 SCL 4 and SCL 5, measuring 1.24 m in length and 1.11 m in width, covering an area of 1.3764 m<sup>2</sup>. V pool blocked.**

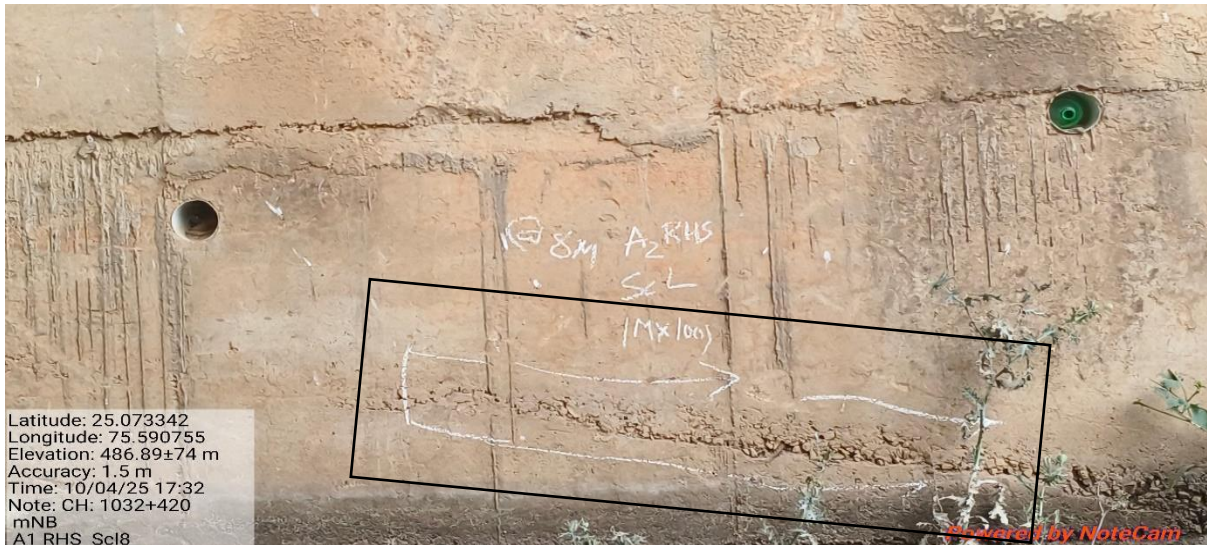
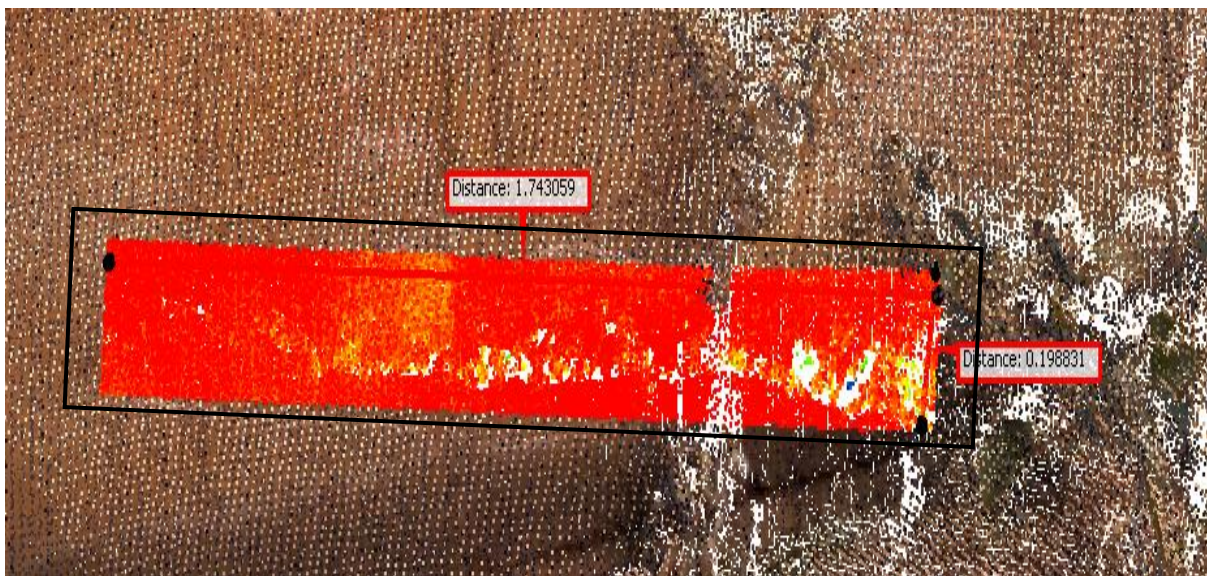
| Element Name | Observation | Location of Distress | Photo No. | Units | Distress Details | | | Area of Repair (Sq.m/R MT) |
|---|---|---|---|---|---|---|---|---|
| Abutment 1 | Scaling | | 8 | M | 1.74 | 0.19 | | 0.330 |

**8. Scaling observed on RHS A1 measuring 1.74 m in length and 0.19 m in width, covering an area of 0.3306 m<sup>2</sup>.**

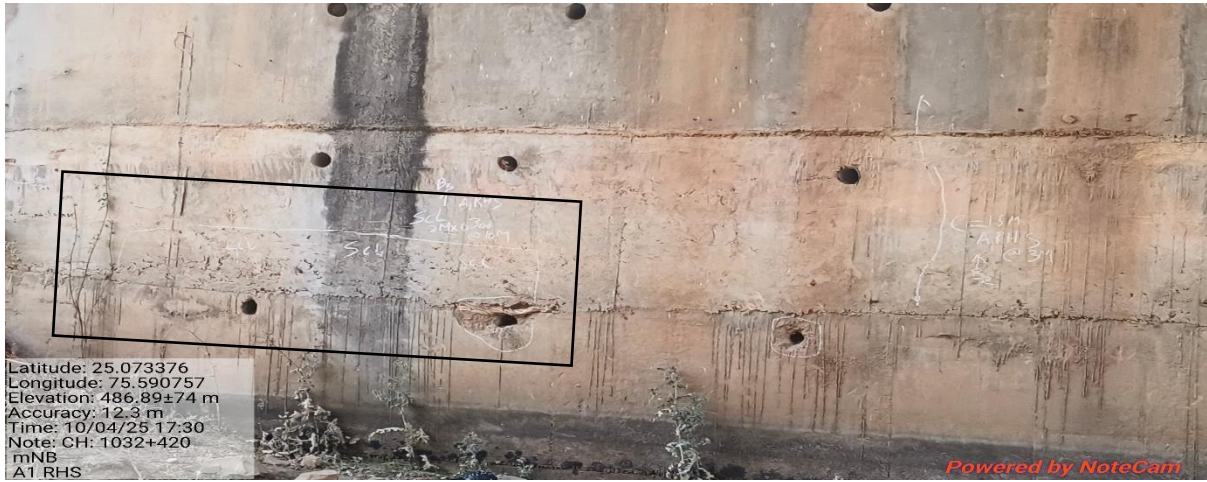
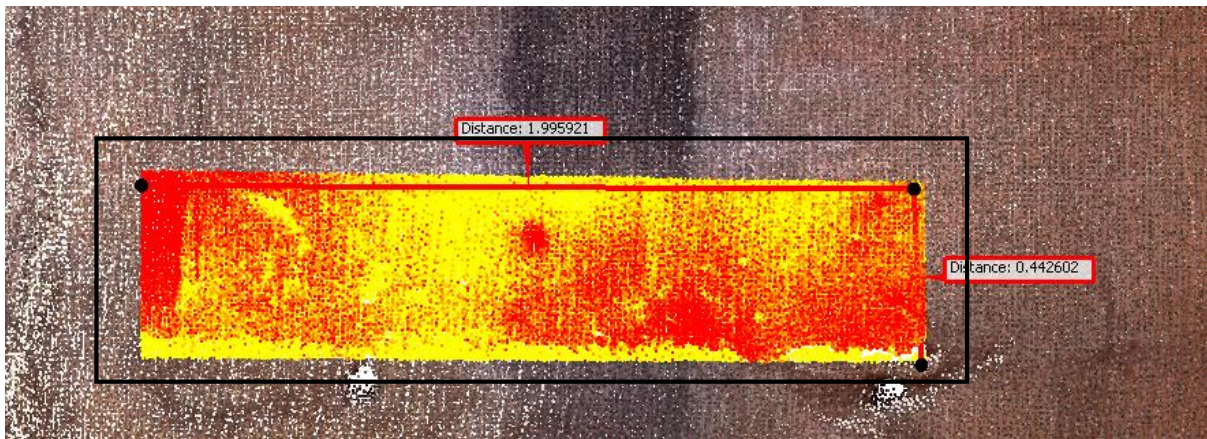
| Element Name | Observation | Location of Distress | Photo No. | Units | Distress Details | | | Area of Repair (Sq.m/R MT) |
|---|---|---|---|---|---|---|---|---|
| Abutment 1 | Scaling | | 9 | M | 1.99 | 0.44 | | 0.875 |

**9. Scaling observed on RHS A1, measuring 1.99 m in length and 0.44 m in width, covering an area of 0.8756 m<sup>2</sup>.**
