# **LIDAR Inspection Report of VUP ch.1038+570**

**Bridge Chainage:** 1038+570(CKRP)

- **CKRP:** Chittorgarh to kota
- **State:** Rajasthan NH 27
- **Zone:** RJ-06

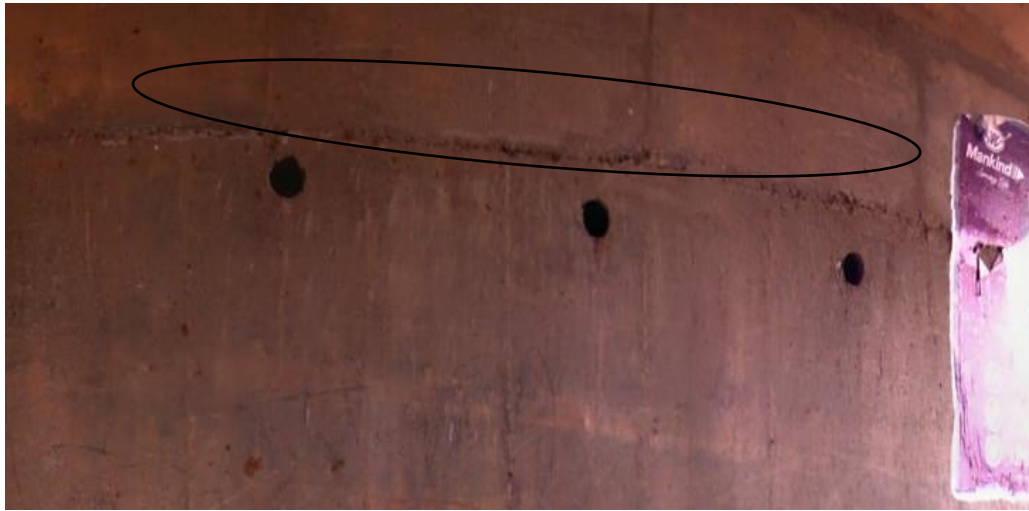
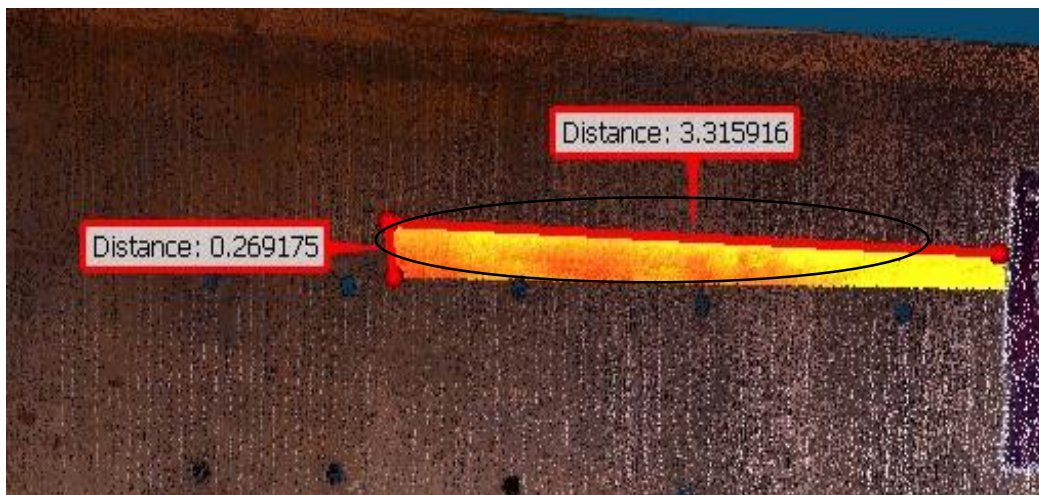
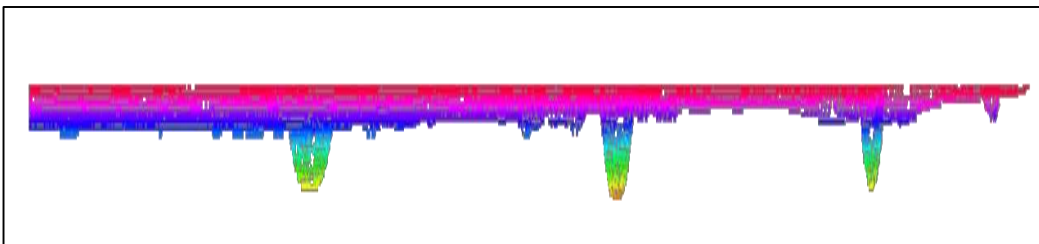
| Element Name | Observation | Location of Distress | Photo No. | Units | Distress Details | | | Area of Repair (Sq.m/ RMT/ m3) |
|---|---|---|---|---|---|---|---|---|
| Abutment 1 | Scaling | - | 1 | M | 3.31 | 0.26 | | 0.8606 |

**1. Scaling observed on LHS A1 wall, measuring 3.31 m in length and 0.26 m in width, covering an area of 0.8606 m<sup>2</sup>.**

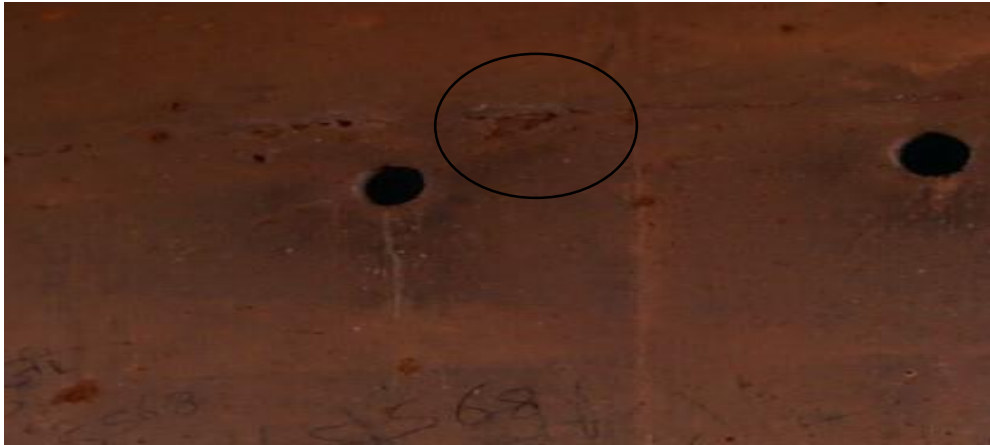
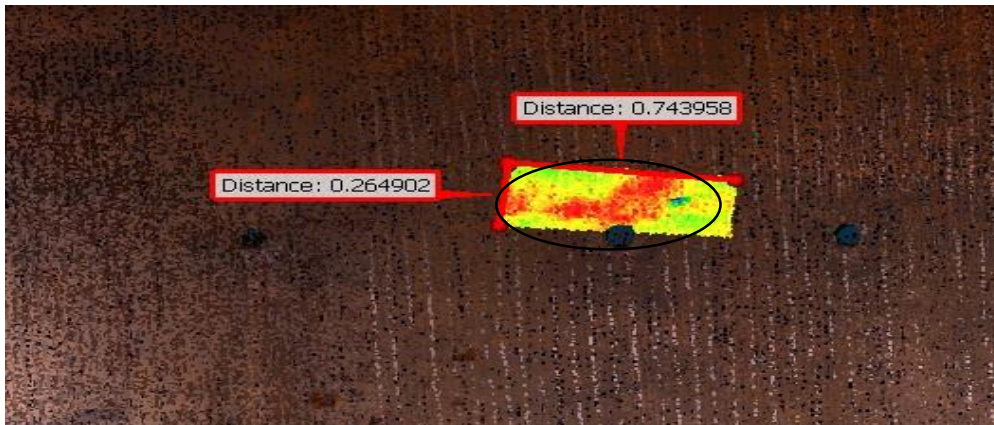
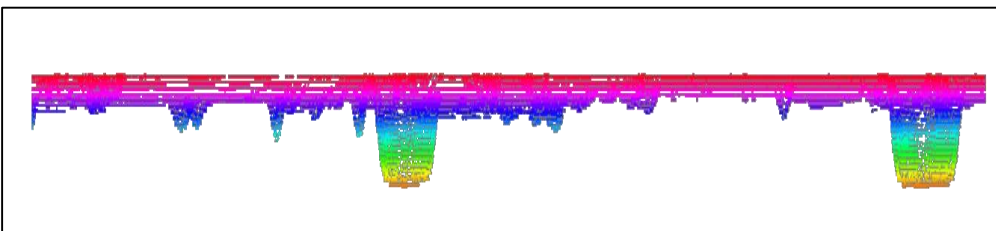
| Element Name | Observation | Location of Distress | Photo No. | Units | Distress Details | | | Area of Repair (Sq.m/ RMT/ m3) |
|---|---|---|---|---|---|---|---|---|
| Abutment 1 | Damage | | 2 | M | 0.74 | 0.26 | | 0.1924 |

**2. Damage observed on LHS A1, measuring 0.74 m in length and 0.26 m in width, covering an area of 0.1924 m<sup>2</sup>.**

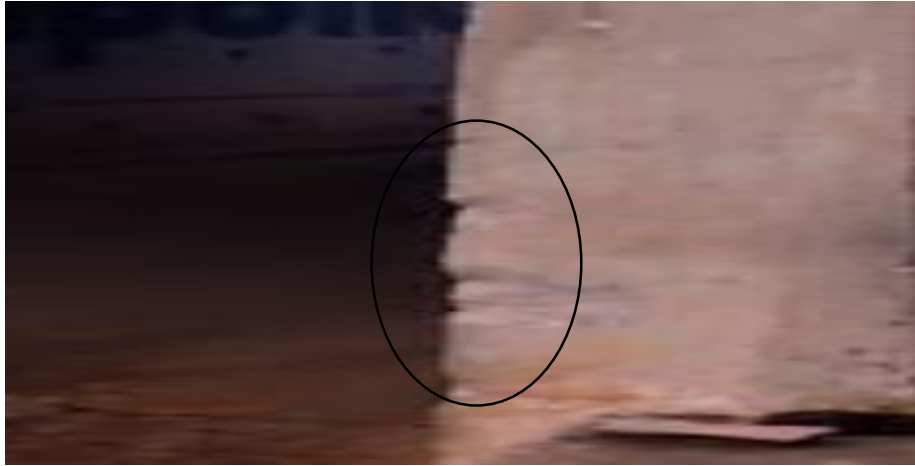
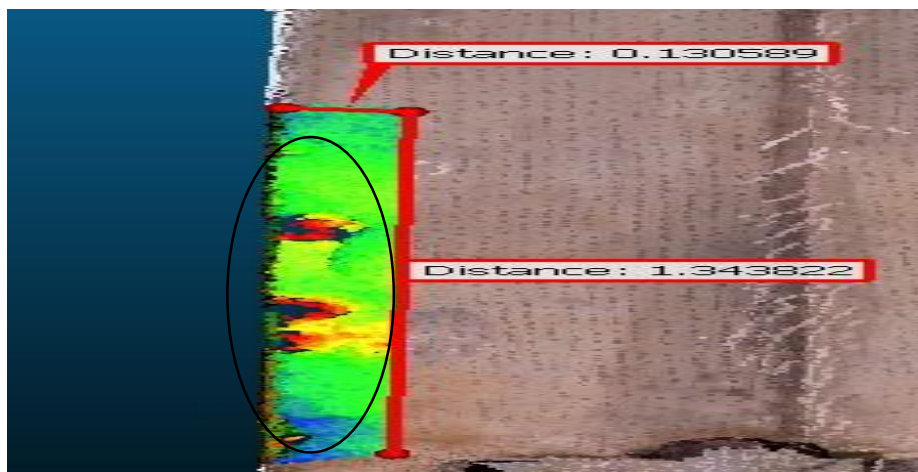
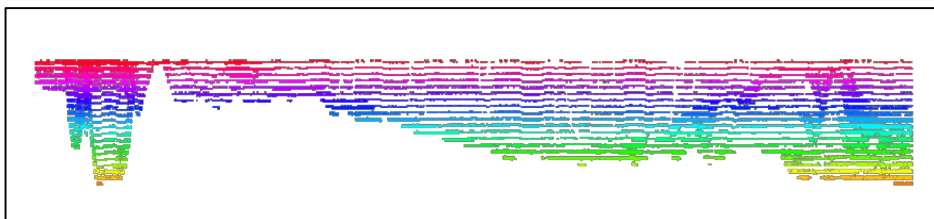
| Element Name | Observation | Location of Distress | Photo No. | Units | Distress Details | | | Area of Repair (Sq.m/ RMT/ m3) |
|---|---|---|---|---|---|---|---|---|
| Abutment 2 | Damage | - | 3 | M | 0.13 | 1.34 | | 0.1742 |

**3. Damage observed on RHS A2, measuring 0.13 m in length and 1.34 m in width, covering an area of 0.1742 m<sup>2</sup>.**

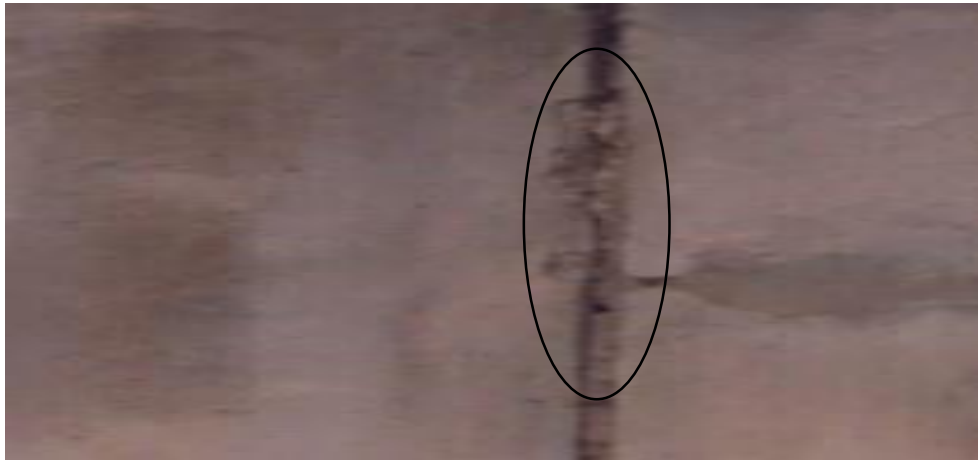
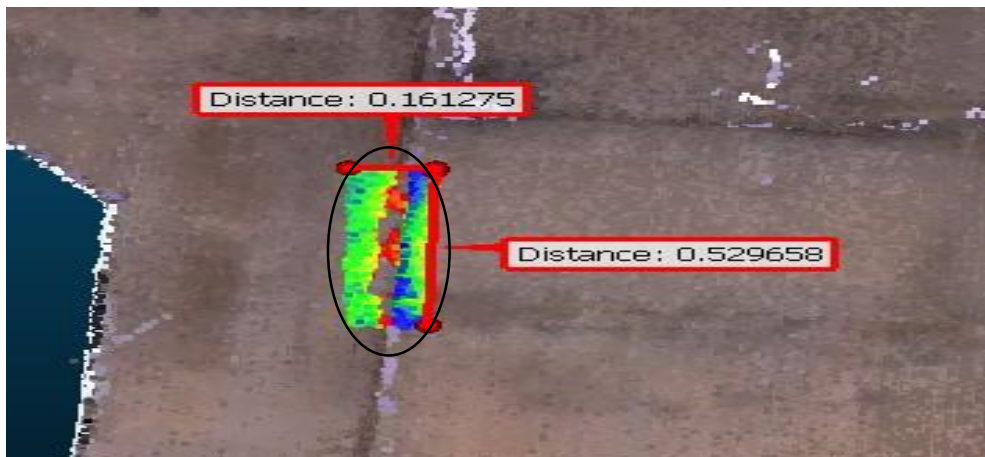
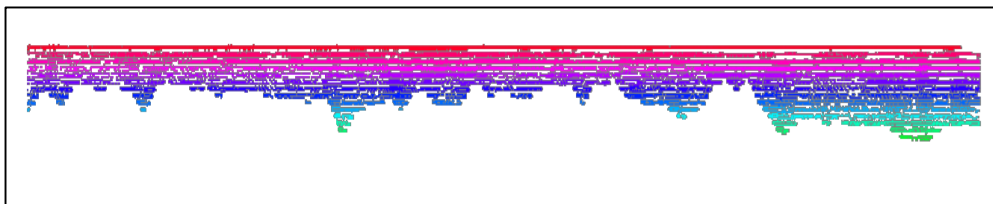
| Element Name | Observation | Location of Distress | Photo No. | Units | Distress Details | | | Area of Repair (Sq.m/ RMT/ m3) |
|---|---|---|---|---|---|---|---|---|
| Abutment 2 | Damage | | 4 | M | 0.16 | 0.52 | | 0.0832 |

**4. Damage observed on RHS A2, measuring 0.16 m in length and 0.52 m in width, covering an area of 0.0832 m<sup>2</sup>.**
