# **LIDAR Inspection Report of **Box Culvert** ch.1038+589**

**Bridge No:** Box Culvert

**Bridge Chainage:** 1038+589(CKRP)

- **CKRP:** Chittorgarh to kota
- **State:** Rajasthan NH 27
- **Zone:** RJ-06

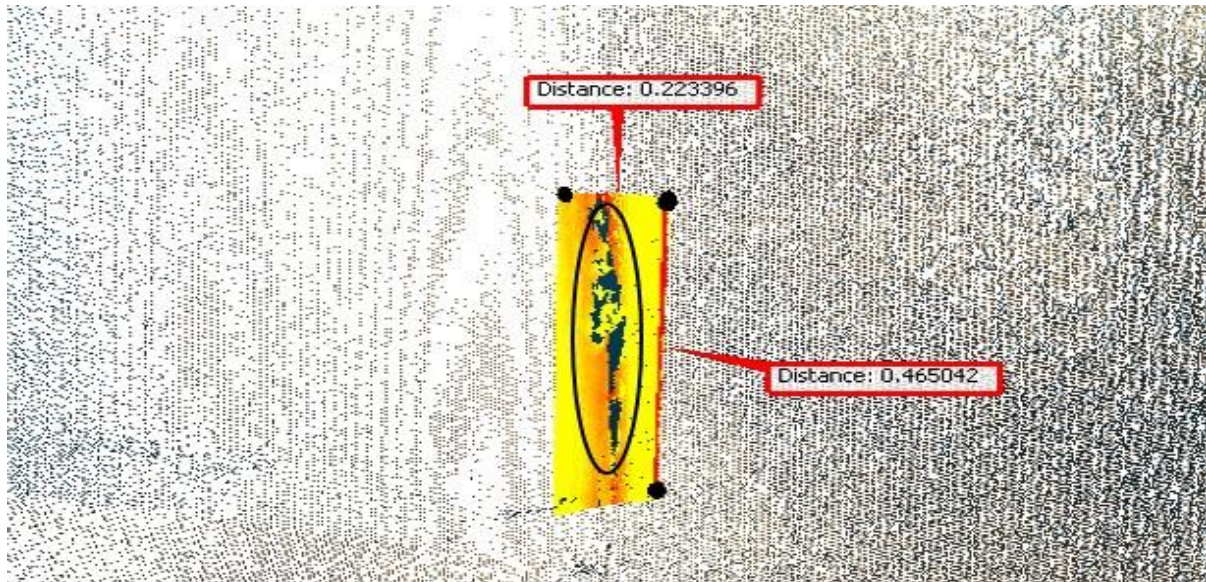
1. "Wing wall damage observed on, measuring 0.22 m in length and 0.45 m in width, covering an area of 0.099 m<sup>2</sup>."

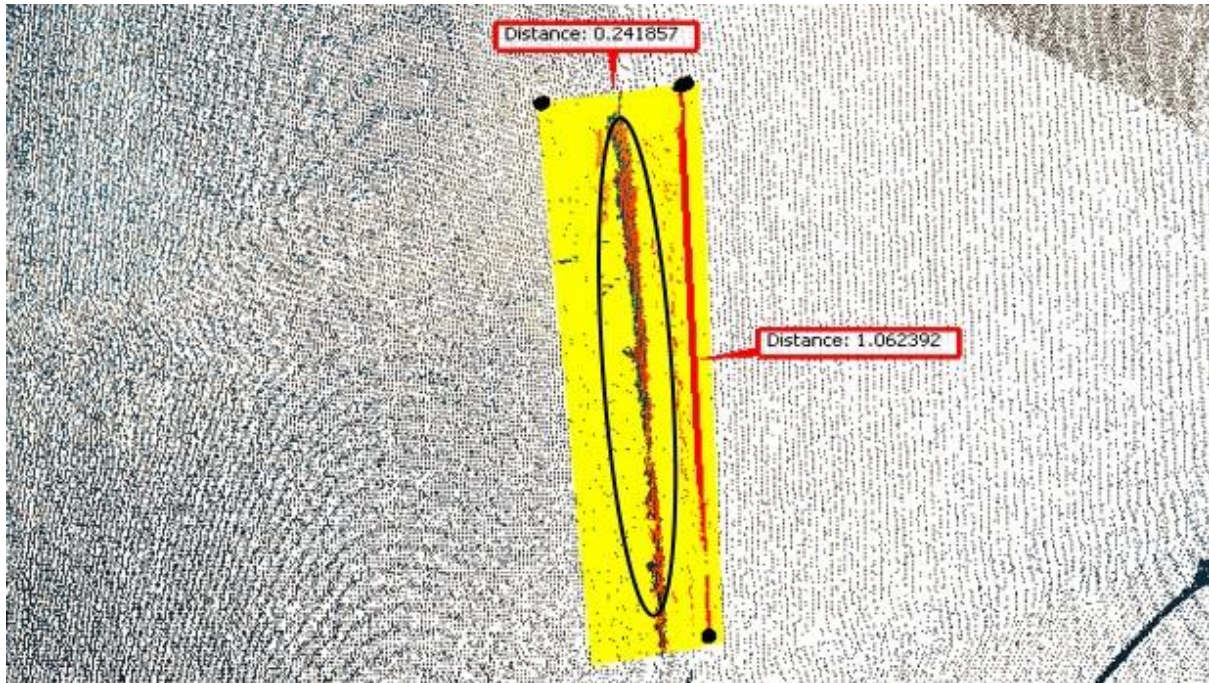
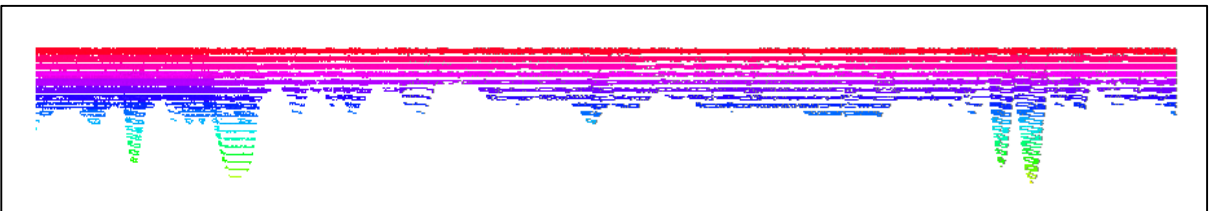
2. "Wing wall damage observed on, measuring 0.24 m in length and 1.06 m in width, covering an area of 0.2544 m<sup>2</sup>."

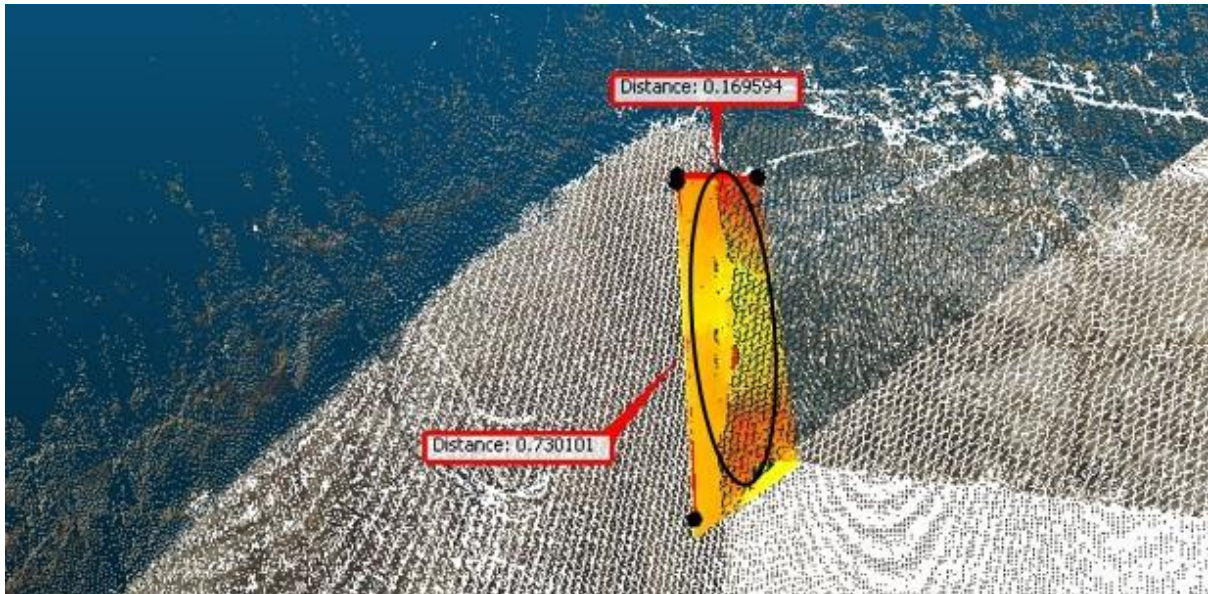
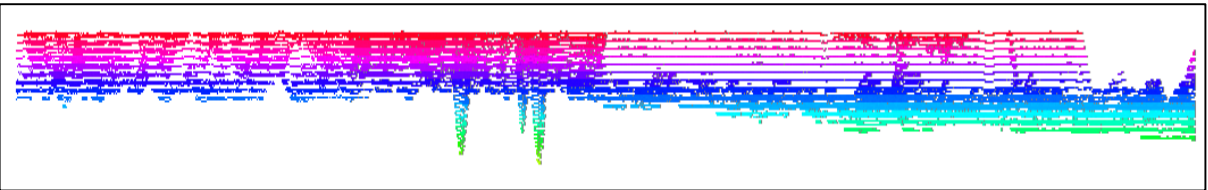
**3. "Wing wall damage observed on, measuring 0.16 m in length and 0.73 m in width, covering an area of 0.1168 m<sup>2</sup>."**

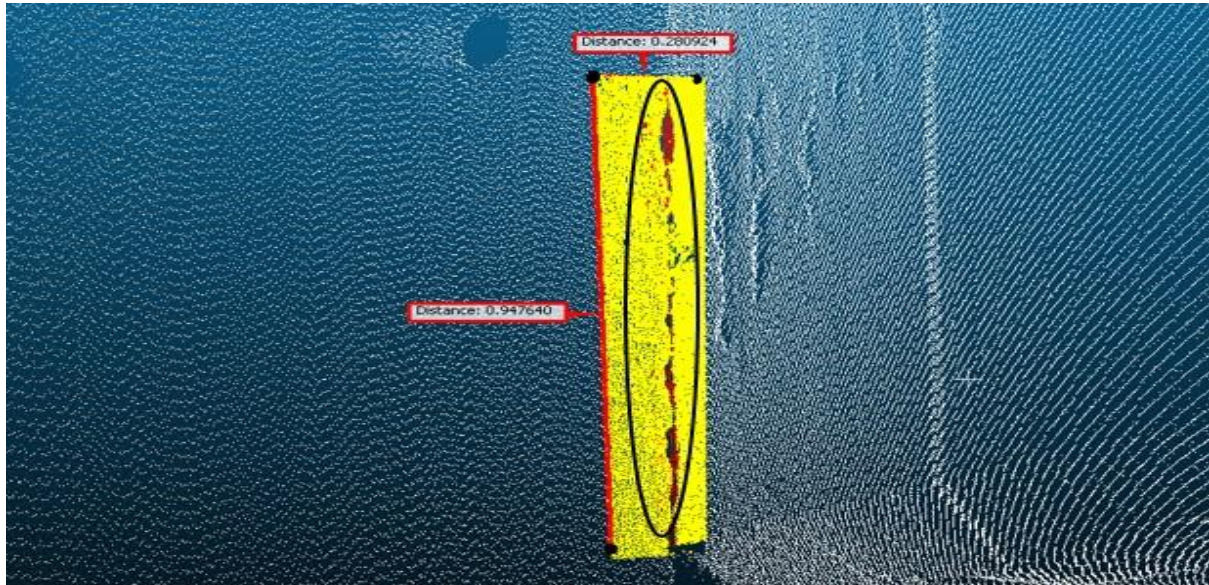
**4. "Wing wall damage observed on, measuring 0.28 m in length and 0.94 m in width, covering an area of 0.2632 m<sup>2</sup>."**

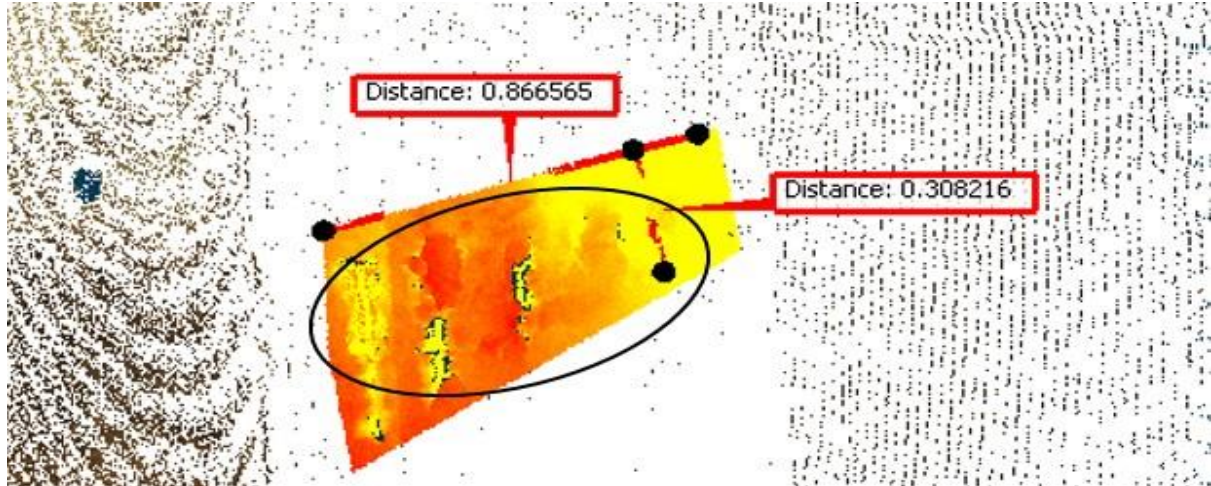
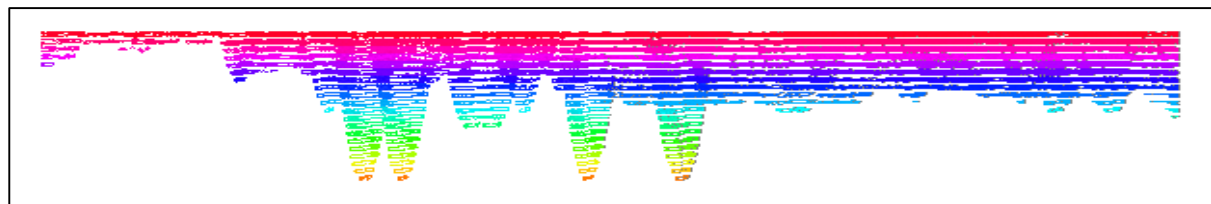
5. "Wing wall damage observed on, measuring 0.86 m in length and 0.30 m in width, covering an area of 0.258 m<sup>2</sup>."

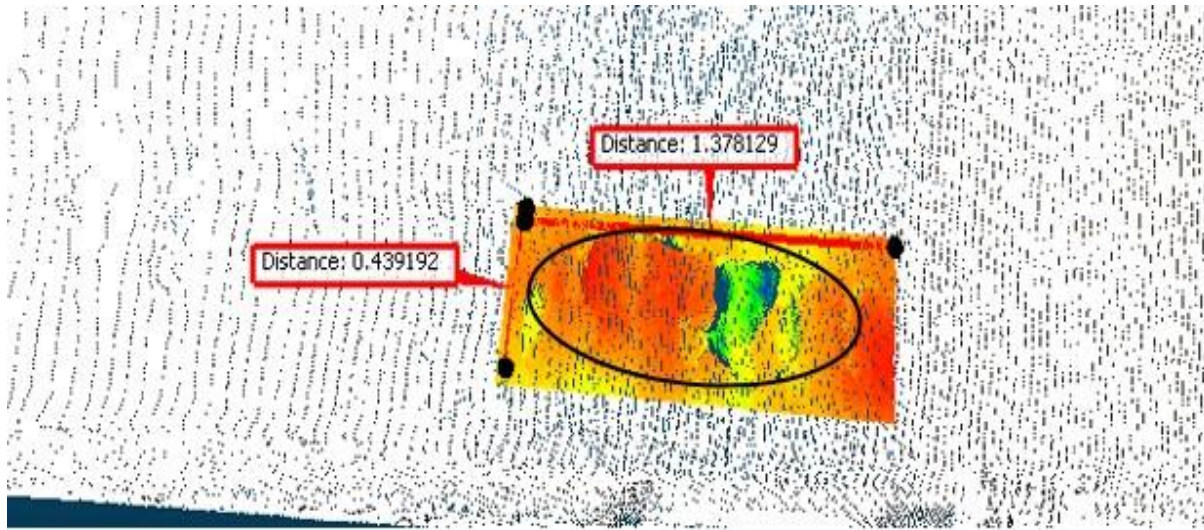
**6. "Wing wall damage observed on, measuring 1.37 m in length and 0.43 m in width, covering an area of 0.5891 m<sup>2</sup>."**
