# **LIDAR Inspection Report of MNB ch.1039+200**

**Bridge No:** MNB - 1040/1

**Bridge Chainage:** 1039 +200 (CKRP)

- **CKRP:** Chittorgarh to kota
- **State:** Rajasthan NH 27
- **Zone:** RJ-06

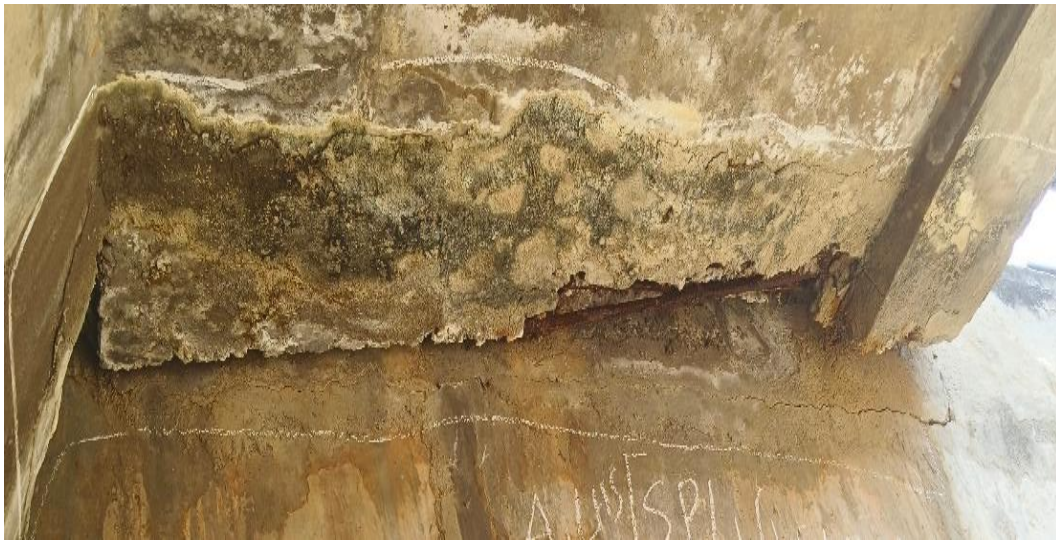
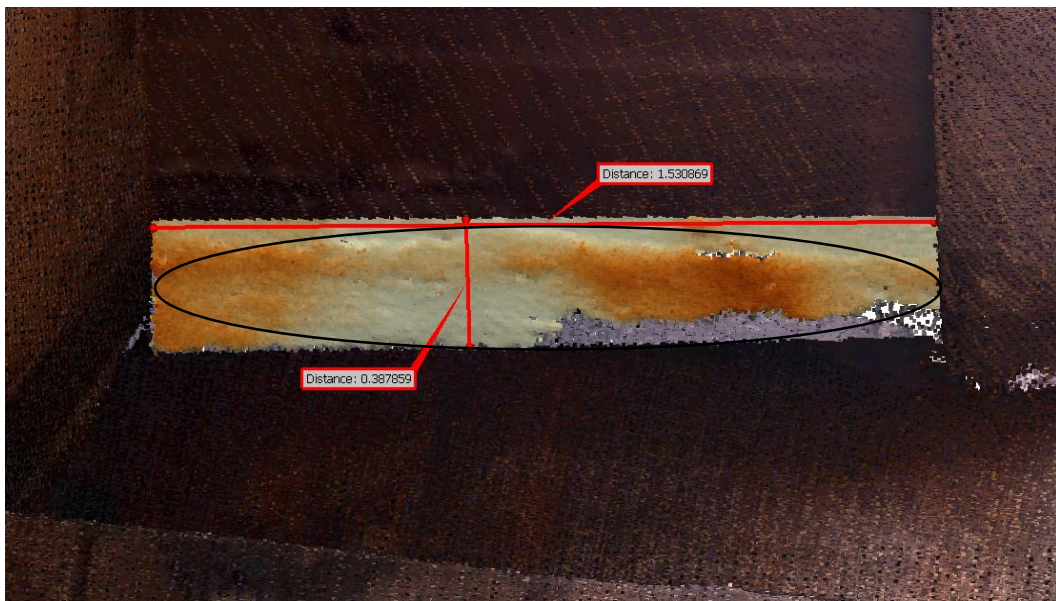
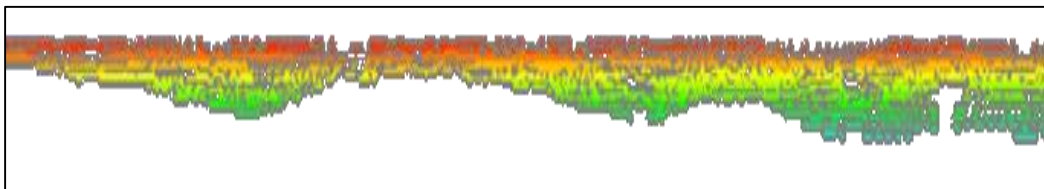
| Element Name | Observation | Location of Distress | Photo No. | Units | Distress Details | | | Area of Repair (Sq./RM T/m3) |
|---|---|---|---|---|---|---|---|---|
| Abutment 2 | Spalling | | 1 | | 1.04 | 1.74 | | 1.809 |

**1. Spalling observed on LHS Abutment 2 , measuring 1.58 m in length and 0.43 m in width, covering an area of 0.6794 m<sup>2</sup>.**

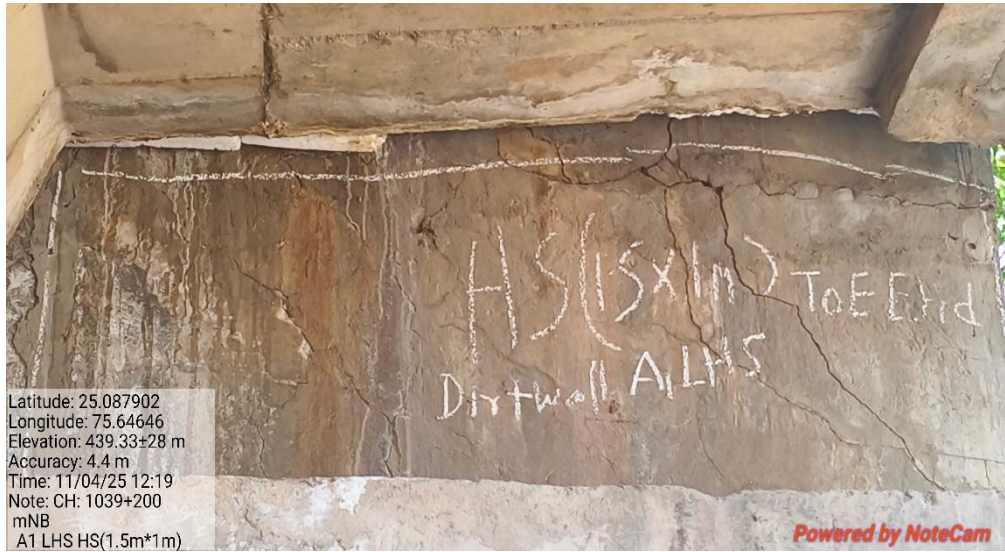
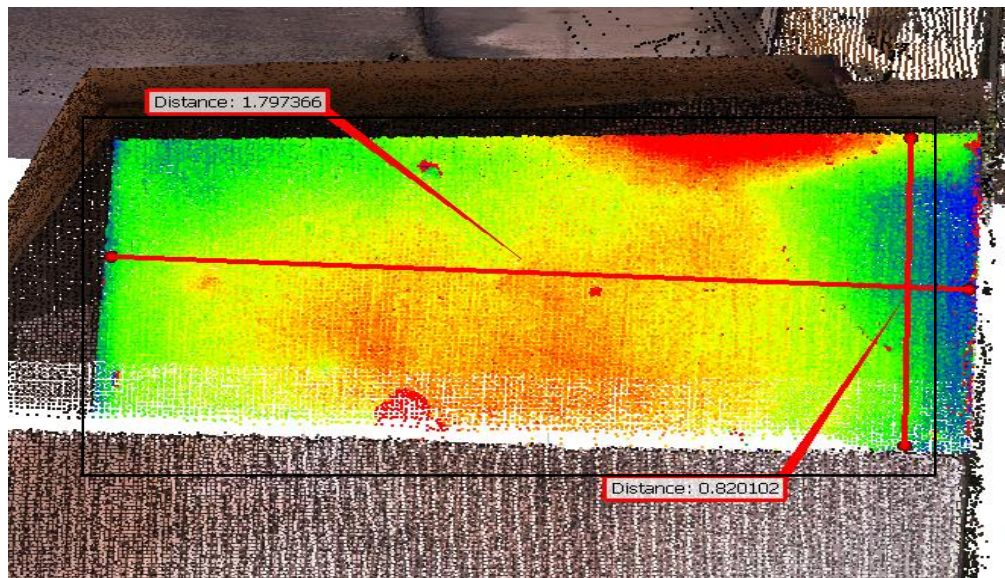
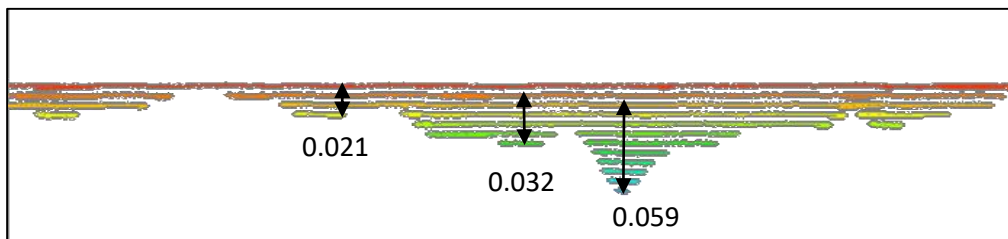
| Element Name | Observation | Location of Distress | Photo No. | Units | Distress Details | | | Area of Repair (Sq./RM T/m3) |
|---|---|---|---|---|---|---|---|---|
| Abutment 1 | Hollow Section | | 2 | | 1.79 | 0.82 | 0.032 | 0.0469 |

**2. Hollow section observed on LHS Abutment 1, measured as 1.79 m in length and 0.82 m in width, Depth ranges from 0.021 m (min) to 0.059 m (max), with an average depth of 0.032 m. The calculated volume of the distress is 0.0469m<sup>3</sup>.**

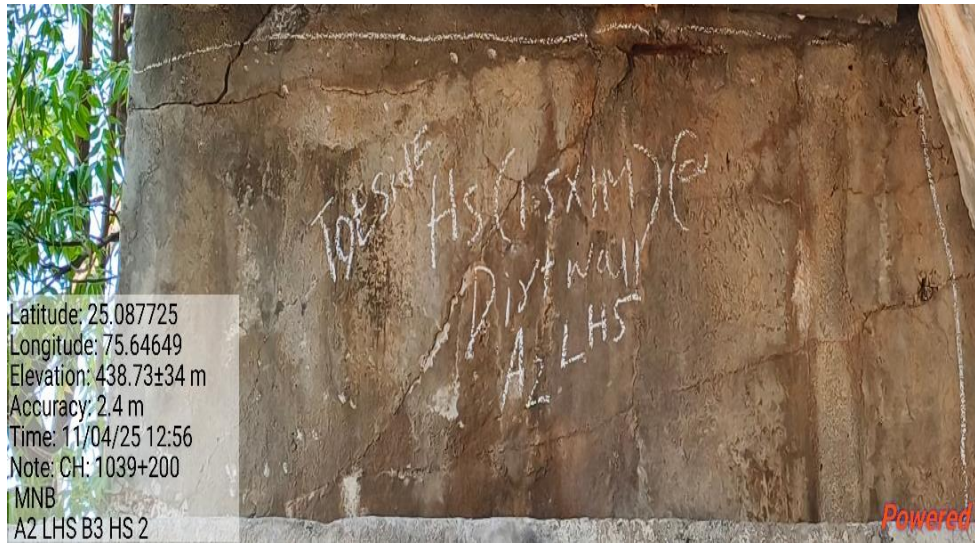
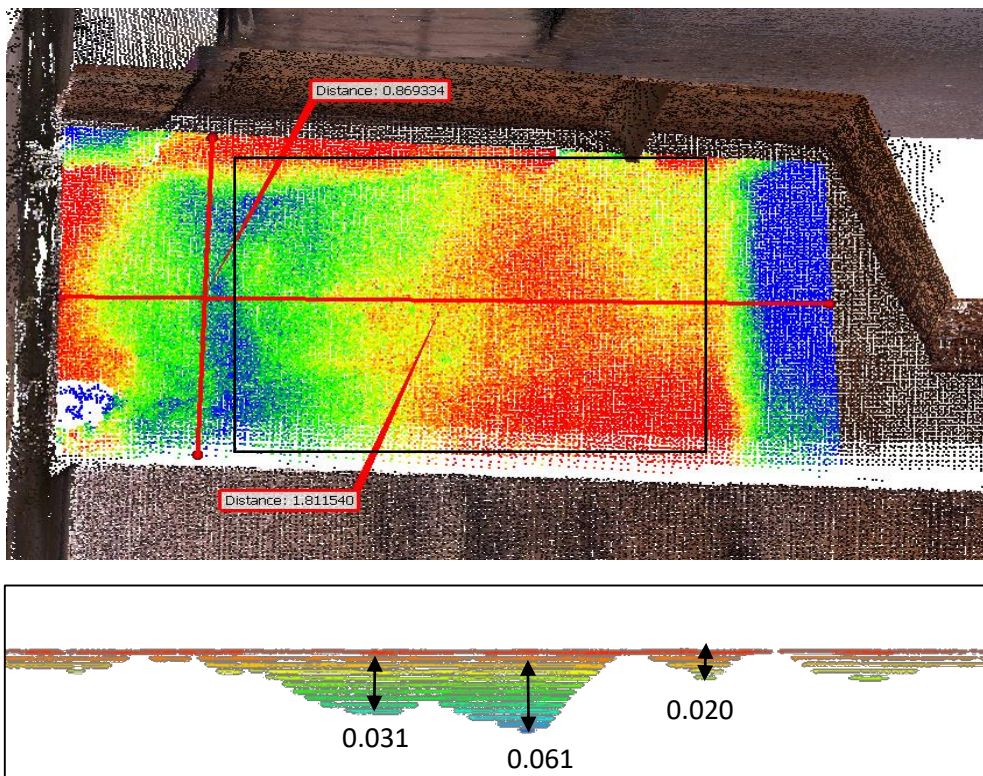
| Element Name | Observation | Location of Distress | Photo No. | Units | Distress Details | | | Area of Repair (Sq./RM T/m3) |
|---|---|---|---|---|---|---|---|---|
| Bearing | Hollow Section | | 3 | | 1.81 | 0.86 | 0.031 | 0.0482 |

**3. Hollow section observed at B3, LHS Abutment 2, measuring 1.81 m in length and 0.86 m in width, Depth ranges from 0.020 m (min) to 0.061 m (max), with an average depth of 0.031 m. The calculated volume of the distress is 0.0482m<sup>3</sup>.**

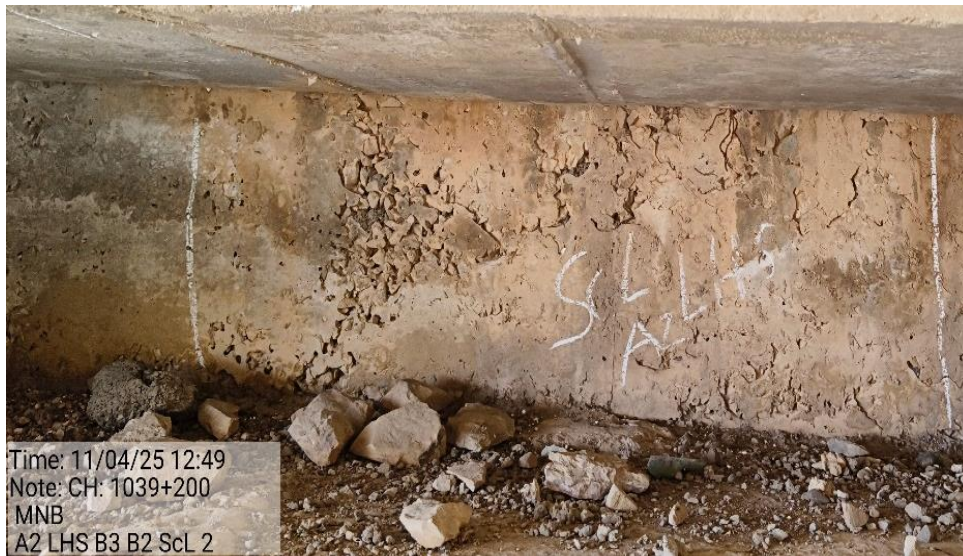
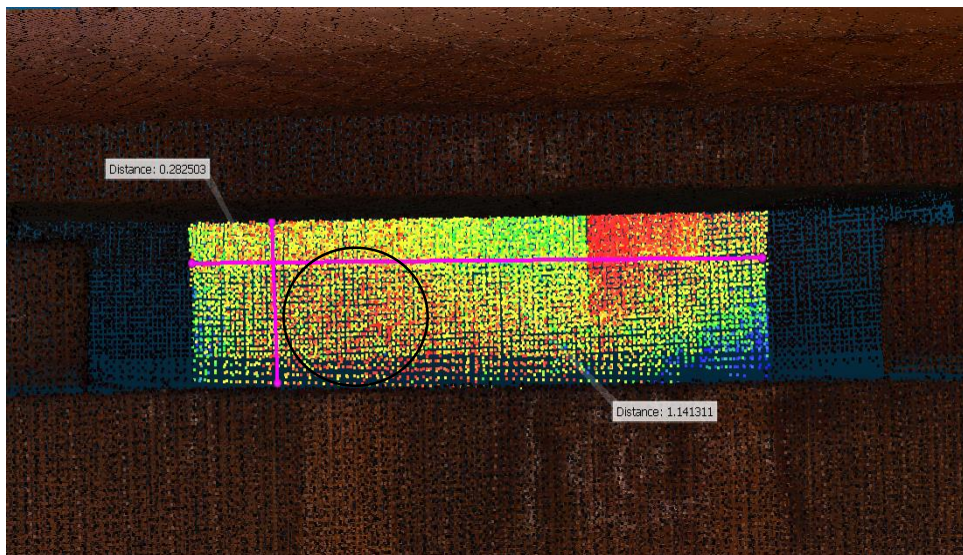
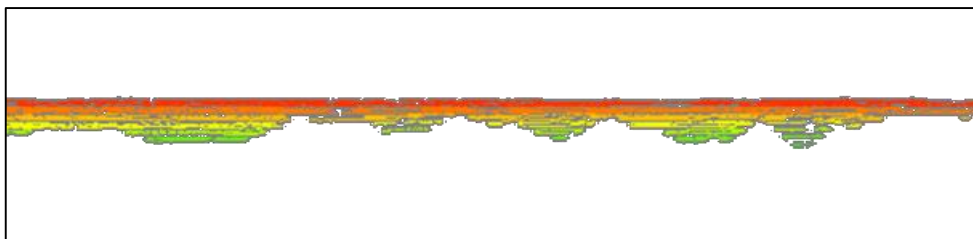
| Element Name | Observation | Location of Distress | Photo No. | Units | Distress Details | | | Area of Repair (Sq./RM T/m3) |
|---|---|---|---|---|---|---|---|---|
| Dirt wall | scaling | | 4 | | 1.14 | 0.28 | | 0.3192 |

**4. Scaling observed between Bearing 3–Bearing 2 on LHS Abutment 2 , measuring 1.14 m in length and 0.28 m in width, area 0.3192 m<sup>2</sup>.**

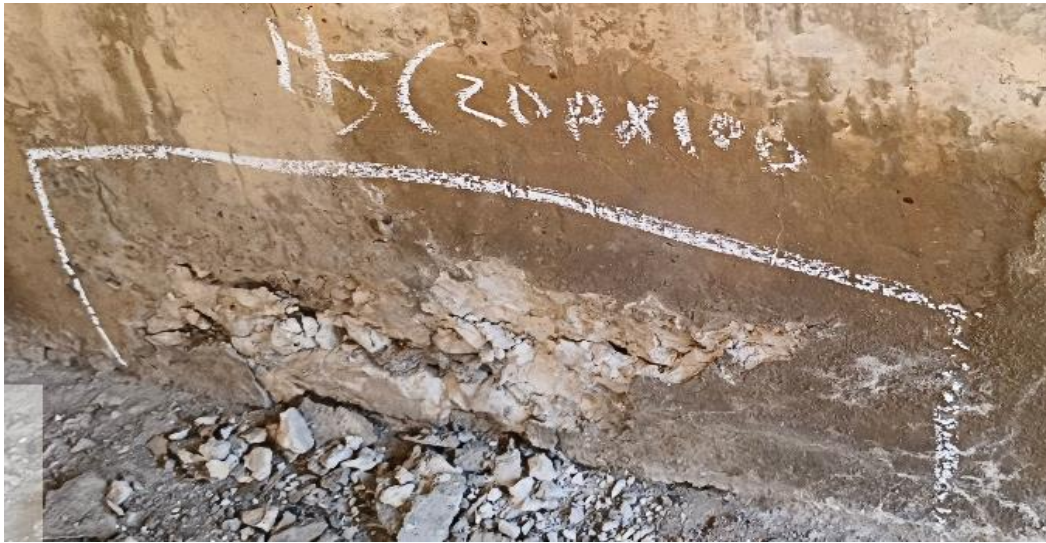
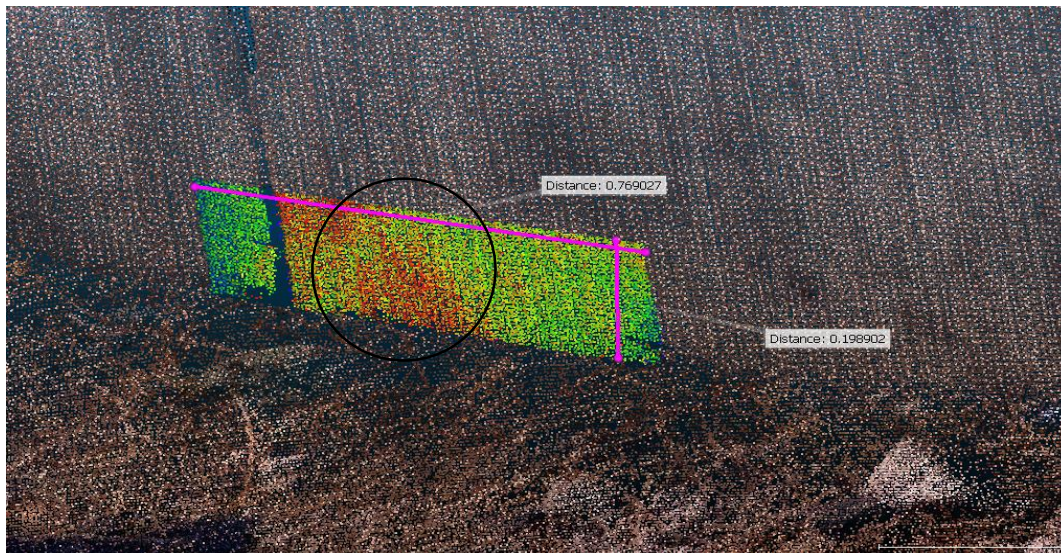
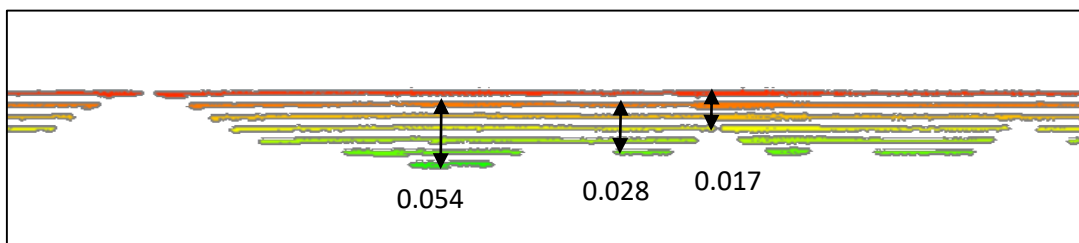
| Element Name | Observation | Location of Distress | Photo No. | Units | Distress Details | | | Area of Repair (Sq./RM T/m3) |
|---|---|---|---|---|---|---|---|---|
| Abutment 2 | Hollow Section | | 5 | | 0.76 | 0.19 | 0.028 | 0.0040 |

**5. Hollow section observed on LHS Abutment 2, measuring 0.76 m in length and 0.19 m in width, Depth ranges from 0.017 m (min) to 0.054 m (max), with an average depth of 0.028 m. The calculated volume of the distress is 0.0040m<sup>3</sup>.**

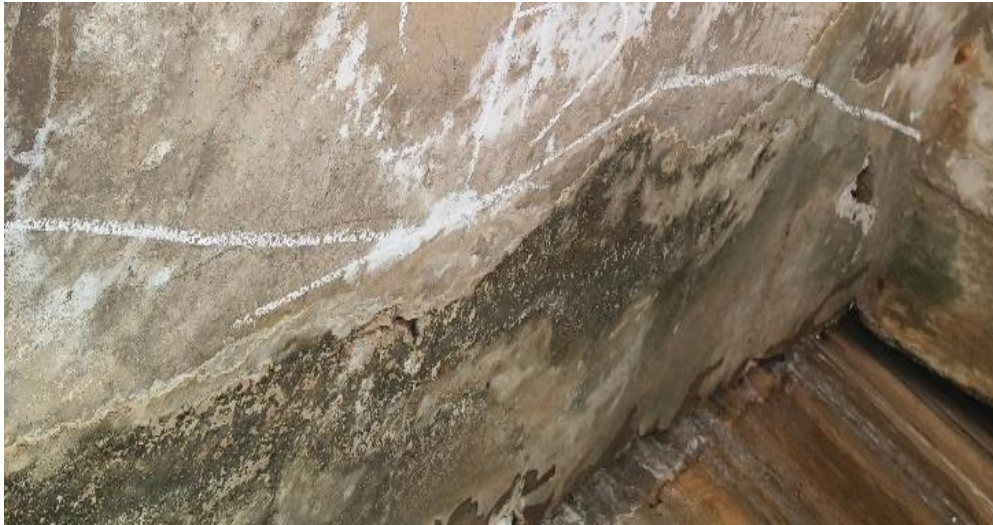
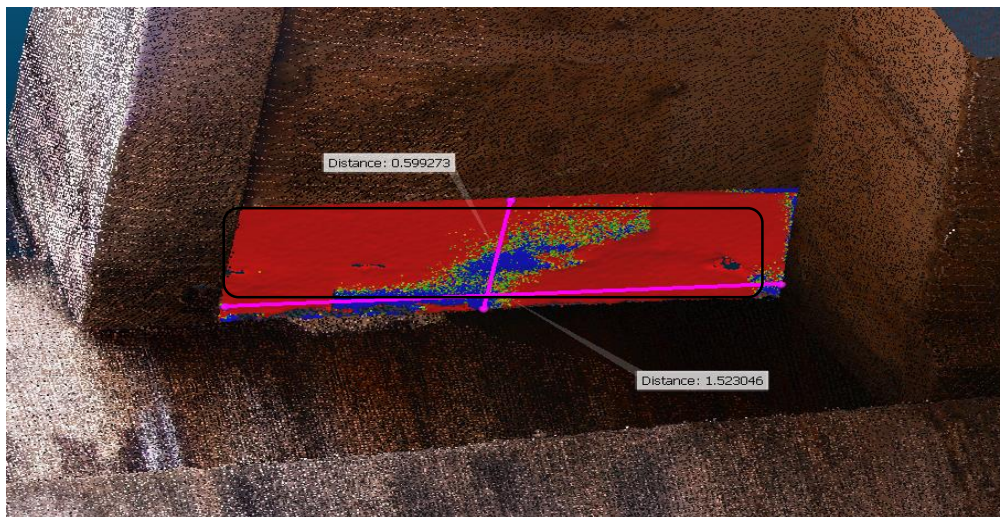
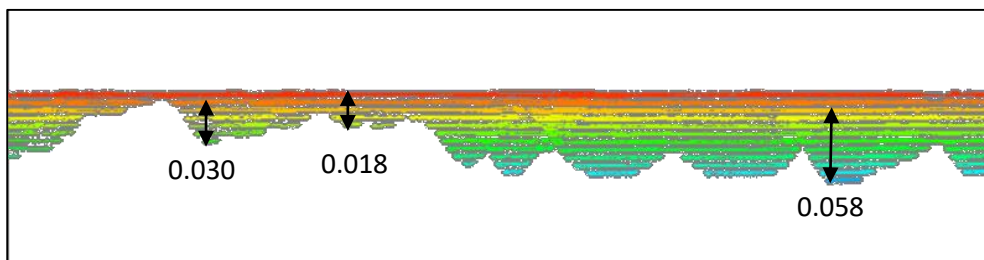
| Element Name | Observation | Location of Distress | Photo No. | Units | Distress Details | | | Area of Repair (Sq./RM T/m3) |
|---|---|---|---|---|---|---|---|---|
| Abutment 1 | Hollow Section | | 6 | | 1.52 | 0.59 | 0.030 | 0.0269 |

**6. Hollow section observed on median side approach LHS Abutment 1, measured as 1.52 m in length and 0.59 m in width, Depth ranges from 0.018 m (min) to 0.058 m (max), with an average depth of 0.030 m. The calculated volume of the distress is 0.0269m<sup>3</sup>.**

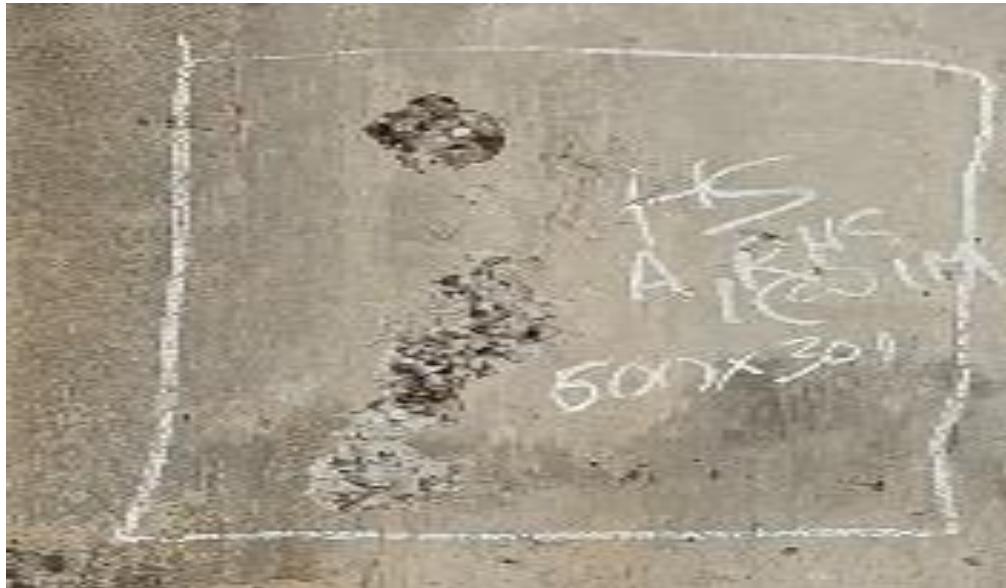
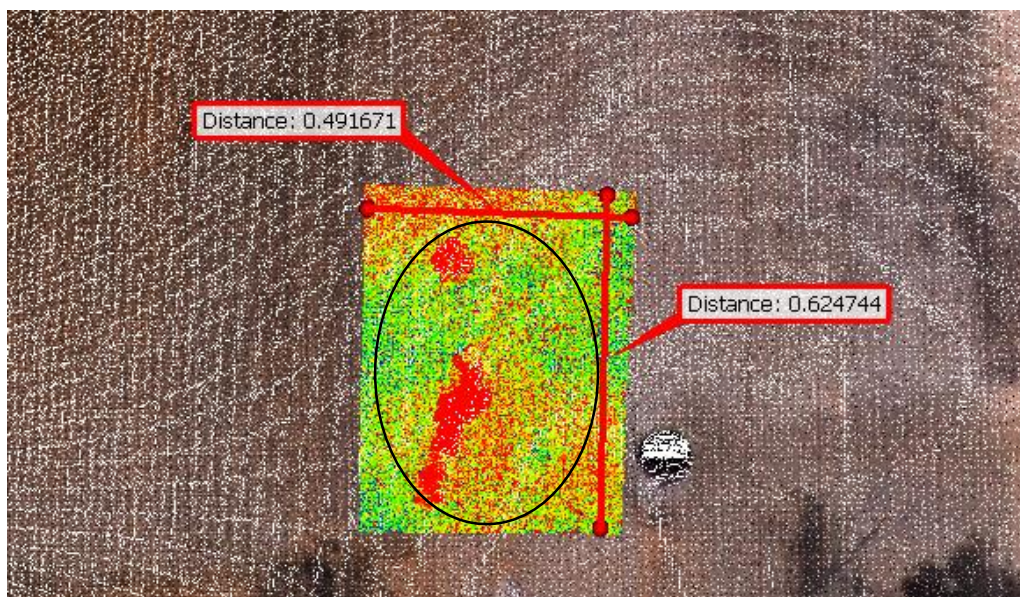
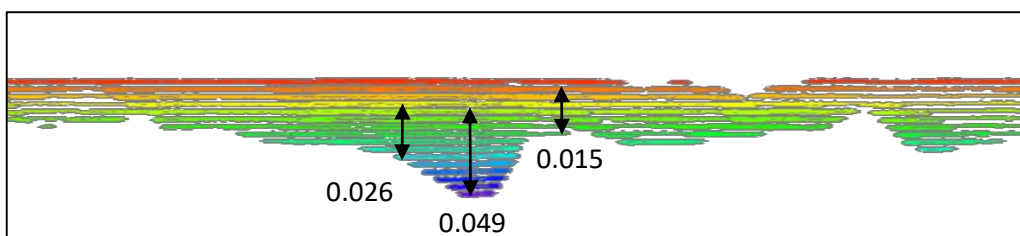
| Element Name | Observation | Location of Distress | Photo No. | Units | Distress Details | | | Area of Repair (Sq./RM T) |
|---|---|---|---|---|---|---|---|---|
| Abutment 1 | Hollow Section | | 7 | | 0.62 | 0.49 | 0.026 | 0.0078 |

**7. Hollow section observed on RHS Abutment 1, measuring 0.62 m in length and 0.49 m in width, Depth ranges from 0.015 m (min) to 0.049 m (max), with an average depth of 0.026 m. The calculated volume of the distress is 0.0078m<sup>3</sup>.**

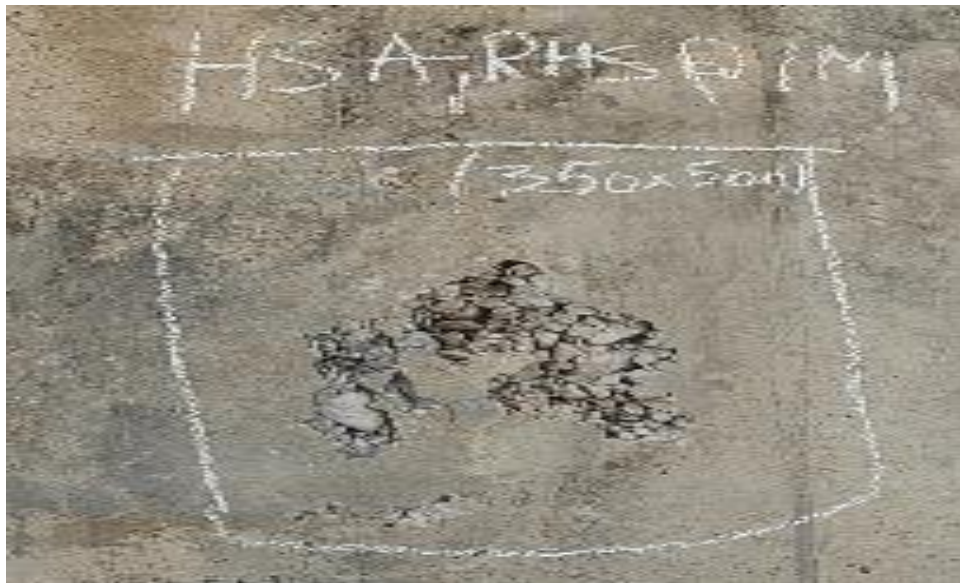
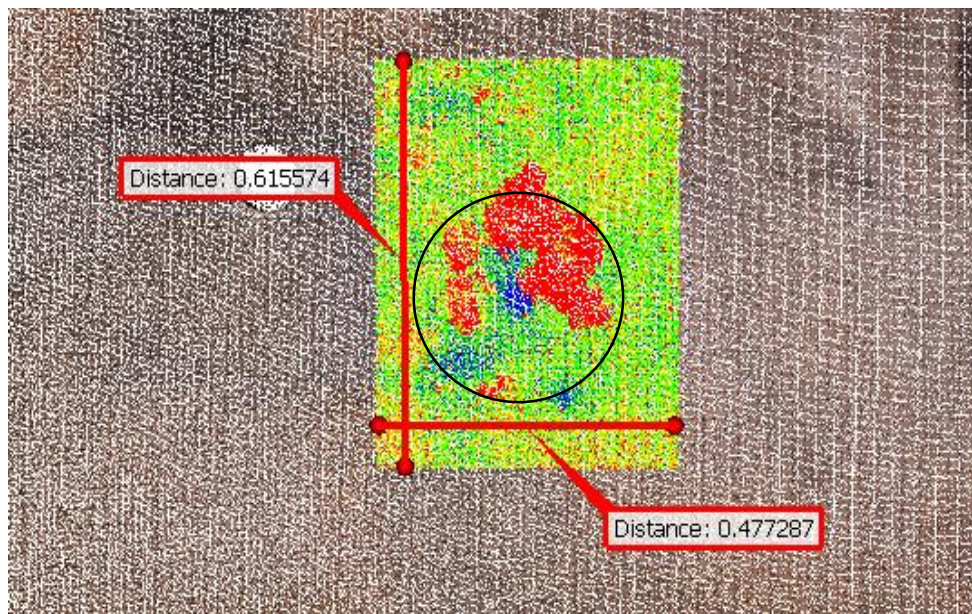
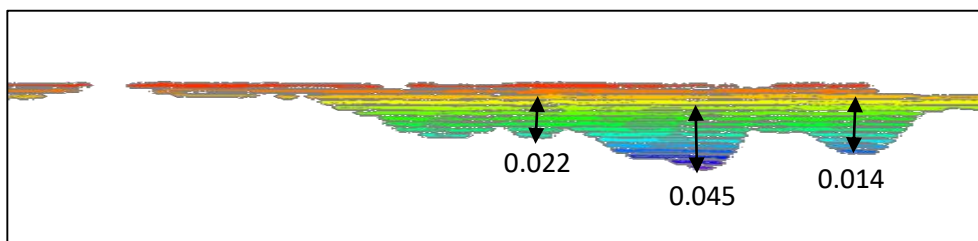
| Element Name | Observation | Location of Distress | Photo No. | Units | Distress Details | | | Area of Repair (Sq./RM T) |
|---|---|---|---|---|---|---|---|---|
| Abutment 1 | Hollow Section | | 8 | | 0.61 | 0.47 | 0.022 | 0.0063 |

**8. Hollow section observed on RHS Abutment1, measuring 0.61 m in length and 0.47 m in width, Depth ranges from 0.014 m (min) to 0.045 m (max), with an average depth of 0.022 m. The calculated volume of the distress is 0.0063m<sup>3</sup>.**

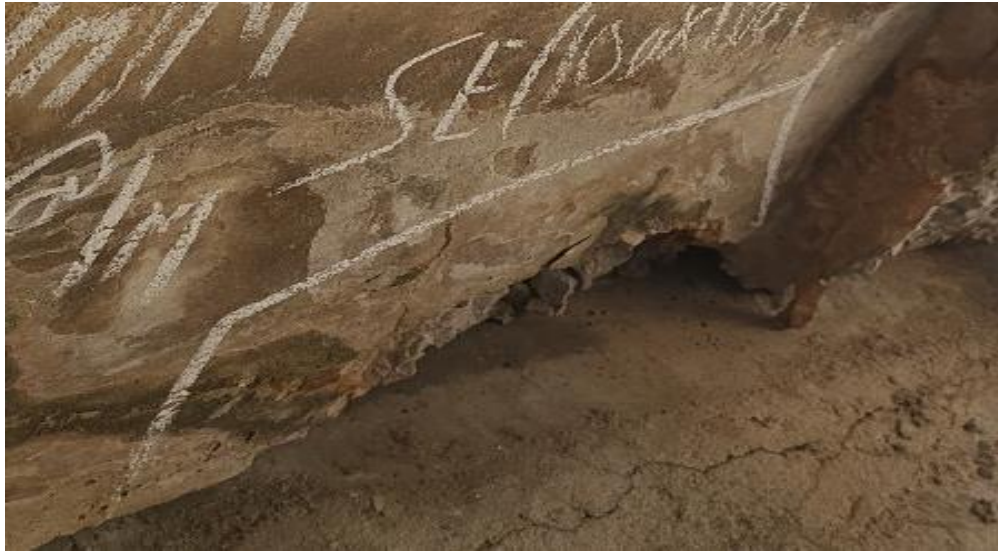
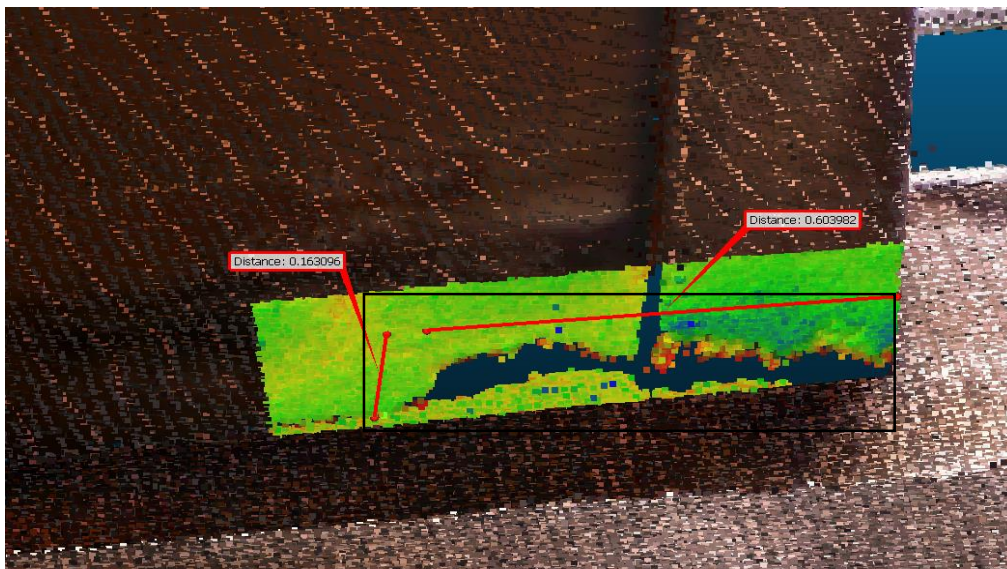
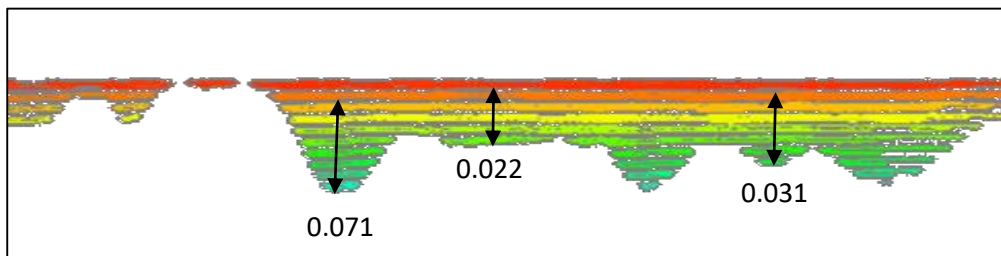
| Element Name | Observation | Location of Distress | Photo No. | Units | Distress Details | | | Area of Repair (Sq./RM T) |
|---|---|---|---|---|---|---|---|---|
| Abutment 1 | Steel Exposed | | 9 | | 0.60 | 0.16 | 0.031 | 0.0029 |

**9. Steel exposed on RHS A1 at median side approach measured as 0.60 m in length and 0.16 m in width, Depth ranges from 0.022 m (min) to 0.071 m (max), with an average depth of 0.031 m. The calculated volume of the distress is 0.0029m<sup>3</sup>.**

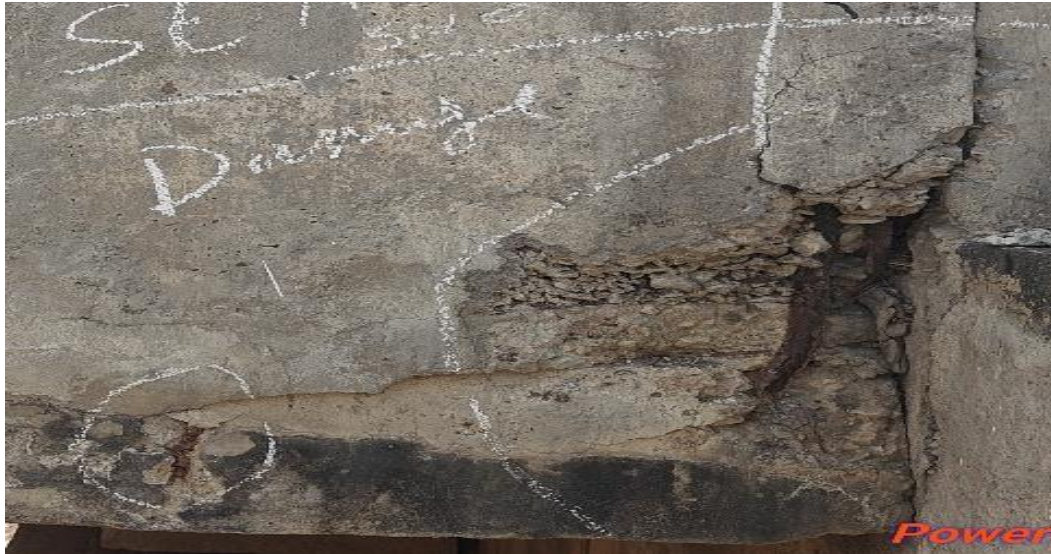
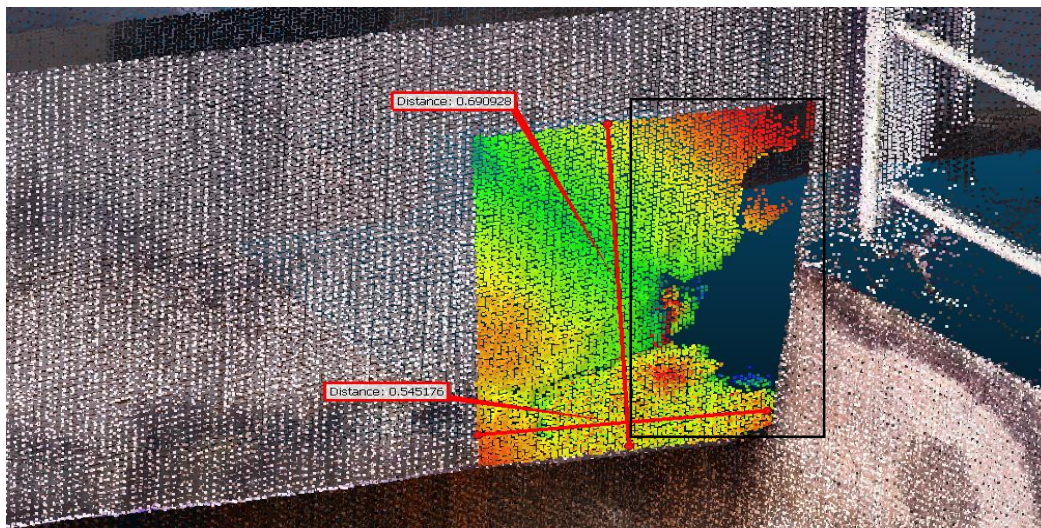
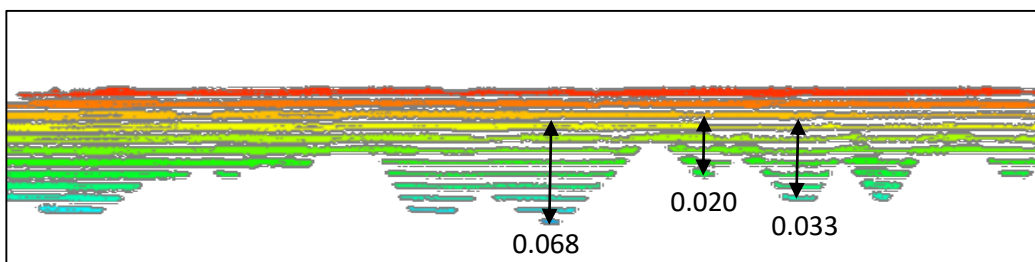
| Element Name | Observation | Location of Distress | Photo No. | Units | Distress Details | | | Area of Repair (Sq./RM T) |
|---|---|---|---|---|---|---|---|---|
| Abutment 1 | Hollow section | | 10 | | 0.69 | 0.54 | 0.033 | 0.0122 |

**10. Steel exposed on RHS Abutment 1 at median side approach measured as 0.69 m in length and 0.54 m in width, Depth ranges from 0.020 m (min) to 0.068 m (max), with an average depth of 0.033 m. The calculated volume of the distress is 0.0122 m<sup>3</sup>.**

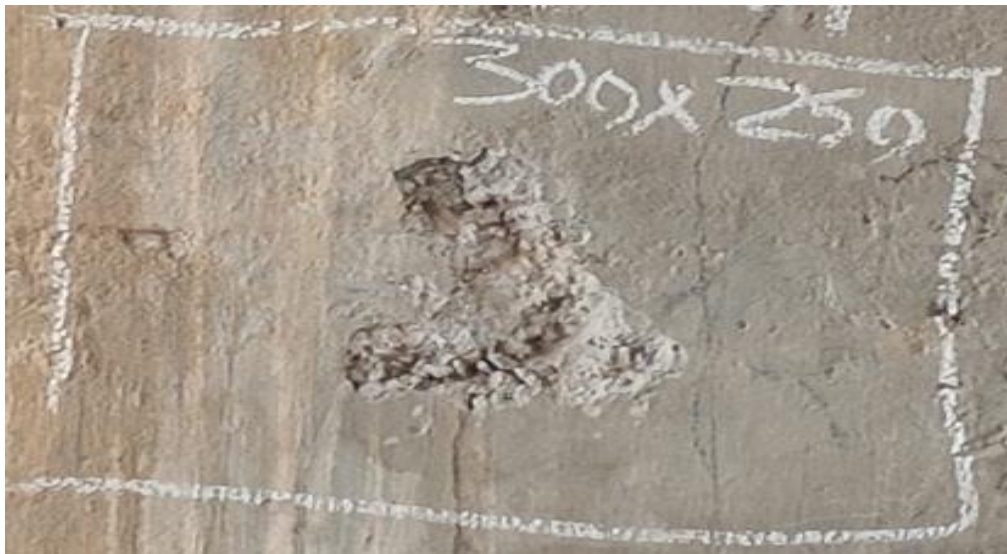
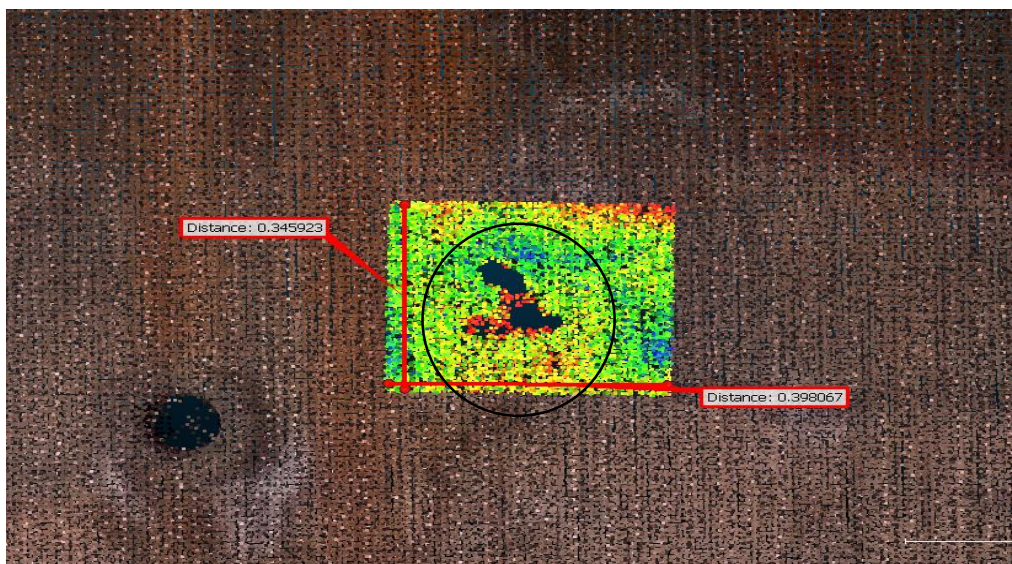
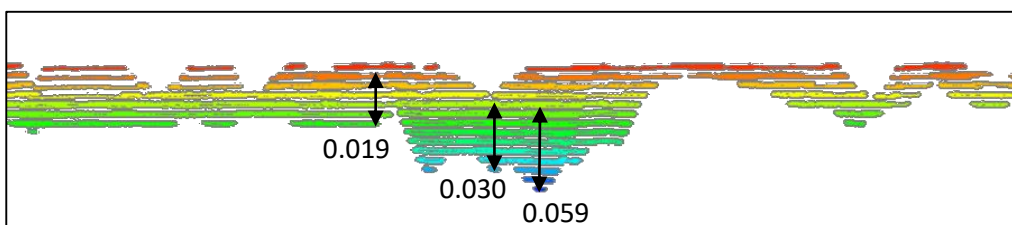
| Element Name | Observation | Location of Distress | Photo No. | Units | Distress Details | | | Area of Repair (Sq./RM T) |
|---|---|---|---|---|---|---|---|---|
| Abutment 1 | Hollow section | | 11 | | 0.39 | 0.34 | 0.030 | 0.0039 |

**11. Hollow section observed on RHS Abutment 1 , measuring 0.39 m in length and 0.34 m in width, Depth ranges from 0.019 m (min) to 0.059 m (max), with an average depth of 0.030 m. The calculated volume of the distress is 0.0039 m<sup>3</sup>.**

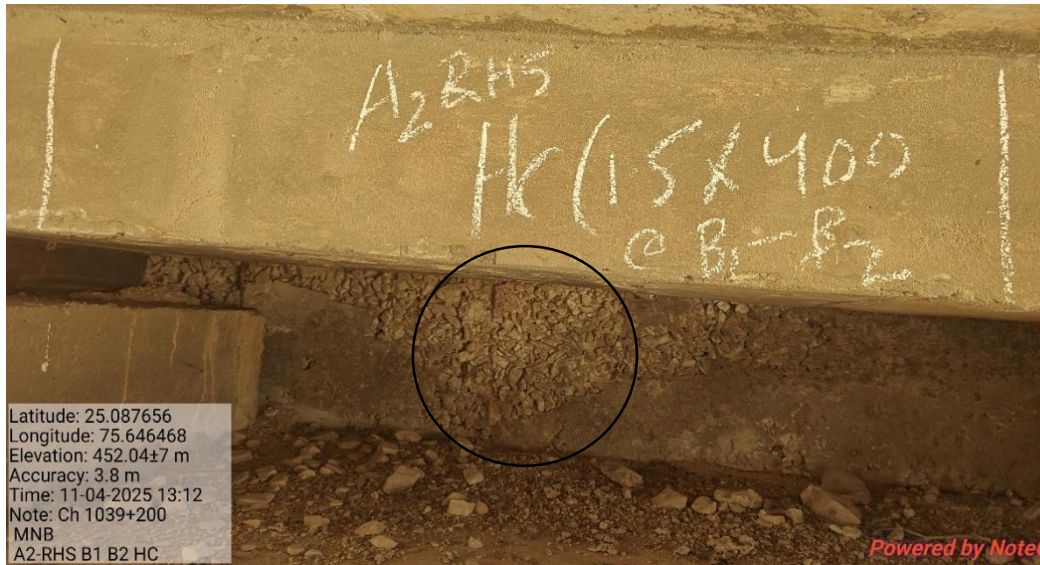
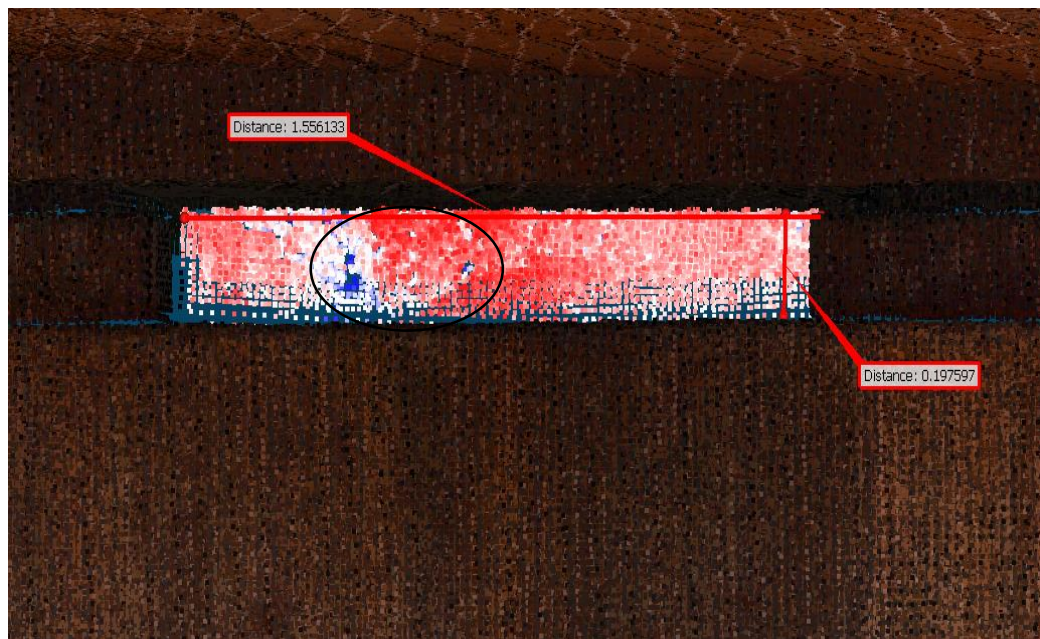
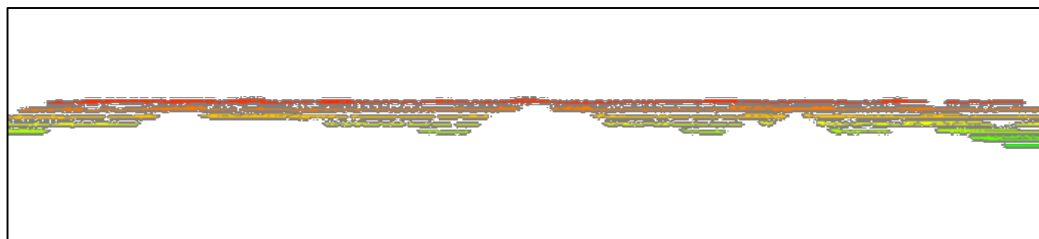
| Element Name | Observation | Location of Distress | Photo No. | Units | Distress Details | | | Area of Repair (Sq./RM T) |
|---|---|---|---|---|---|---|---|---|
| Dirt Wall | Honey Combing | | 12 | | 1.55 | 0.19 | | 0.2945 |

**12. Honeycombing observed between Bearing 1–Bearing 2 on RHS Abutment 2, measuring 1.55 m in length and 0.19 m in width, area 0.2945 m<sup>2</sup>.**

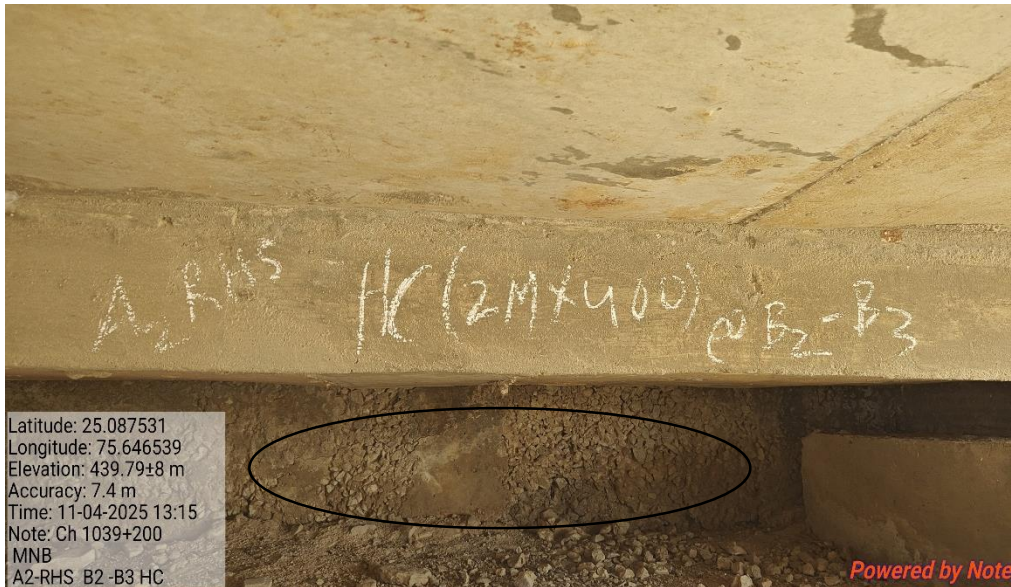
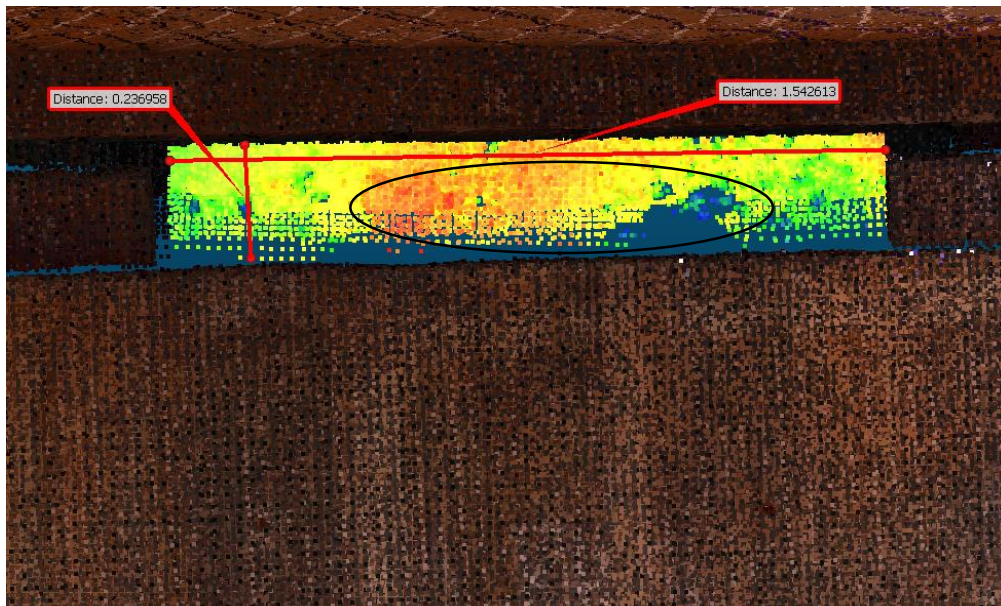
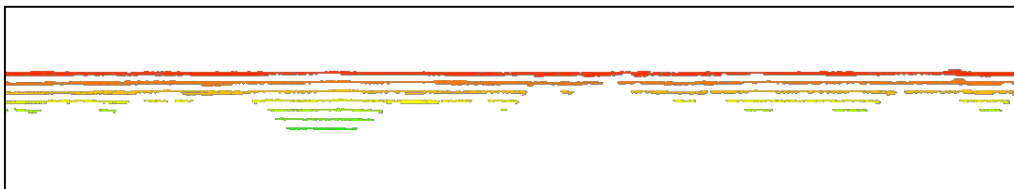
| Element Name | Observation | Location of Distress | Photo No. | Units | Distress Details | | | Area of Repair (Sq./RM T) |
|---|---|---|---|---|---|---|---|---|
| Dirt wall | Honey Combing | | 13 | | 1.54 | 0.23 | | 0.3542 |

**13. Honeycombing observed between Bearing 2–Bearing 3 on RHS Abutment 2, measuring 1.54 m in length and 0.23 m in width, covering an area of 0.3542 m<sup>2</sup>.**

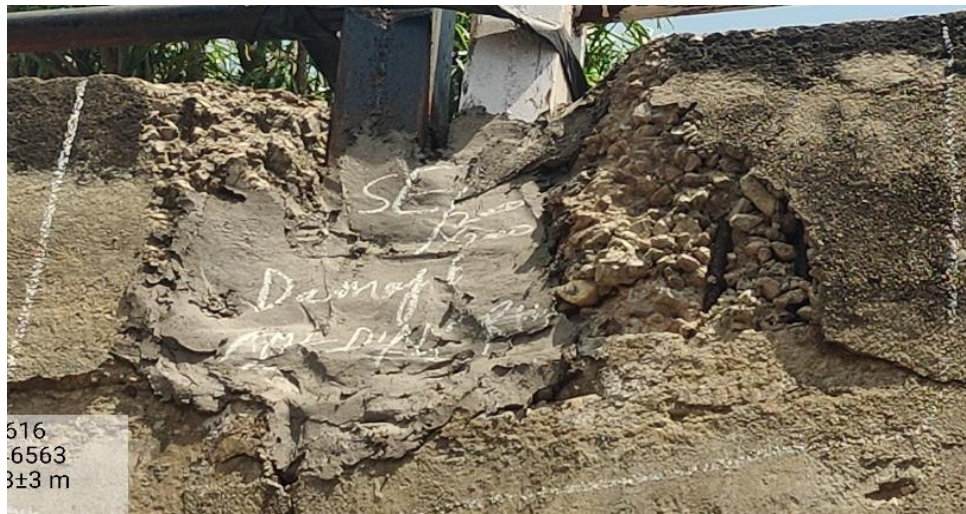
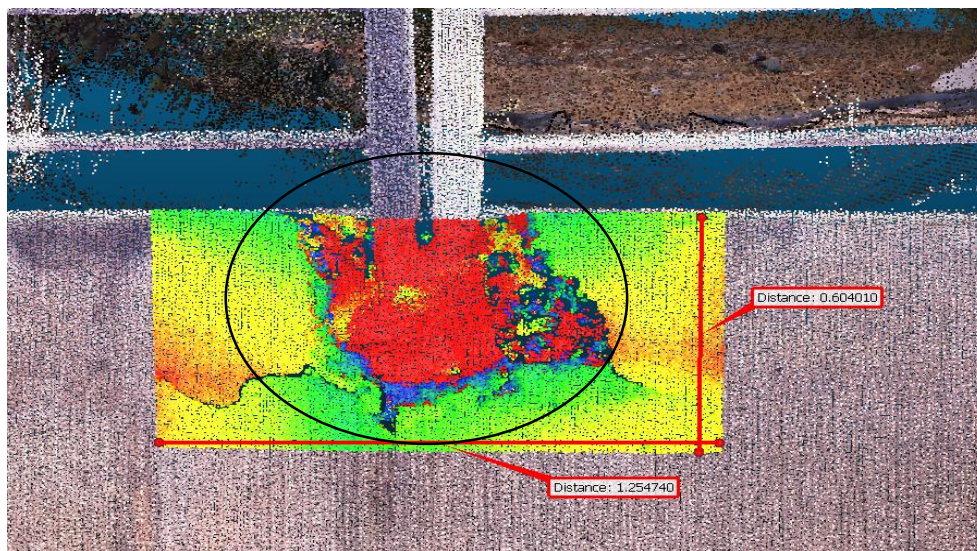
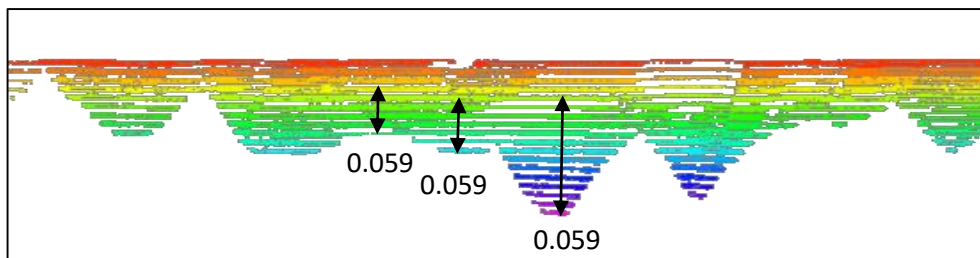
| Element Name | Observation | Location of Distress | Photo No. | Units | Distress Details | | | Area of Repair (Sq./RM T) |
|---|---|---|---|---|---|---|---|---|
| Median | Steel Exposed | | 14 | | 1.25 | 0.60 | 0.030 | 0.0225 |

**14. Steel exposed at median on RHS Abutment 2, measuring 1.25 m in length and 0.60 m in width, Depth ranges from 0.019 m (min) to 0.059 m (max), with an average depth of 0.030 m. The calculated volume of the distress is 0.0225 m<sup>3</sup>.**
