# **LIDAR Inspection Report of MNB ch.1039+350**

**Bridge No:** MNB - 1040/2

**Bridge Chainage:** 1039+350 (CKRP)

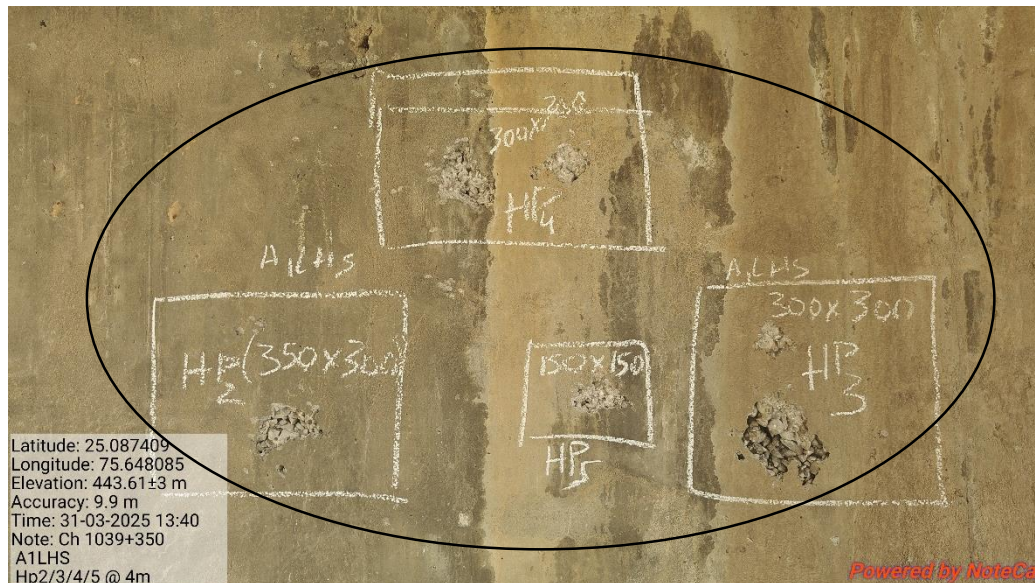
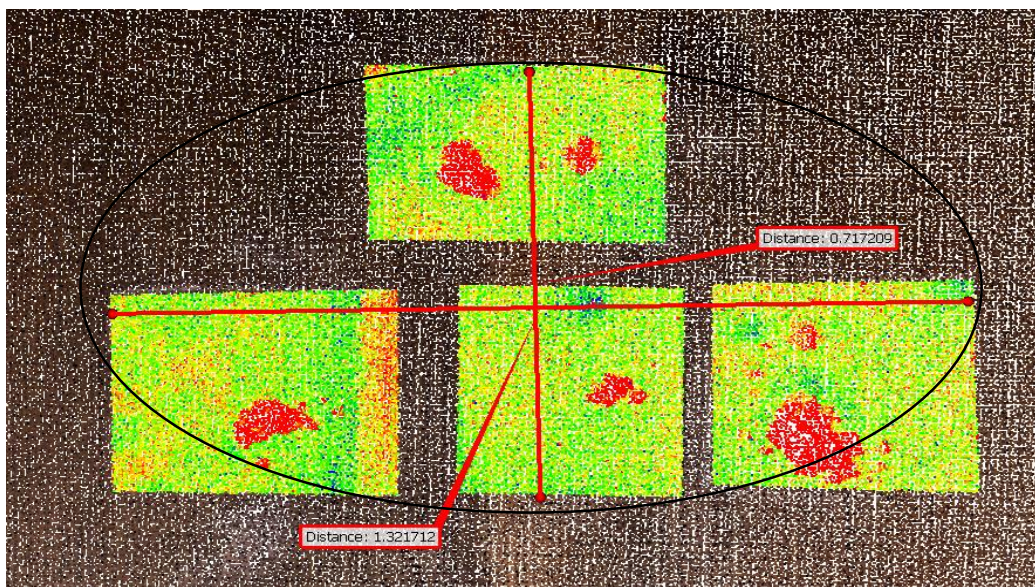
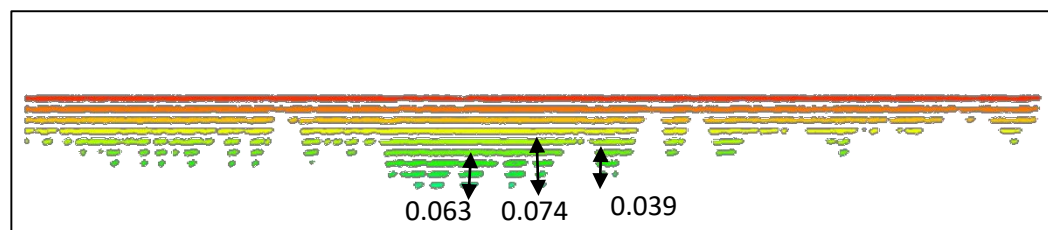
| Element Name | Observation | Location of Distress | Photo No. | Units | Distress Details | | | Area of Repair (Sq./RM T/m3) |
|---|---|---|---|---|---|---|---|---|
| Abutment 1 | Hollow Section | | 1 | | 1.32 | 0.71 | 0.063 | 0.0590 |

**1. Hollow section observed on LHS Abutment 1, measuring 1.32 m in length and 0.71 m in width, covering an area of 0.9372 m<sup>2</sup>. Depth ranges from 0.039 m (min) to 0.074 m (max), with an average depth of 0.063 m. The calculated volume of the distress is 0.0590 m<sup>3</sup>.**

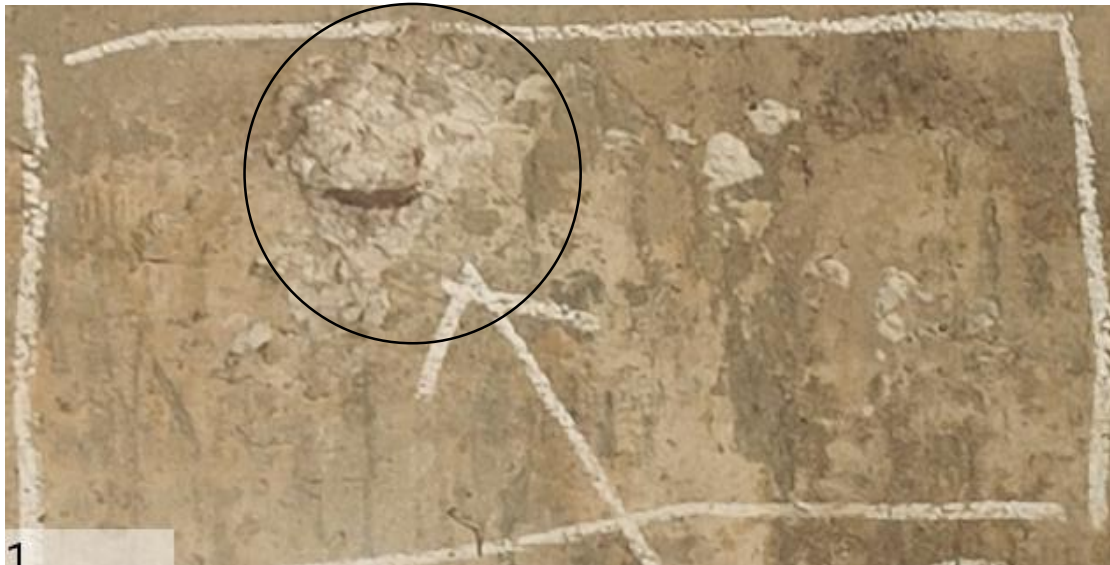
| Element Name | Observation | Location of Distress | Photo No. | Units | Distress Details | | | Area of Repair (Sq./RM T/m3) |
|---|---|---|---|---|---|---|---|---|
| Dirt Wall | Steel Exposed | | 2 | | 0.43 | 0.24 | | 0.1032 |

**2. Steel exposure with dirt accumulation observed on LHS Abutment 1 wall, measuring 0.43 m in length and 0.24 m in width, area 0.1032 m<sup>2</sup>**

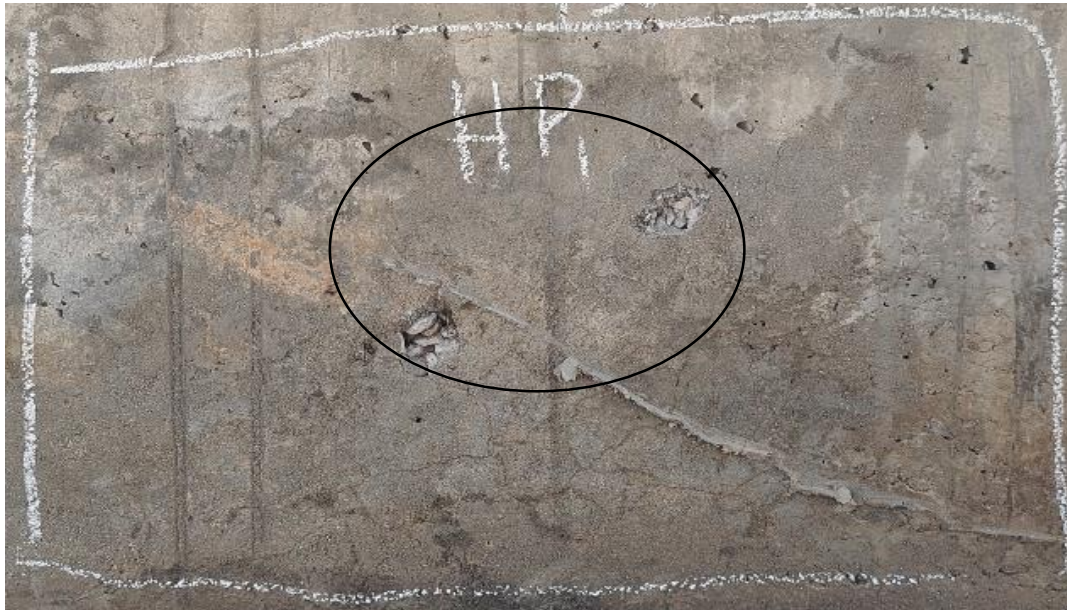
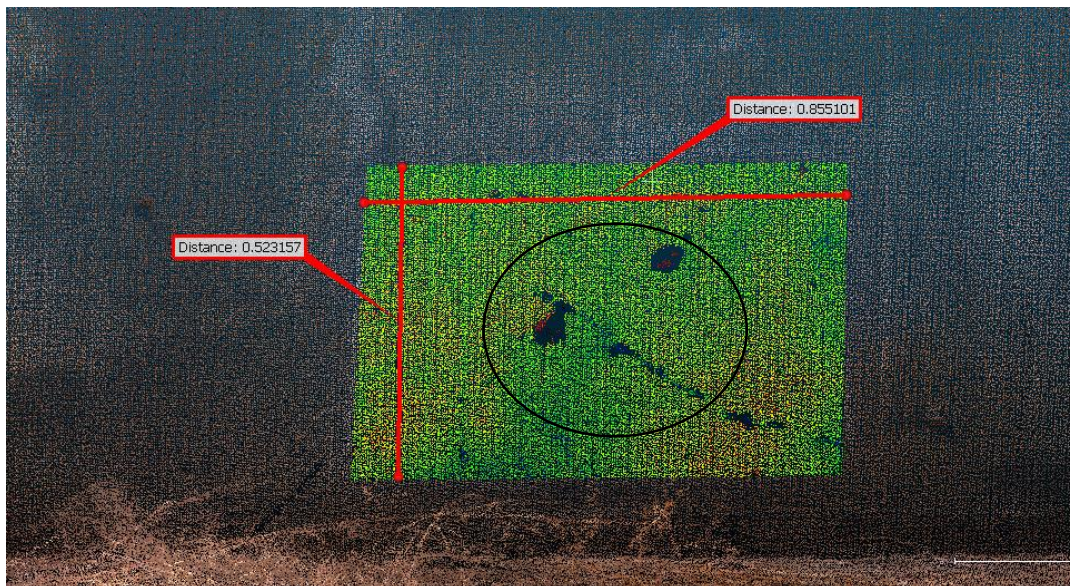
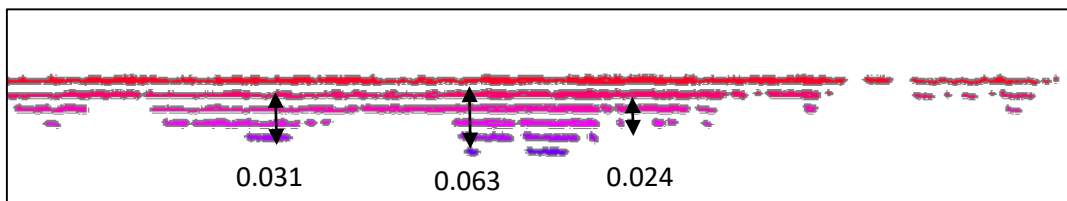
| Element Name | Observation | Location of Distress | Photo No. | Units | Distress Details | | | Area of Repair (Sq./RM T/m3) |
|---|---|---|---|---|---|---|---|---|
| Abutment 1 | Hollow Pocket | | 3 | | 0.85 | 0.52 | 0.024 | 0.0106 |

**3. Hollow pocket observed at on LHS Abutment 1, measuring 0.85 m in length and 0.52 m in width, Depth ranges from 0.031 m (min) to 0.063 m (max), with an average depth of 0.024 m. The calculated volume of the distress is 0.0106 m<sup>3</sup>.**

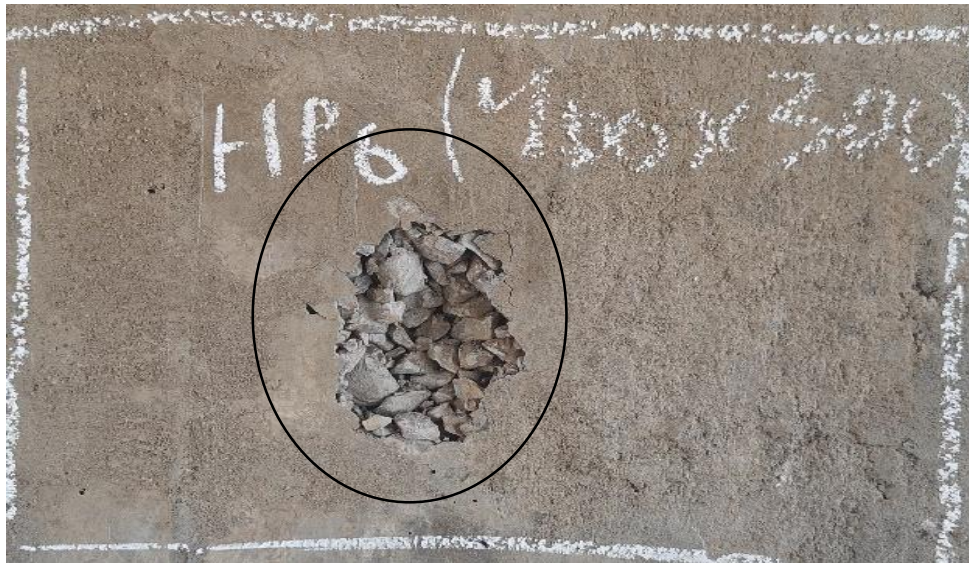
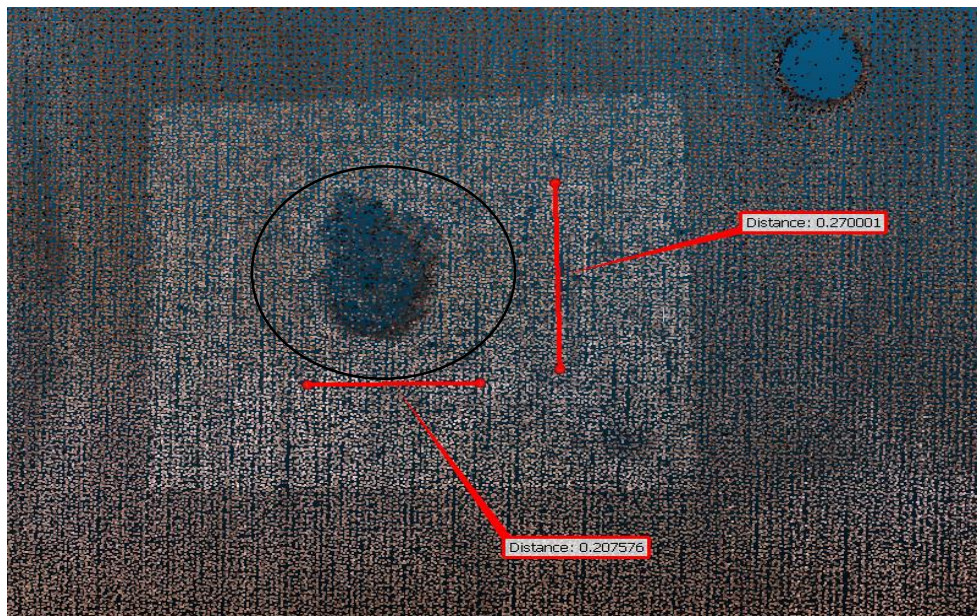
| Element Name | Observation | Location of Distress | Photo No. | Units | Distress Details | | | Area of Repair (Sq./RM T/m3) |
|---|---|---|---|---|---|---|---|---|
| Abutment 1 | Hollow Pocket | | 4 | | 0.27 | 0.20 | 0.055 | 0.00297 |

**4. Hollow pocket observed on LHS Abutment 1, measuring 0.27 m in length and 0.20 m in width, Depth ranges from 0.016 m (min) to 0.071 m (max), with an average depth of 0.055 m. The calculated volume of the distress is 0.00297 m<sup>3</sup>.**

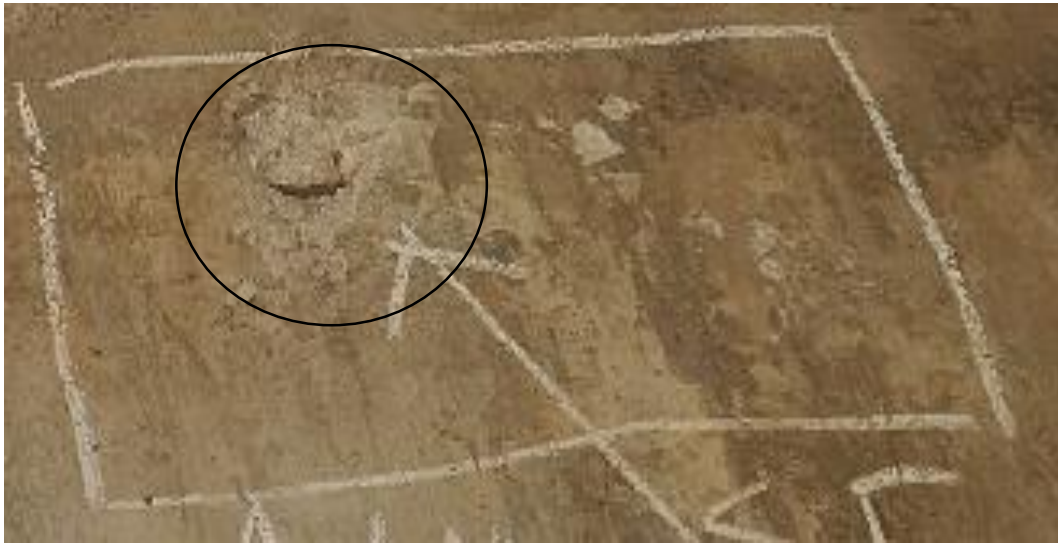
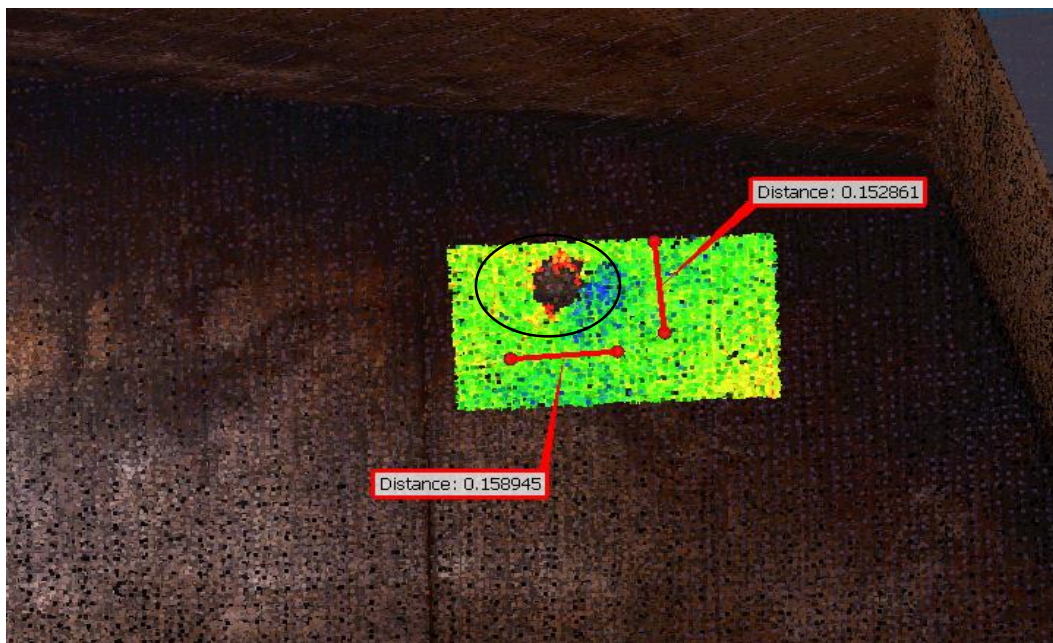
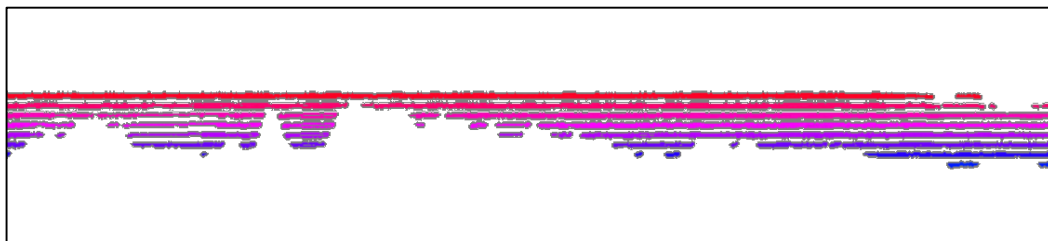
| Element Name | Observation | Location of Distress | Photo No. | Units | Distress Details | | | Area of Repair (Sq./RM T/m3) |
|---|---|---|---|---|---|---|---|---|
| Abutment 1 | Steel Exposed | | 5 | | 0.15 | 0.15 | | 0.0225 |

**5. Steel exposed surface observed on LHS Abutment 1, measuring 0.15 m in length and 0.15 m in width, covering 0.0225 m<sup>2</sup>.**

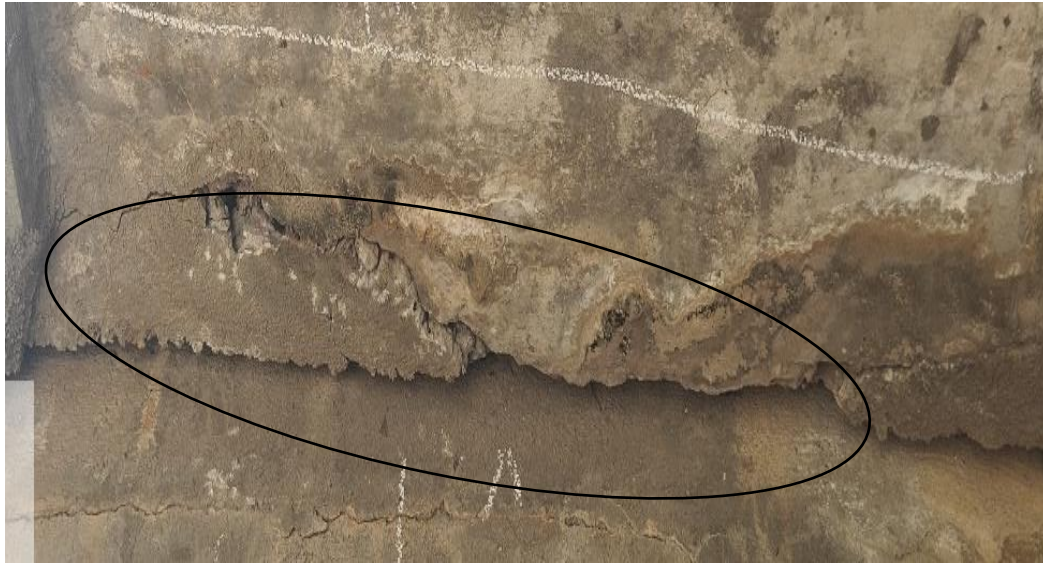
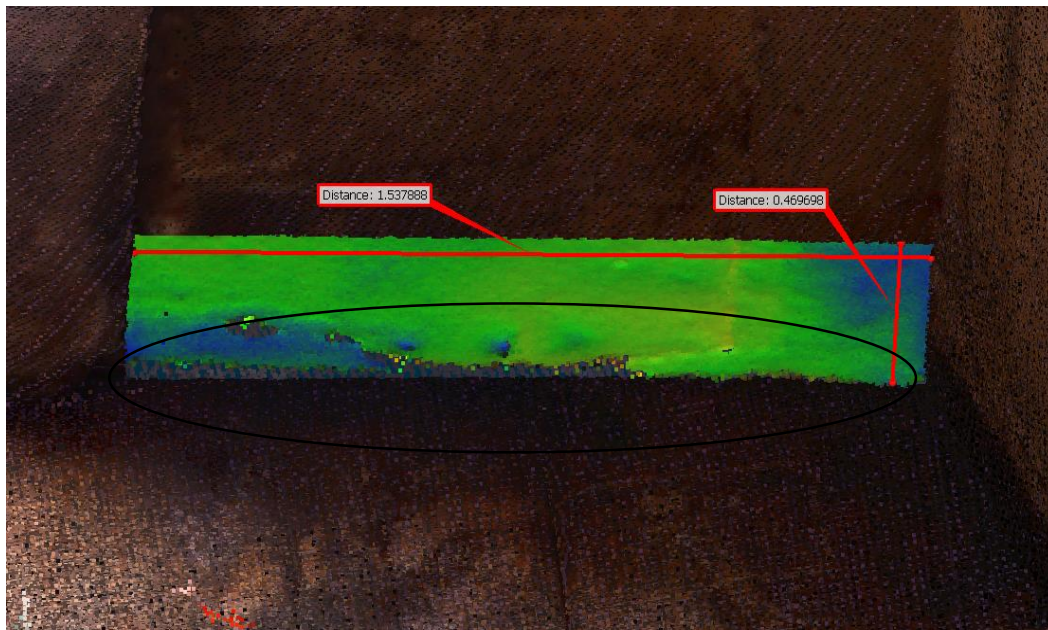
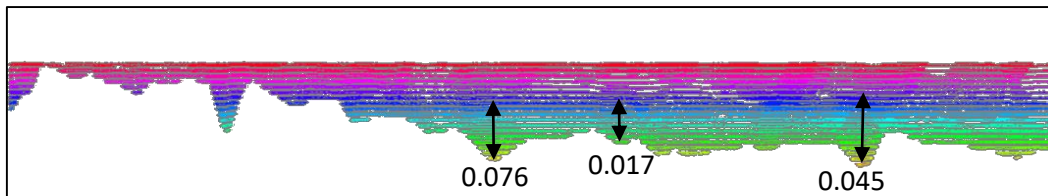
| Element Name | Observation | Location of Distress | Photo No. | Units | Distress Details | | | Area of Repair (Sq./RM T/m3) |
|---|---|---|---|---|---|---|---|---|
| Abutment 1 | Hollow Pocket | | 6 | | 1.53 | 0.46 | 0.045 | 0.03167 |

**6. Hollow pocket observed on approach slab dirt wall bottom, LHS Abutment 1, measuring 1.53 m in length and 0.46 m in width, Depth ranges from 0.016 m (min) to 0.071 m (max), with an average depth of 0.045 m. The calculated volume of the distress is 0.03167 m<sup>3</sup>.**

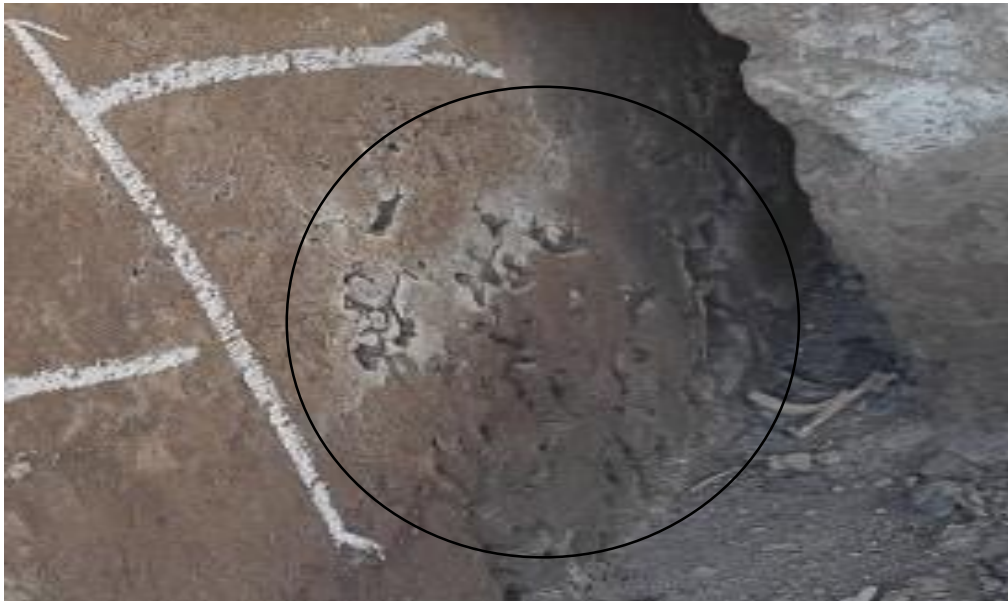
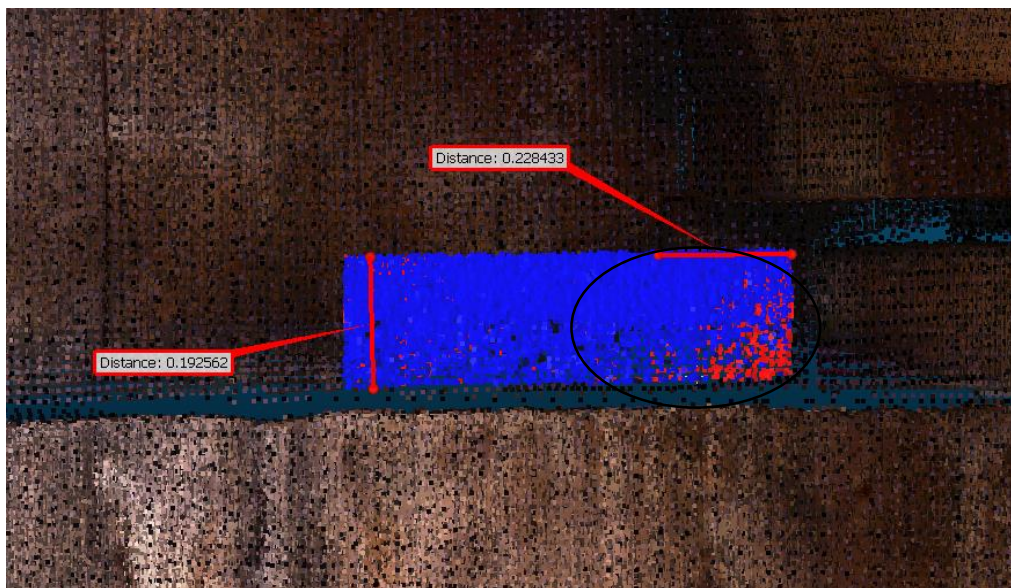
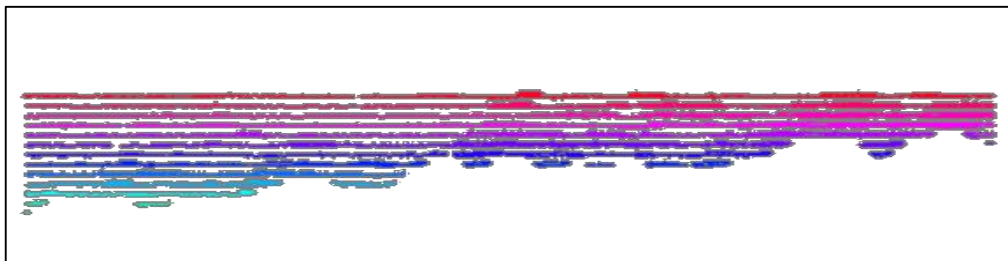
| Element Name | Observation | Location of Distress | Photo No. | Units | Distress Details | | | Area of Repair (Sq./RM T/m3) |
|---|---|---|---|---|---|---|---|---|
| Dirt Wall | Honey combing | | 7 | | 0.22 | 0.19 | | 0.0418 |

**7. Honeycombing observed at Bearing 1 pedestal dirt wall, LHS Abutment 1, measuring 0.22 m in length and 0.19 m in width, area 0.0418 m<sup>2</sup>.**

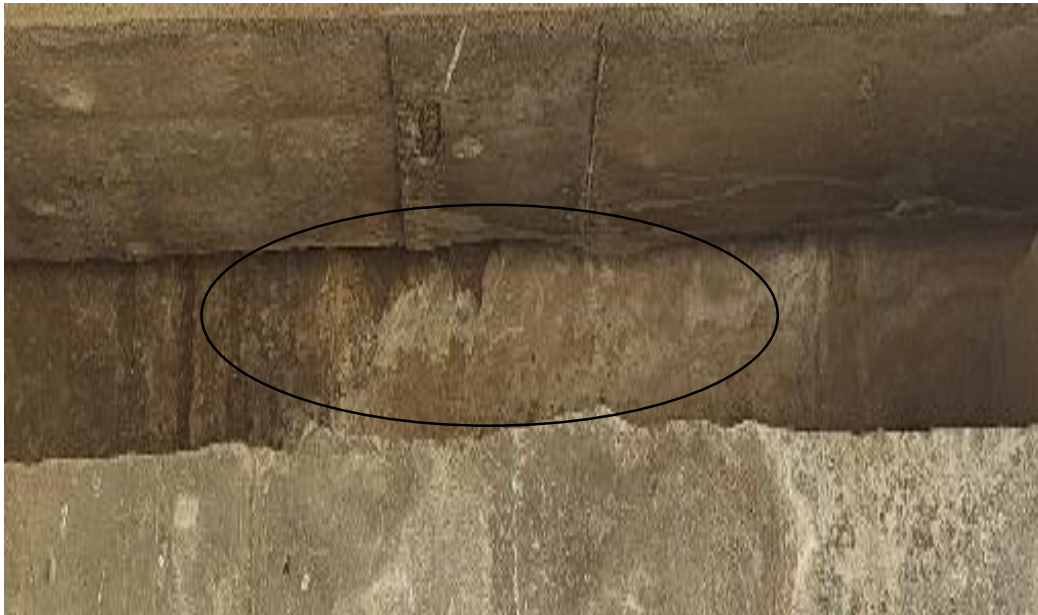
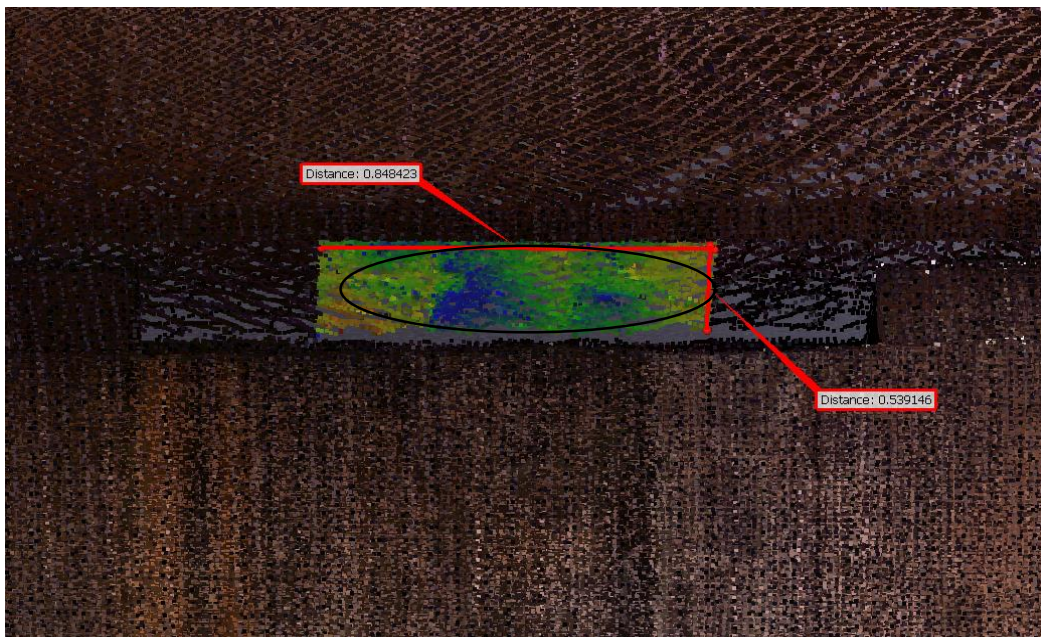
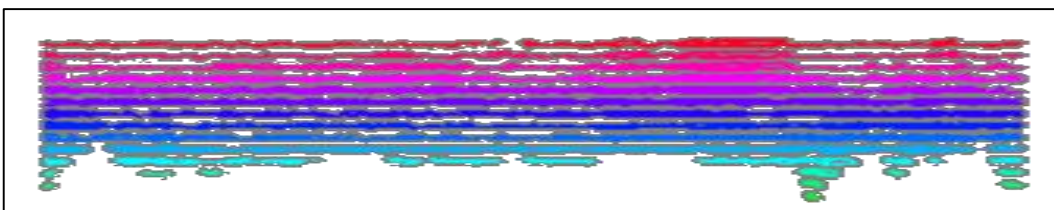
| Element Name | Observation | Location of Distress | Photo No. | Units | Distress Details | | | Area of Repair (Sq./RM T/m3) |
|---|---|---|---|---|---|---|---|---|
| Dirt Wall | Steel Exposed | | 8 | | 0.84 | 0.53 | | 0.4452 |

**8. Steel exposed section observed between Bearing 2–Bearing 3, LHS Abutment 1, measuring 0.84 m in length and 0.53 m in width, covering 0.4452 m<sup>2</sup>.**

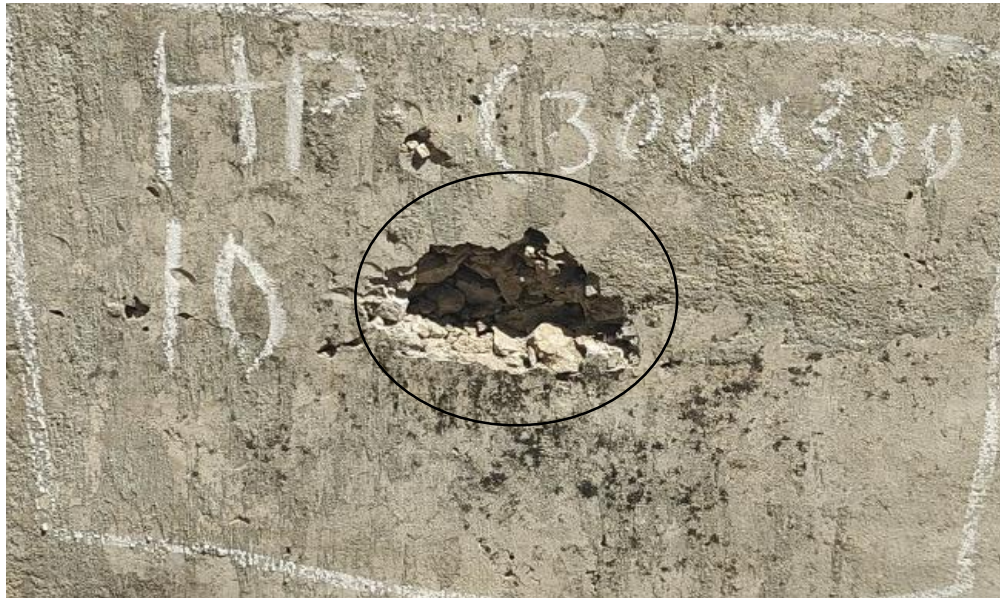
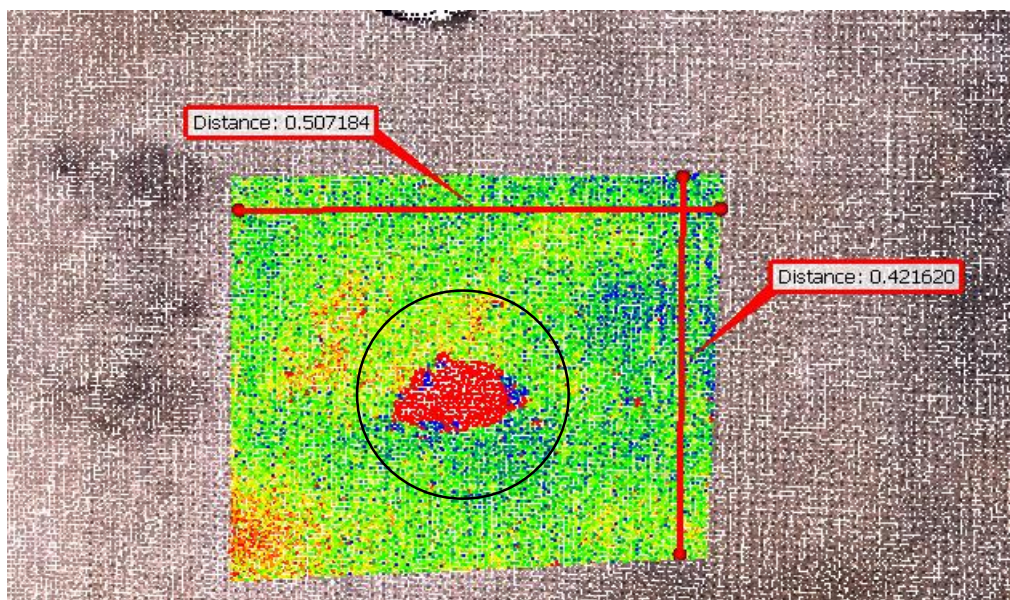
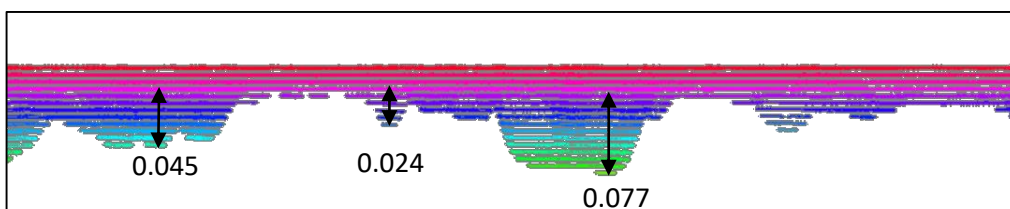
| Element Name | Observation | Location of Distress | Photo No. | Units | Distress Details | | | Area of Repair (Sq./RM T/m3) |
|---|---|---|---|---|---|---|---|---|
| Abutment 2 | Hollow Pocket | | 9 | | 0.50 | 0.42 | 0.045 | 0.00945 |

**9. Hollow pocket observed on LHS Abutment 2 , measuring 0.50 m in length and 0.42 m in width, covering 0.21 m<sup>2</sup>. Depth ranges from 0.024 m (min) to 0.077 m (max), with an average depth of 0.045 m. The calculated volume of the distress is 0.00945 m<sup>3</sup>.**

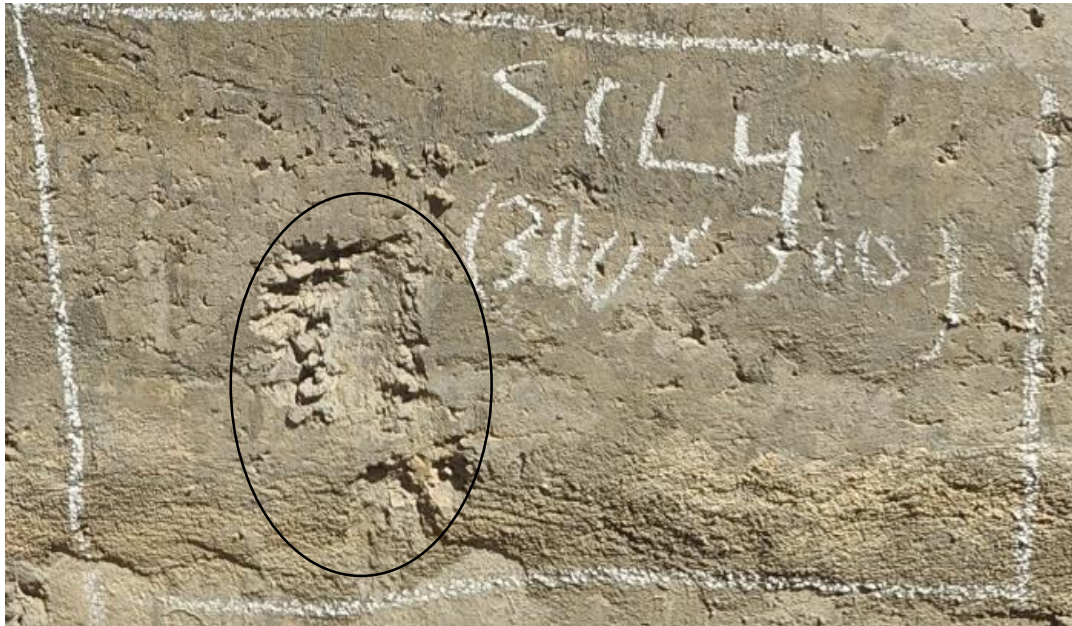
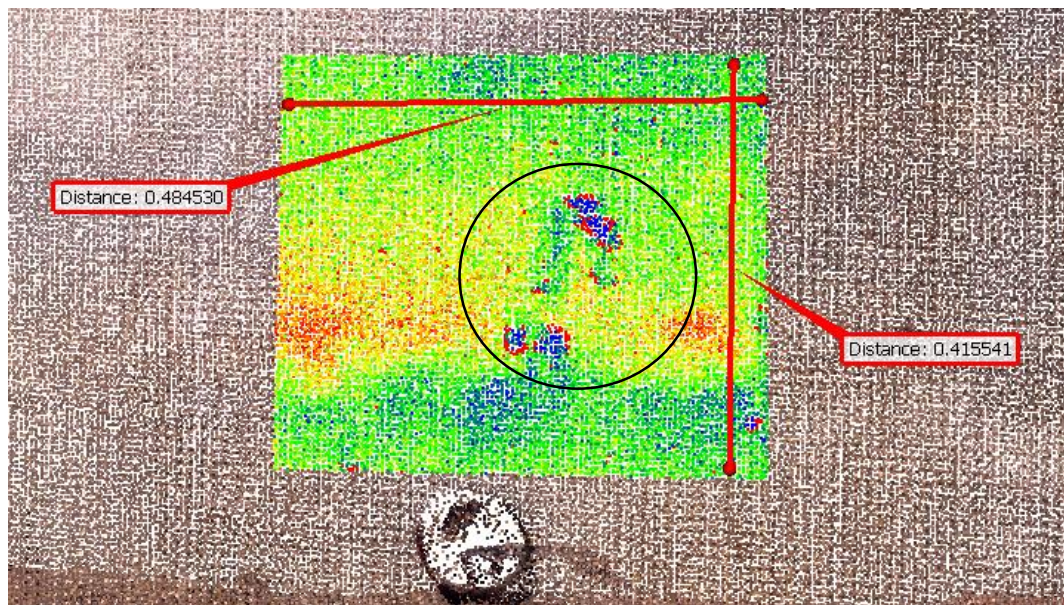
| Element Name | Observation | Location of Distress | Photo No. | Units | Distress Details | | | Area of Repair (Sq./RM T/m3) |
|---|---|---|---|---|---|---|---|---|
| Abutment 2 | Scaling | | 10 | | 0.48 | 0.41 | | 0.1968 |

**10. Scaling observed on LHS Abutment 2, measuring 0.48 m in length and 0.41 m in width, area 0.1968 m<sup>2</sup>**

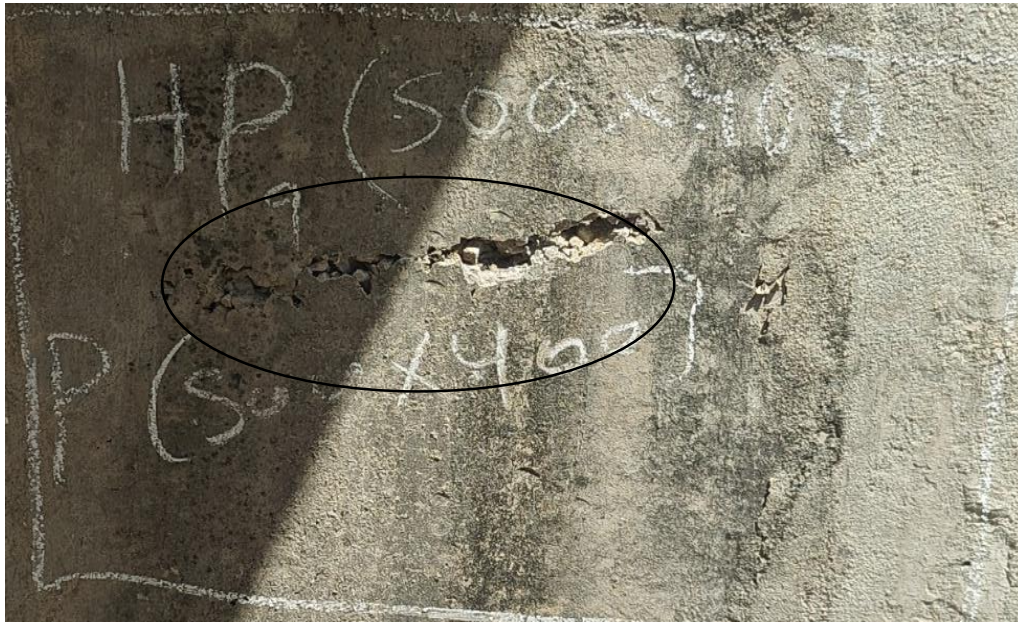
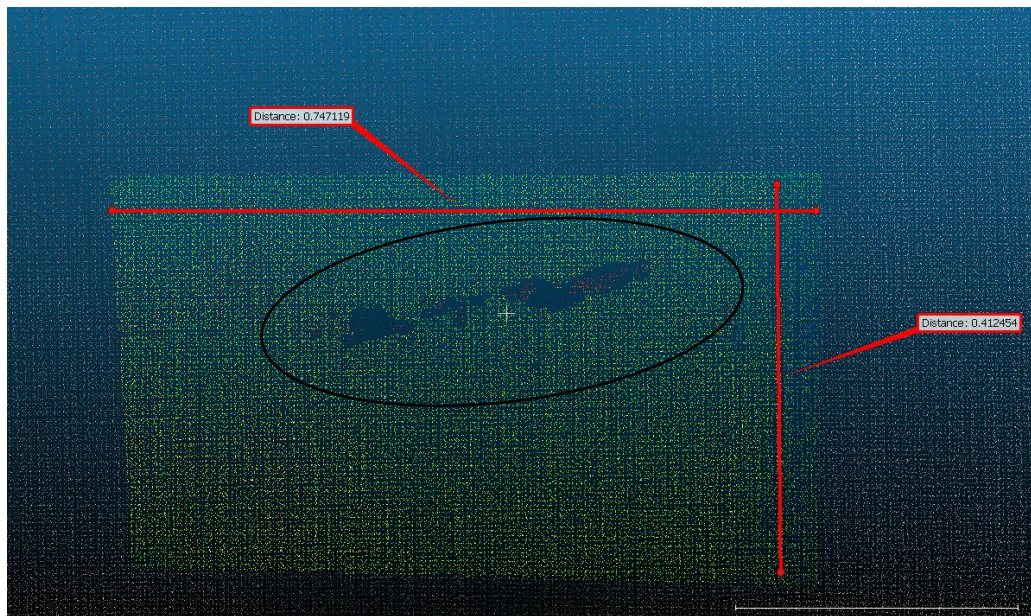
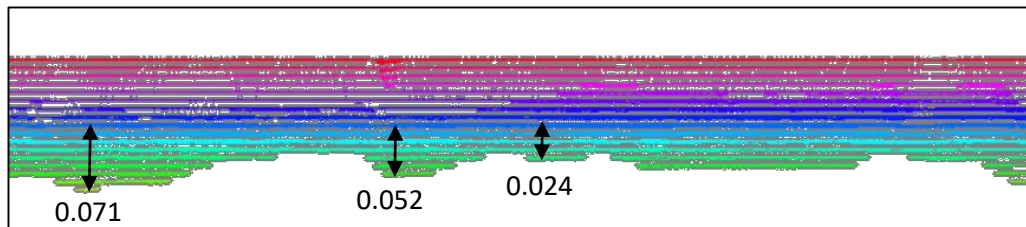
| Element Name | Observation | Location of Distress | Photo No. | Units | Distress Details | | | Area of Repair (Sq./RM T/m3) |
|---|---|---|---|---|---|---|---|---|
| Abutment 2 | Hollow Pocket | | 11 | | 0.74 | 0.41 | 0.052 | 0.01577 |

**11. Hollow pocket observed on LHS Abutment 2, measuring 0.74 m in length and 0.41 m in width, Depth ranges from 0.024 m (min) to 0.071 m (max), with an average depth of 0.052 m. The calculated volume of the distress is 0.01577 m<sup>3</sup>.**

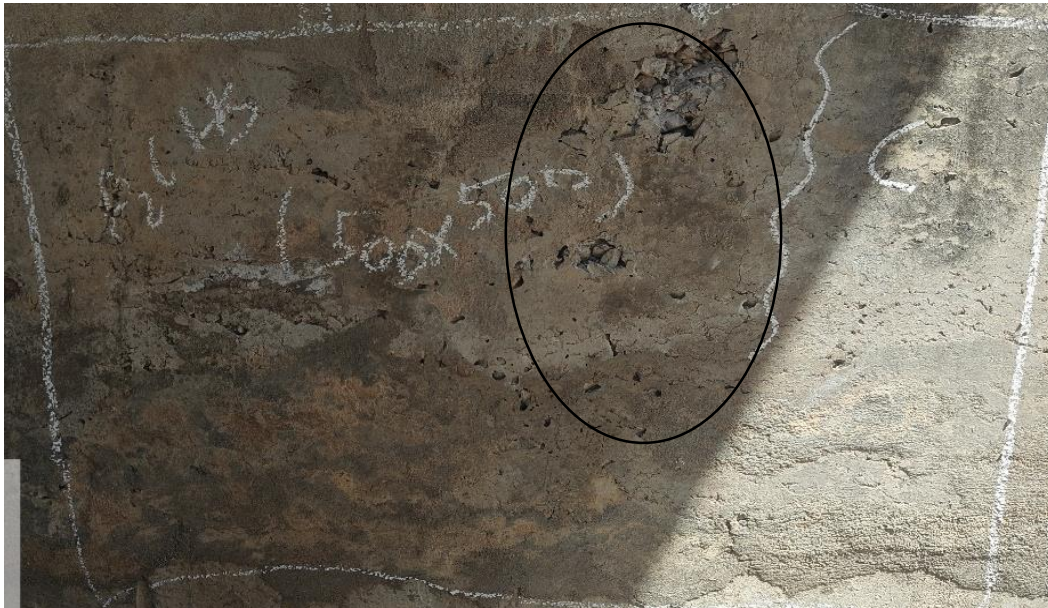
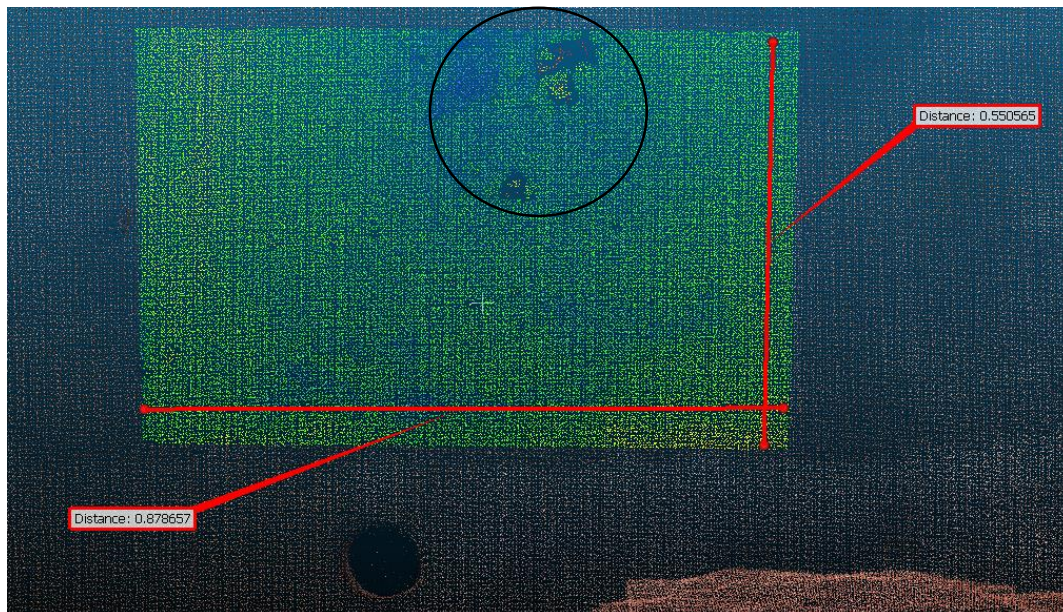
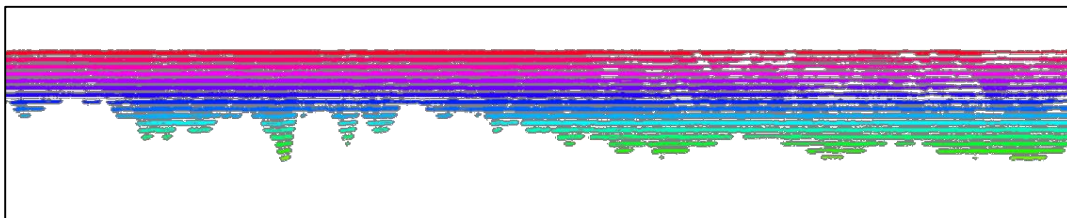
| Element Name | Observation | Location of Distress | Photo No. | Units | Distress Details | | | Area of Repair (Sq./RM T/m3) |
|---|---|---|---|---|---|---|---|---|
| Abutment 2 | Scaling | | 12 | | 0.87 | 0.55 | | 0.4785 |

**12. Scaling observed on LHS Abutment 2, measuring 0.87 m in length and 0.55 m in width, area 0.4785 m<sup>2</sup>.**

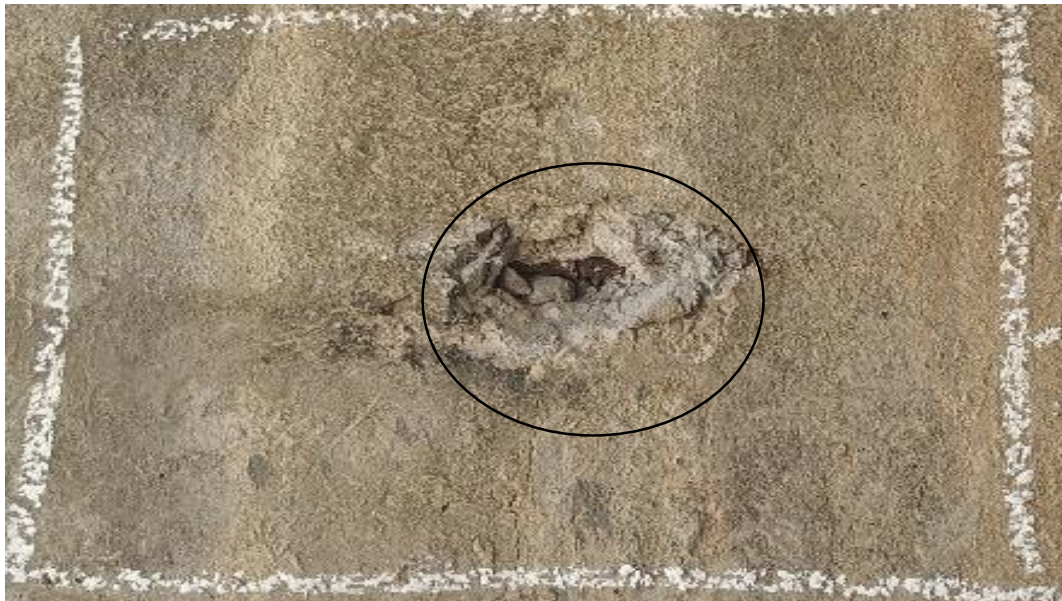
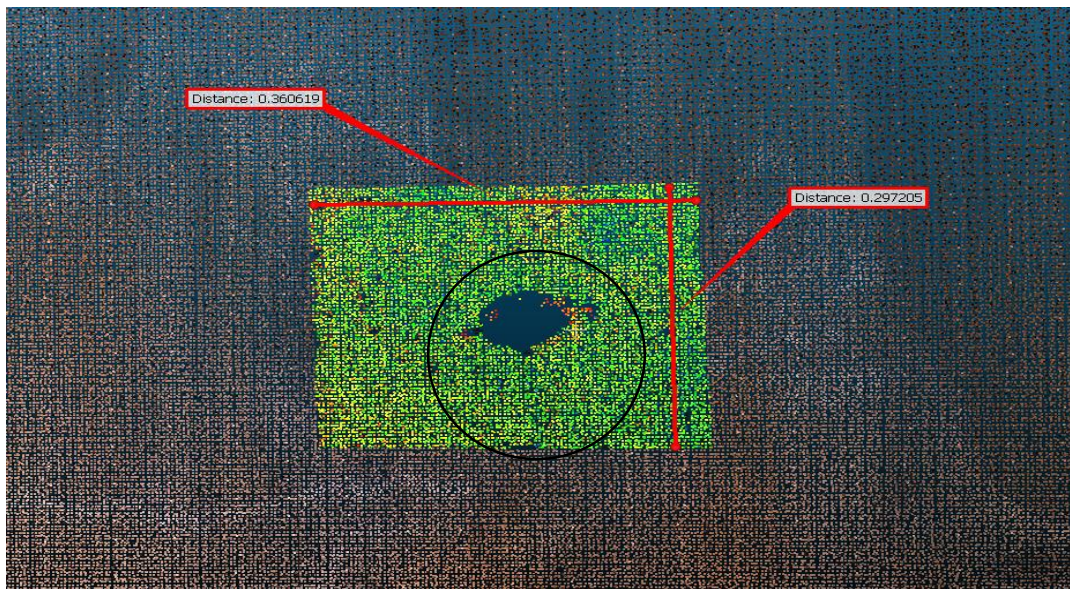
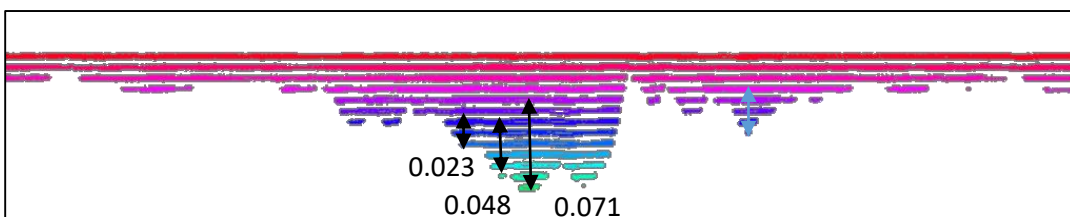
| Element Name | Observation | Location of Distress | Photo No. | Units | Distress Details | | | Area of Repair (Sq./RM T) |
|---|---|---|---|---|---|---|---|---|
| Abutment 1 | Hollow Pocket | | 13 | | 0.36 | 0.29 | 0.048 | 0.00501 |

**13. Hollow pocket observed on RHS Abutment 1 measuring 0.36 m in length and 0.29 m in width, Depth ranges from 0.023m (min) to 0.071 m (max), with an average depth of 0.048 m. The calculated volume of the distress is 0.00501m<sup>3</sup>.**

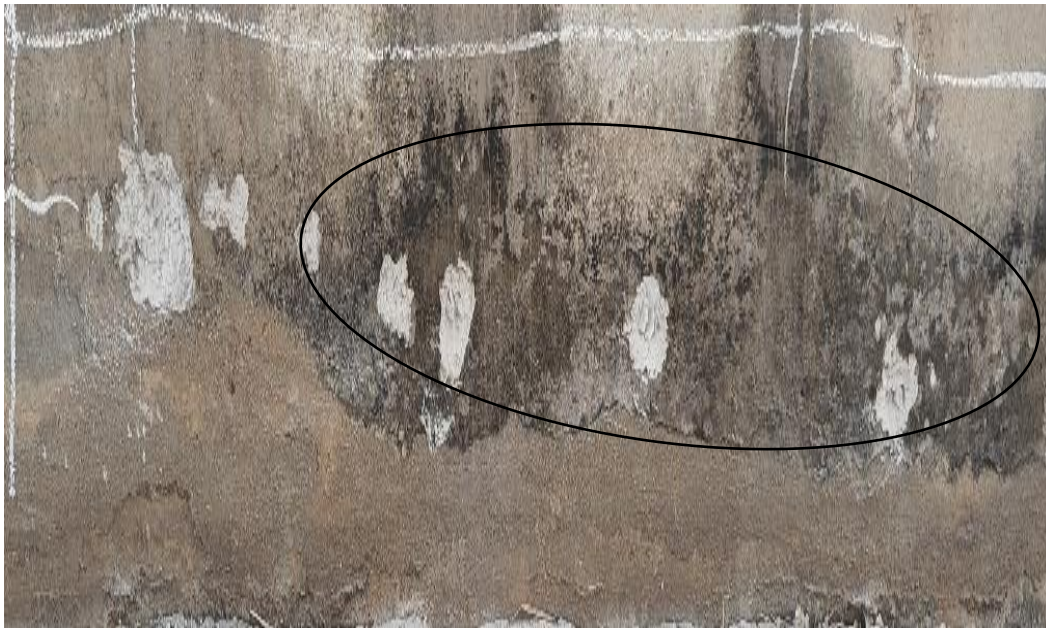
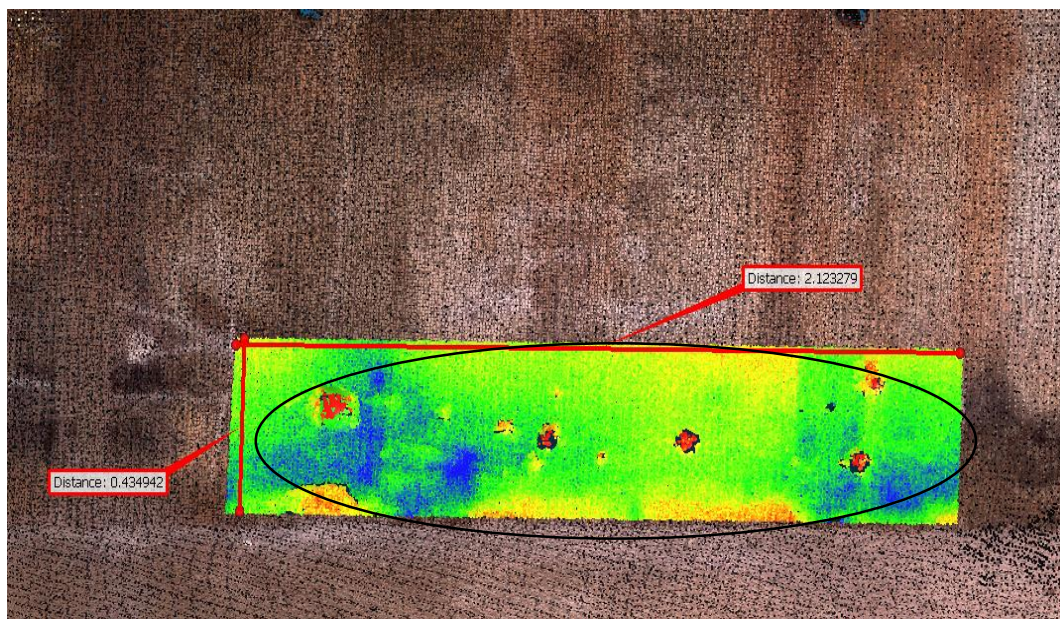
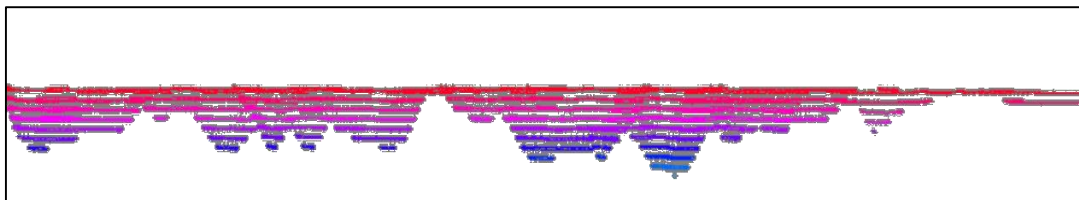
| Element Name | Observation | Location of Distress | Photo No. | Units | Distress Details | | | Area of Repair (Sq./RM T) |
|---|---|---|---|---|---|---|---|---|
| Abutment 1 | Spalling | | 14 | | 2.12 | 0.43 | | 0.9116 |

**14. Spalling observed on RHS Abutment 1 due to sulphate attack, measuring 2.12 m in length and 0.43 m in width, covering an area of 0.9116 m<sup>2</sup>.**

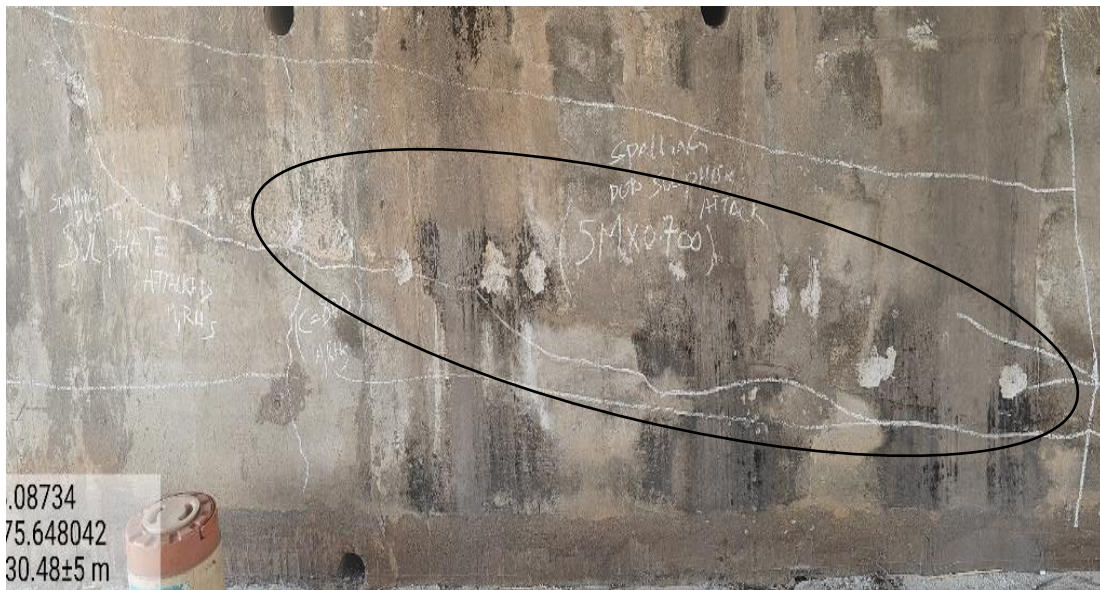
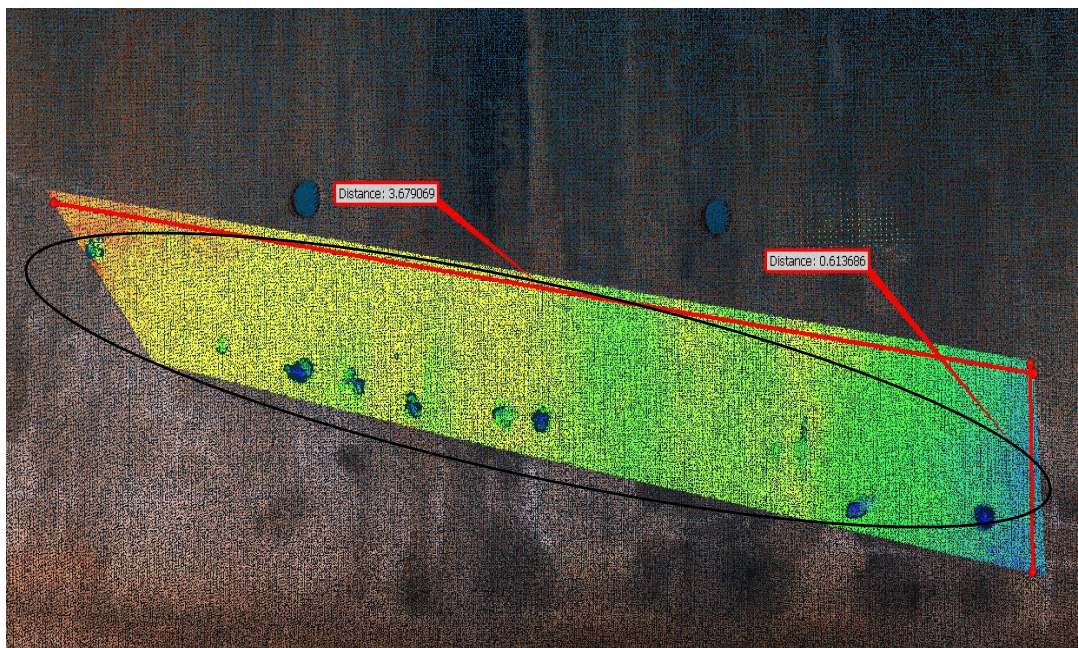
| Element Name | Observation | Location of Distress | Photo No. | Units | Distress Details | | | Area of Repair (Sq./RM T) |
|---|---|---|---|---|---|---|---|---|
| Abutment 1 | Spalling | | 15 | | 3.67 | 0.61 | | 2.2387 |

**15. Spalling observed on RHS Abutment 1 due to sulphate attack, measuring 3.67 m in length and 0.61 m in width, covering an area of 2.2387 m<sup>2</sup>.**
